National Register of Historic Places
Registration Form

historic name Sherrard Banking Company

street & number 314 Third Street not for publication

state Illinois code IL county Mercer code 131 zip code 61281

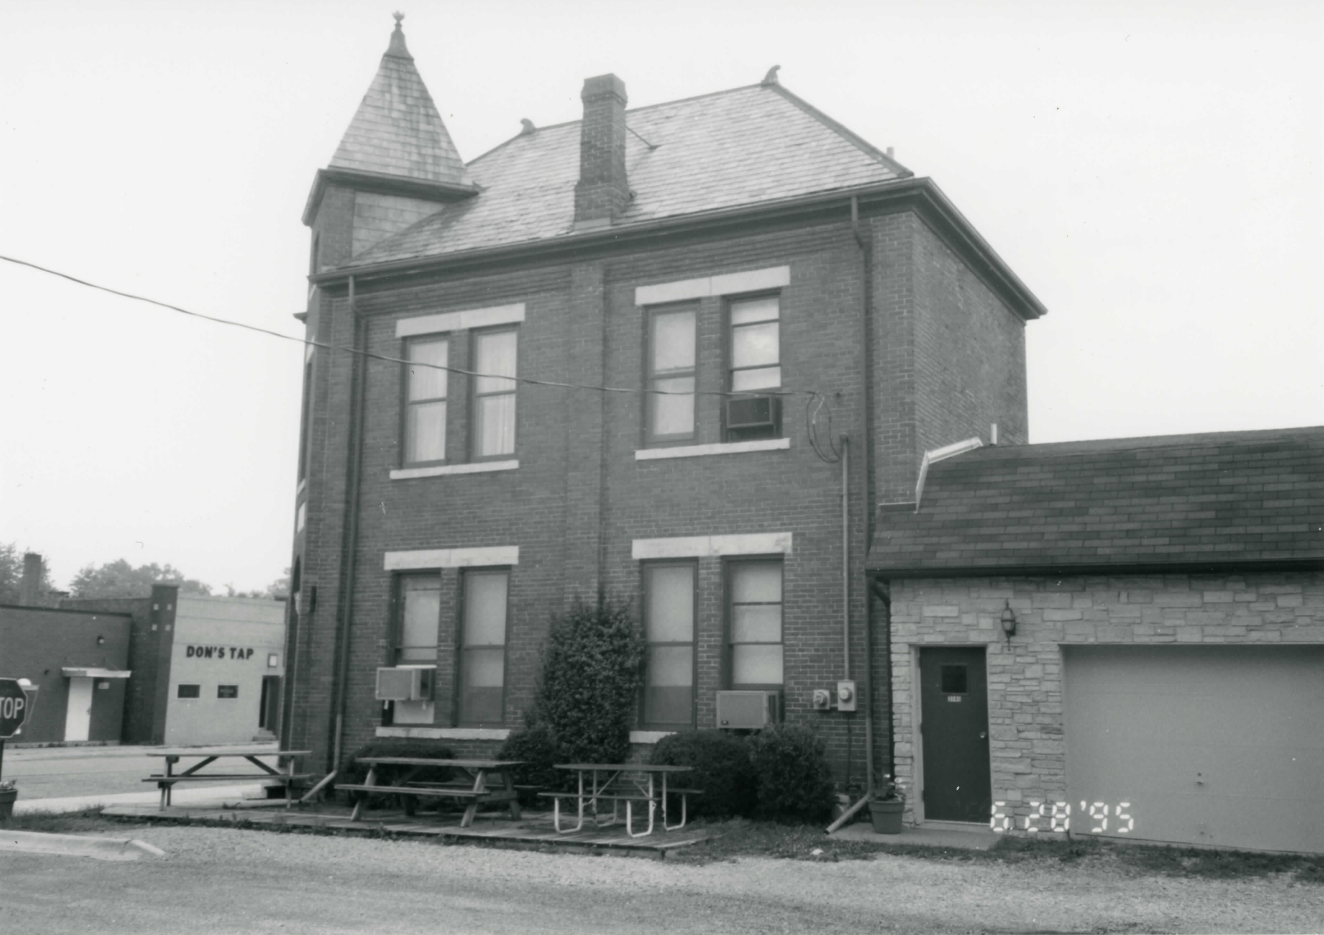
PHOTO # 1

LOOKING EAST

On the north elevation first story is a pair of windows with another pair directly above them on the second story. The tower has a single window on the second story and a small one-pane window above. This small attic window has a segmental brick arch with soldier brick. A small one-pane window is also on the east side of the tower.

The west elevation first story has two sets of double windows. Directly above on the second story are two sets of double windows. The brick chimney is located between the pairs of windows.

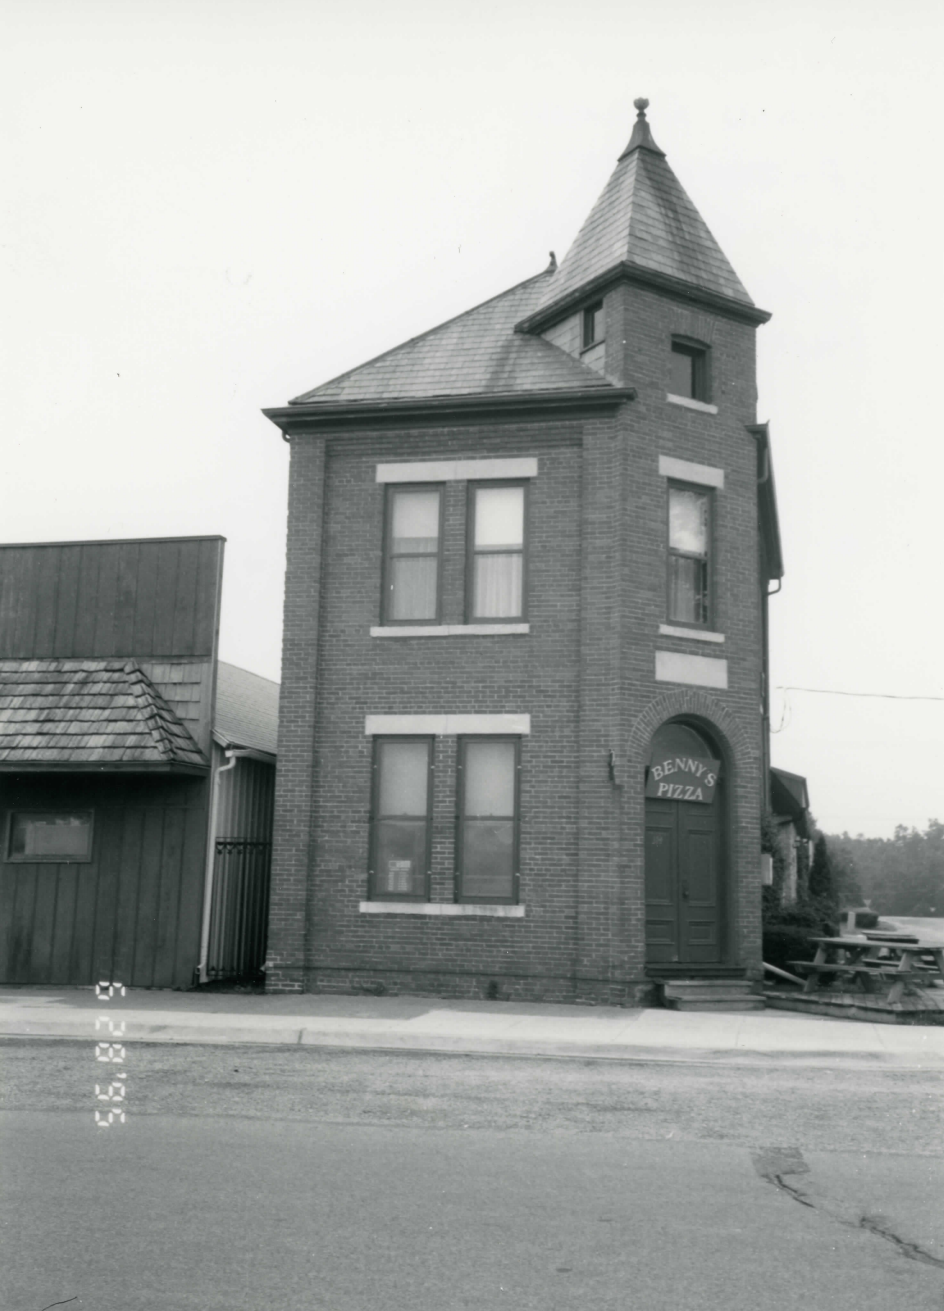
PHOTO # 2

LOOKING SOUTH

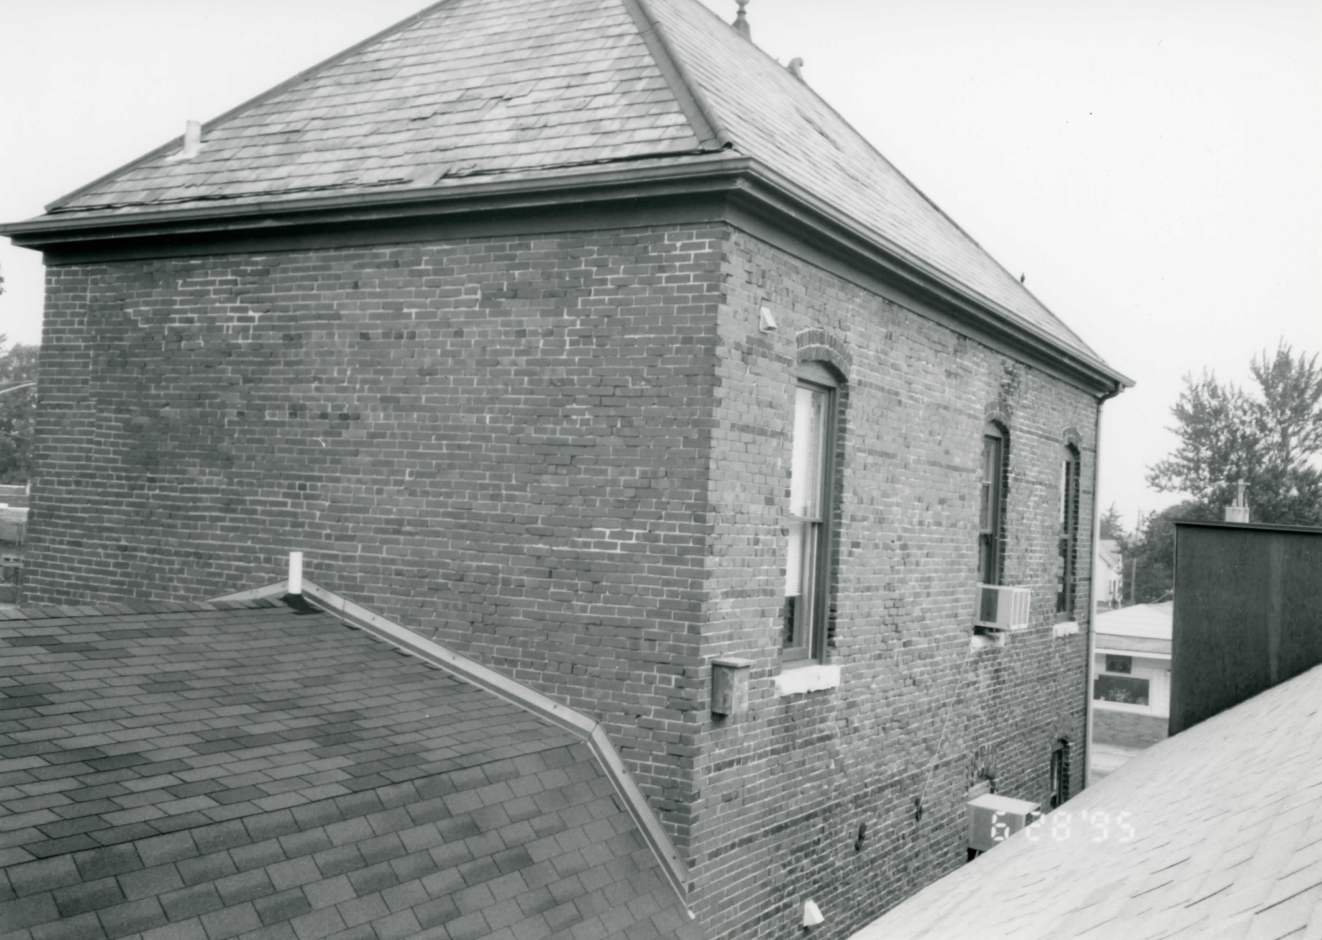
PHOTO # 3

LOOKING NORTH WEST

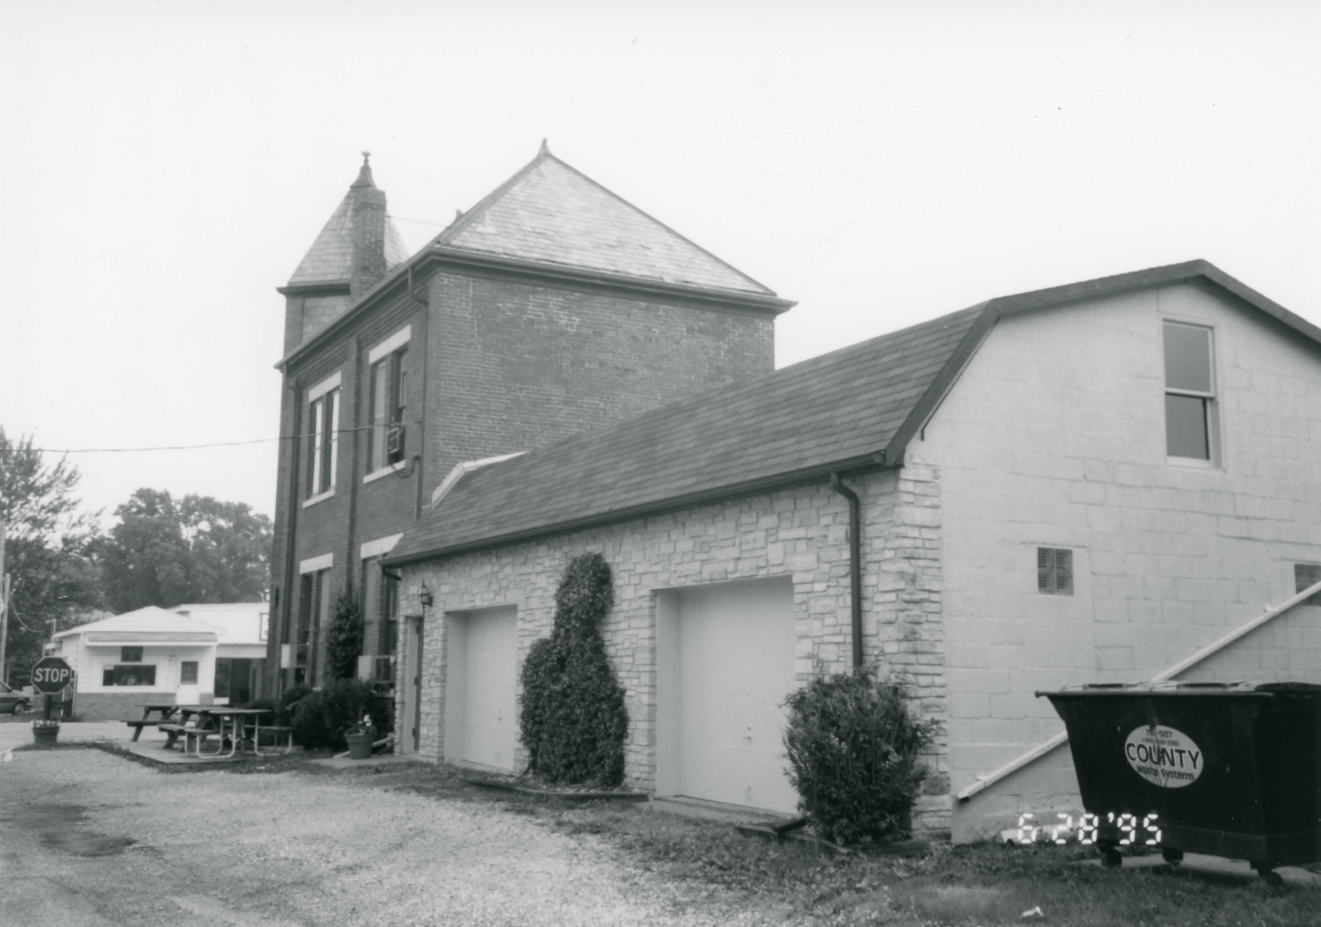
PHOTO # 4

LOOKING NORTH EAST

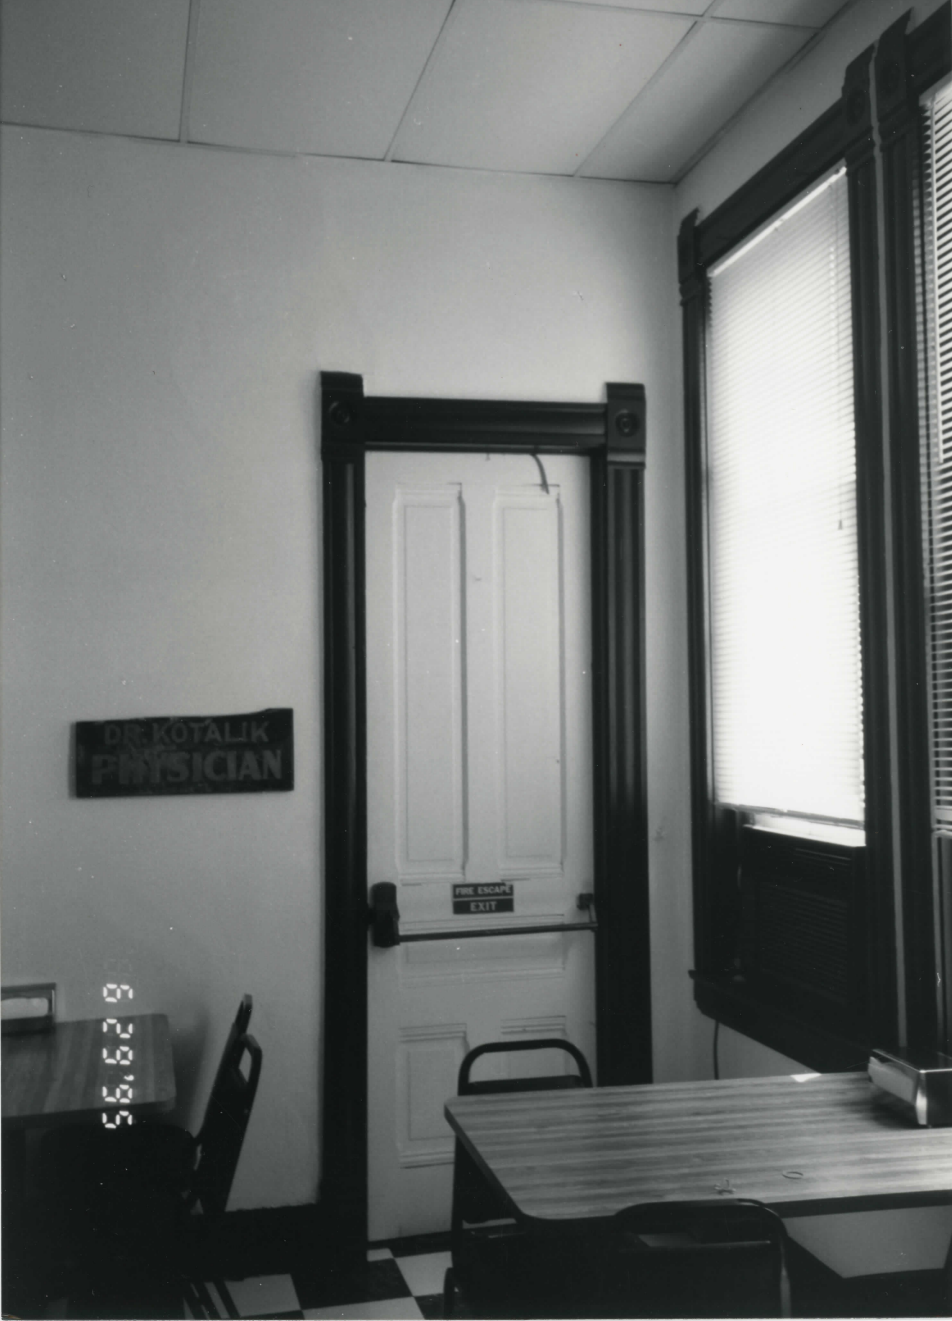
PHOTO # 5

INSIDE - LOOKING SOUTH - 1 ST FLOOR

The interior first floor is composed of 2 x 12 wood joists topped by a wood floor. A small vestibule on the northwest corner leads into the banking room. A smaller office is located to the south of the banking room and has two doorways on its north wall. The original masonry vault with arched ceiling and original vault door is located to the south. Behind the office to the south is the staircase leading east to the second floor. A small half bath is located in the southeast corner of the building. The door and window trim has fluting and corner blocks with bullseye decoration. The bank vault door trim has a broken segmental pediment with a decorative urn. There are dentils below the pediment. The wood trim on the side of the door has fluting and Corinthian inspired capitals. The first story has a 11' 6" ceiling height. Dropped tile ceilings have been added on both stories but they do not cover the window or door trim.

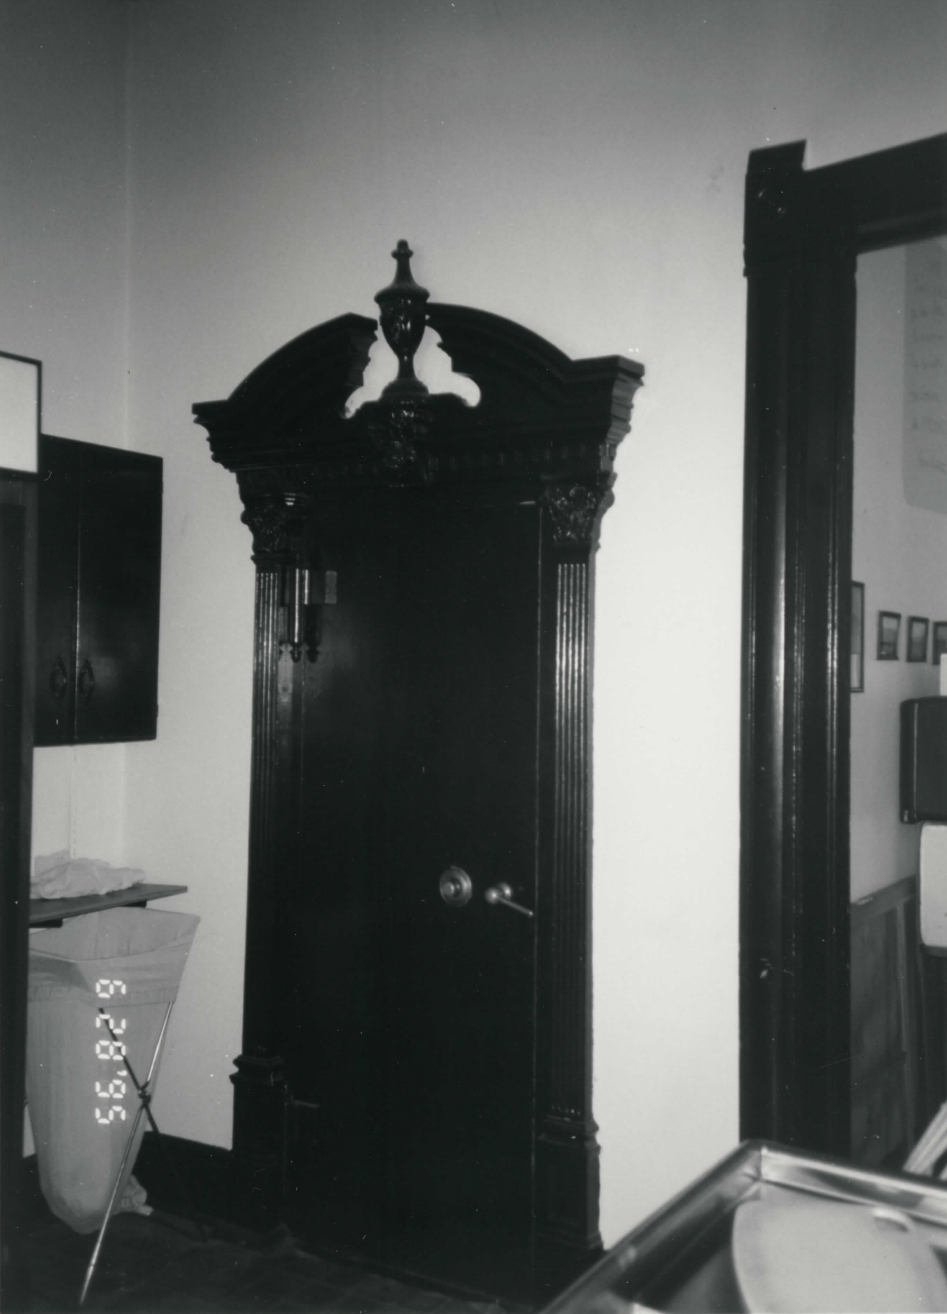
PHOTO # 6

INSIDE - LOOKING SOUTH - 1ST FLOOR
