National Register of Historic Places Inventory—Nomination Form

historic Ray, A. Taylor, House

street & number 212 West Van Buren Street not for publication

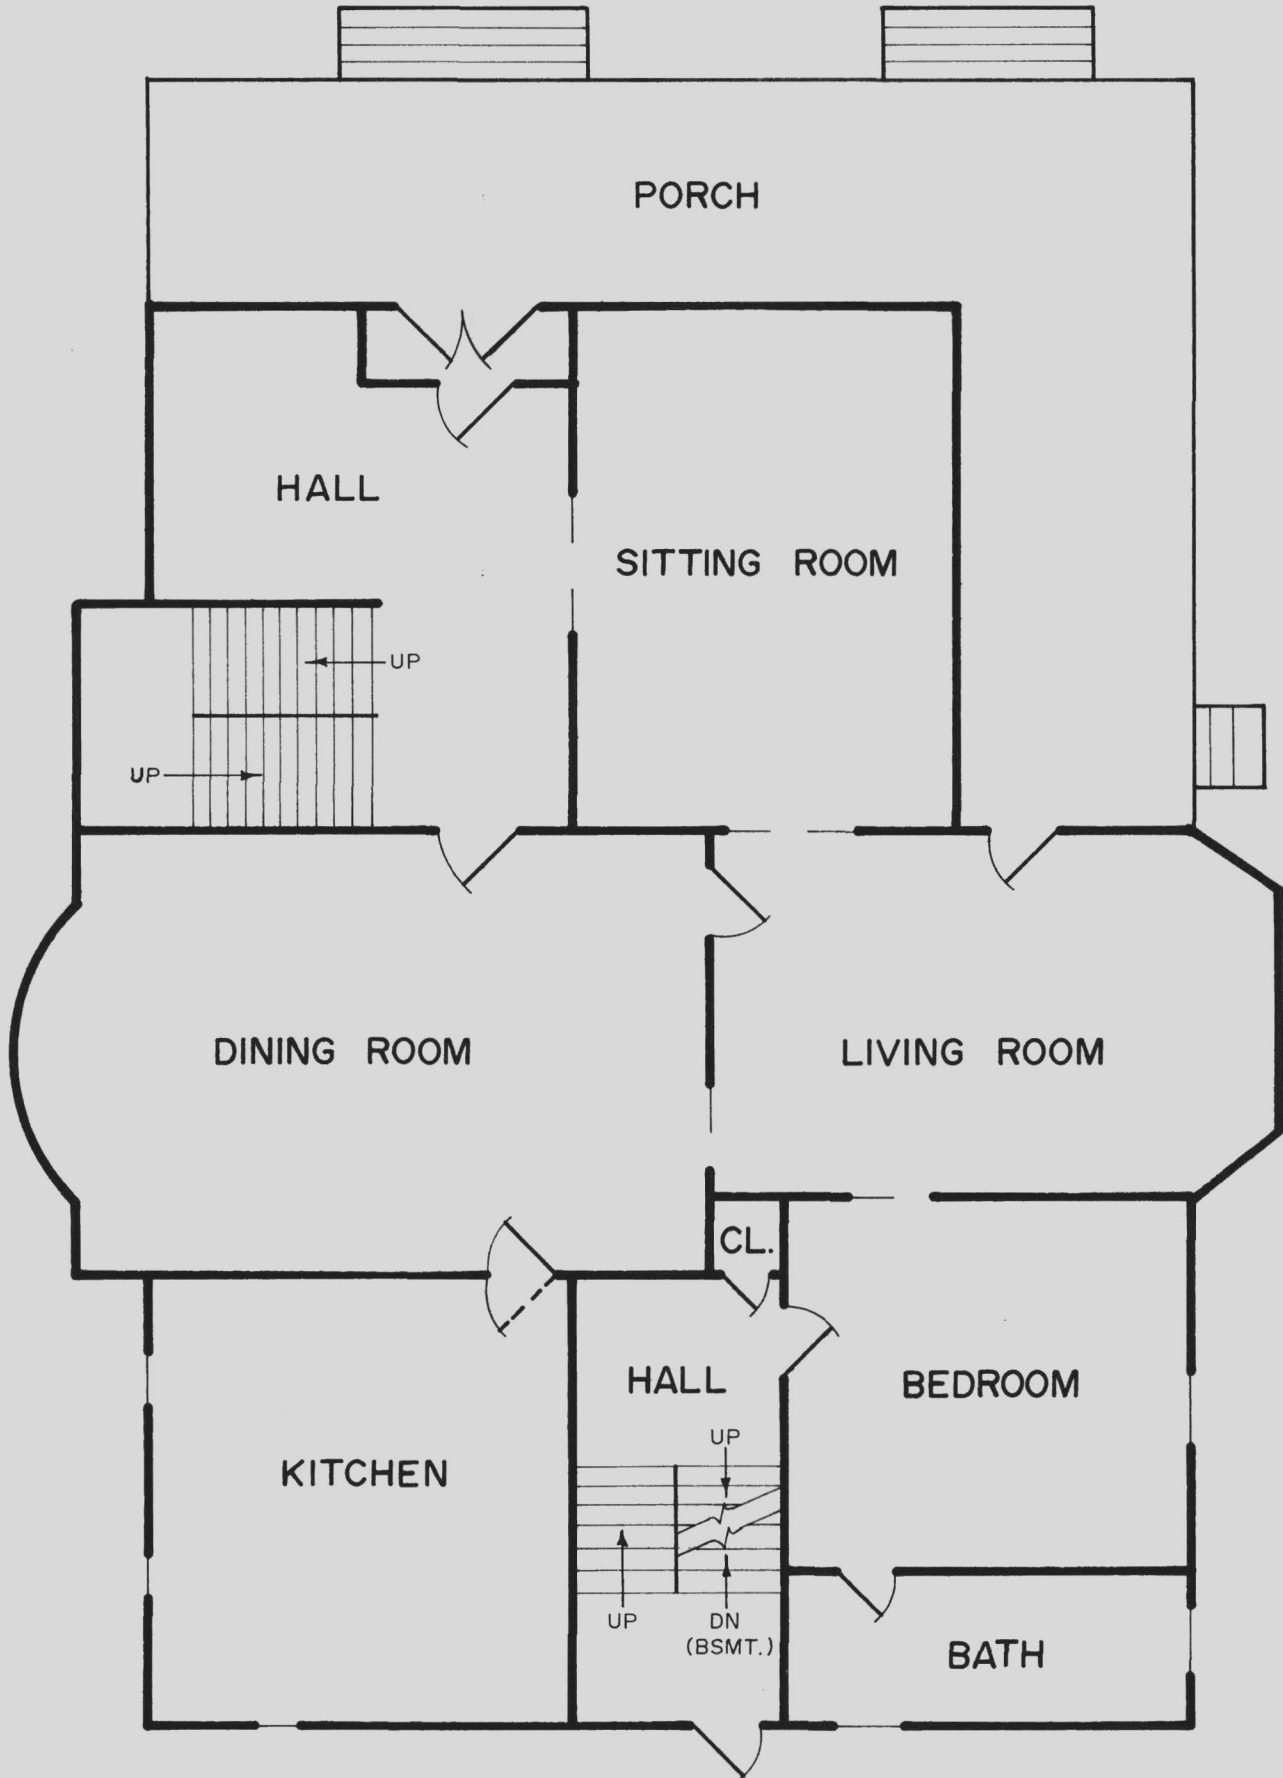
FIRST FLOOR PLAN

A. TAYLOR RAY HOUSE
GALLATIN, MISSOURI

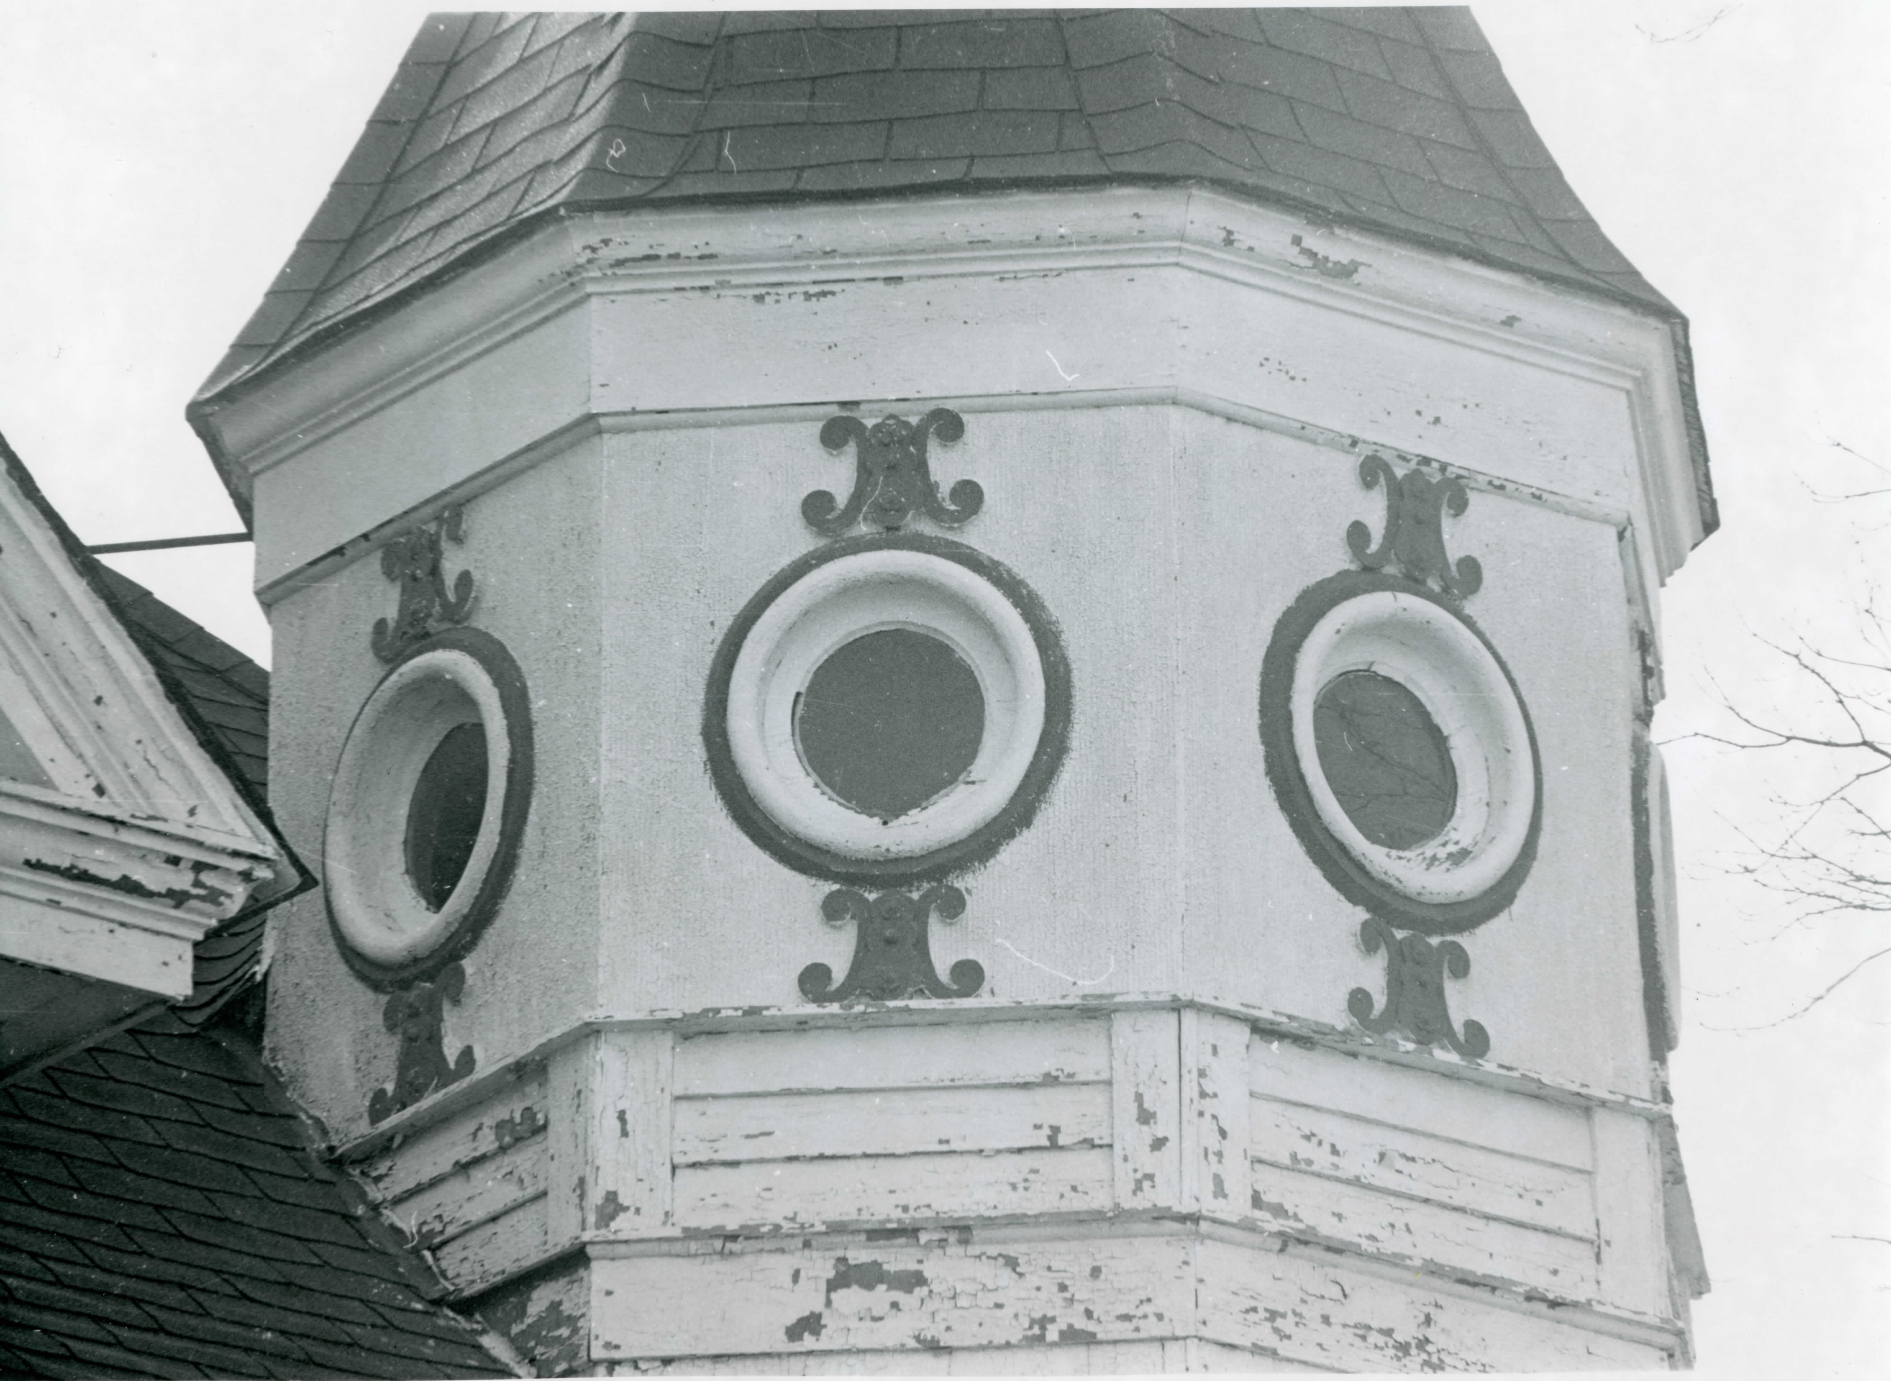
RAY, A. TAYLOR HOUSE #3 of 10
212 West Van Buren, Gallatin, Daviess County,
MO.

Primary facade, detail, northwest tower.

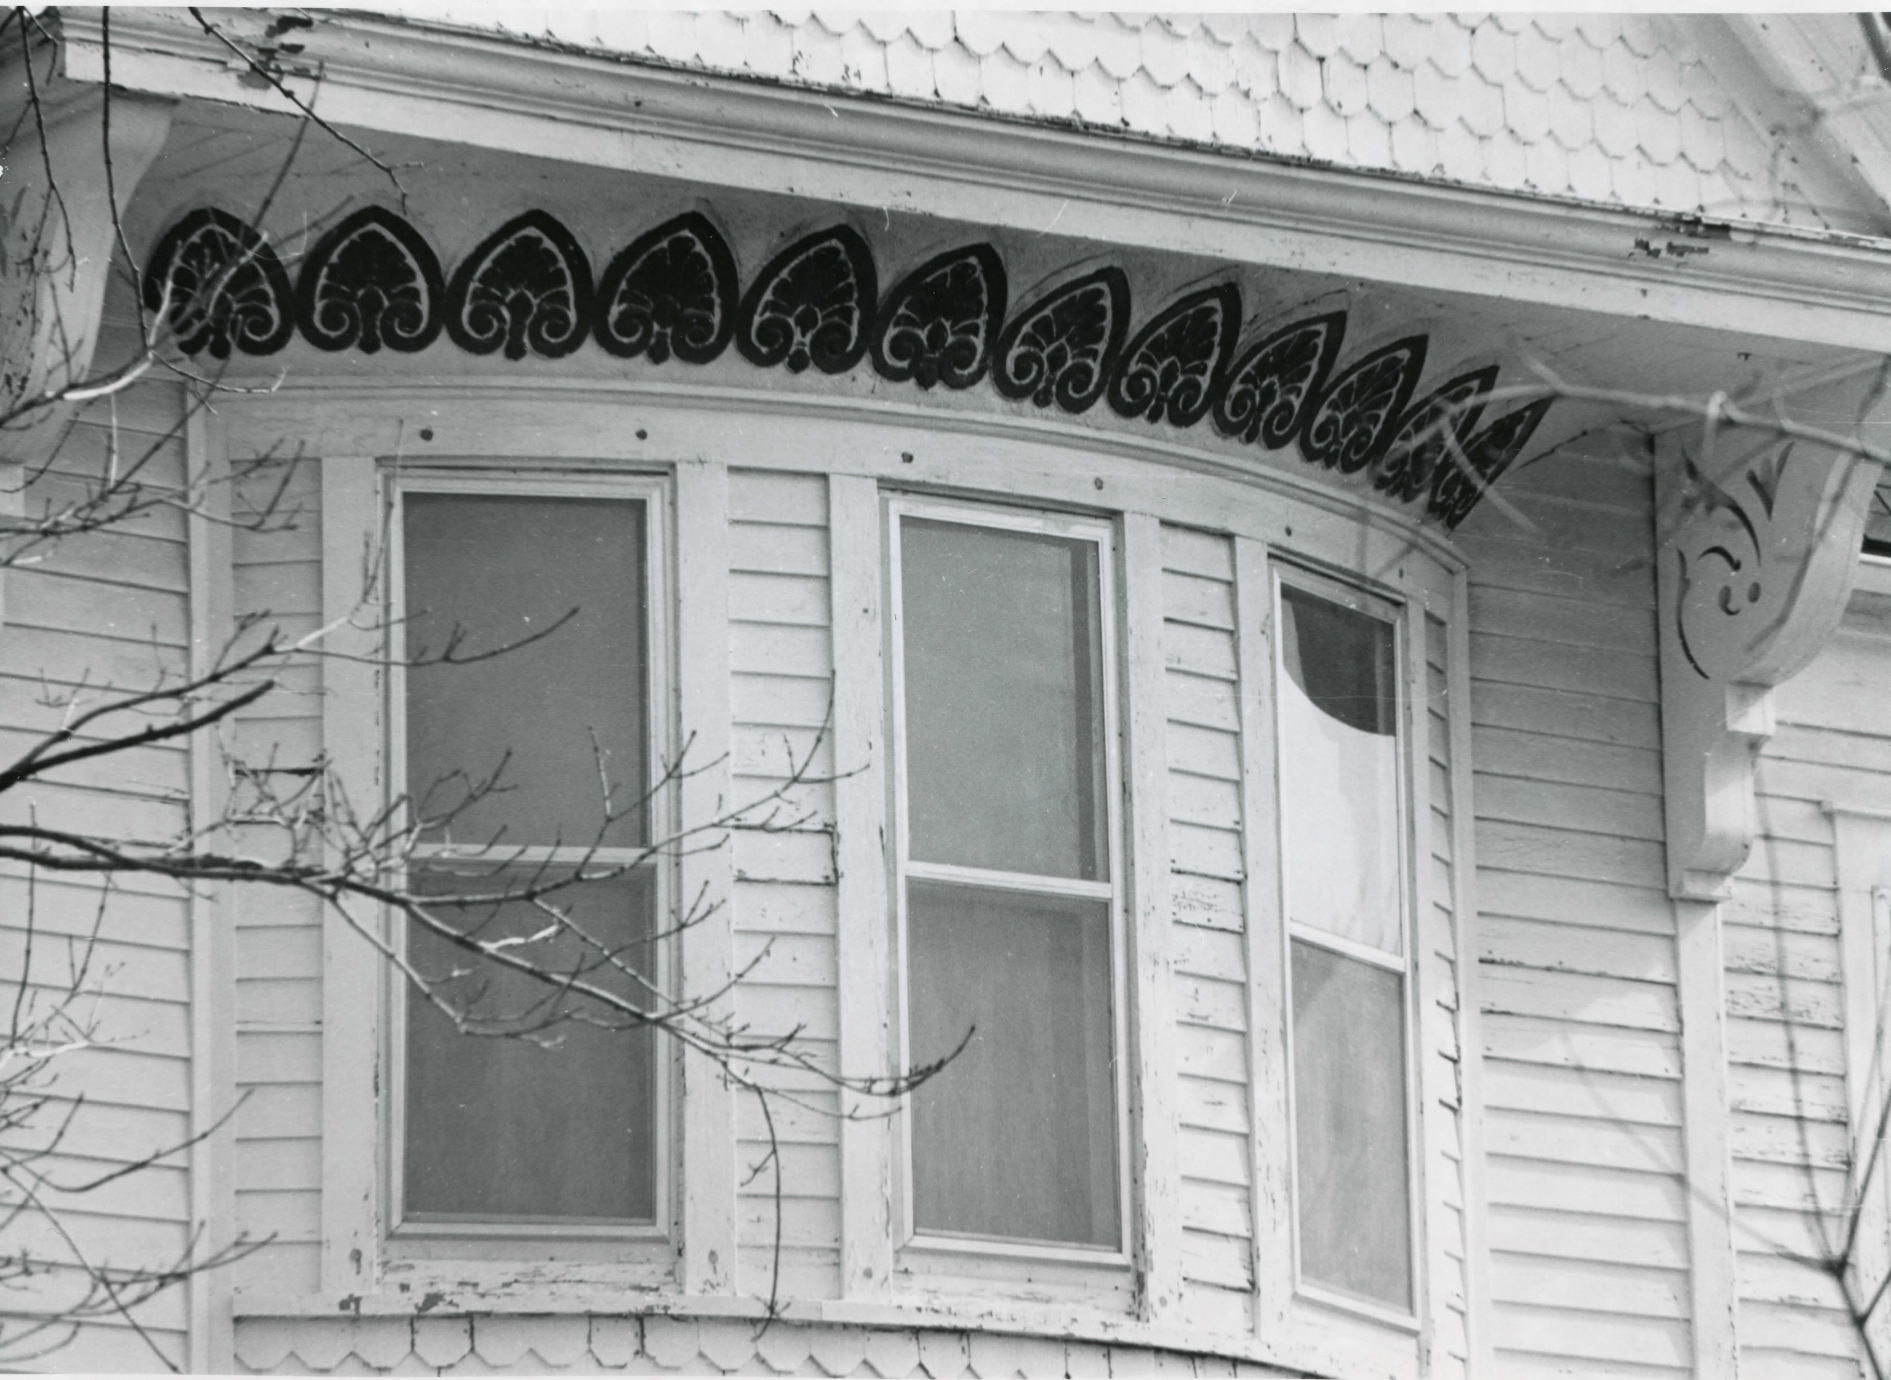
RAY, A. TAYLOR HOUSE #7 of 10
212 West Van Buren, Gallatin, Daviess County,
MO.

West side, second floor level, detail of
cavetto molding with anthemion design.

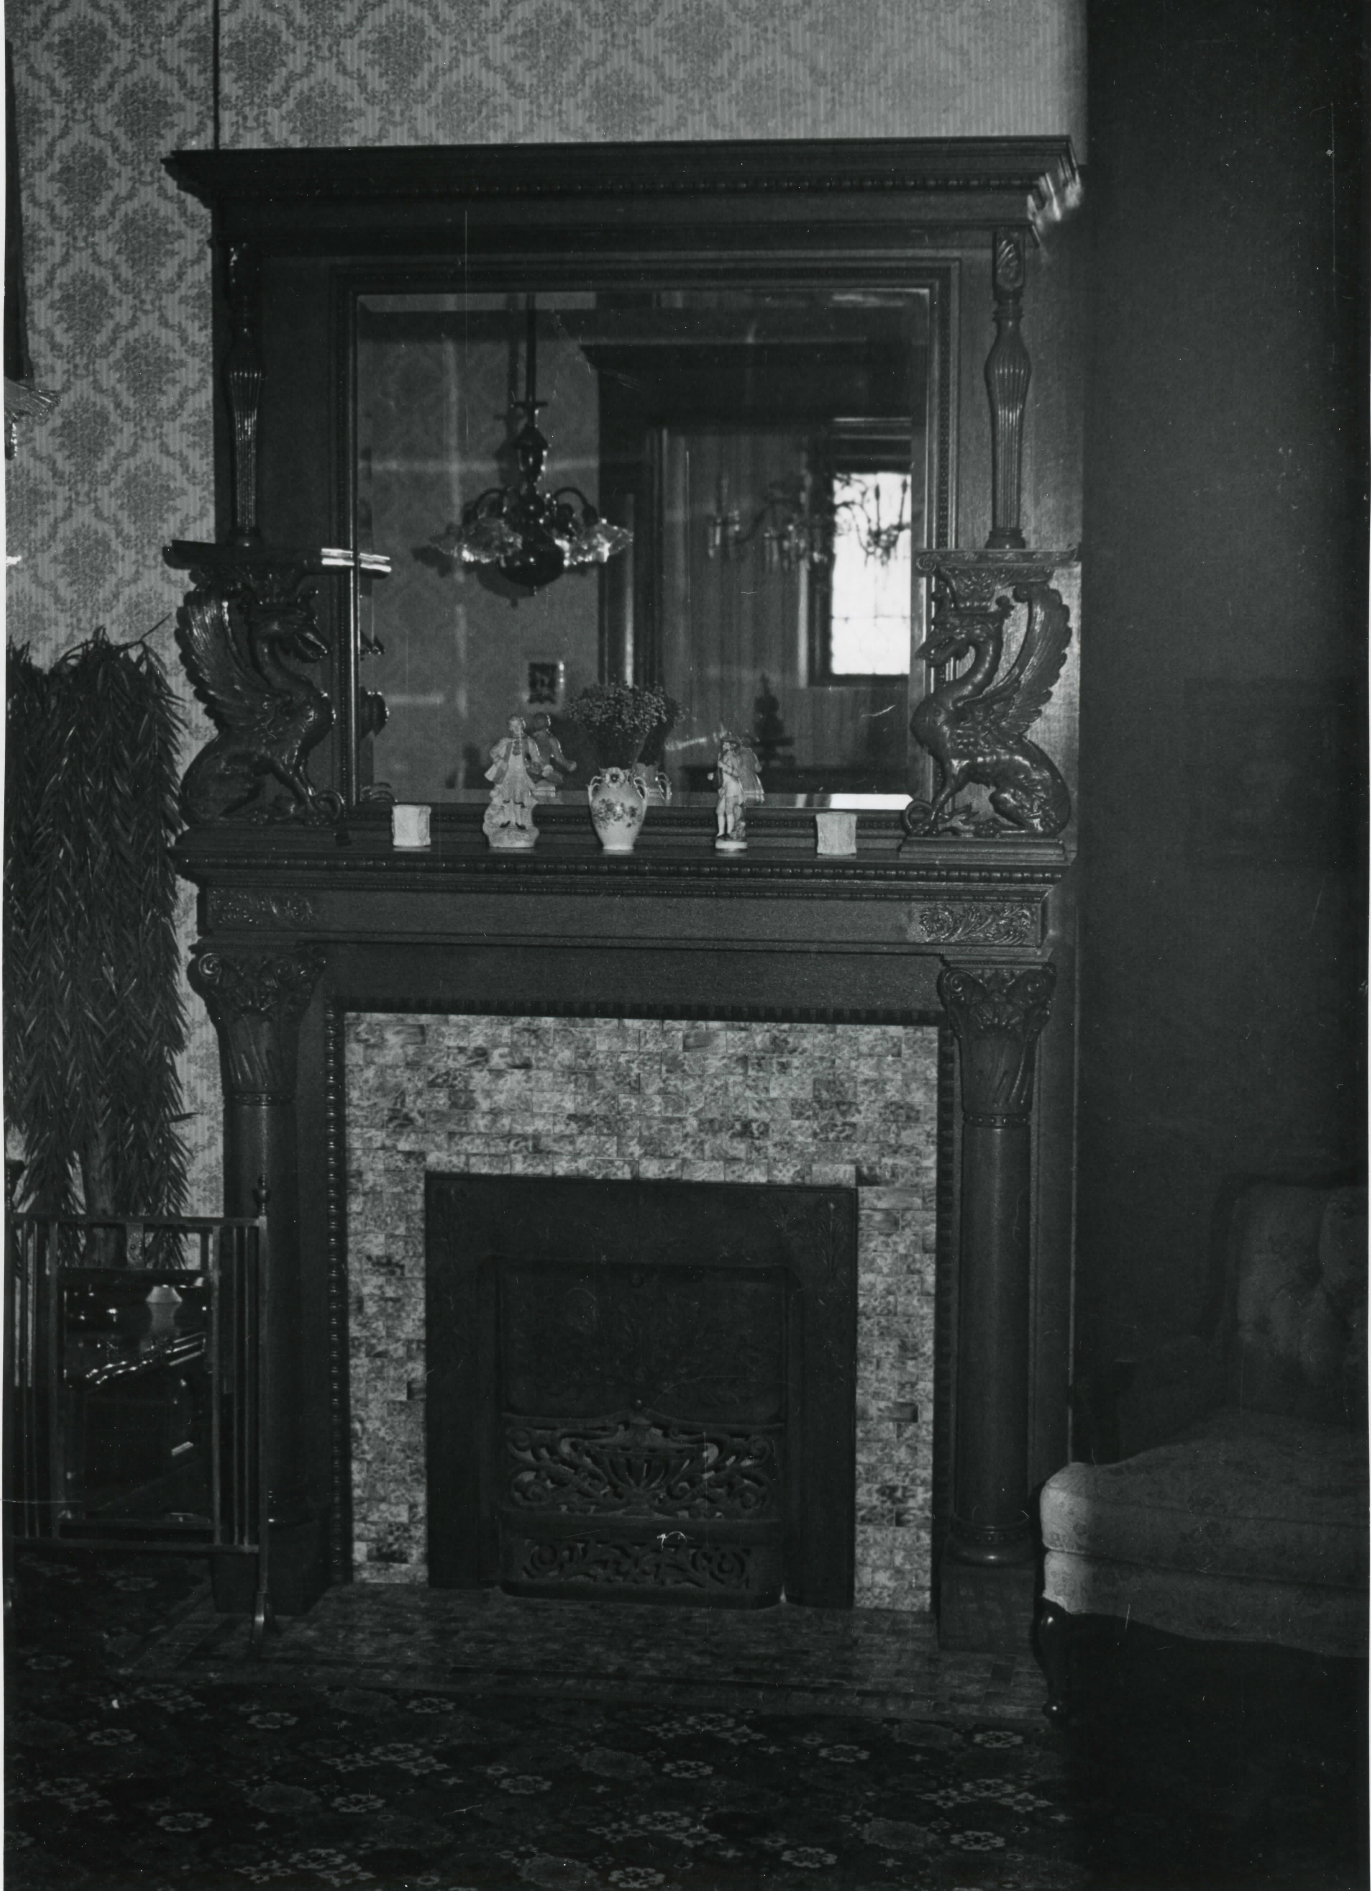
RAY, A. TAYLOR HOUSE #8 of 10
212 West Van Buren, Gallatin, Daviess County,
MO.

Interior, first floor sitting room, east wall,
chimney piece.

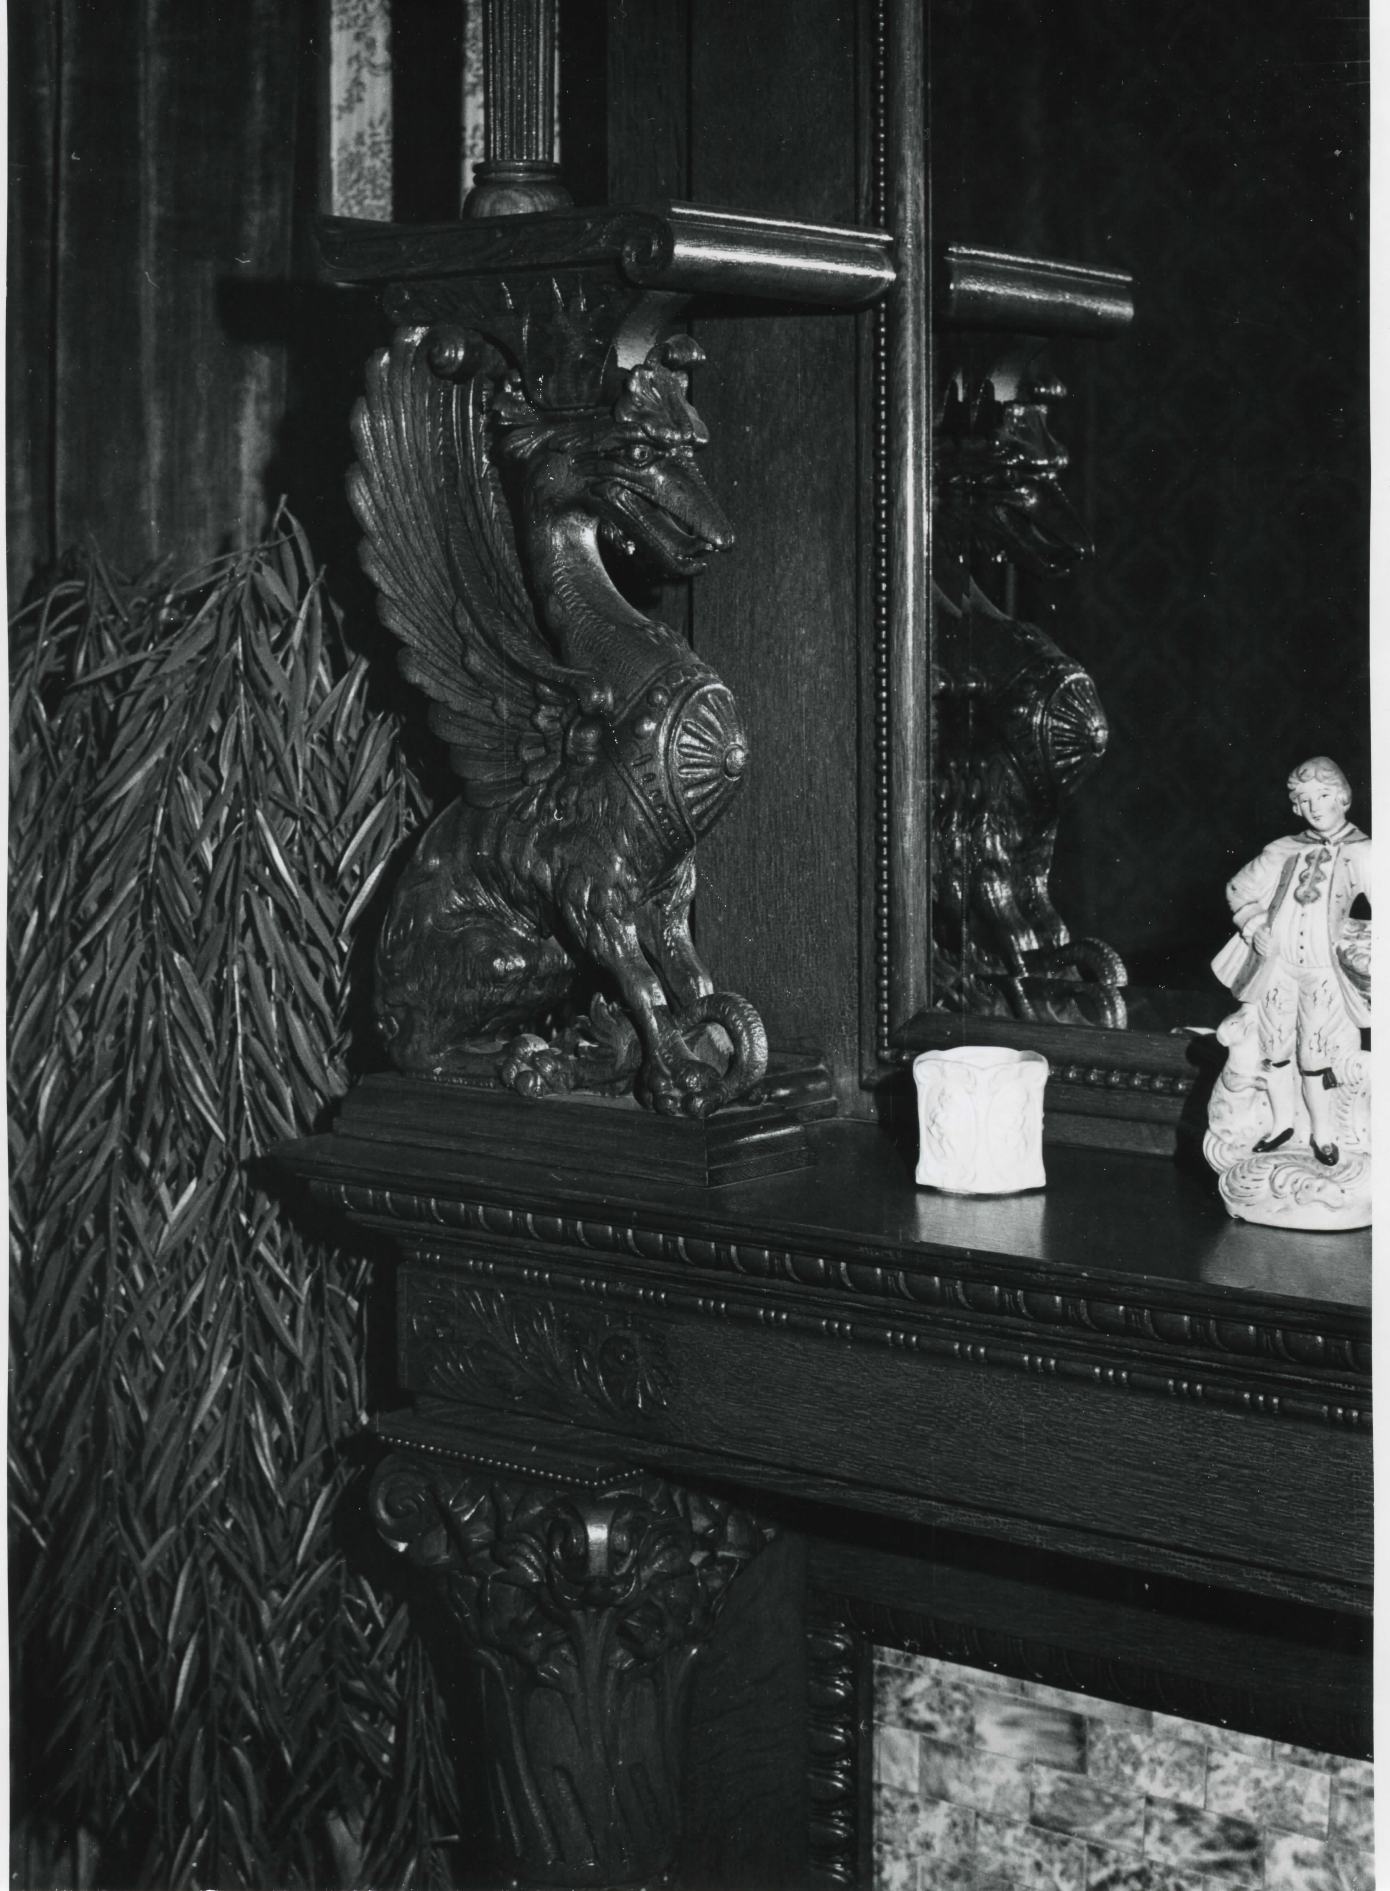
RAY, A. TAYLOR HOUSE #9 of 10
212 West Van Buren, Gallatin, Daviess County,
MO.

Interior, first floor, sitting room, east wall,
chimney piece, detail of griffin.

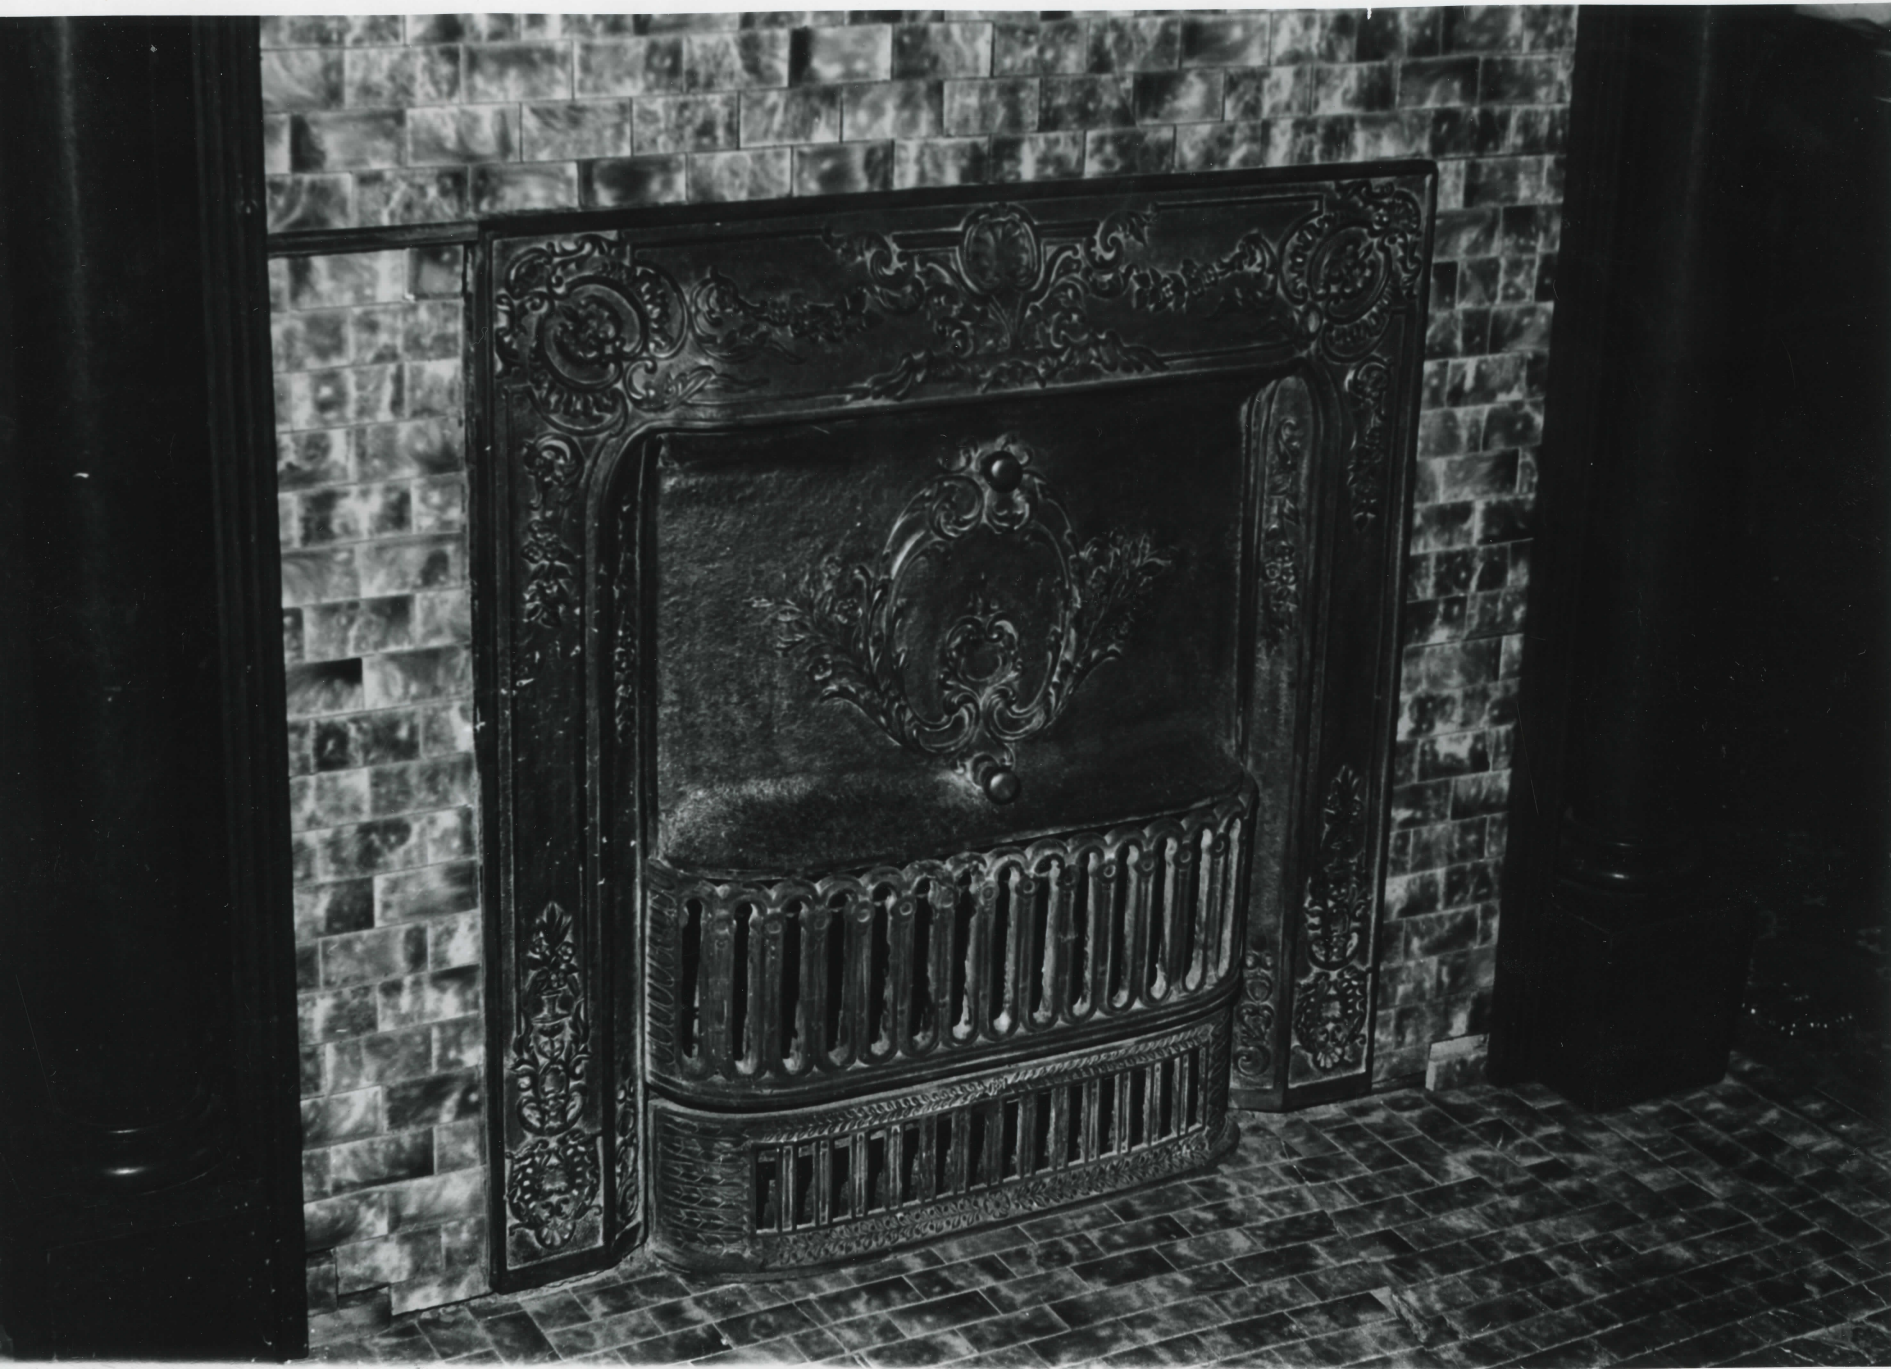
RAY, A. TAYLOR HOUSE #10 of 10
212 West Van Buren, Gallatin, Daviess County,
MO.

Interior, first floor, dining room,
ornamental iron grate at fireplace.
