NATIONAL REGISTER OF HISTORIC PLACES
REGISTRATION FORM

historic name Centenary Methodist Church

state North Carolina code NC county Robeson code 155 zip code 28383

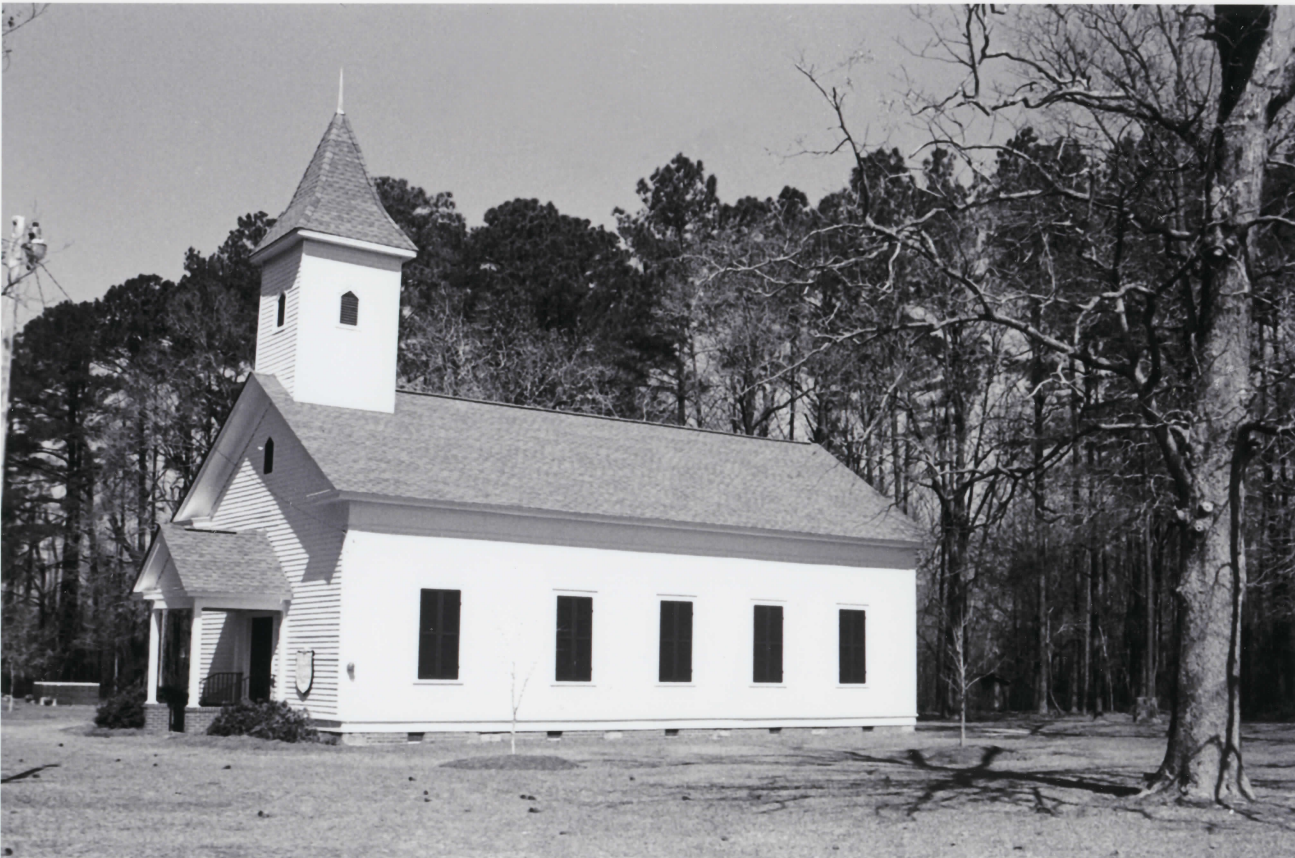
Centenary Methodist Church
Robeson County, NC
Photograph 1

Photograph 1: South and east elevations; camera looking northwest

According to John Edens, a life-time member of the church and a descendent of one of the original members, Centenary Methodist Church was constructed by church members from timber harvested from a nearby stand of virgin long leaf pine. The church, as originally built, was a modest gable-front frame building with weatherboard siding and a small, front stoop. The church rested on brick piers which have since been infilled with a continuous brick foundation. Its original length, approximately forty-five feet, was roughly equal to the height of its front gable, making for a very stout and stable structure. The church had two entrance doors and four six-over-six sash windows on each side elevation.

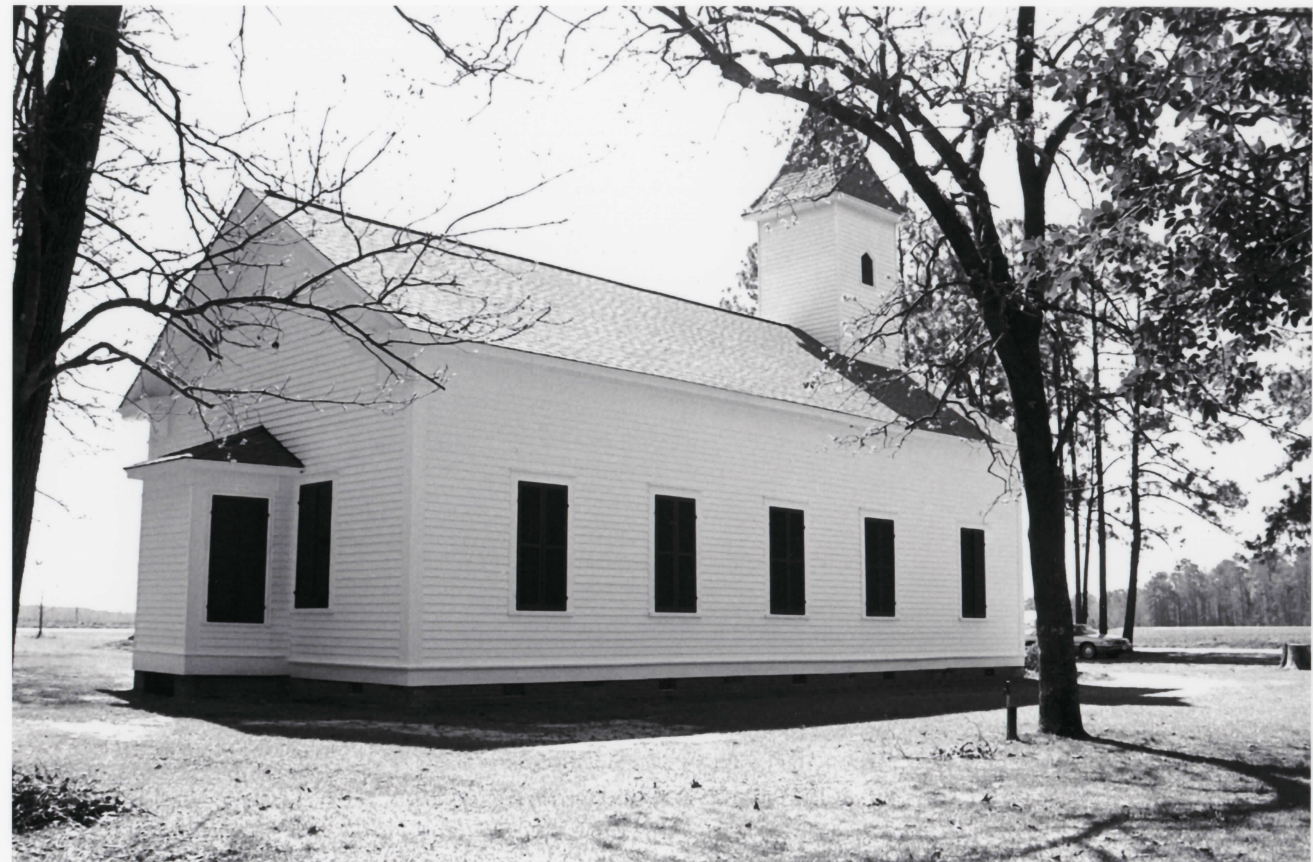
Centenary Methodist Church
Robeson County, NC
Photograph 2

Photograph 2: North and west elevations; camera looking southeast

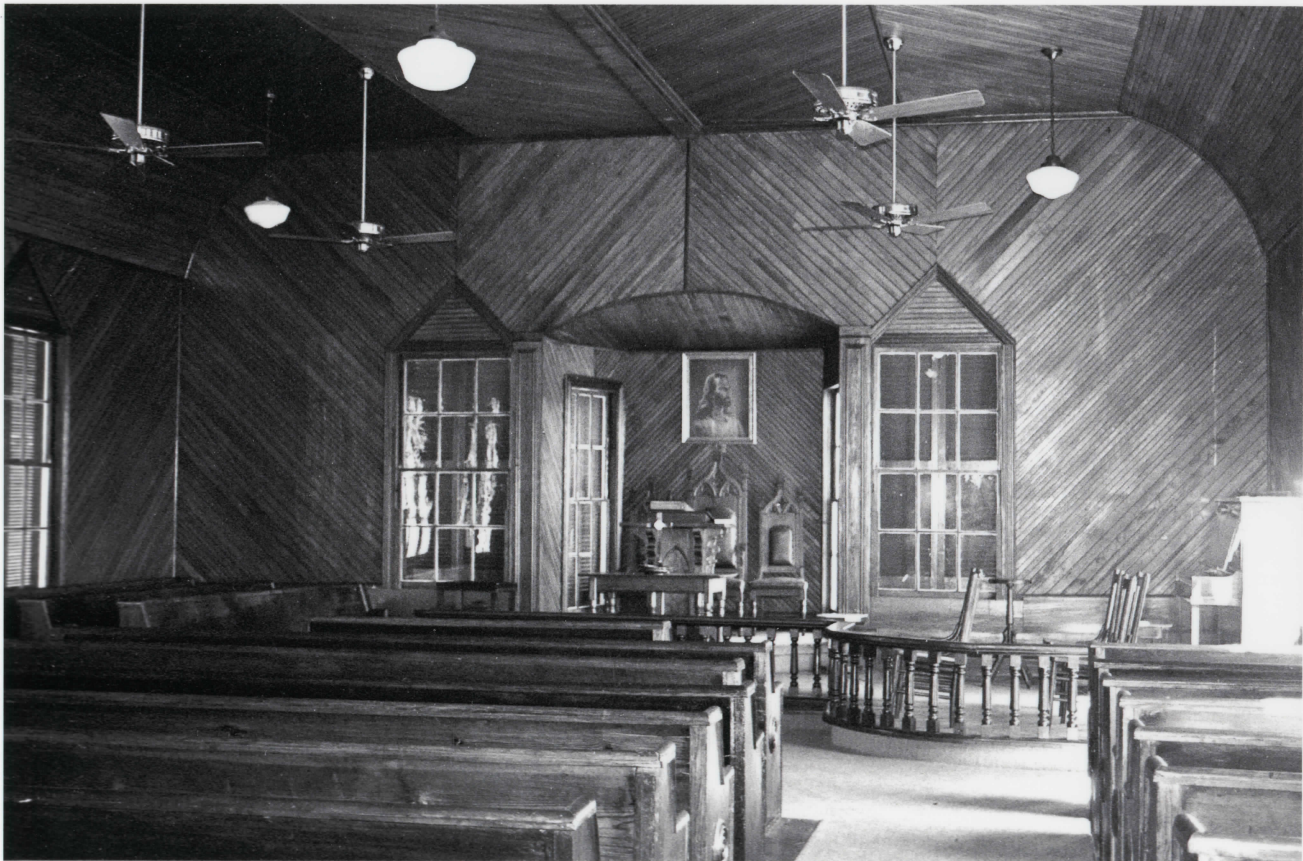
Centenary Methodist Church
Robeson County, NC
Photograph 3

Photograph 3: Interior of sanctuary looking at the alter

The chancel features a concave ceiling and is set off by flanking pilasters. A communion rail marks the raised platform of the altar and curves to the right enclosing the individual chairs used by the choir. An upright piano sits in the corner behind the chairs. The interior woodwork is finished with a rich glossy dark pine stain that glows in the natural light provided by the large windows.

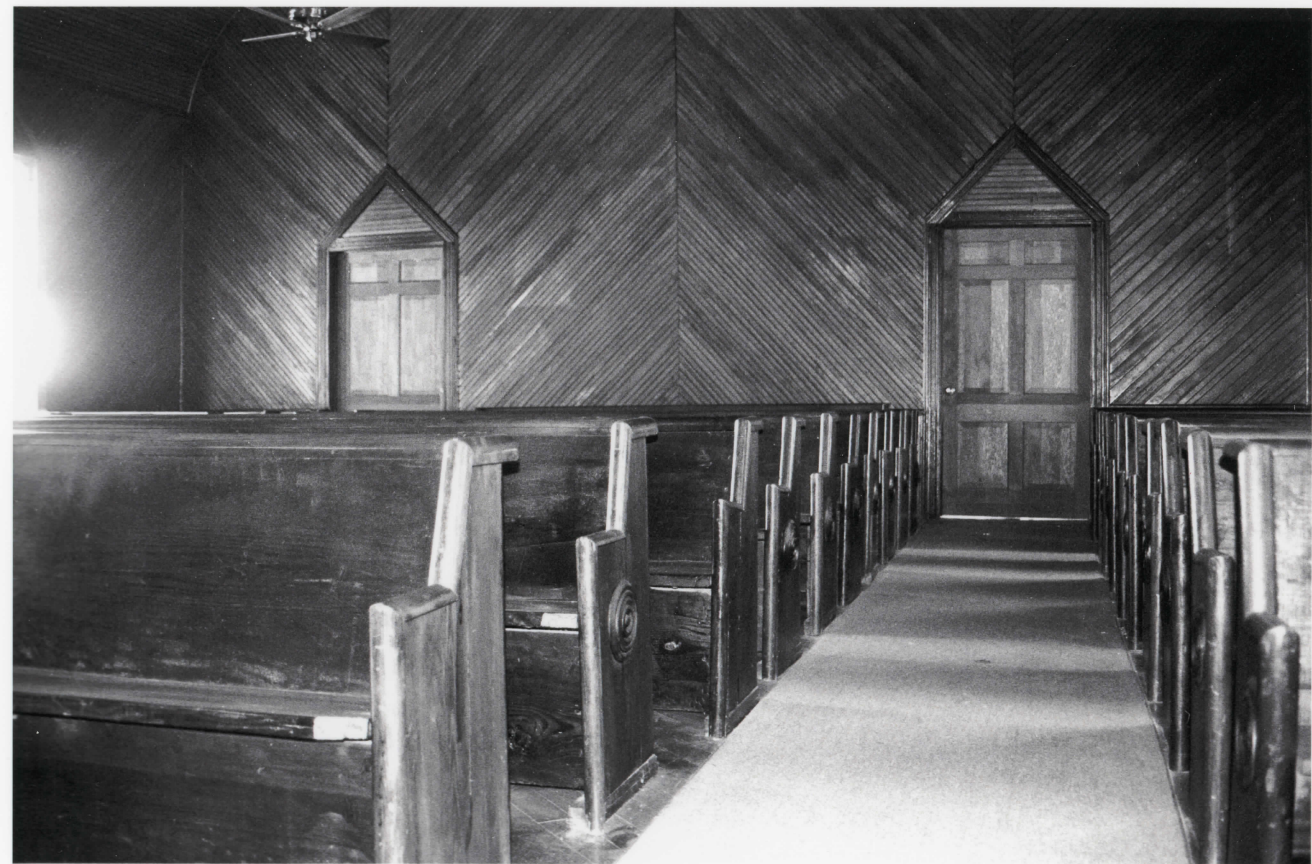
Centenary Methodist Church
Robeson County, NC
Photograph 4

Photograph 4: Interior of sanctuary looking at the entrance doors

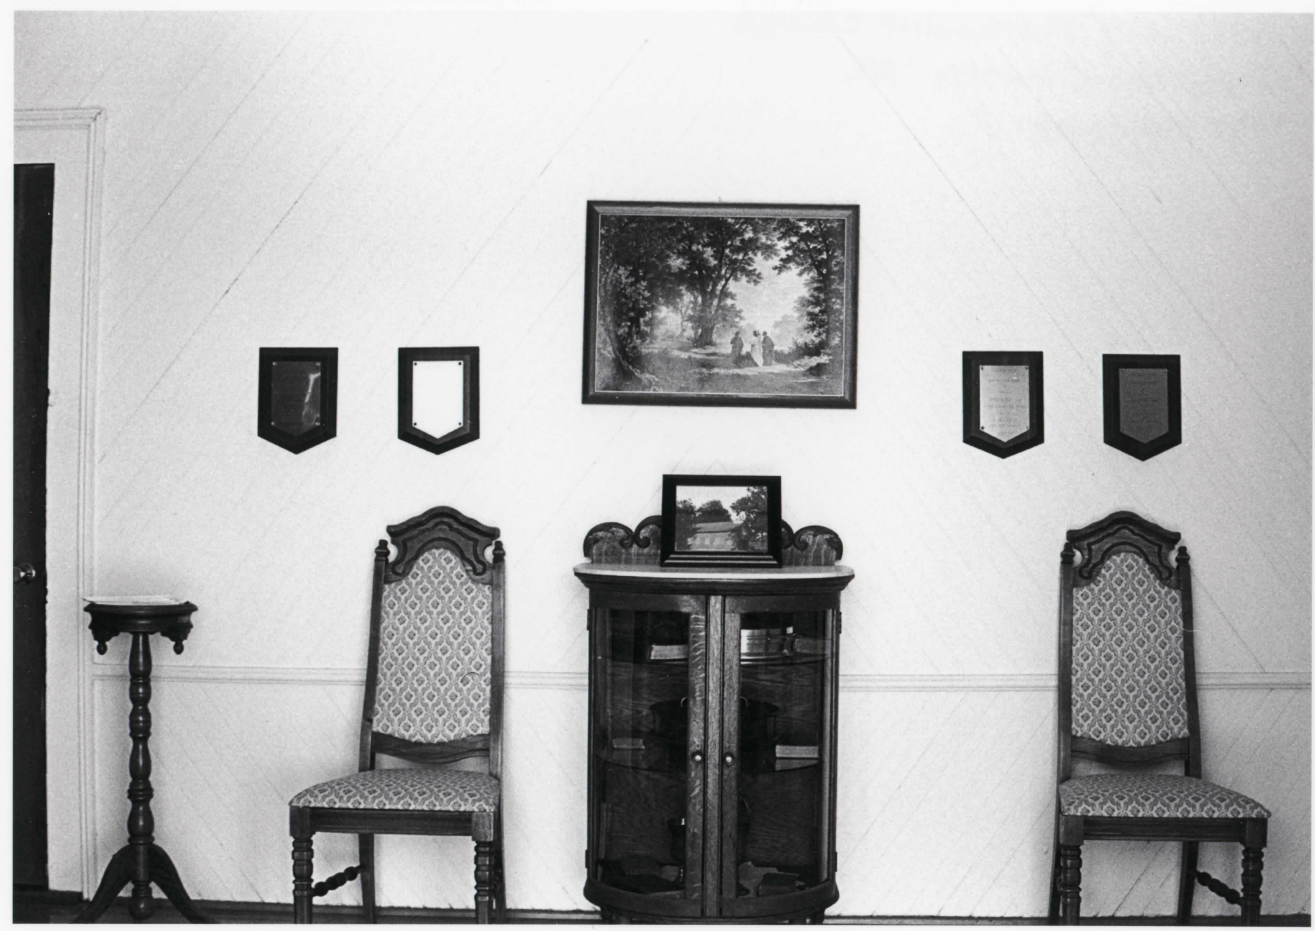
Centenary Methodist Church
Robeson County, NC
Photograph 5

Photograph 5: Interior of vestibule

The interior vestibule doors and floor replaced the original features in the 1950s. The four six-panel doors each measure three feet, five-inches wide. The side doors provide access to the flanking classrooms, while the doors on the north wall open into the side aisles of the sanctuary. The diminutive classrooms are also sheathed with beaded boards. A bench attached to the side wall in each classroom provided seating for the children during their Sunday school lessons. The ceiling of the vestibule and classrooms are also sheathed with tongue-and-groove beaded boards laid diagonally. An attic can be reached through a square opening in the vestibule ceiling; however, the attic was not accessible for inspection. A small display cabinet in the vestibule holds the original wooden communion set and small glass communion cups used by the congregation.

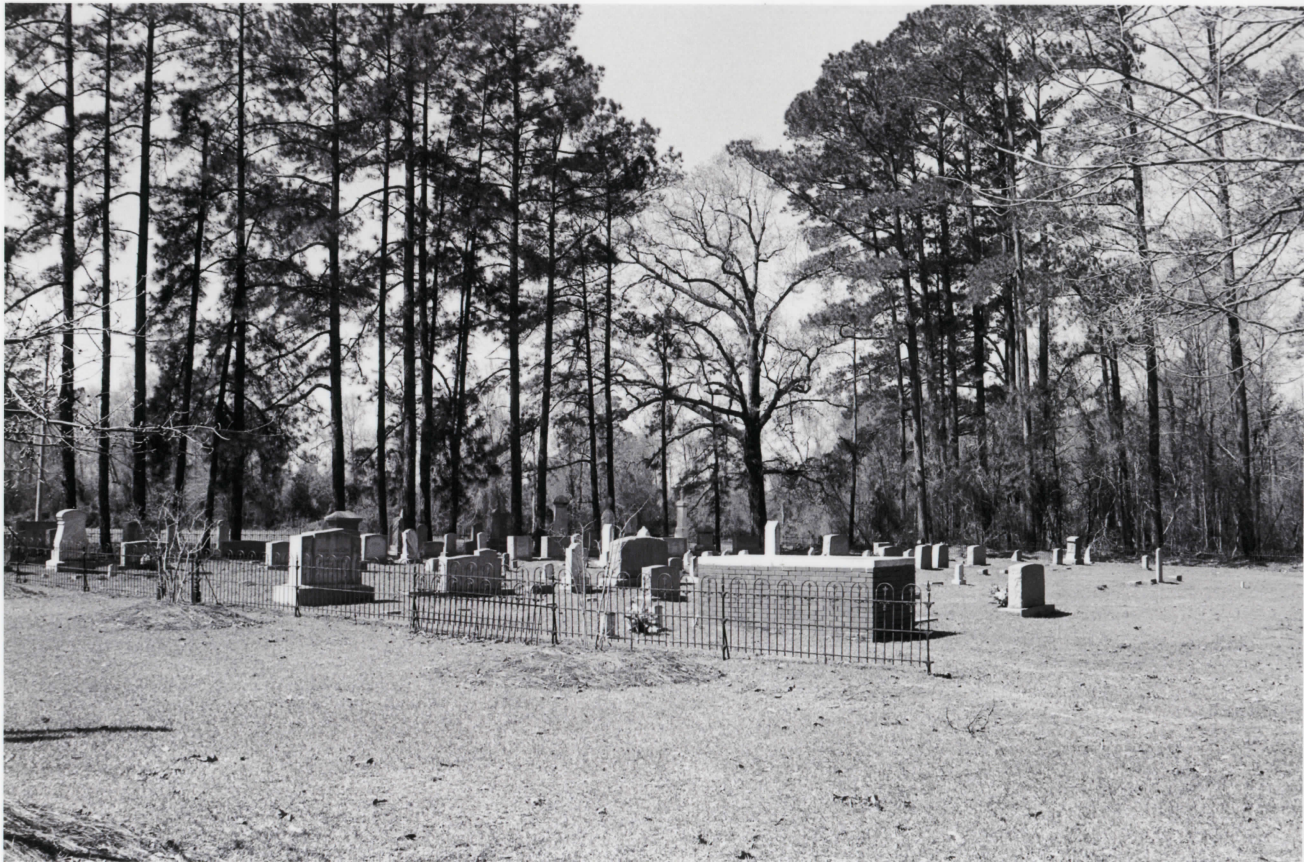
Centenary Methodist Church
Robeson County, NC
Photograph 6

Photograph 6: Cemetery; camera looking southwest

A cemetery, located approximately one hundred feet west of the church, contains approximately 160 marked graves. The south-facing stones are arranged in eight rows with approximately twenty graves in each row. A number of different marker styles are represented in the cemetery including one brick box tomb. The earlier markers tend to be upright slabs with segmental arches. Several of the stones marking the graves of children are topped by lambs or doves. There are also a number of obelisks and pedestal tombstones. Many of the newer markers consist of substantial marble stones.

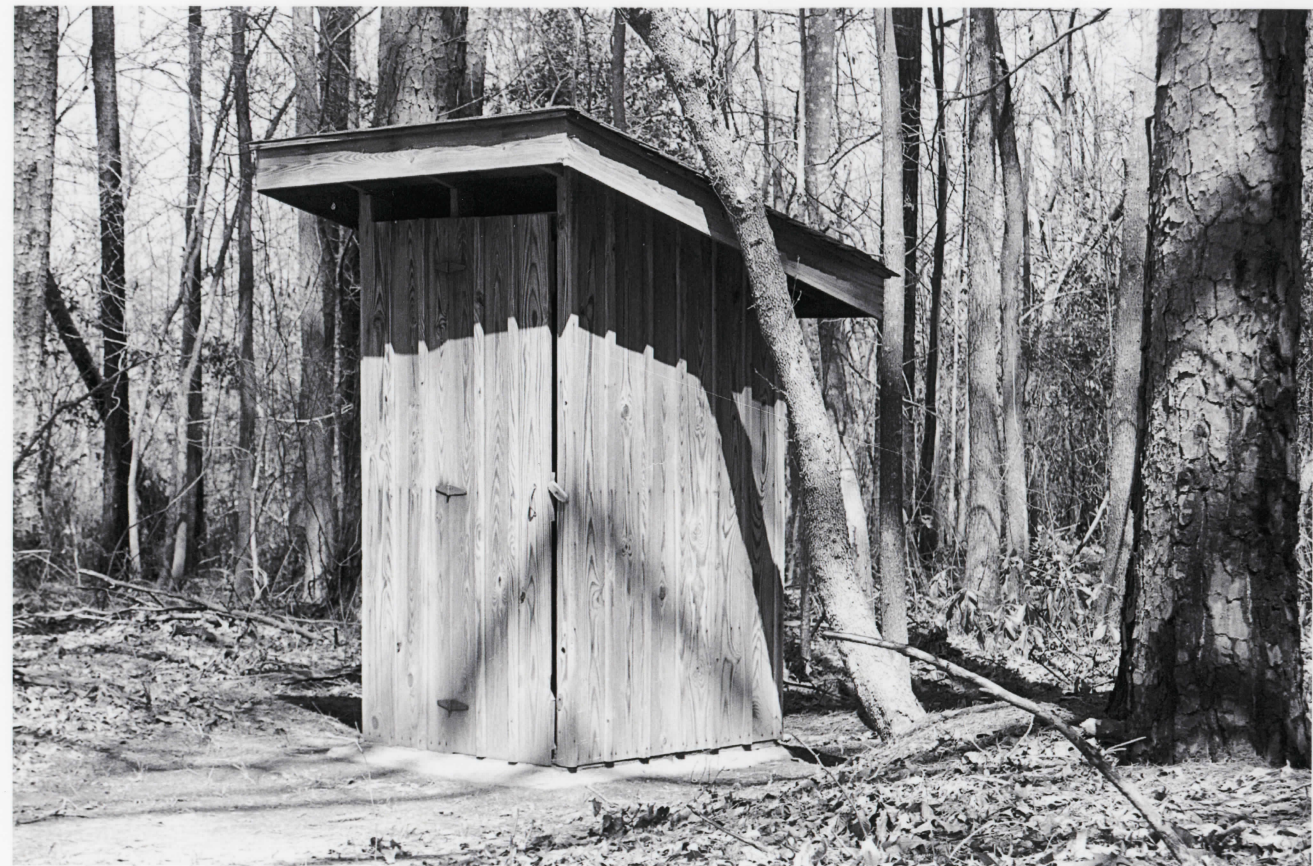
Centenary Methodist Church
Robeson County, NC
Photograph 7

Photograph 7: Outhouse; camera looking northwest

Two outhouses, rebuilt in 1966, are associated with the church, although only one is located on the church property and included with the nomination as a noncontributing building. The simple frame buildings have board-and-batten siding and a shed roof. The included outhouse is located north of the cemetery on a narrow strip of land that runs between the wrought iron fence and the edge of the woods.
