National Register of Historic Places
Inventory—Nomination Form

Badin Historic District

Introduction to Inventory

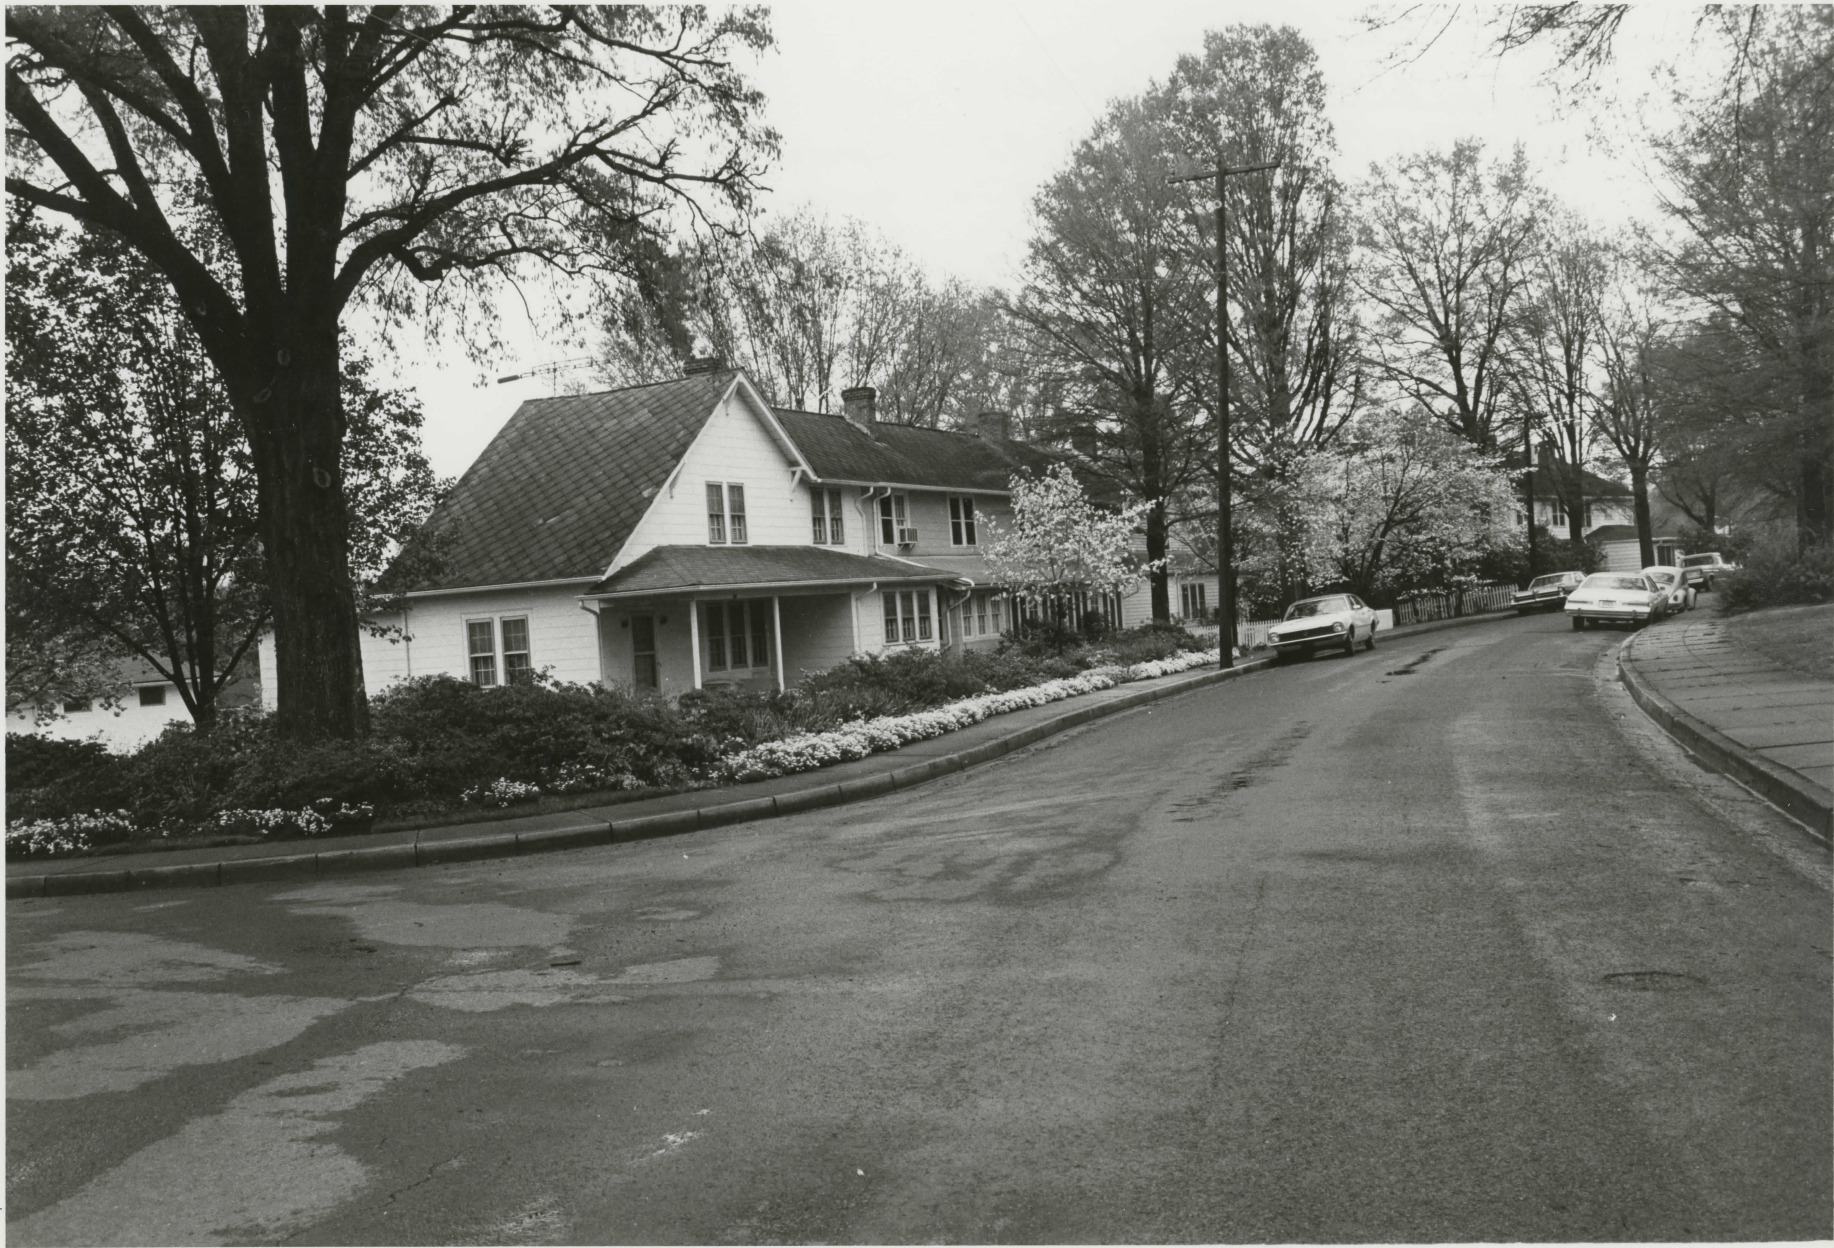
92-98 Spruce Street
#76 - quadraplex

NEGATIVE NUMBER N-80-4-85
PHOTOGRAPHER BRENT GLASS
PHOTO DATE 4-1-80
SUBJECT BADIN - MAPLE STREET
STANLY COUNTY
view #7

The quadraplexes share many original architectural features with variances occurring primarily in the rooflines. These two-story rectilinear, one bay deep units have a centrally located projecting shed roofed screened porch which provides access to the two central units. Projecting screened or enclosed end porches provide access to the end units. Each apartment has its own centrally located brick chimney. Windows are six-over-six sash and are often paired or grouped in threes. Rooflines vary from the cross gables of the quadraplex at 27-33 Cedar, to the high hipped roof of 36-38 Cedar (originally a quadraplex, now a duplex), to the gable roof of 17-23 Holly Place with a center ridge that runs parallel to the street and whose end gables slope steeply to form the roofline of the projecting end porches. Trim is simple on these clapboard sheathed houses, often only exposed brackets supporting the gable ends.

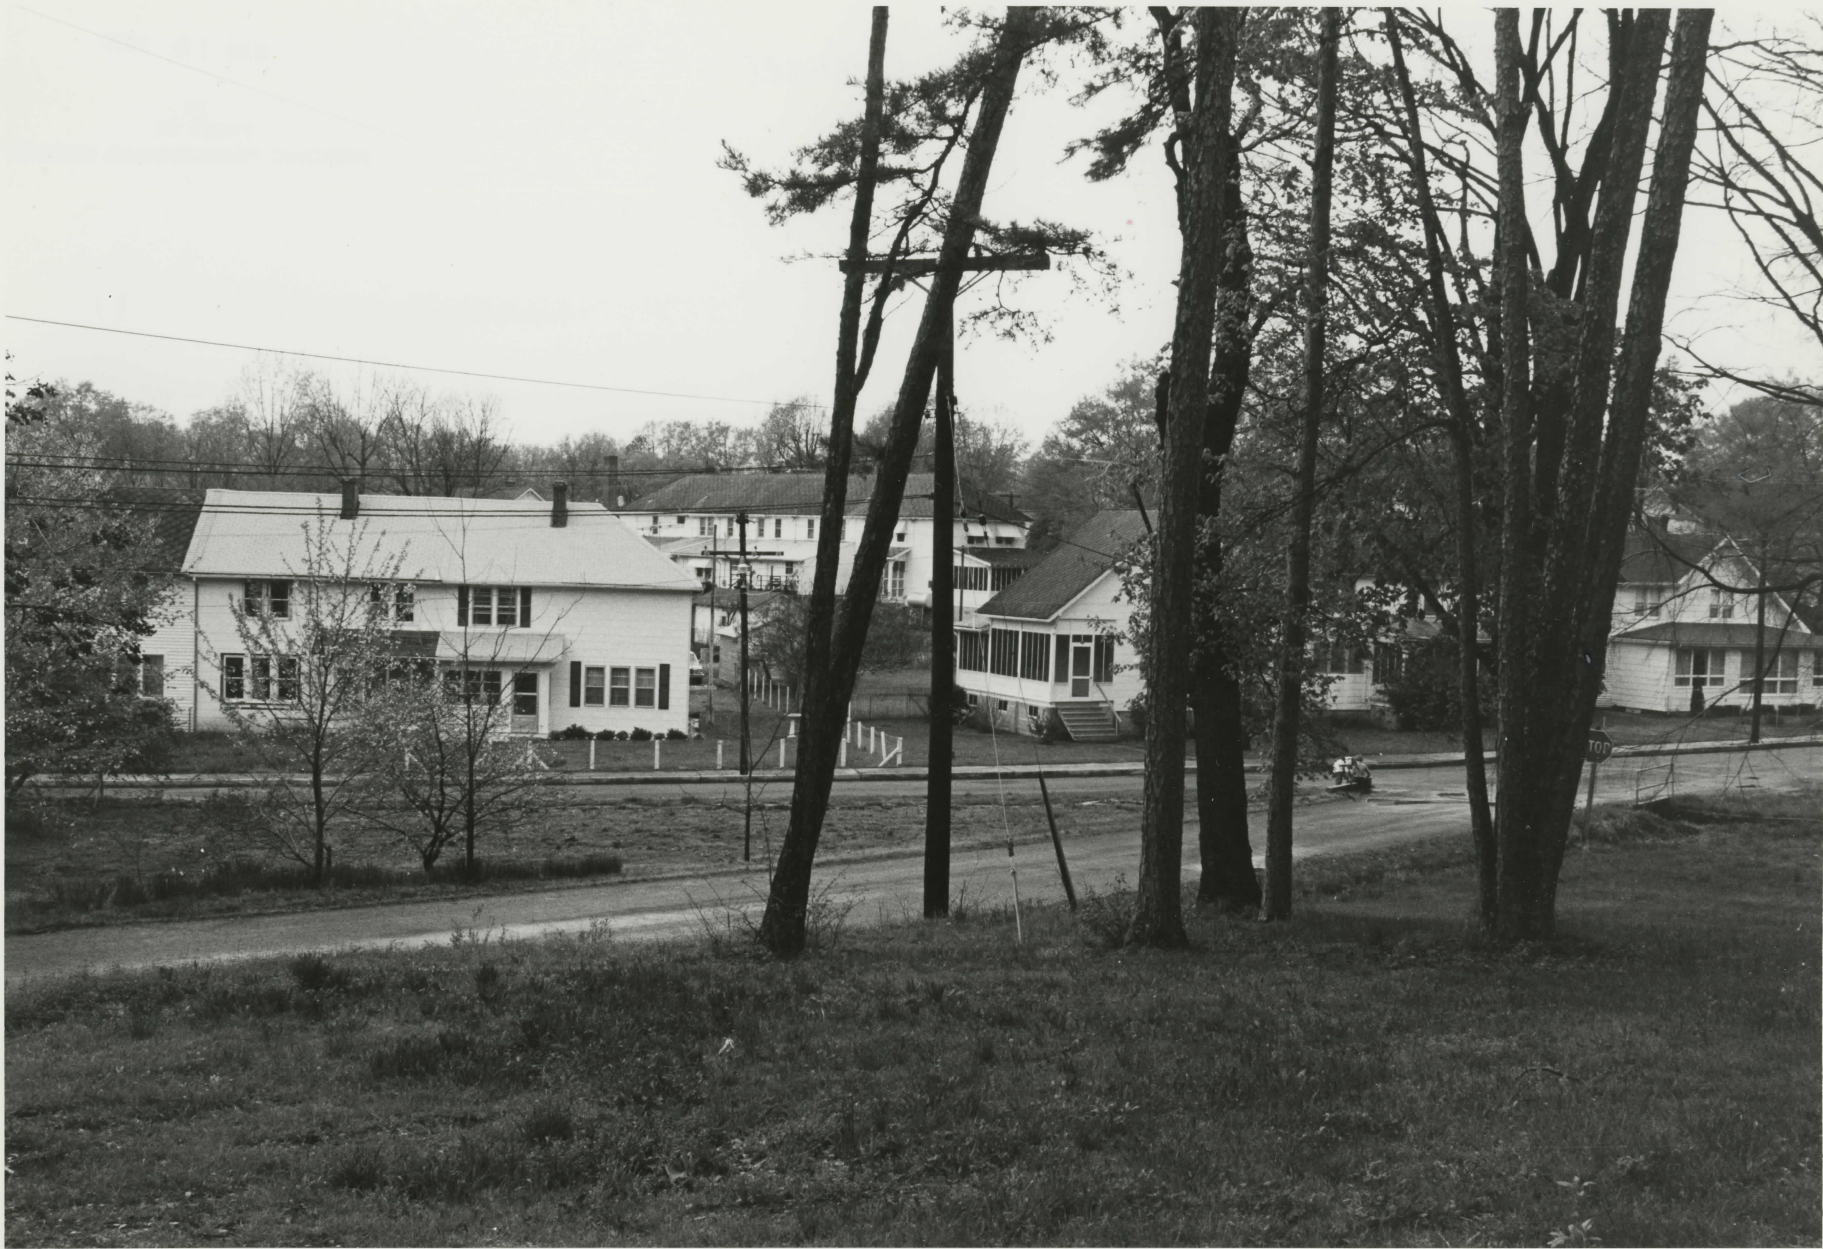
View #8

NEGATIVE NUMBER N-80-4-84
PHOTOGRAPHER BRENT GLASS
PHOTO DATE 4-1-80
SUBJECT BADIN - French Village Overall
STANLY Co.

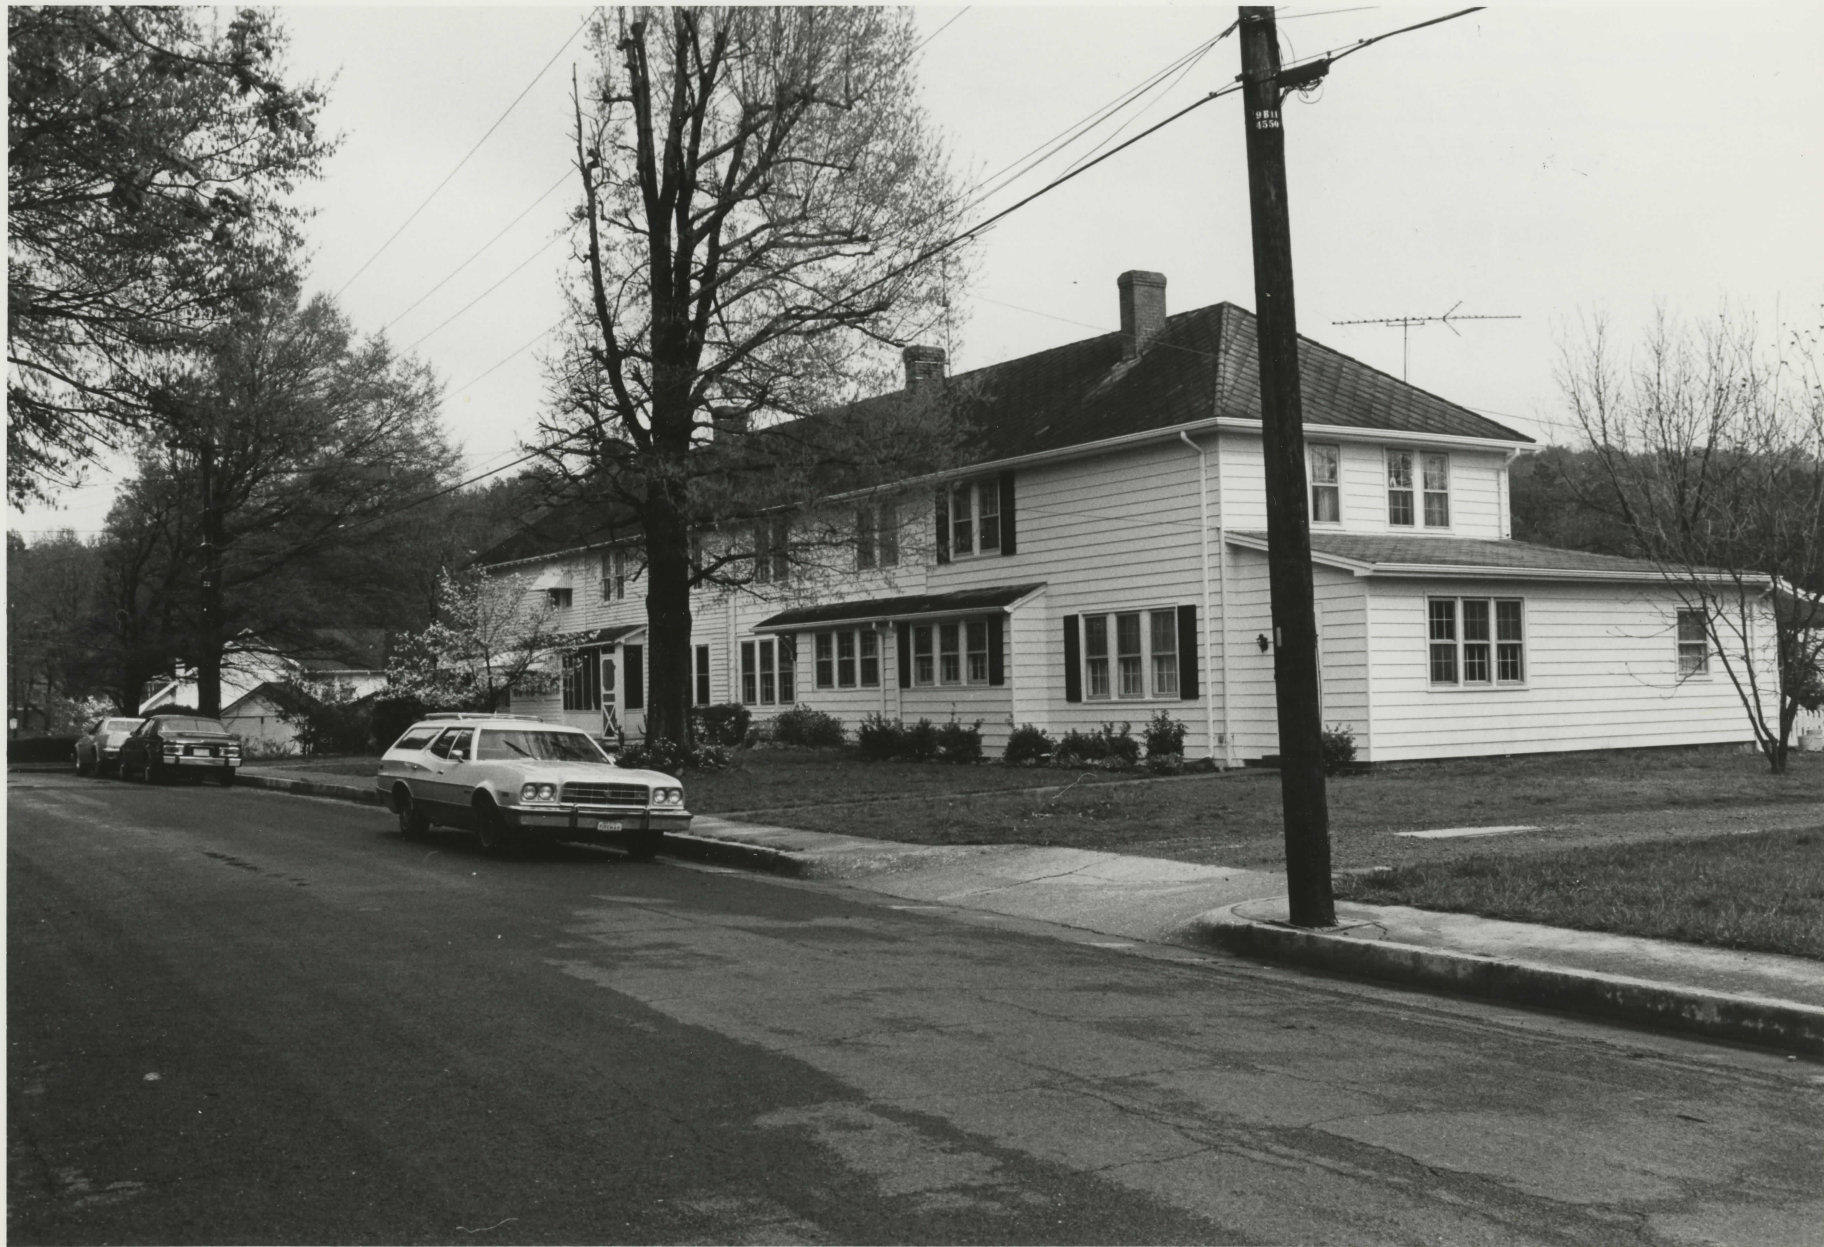
View #9

126-32 Spruce Street - quadraplex

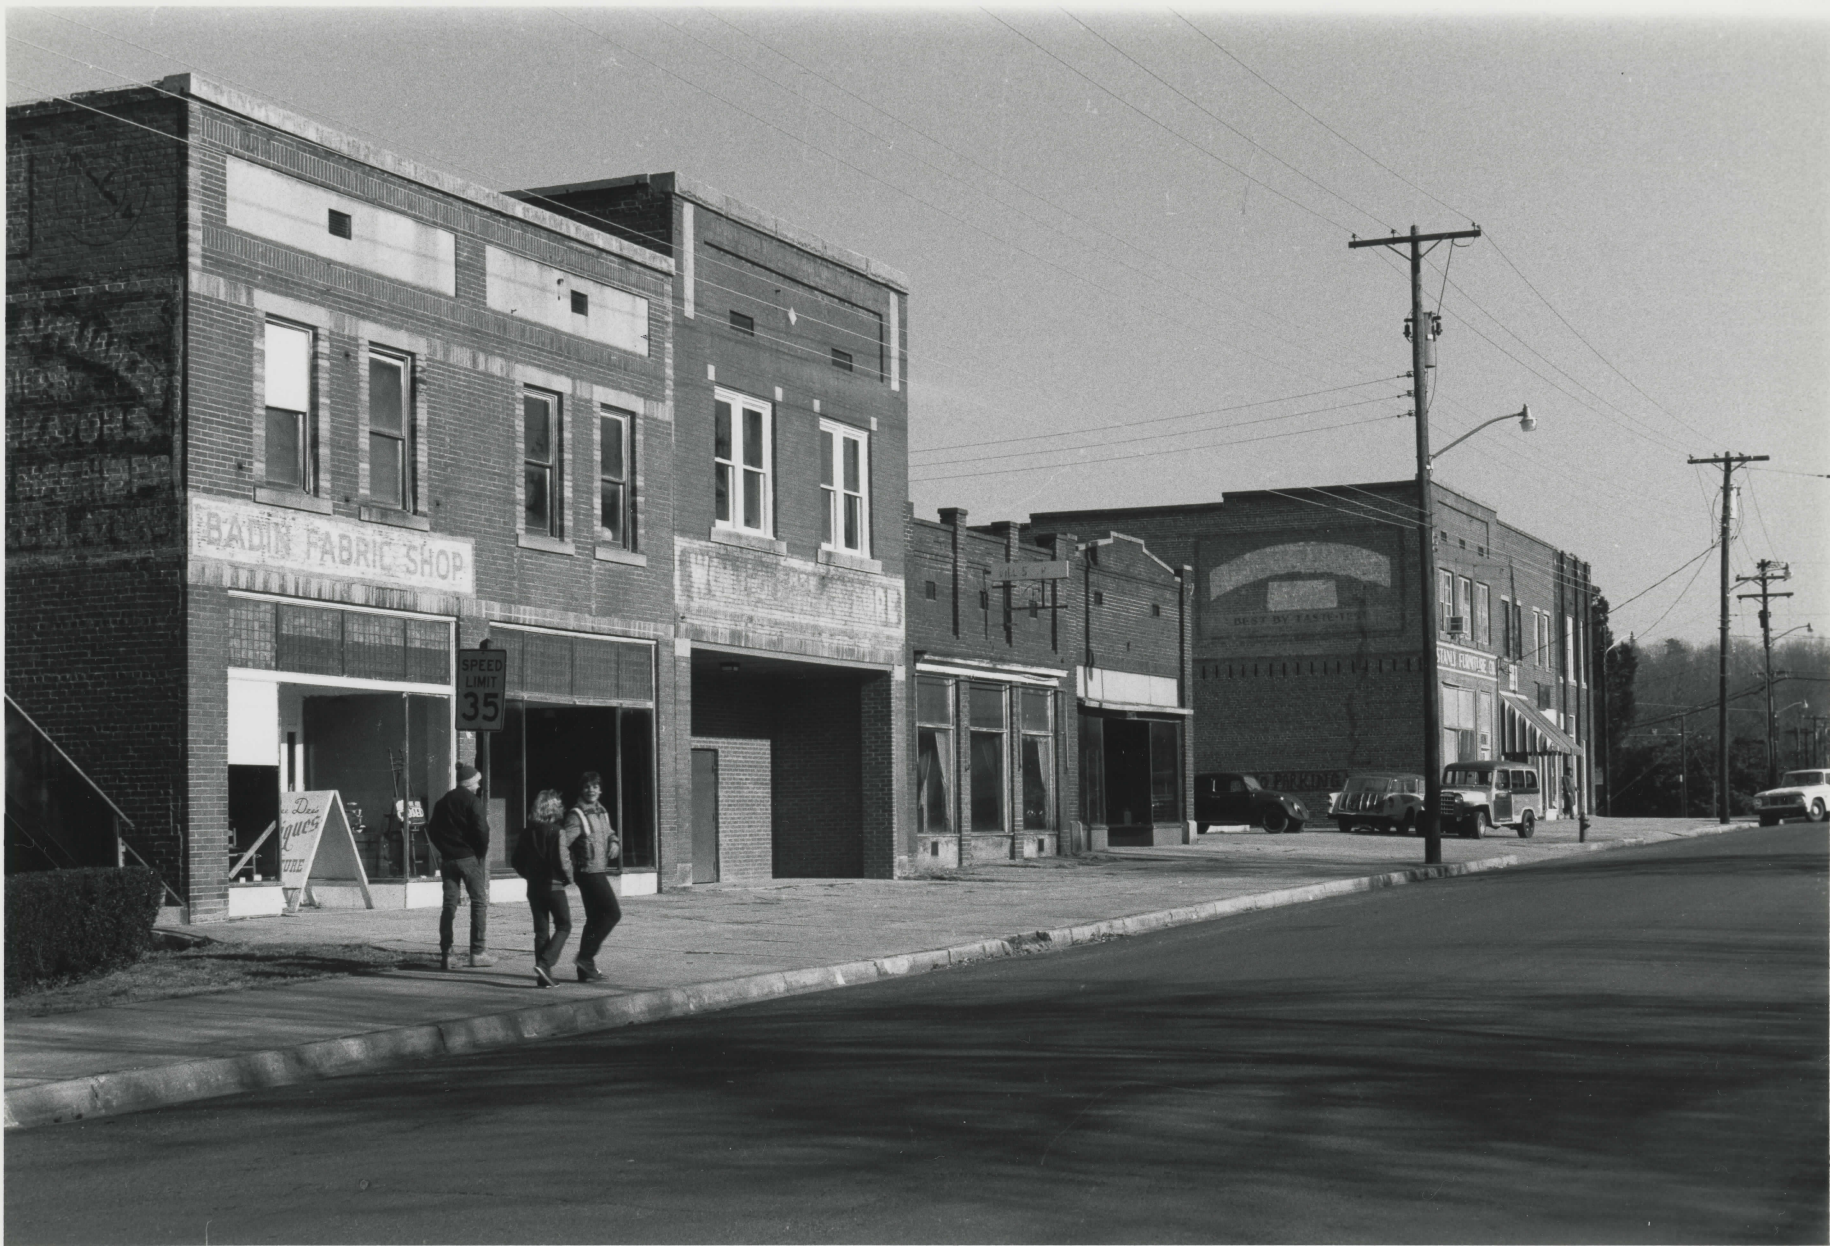
View 12

Streetscape - Badin Business District - Falls Road #151

The remaining original commercial buildings in Badin, largely vacant, but in good condition, are grouped along Falls Road, Walnut and Pine Streets, the most prominent being the "Commercial Block" at the corner of Pine Street and Yadkin Court. This is a large, rectangular handsome structure distinguished by its size, prominent corner site and fine brick work. The red brick with dark glazed headers are laid in Flemish bond with brick pilasters dividing the retail units, cornice corbelling and row of bricks set on end over the groups of three eight-over-eight second-story sash windows. Access to the second floor space is through paired double doors in the base of the tower-like units. These entrances are further marked on the second-story by a large arch-headed opening in the stairwell containing paired fully glazed doors below a fanlight, the doors open onto a small wrought iron balcony.

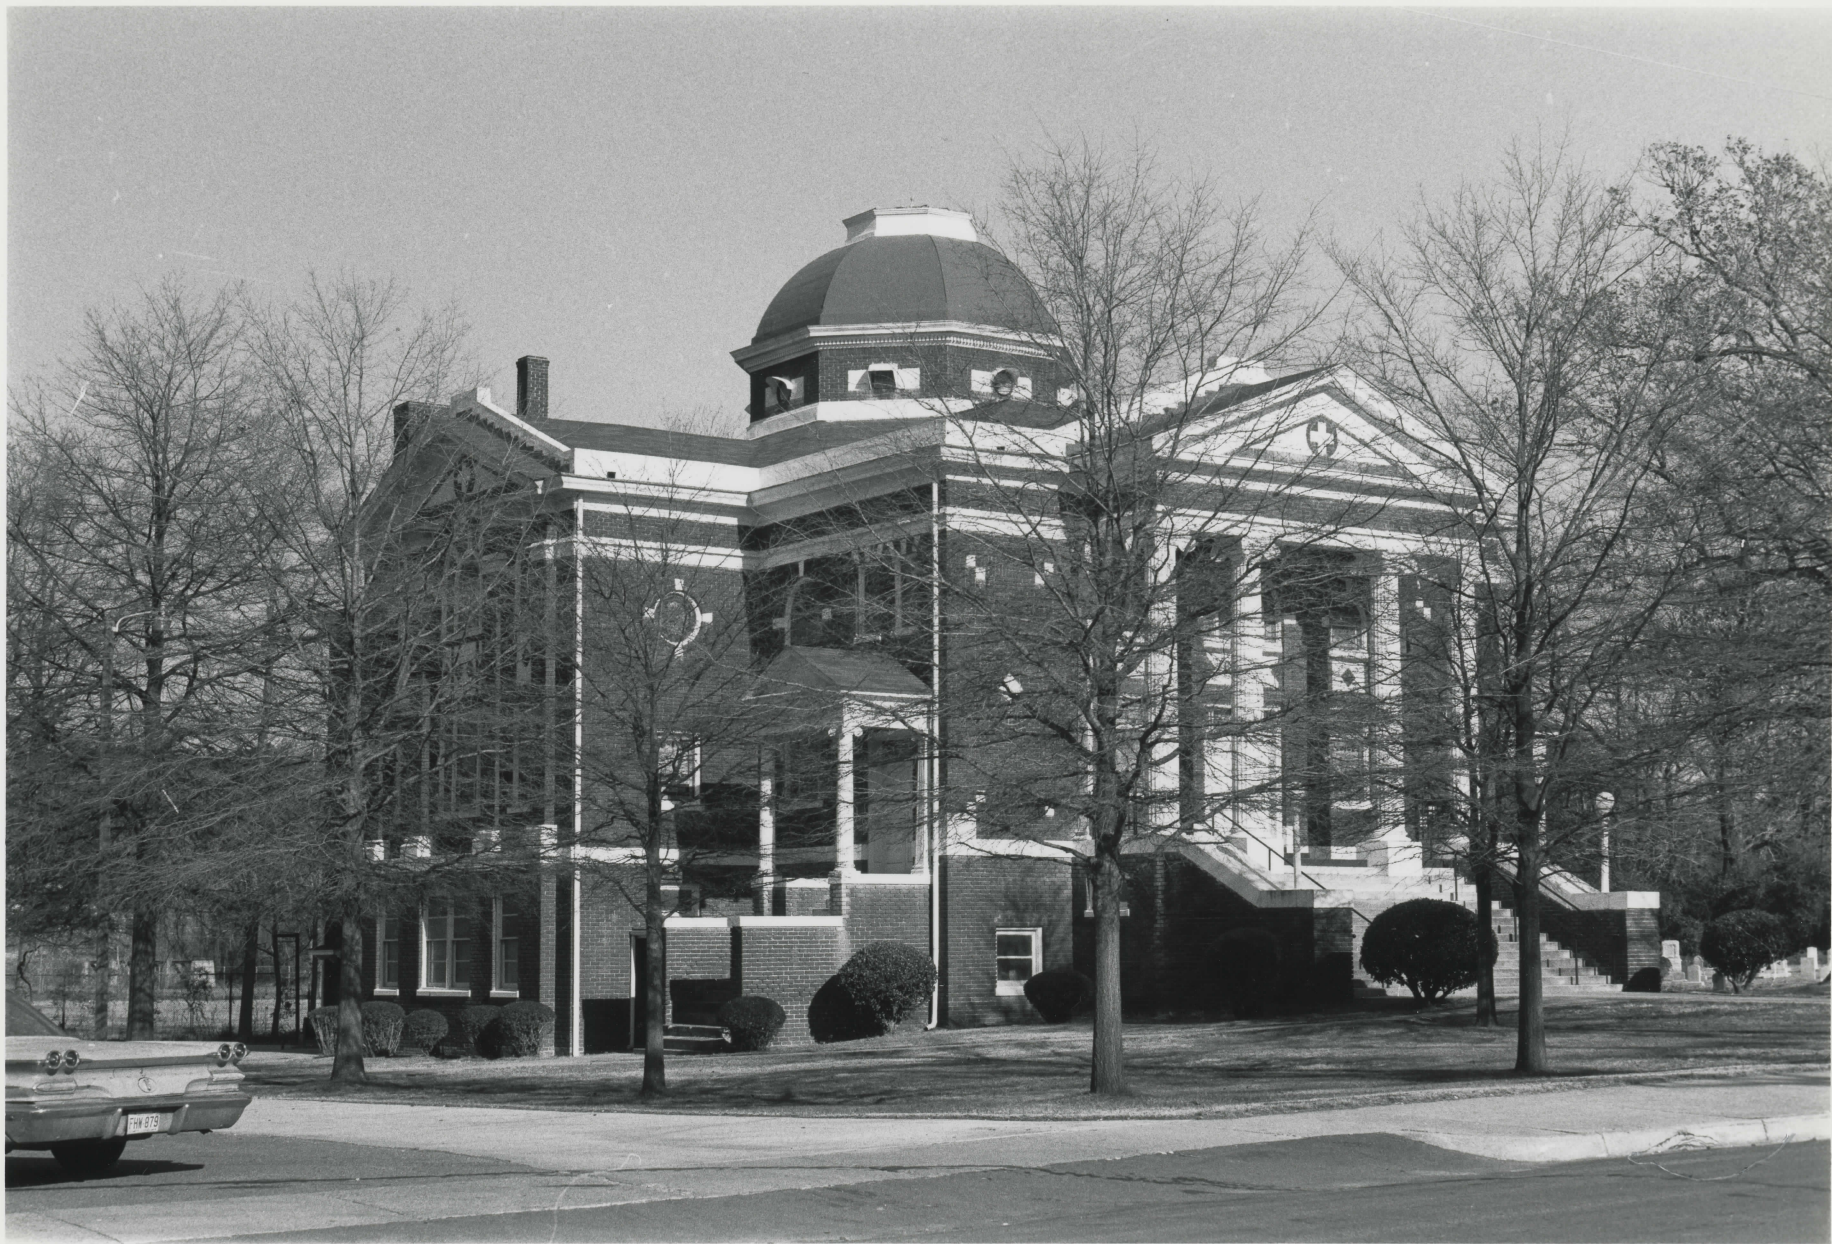
View 13

Badin Baptist Church - # 125

No company town could be complete without the company built churches, and several examples of the sure hand of the Badin masons remain. Perhaps the most imposing structure in Badin is the Badin Baptist Church on Falls Road. An earlier frame building (the Ebenezer Baptist Church) occupied the site and was a well known landmark. The site was later flooded when the dam was built and the new church was built closer to the road. The present large brick church was built in 1918-1919 under the leadership of Rev. Arnett. (Arnett planned to establish a church school there, hence the relatively large class room space. The school was never started). Stylistically the church contains many elements of Roman Classicism, but its basic classical symmetry is somewhat obscured by the eclectic busyness of the brick pattern and use of white painted stucco as accents against the red brick.

Built on a raised first floor or podium and approached by a broad, steep flight of stairs, the main facade features a large two-story projecting portico with pediment supported by four fluted Ionic columns. A white painted Greek cross is set in a brick circle in the center of the pediment. Fluted Ionic pilasters bracket the panelled double front doors with stained glass transom, which are flanked by transomed rectangular stained glass windows. Above these are stuccoed rectangles centered by bricks laid to form a diamond. Surmounting these are stained glass hemispherical windows. On either side of the prominent portico are fanciful brick work, two-story rectangular panels with a center circle enclosing a white stucco diamond. At each corner of the panel are diagonal white squares. The church is crowned by an octagonal dome (creating a domed sanctuary). Round ventilators and hooded loud speakers, each outlined by a white rectangle, alternate on each lower panel of the dome. The overall shape of the church reflects the Greek cross and the right and left elevations are identical, with double door side entrances sheltered by smaller classical pedimented porches supported by fluted Ionic columns and pilasters. The multitude of stained glass windows, round rectangular and hemispherical, are accented with white trim.

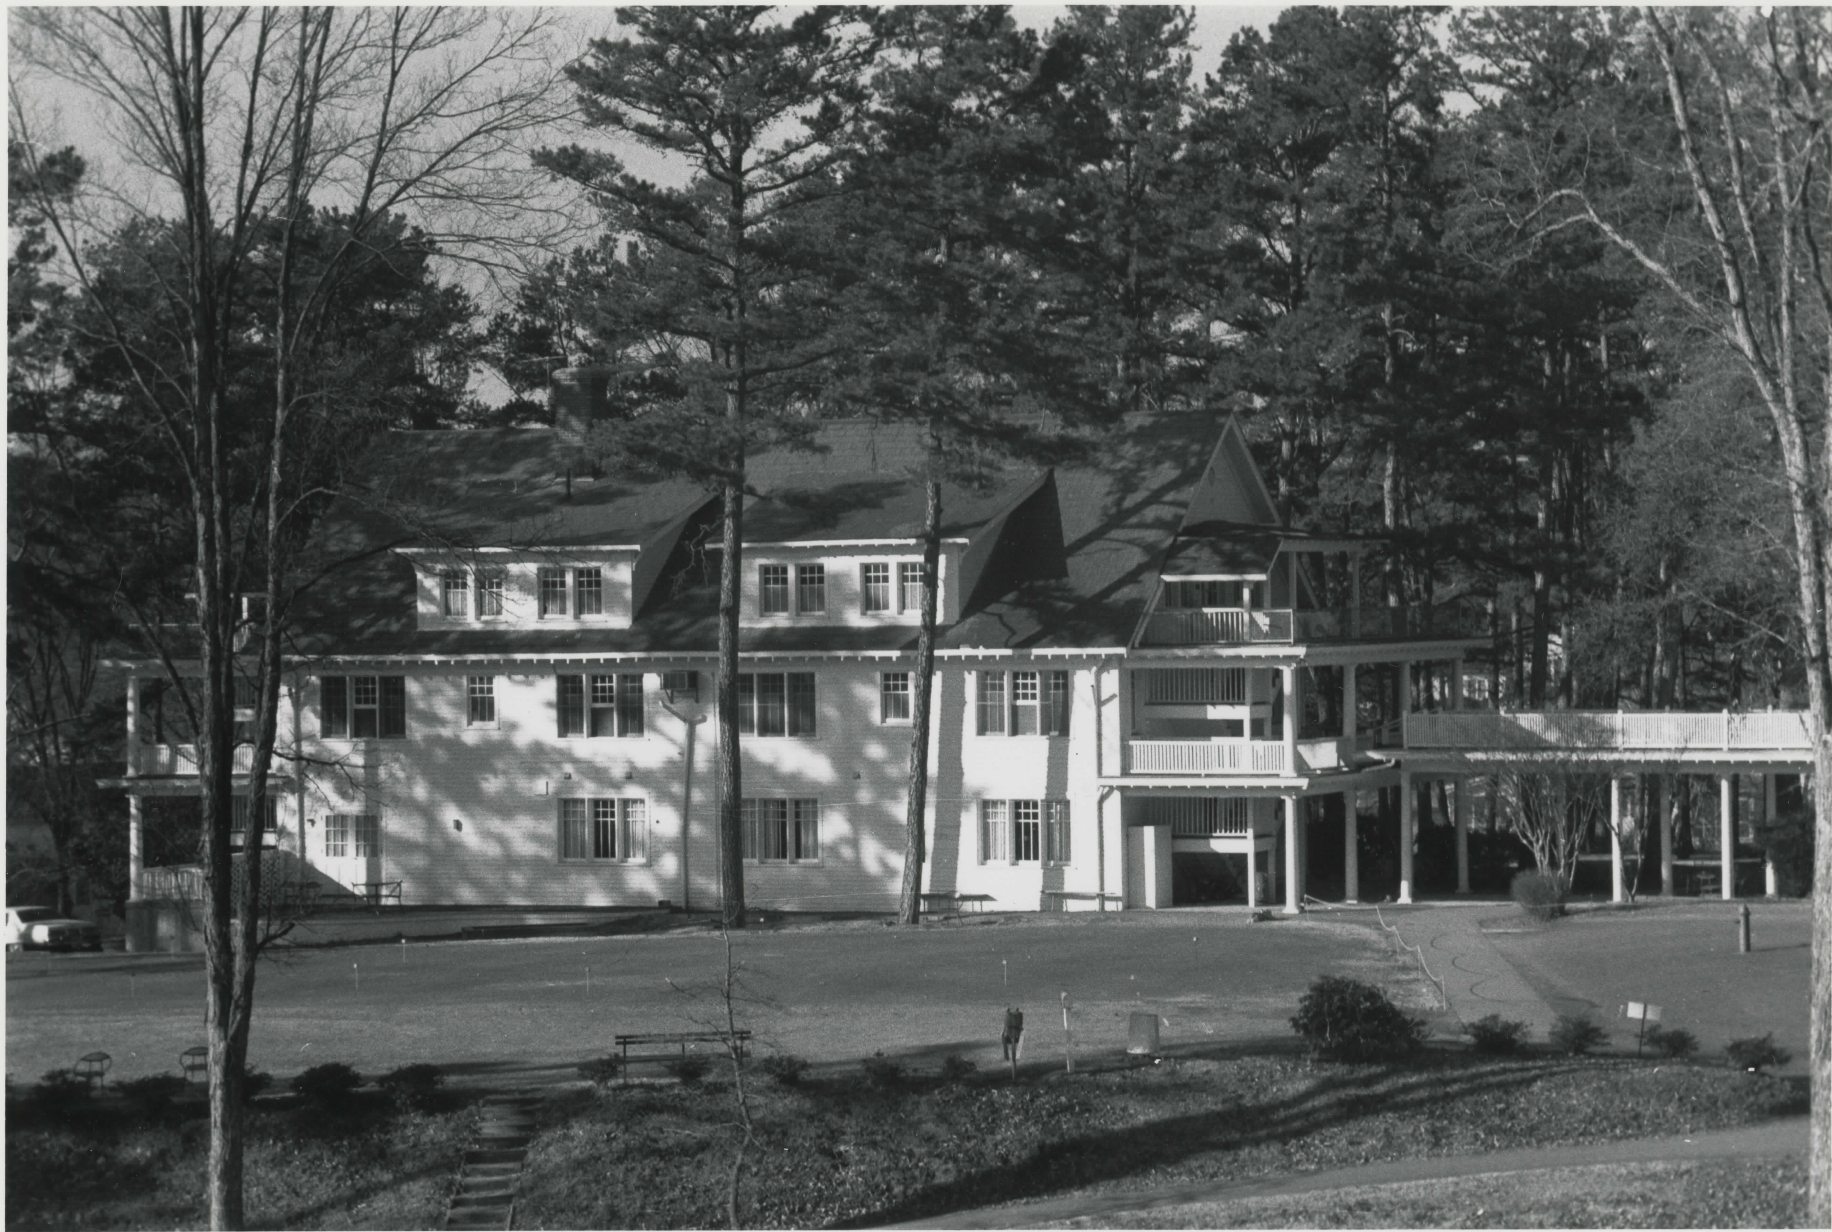
View 14

Club House Annex - #74

A covered Doric columned arcade topped by a simple balustrade connects the Club House to the three-story annex. Its most prominent features are the identical three-story verandahs at both ends, with their exterior stairs forming strong diagonal lines, reminiscent of resort architecture. The spacious first and second-story porches are surrounded by simple balustrades and are supported by Doric columns. There is a smaller balustraded third-story porch supported by posts. As in so many of the smaller Badin dwellings, the rafter ends are exposed. The annex's many windows are again paired, or in bands of three, but they differ from the commonly found six-over-six sash types. These are more deeply inset and consist of six small panes clustered near the top, with three long panes beneath. The annex retains its original slate roof and rests on a stuccoed foundation.

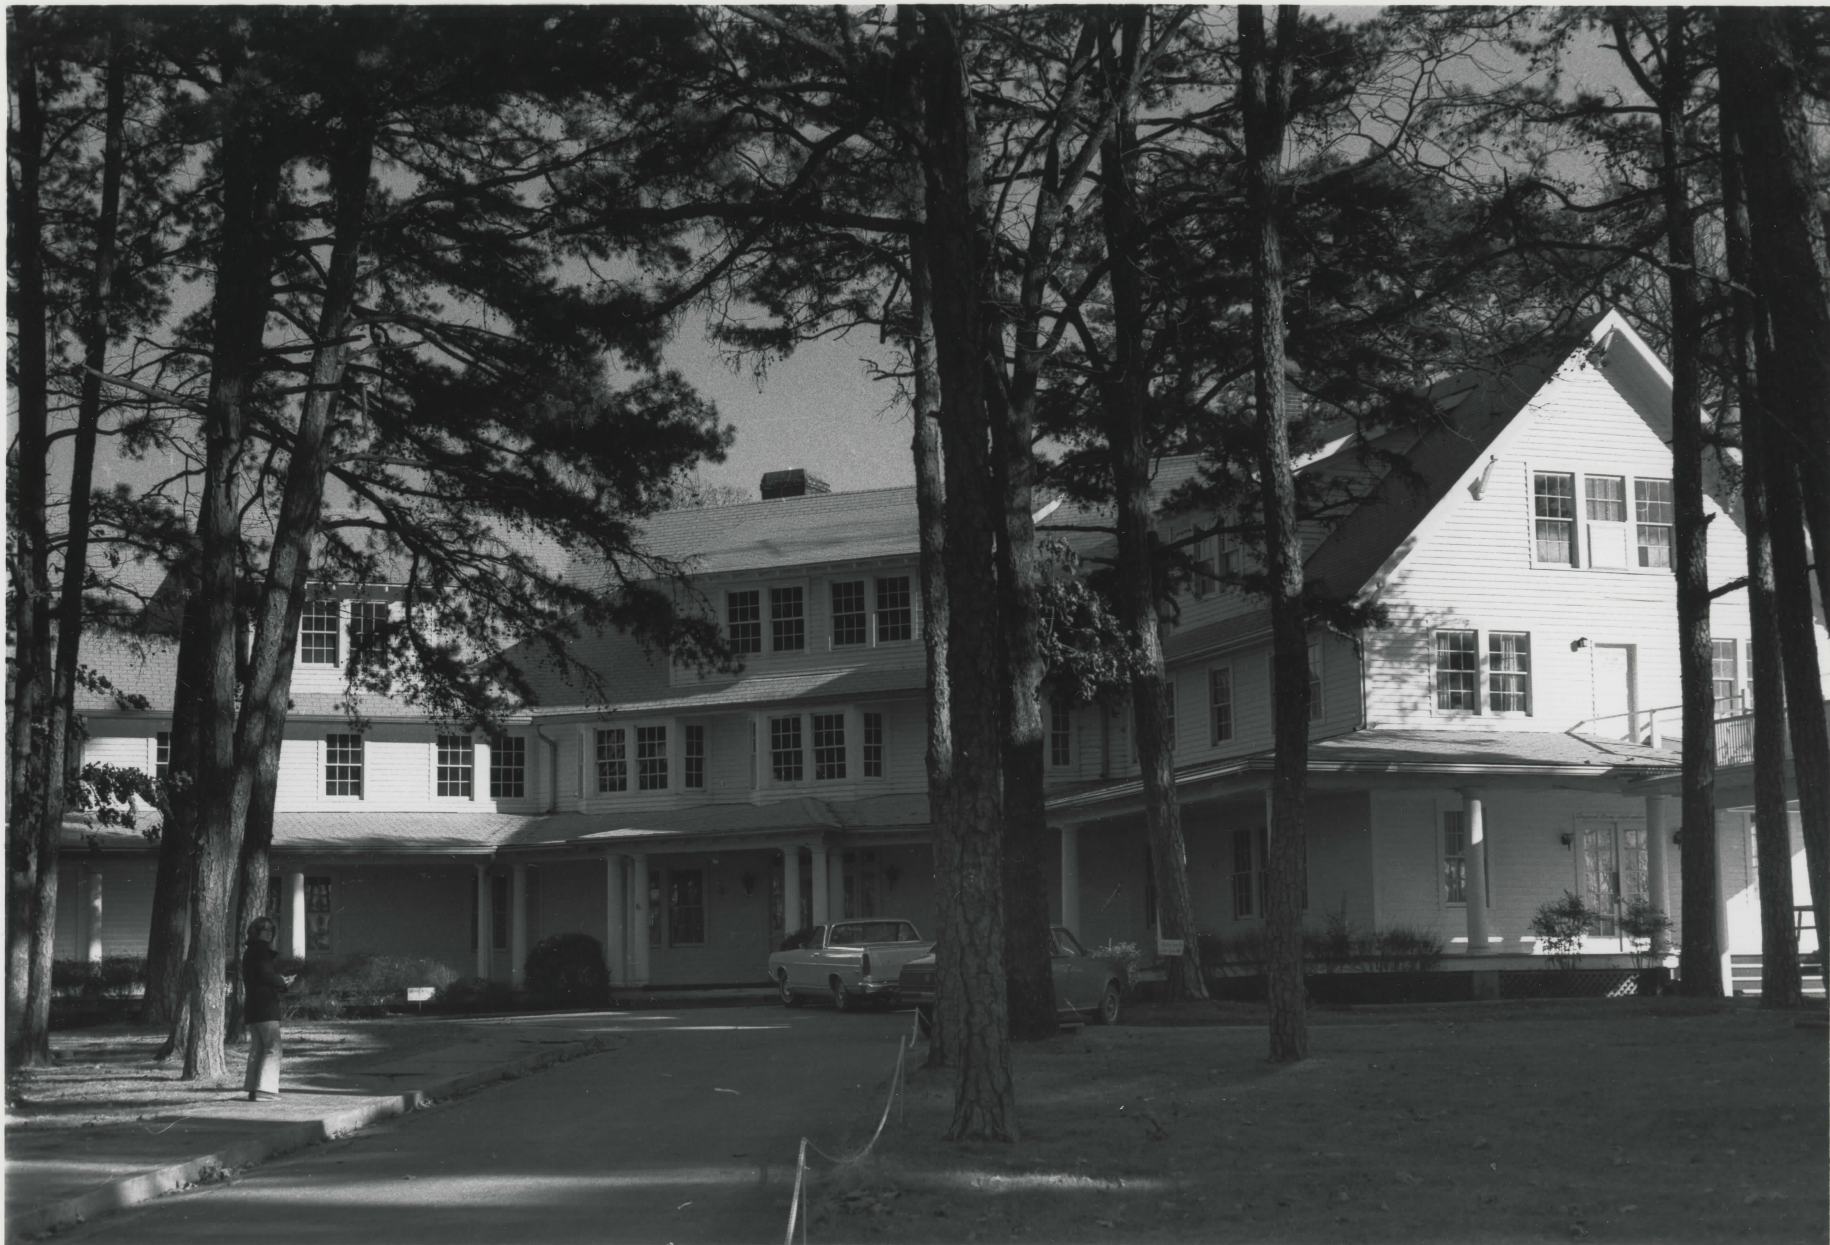
view 15

Badin Club House - # 73

The Club House (now the Stanly County Country Club) is set amidst a pine grove on a hill commanding a view of the village. It was constructed 1912-1914 by the French Company. The main Club House and an annex (built by Alcoa after 1915) are connected by an open colonnade. Both the Club House and the annex are three-stories, sheathed with white clapboards. Both structures have a profusion of six-over-six sash windows, often paired or in groups of three.

The main Club House is built in a modified U shape with the central portion facing north with east and west wings projecting at 45 degree angles. The graceful one-story wraparound porch, supported by Doric columns is cool and shady. The central block has a trio of bay windows projecting on the second-story elevation. Shed dormers project from the roof of the central block and east and west wings. The entrance consists of a pair of glass doors flanked by sidelights and a transom. Entrance to the east and west wings is also through French doors. Replacement asphalt shingles cover the roof with its central brick chimney. Wooden lattice infills between the brick piers of the low foundation.

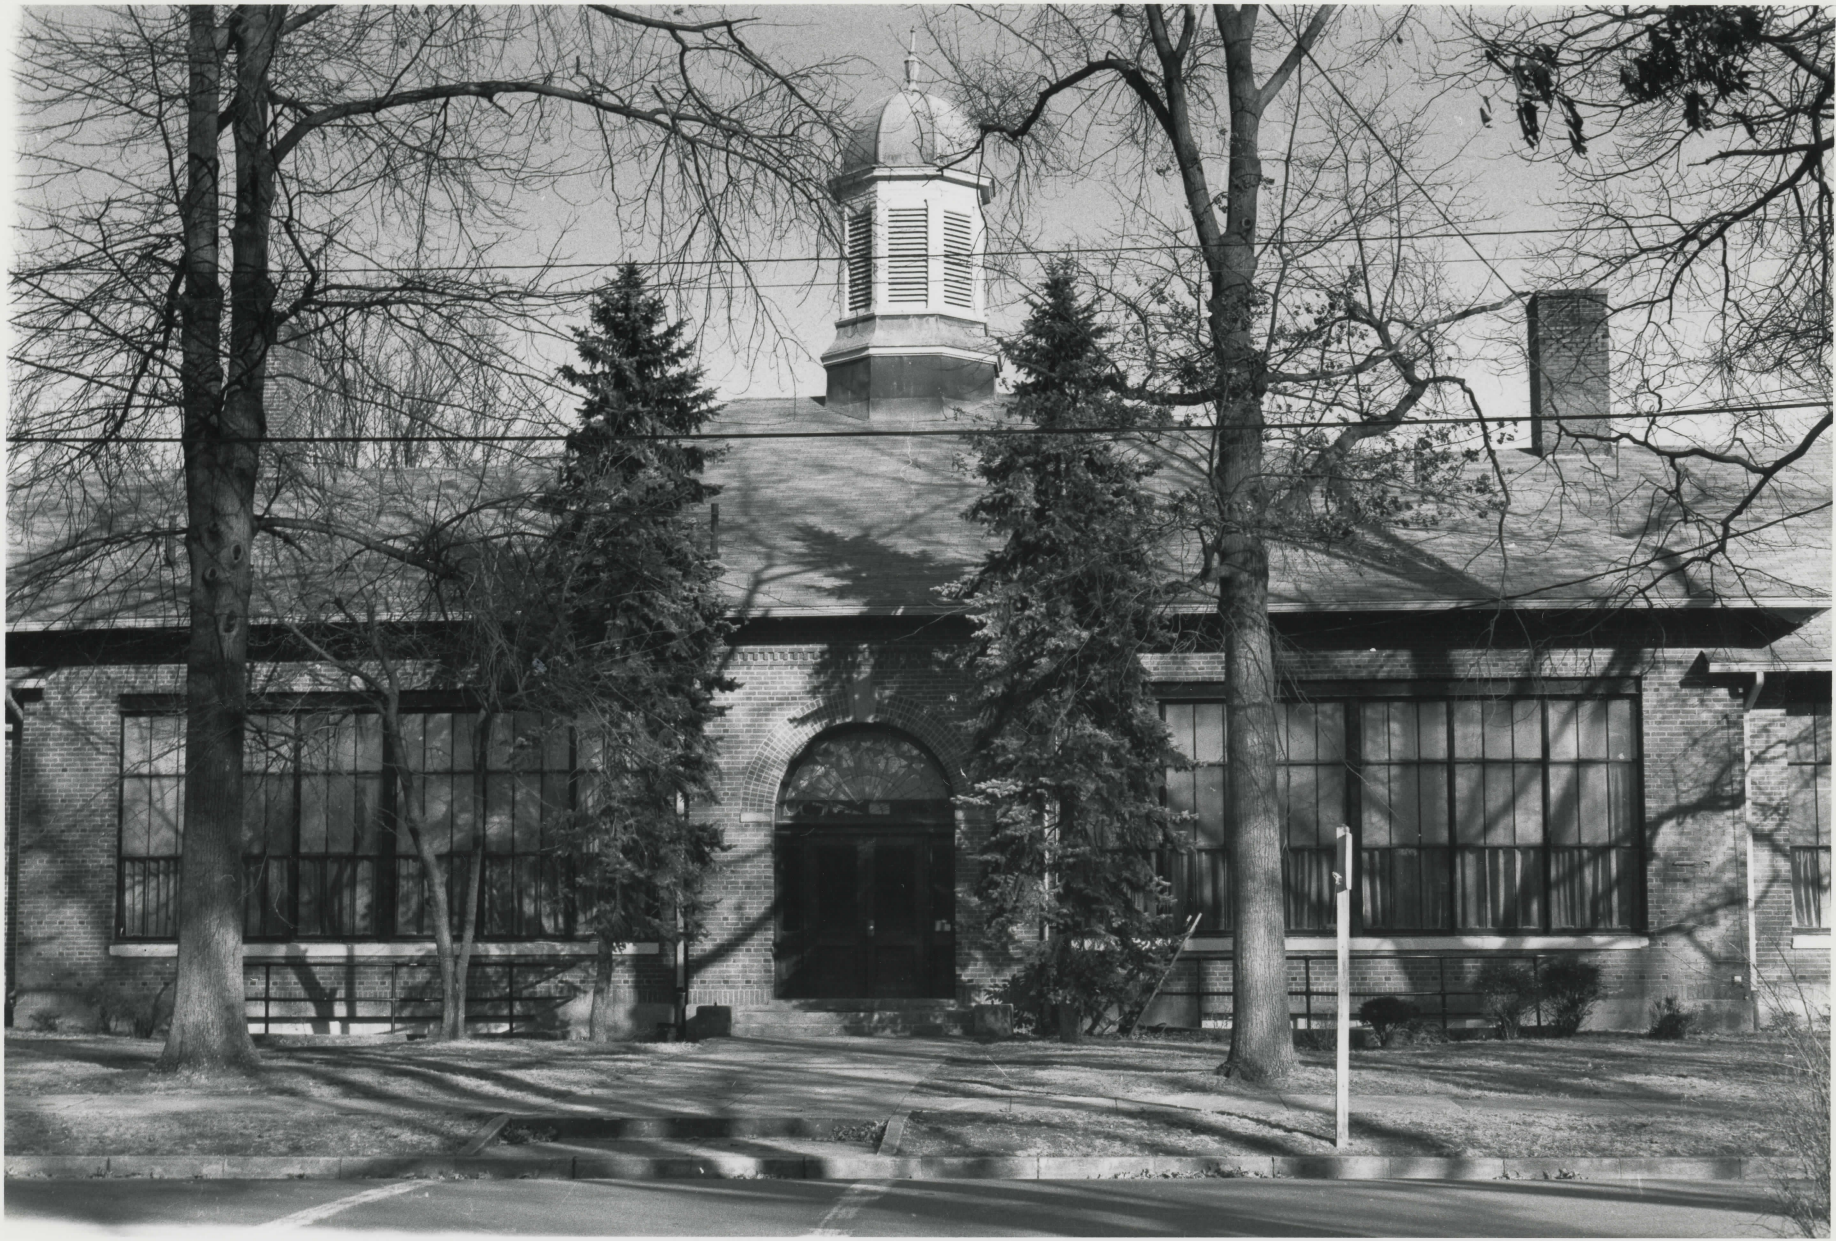
View 16

Badin Elementary School - #35

The central portion of the one-story brick Badin Elementary School on Henderson Street is hip roofed with an octagonal dome-covered louvered cupola. The projecting entrance contains double glass and flush panel front doors with sidelights. The doors are topped by a leaded tracery glass fanlight, which is in turn outlined by a four course brick arch with keystone. Decorative brick corbelling outlines the entrance cornice. The rooflines of the identical wings echo the pavilion style of the houses across the street. Every fifth course of the brick work is alternating glazed header and stretcher. The ends of each wing have a center panel of herringbone brick. The walls appear to be largely glass, with long ribbons of nine pane windows amply lighting the central and wing sections.
