**National Register of Historic Places
Inventory—Nomination Form**

Name: Ballou House
Location: Albion Road (near pole 56), Lincoln
Classification: Building; Private; Occupied; Accessible--restricted;
Private Residence
Owner: Mr. & Mrs. David Smith (same address)
Condition: Good; Altered; Original Site

BALLOU HOUSE
Lincoln, Rhode Island

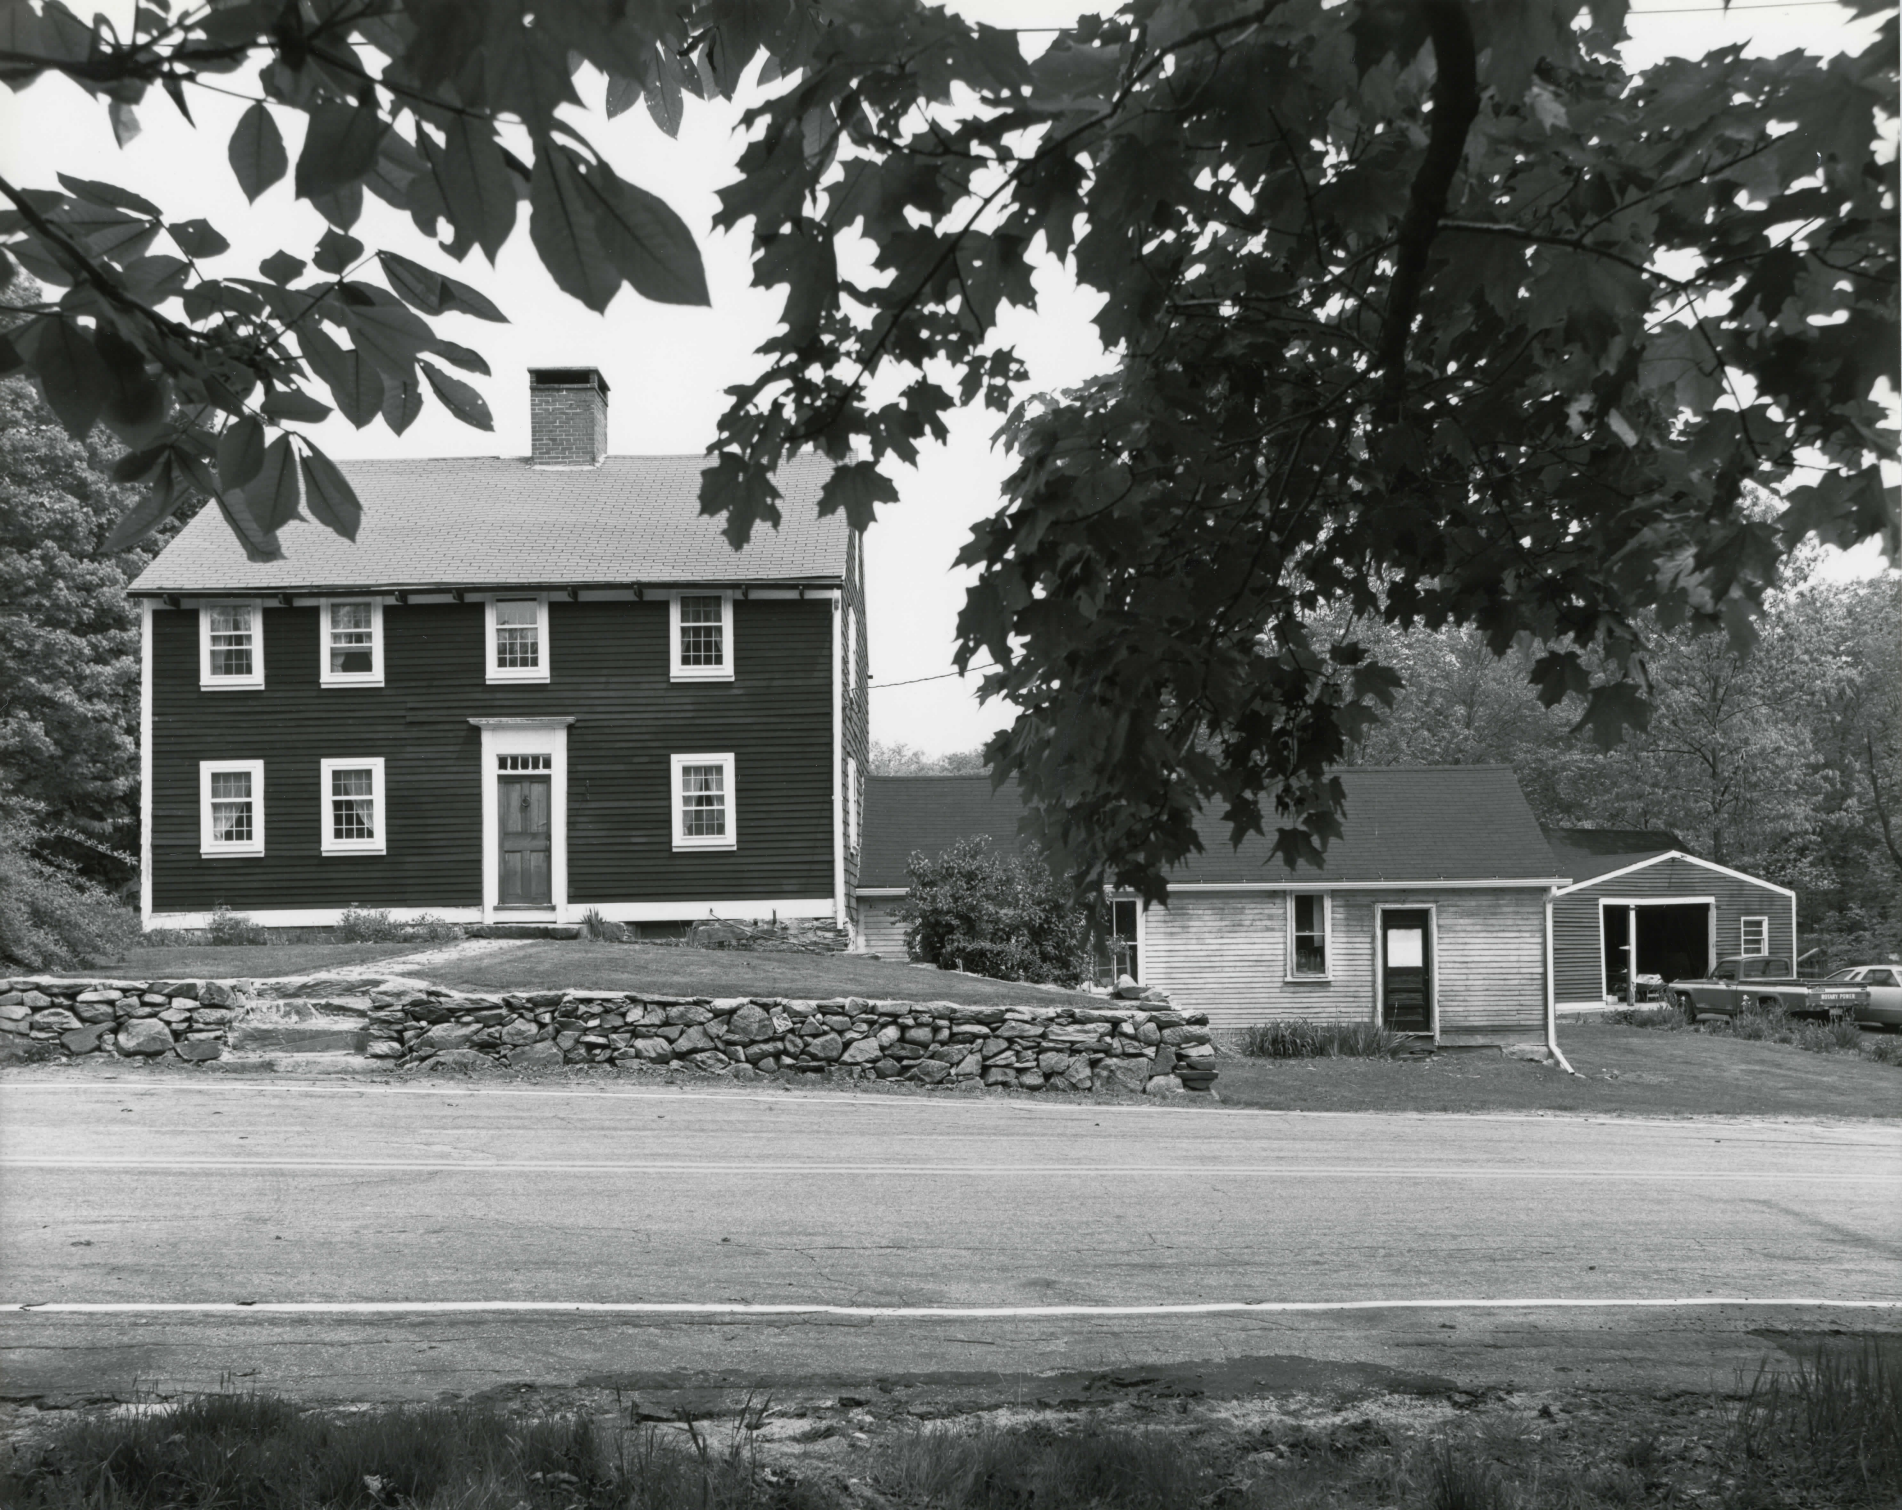
Photo #17

The Ballou House is a handsome center-chimney, Federal house, gable-roofed, two-and-a-half-stories, of heavy post-and-beam construction. The clapboarded house is four bays wide; its roughly centered door is set under a heavy molded cap and a transom.

View: From the south.

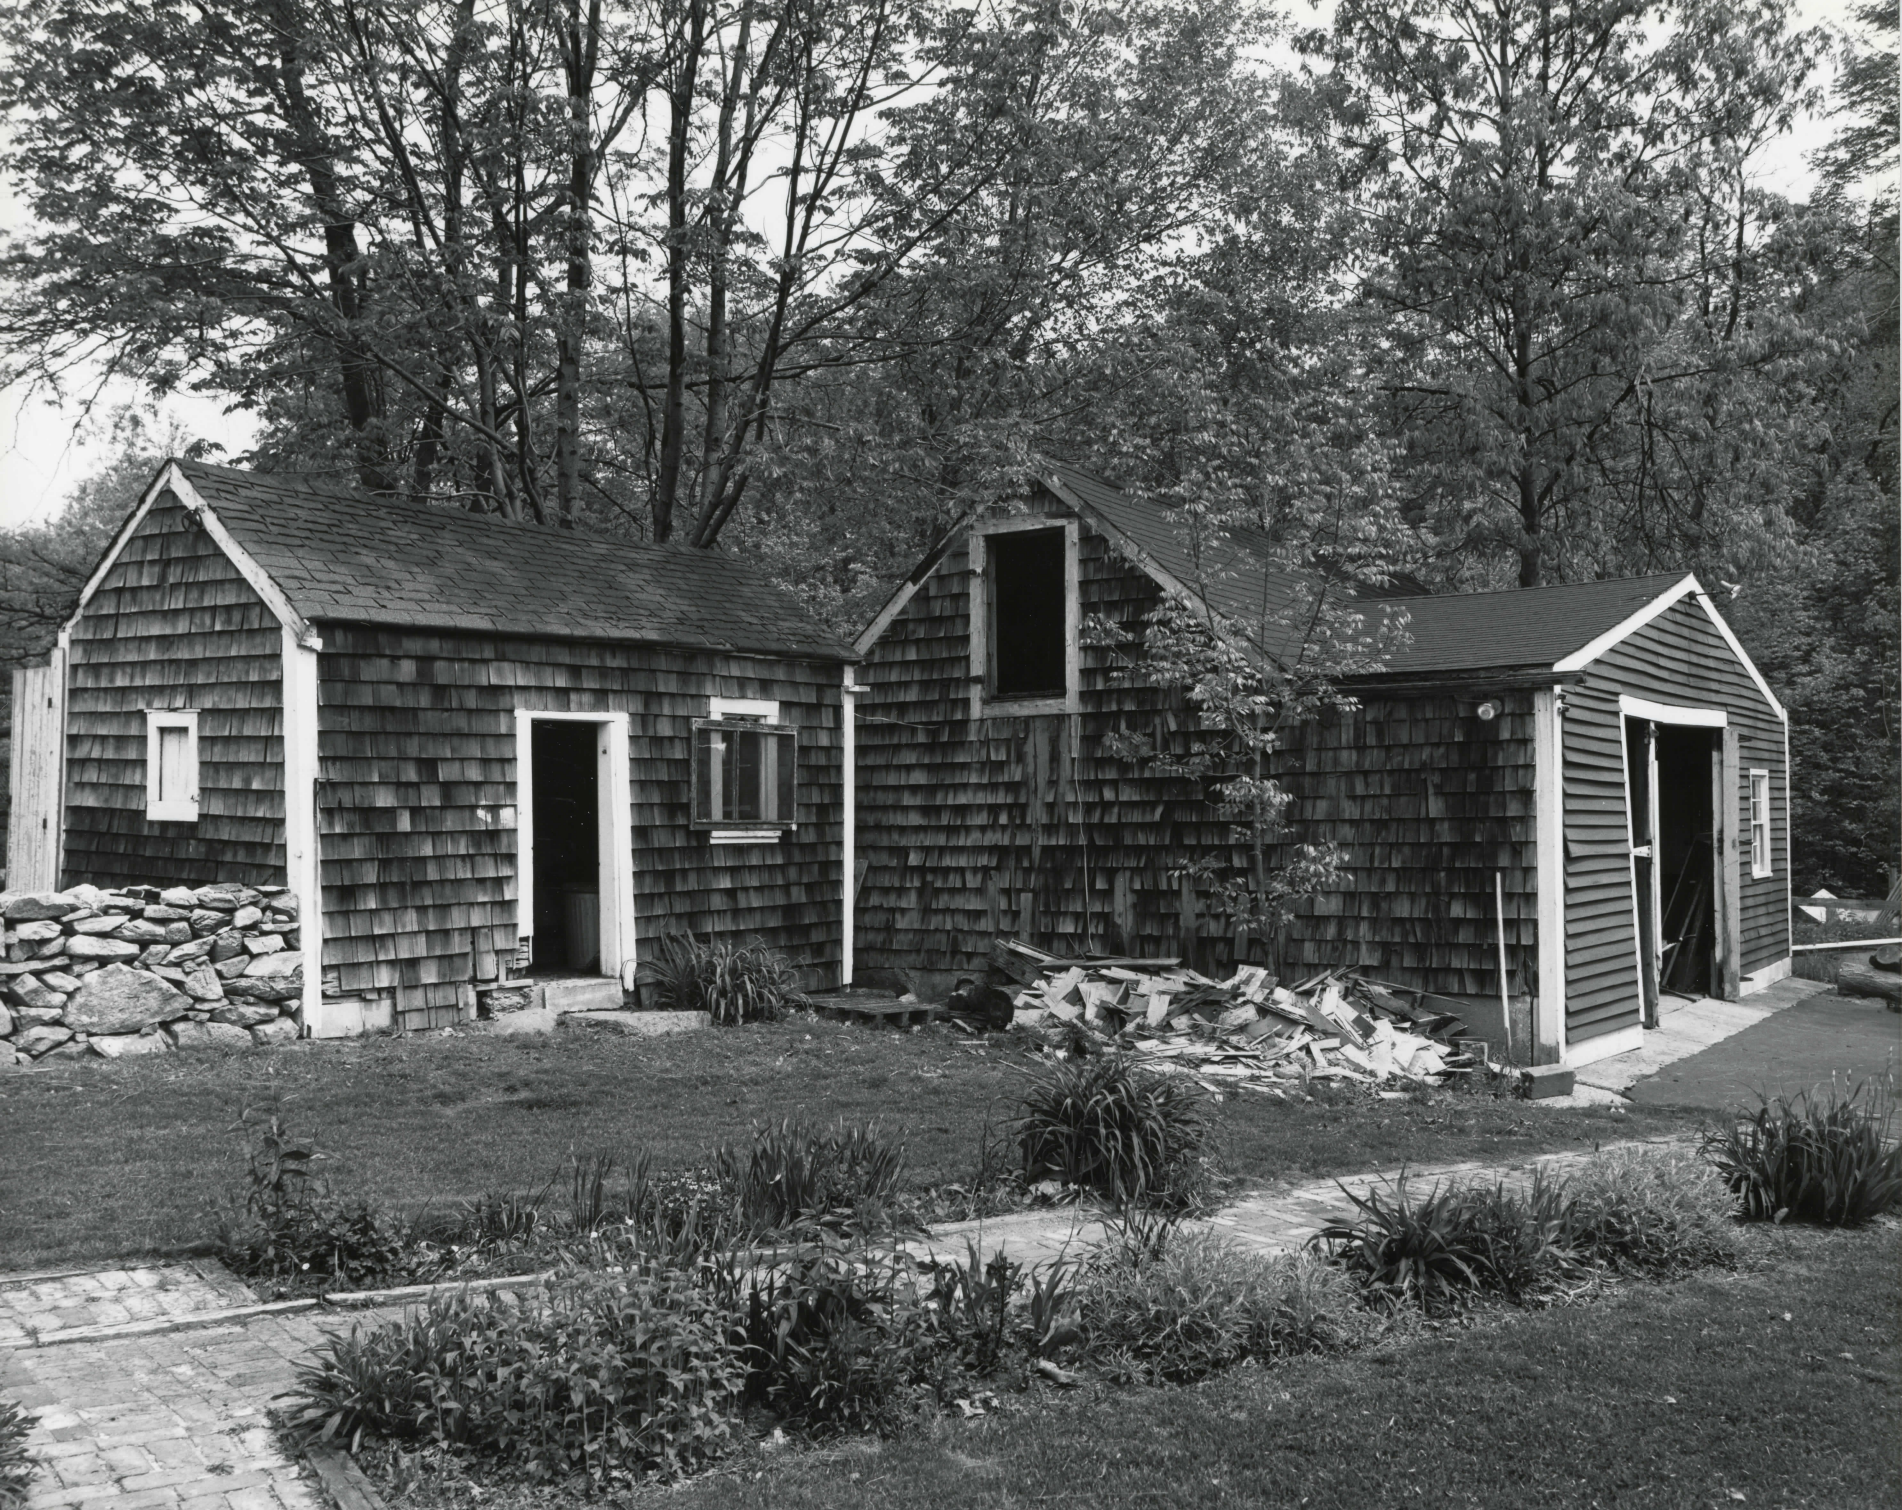
Photo #18

Three outbuildings of note still remain on the property: a privy; a small shed; and an early barn of post-and-beam construction, later extended, apparently to accommodate a farm vehicle. The caved-in remains of a spring house can be seen just northwest of the house.

View: Outbuildings, from the southwest.

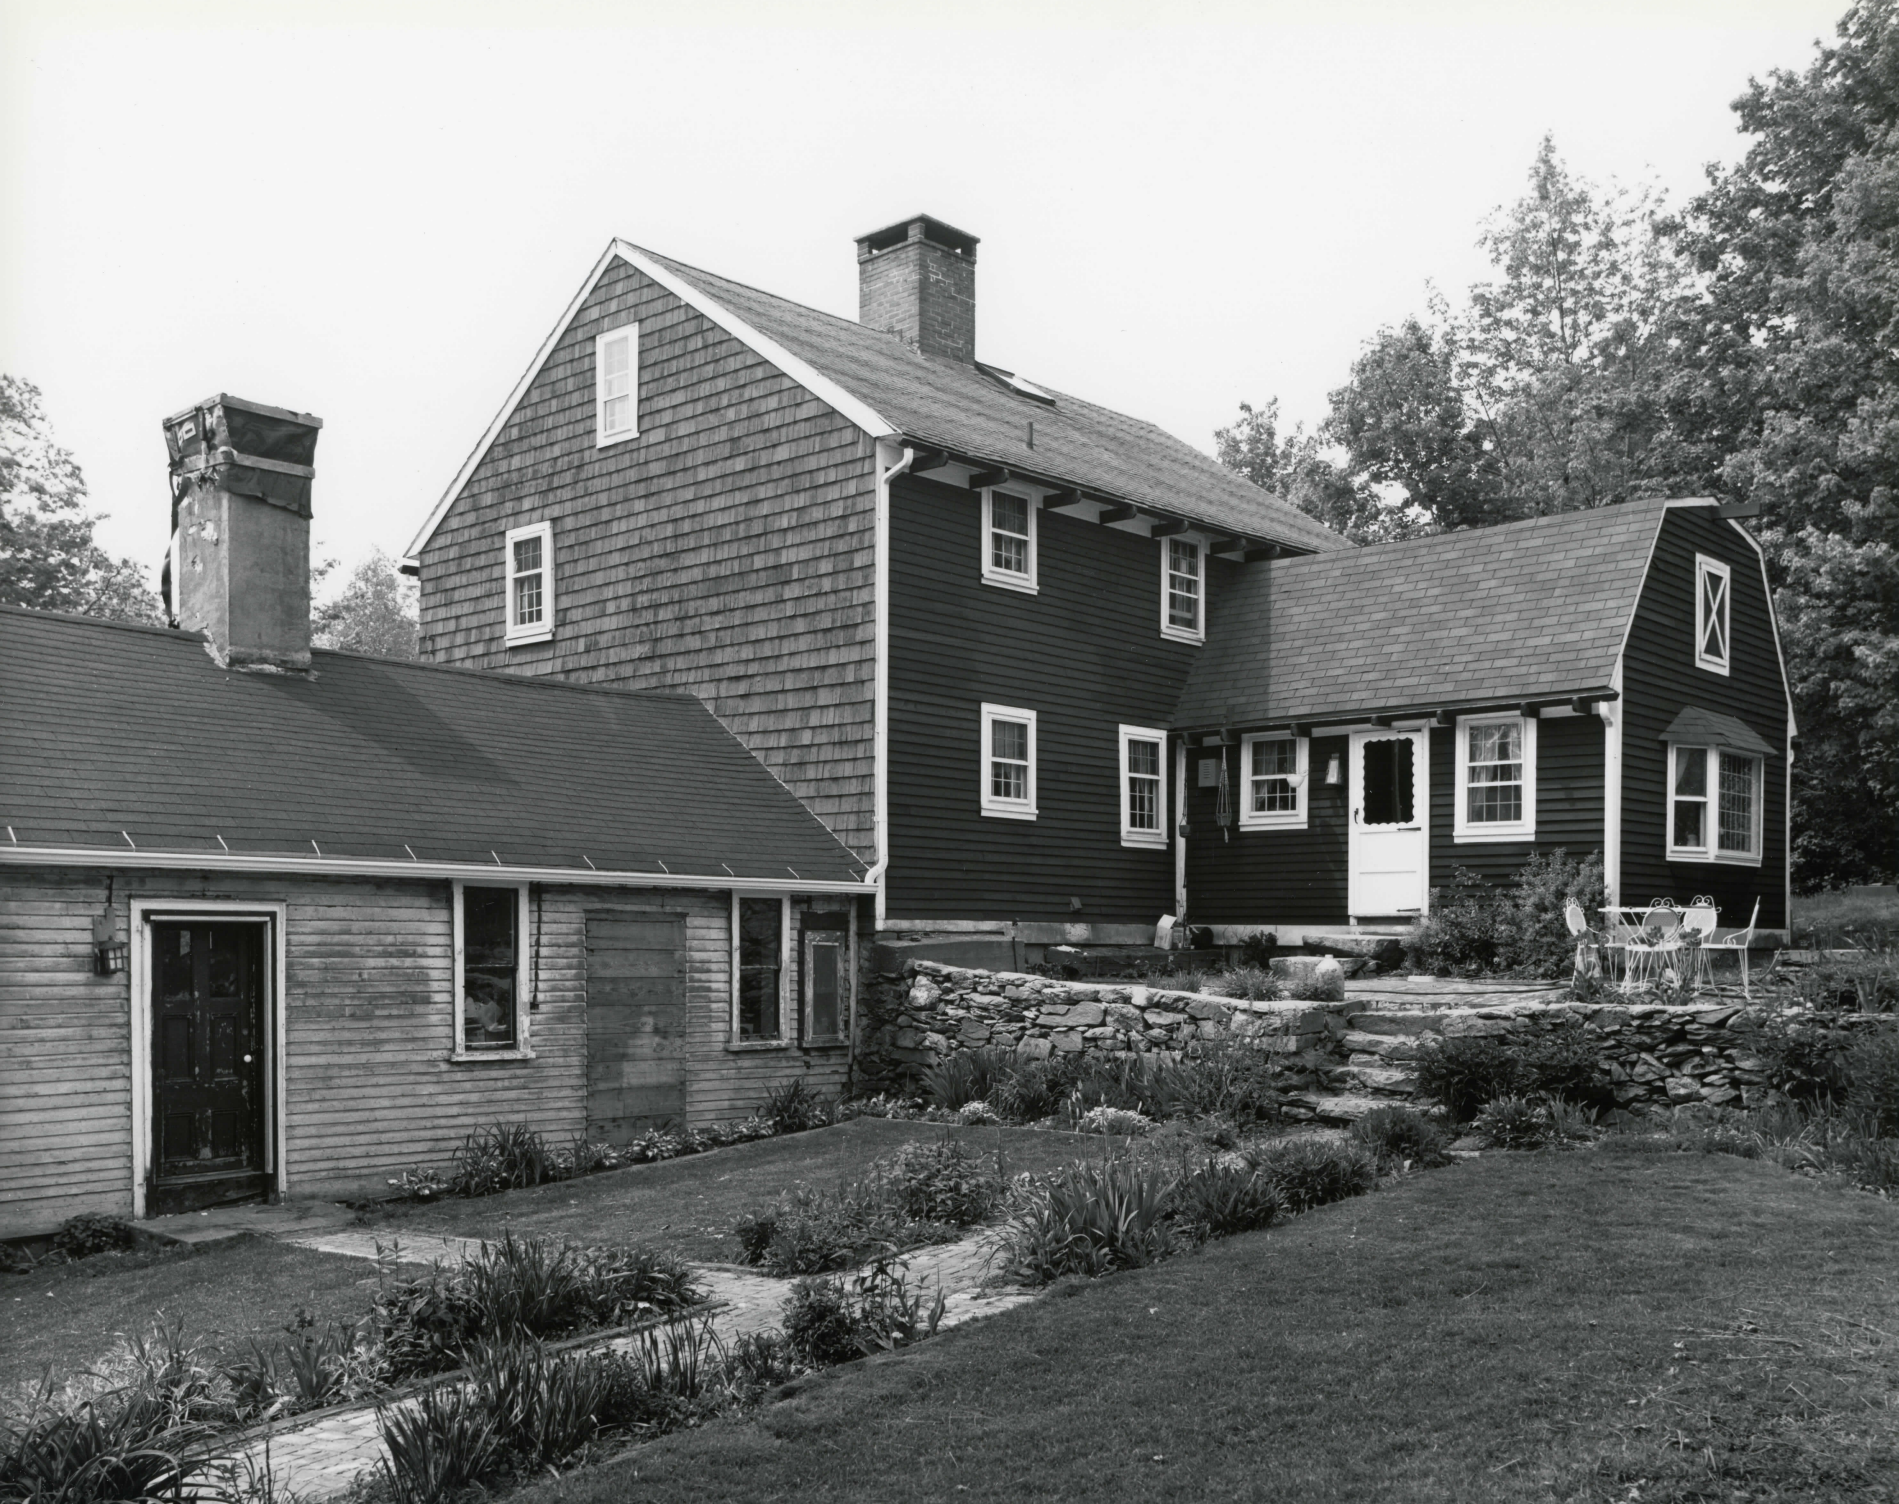
Photo #19

Two additions have been made to the Ballou House. On the east side, a one-story addition with a brick chimney is set at basement level; it was probably built in the mid-nineteenth century to serve some utilitarian function associated with the Ballou farm. In the 1970s, a second addition was made on the north side of the house, a small one-story, gambrel-roof kitchen wing.

View: From the northeast.

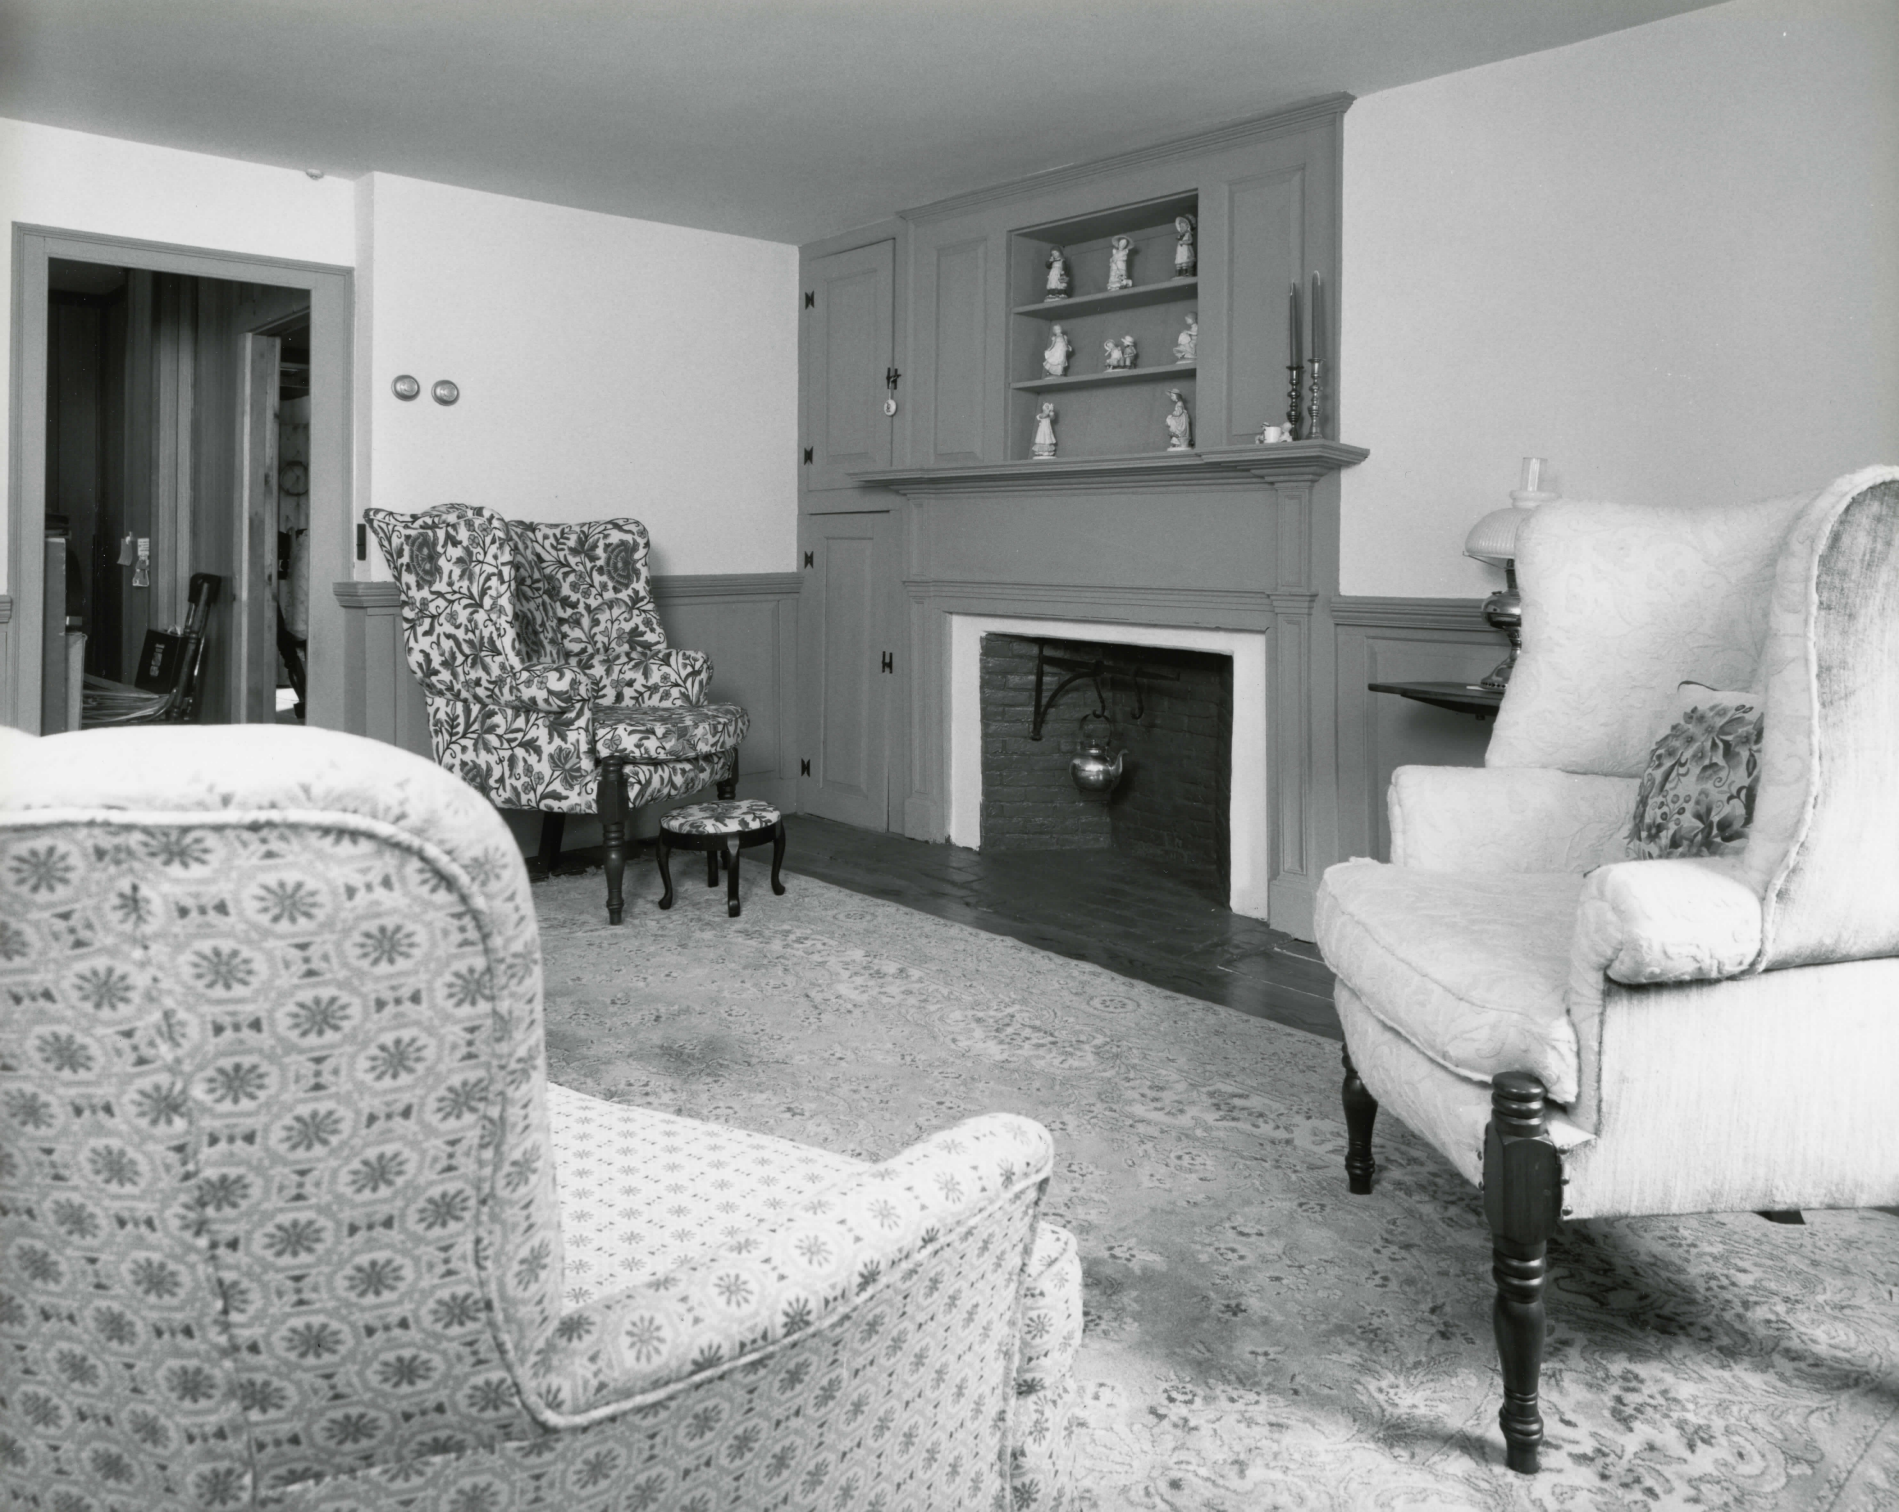
Photo #20

View: Southwest chamber, first floor.

The plan of the house follows the standard five-room pattern dictated by its large central chimney. Its three-run stair is tucked in the space between the door and the chimney and is ornamented with a ball finial on its newel post and acorn pendant on its angle post. The interior of the house is finished with wide floor boards and plain plastered ceilings and walls, except for the first-floor central rear room where there is a wainscot of horizontal boards, and the left front chamber of the first floor where raised panels have been inserted (c. 1978) below the original chair rail. The fireplaces remain intact, though in some rooms the hearth openings have been temporarily closed, and in the right front chamber on the first floor the deteriorating brick face has been replaced with modern brick. Many of the original doors and much of the early hardware remains throughout the house.

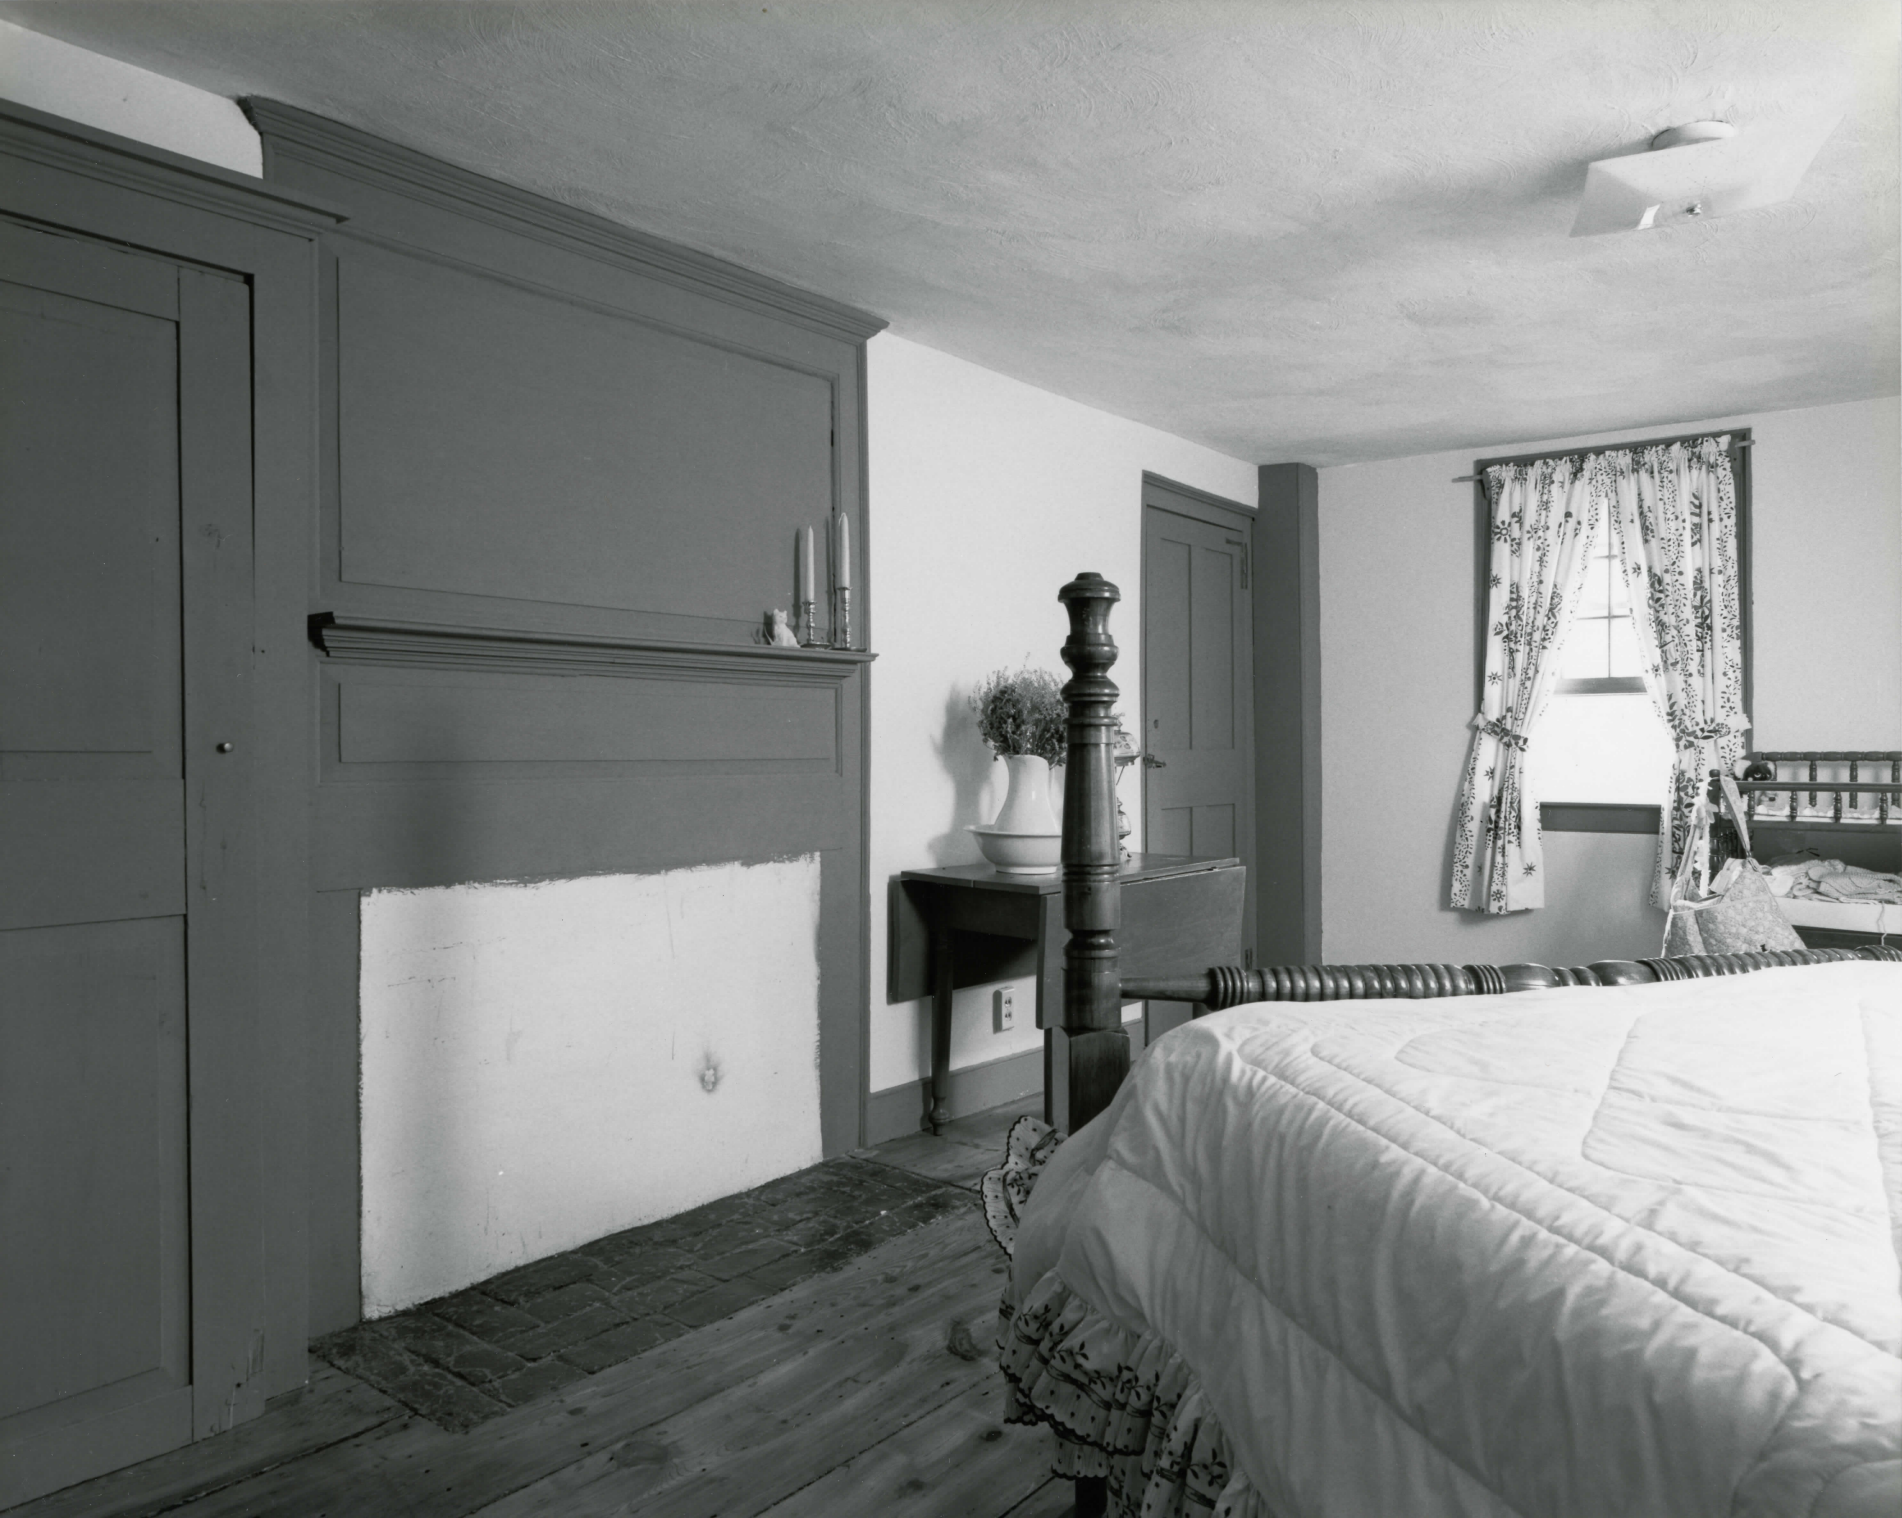
Photo #21

View: Southwest chamber, second floor.
