### NATIONAL REGISTER OF HISTORIC PLACES REGISTRATION FORM

historic name Westview

other names/site number Elam homestead, Terrell place, DHR File # 19-5169

street & number 1672 Terrell Road not for publication N/A  
city or town \_\_\_\_\_ vicinity X  
state Virginia code VA county Charlotte code 037 Zip code 24528

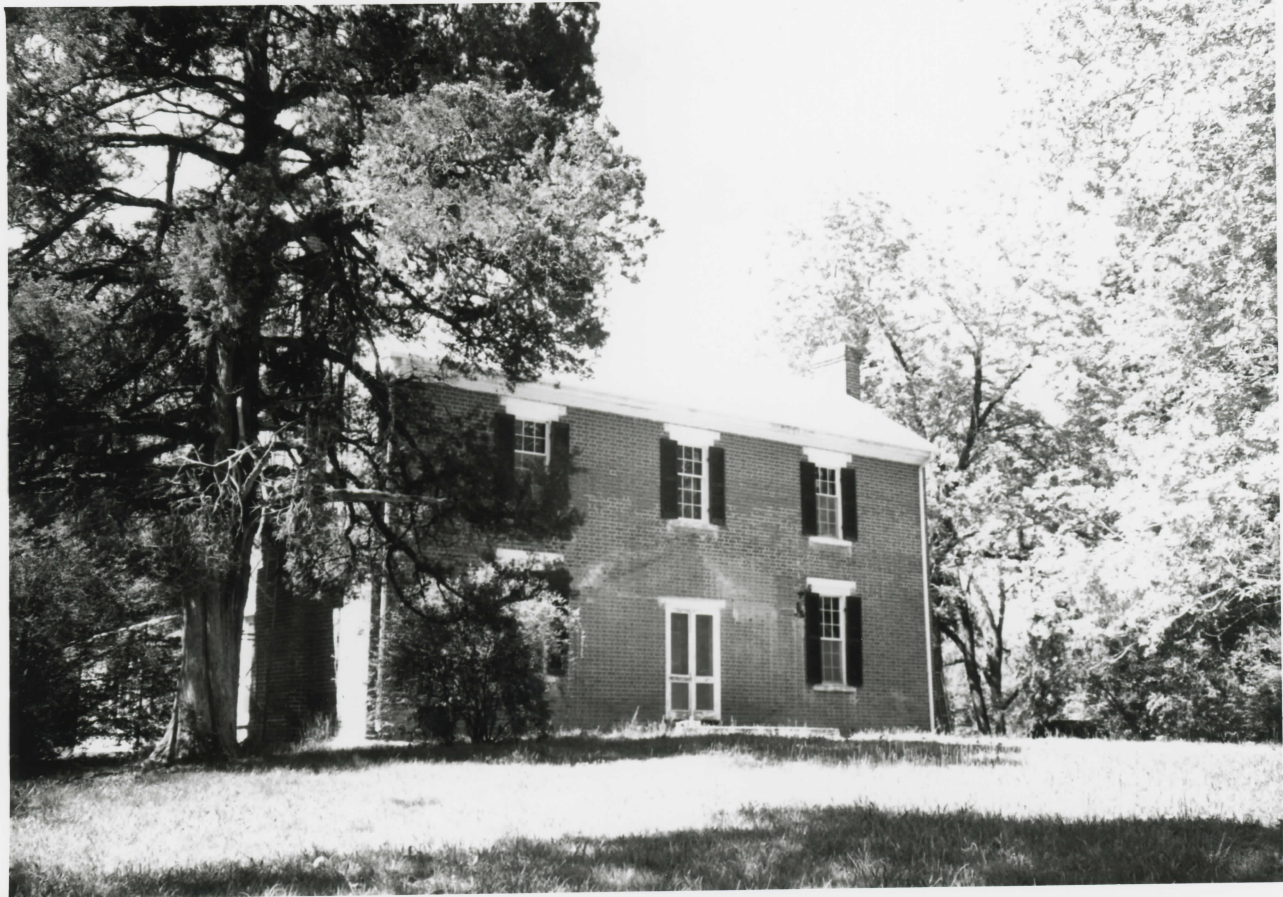
1988

- 1 of 8: View of main(north) façade
- 2 of 8: View of front hall
- 3 of 8: View from front to back hall
- 4 of 8: View of mantel and door in old dining room
- 5 of 8: Log barn with frame shed additions
- 6 of 8: Log slave cabin
- 7 of 8: View of rear additions (west side)
- 8 of 8: View of rear additions (east side)

Westview consists of a center-hall, single-pile, two-story brick main block of the late Federal style with two later frame additions. The brick portion is 48' x 20', three bays wide, with exterior brick end chimneys. The front wall is in Flemish bond while the side and rear walls are in 3-course common bond. The walls are 12 inches thick. The house is earth fast with a very narrow crawl space. A molded concrete water table was added in 1961. It has a low-pitched, gable roof that has been covered with standing seam metal since at least the late 19th century (there is evidence that it was originally hand cut cedar shingles). The cornice is molded. Originally the north and south elevations were identical, with the south side being the main entrance; this was reversed when an addition was made to the south elevation ca. 1840. The windows have 9-over-9 sash on the first floor and 6-over-9 on the second, all with large lights and thin muntins. The window architraves are molded with heavy lintel-type window heads ending in bull's-eye corner blocks. There are louvered shutters. All of the woodwork is original, as is some of the glass. The double doors have raised panels and were originally secured on the inside with an iron bar. The architrave echoes the windows with a heavy lintel and bull's-eye corner blocks. The original door on the south side is identical with one exception: there is no architrave on what was originally the exterior wall; that wall is now plastered. The brick on the north front bears the ghost of a porch. Undated photographs of the house belonging to Susan Yauger (a Terrell descendant) show this porch as a fanciful "high Victorian" confection. It had a scroll-sawn balustrade and square posts with openwork brackets supporting a full entablature. The low pitched roof was hidden behind a Chinese lattice railing topped with scalloped cresting which seems to have been, of all things, a country carpenter's version of the roof ornament of the Doge's Palace in Venice. This porch was removed in the last quarter of the 20<sup>th</sup> century. There is also a primitive mid-19th century watercolor of the house that shows only a small two-stepped stoop. This may be a view of the south side before the additions were made, or of the north side before the addition of its fanciful porch. There is a door on the east gable end, south of the chimney, which once led from the old dining room to an outside kitchen (no longer in existence).
