NATIONAL REGISTER OF HISTORIC PLACES
REGISTRATION FORM

historic name Melrose

Melrose
Fluvanna Co.
Virginia

7. Summary Description:

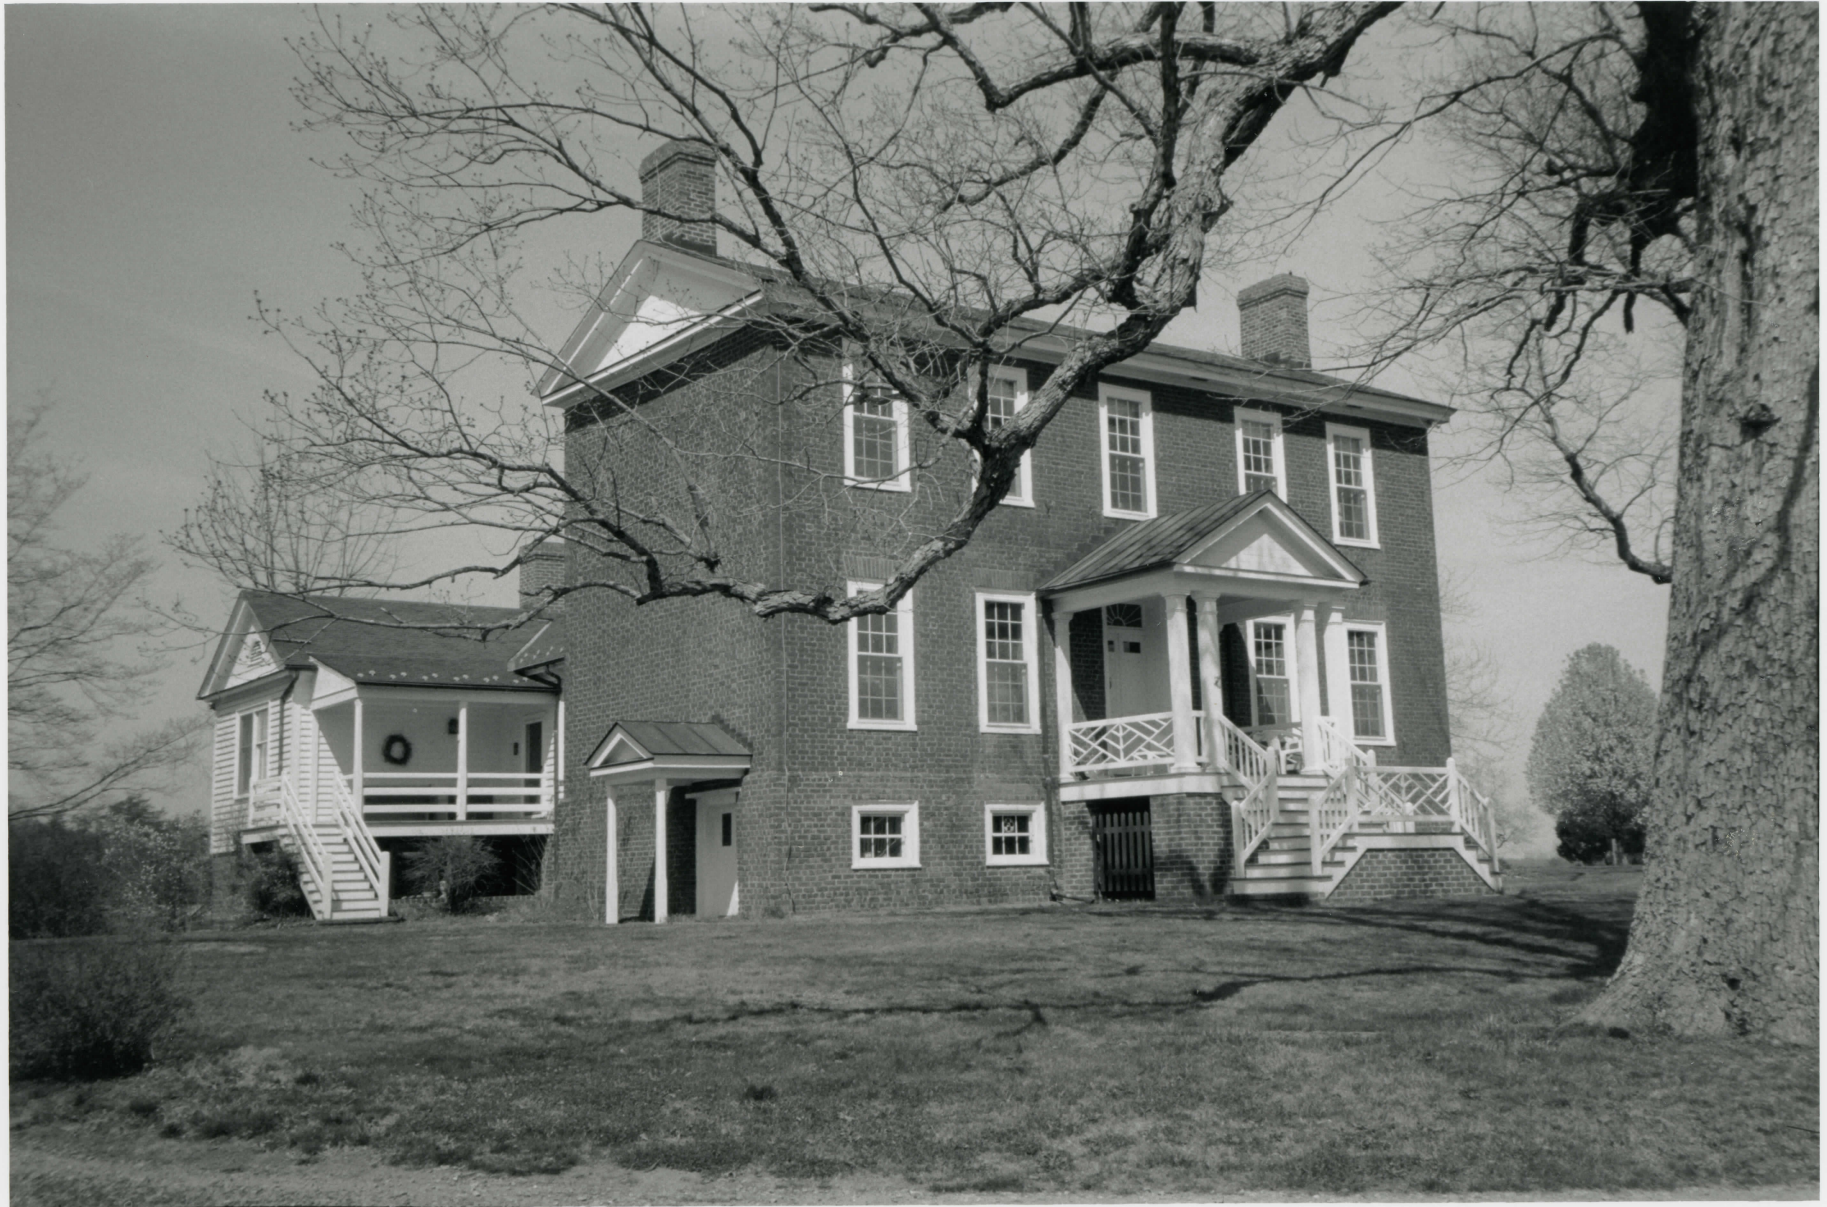
Date: 1995
View of south elevation, view looking northeast
Negative #18108
Photo 1 of 15

Melrose appears tall and stately, due in part to the fact that the English basement is not set deeply into the ground; the main floor is nearly seven feet above grade. The brick above the molded water table on all four elevations is laid in Flemish bond with rubbed corner bricks and Queen's closers. Below the water table, brick is laid in a three-course American bond. Walls below the water table are nearly two feet thick. Chimneys were rebuilt in the 1980s using the old brick. At that time a brick with the date 1813 inscribed on it was found under the corbeling of the west chimney.

The two outer bays on the front elevation are symmetrical, but the middle bay is slightly off-center to accommodate the stairwell on the inside. When the present owners purchased Melrose, the first-story front window on the far left had been altered to a doorway. The basement window below it had been bricked up. The porch, stoop, or steps had disappeared so that the doorway hung in space. The present owners restored both openings to their original configurations as windows.

The front porch is a recent addition. There are no photos of the original structure, which was taken off prior to the 1890s when a Victorian-style porch was built. That porch covered the windows on each side of the entrance. The porch was replaced in the 1980s with the present one, which does not cover the windows and is the same width as the original. The absence of water table bricks and iron spikes protruding from the walls indicated where the original porch had been attached, and gave clues to its width. The owners chose to use a pedimented roof to match the pediments on the end walls. Steps rise from either side to a landing and then rise to the porch. The porch is finished with square columns and Chippendale railings.

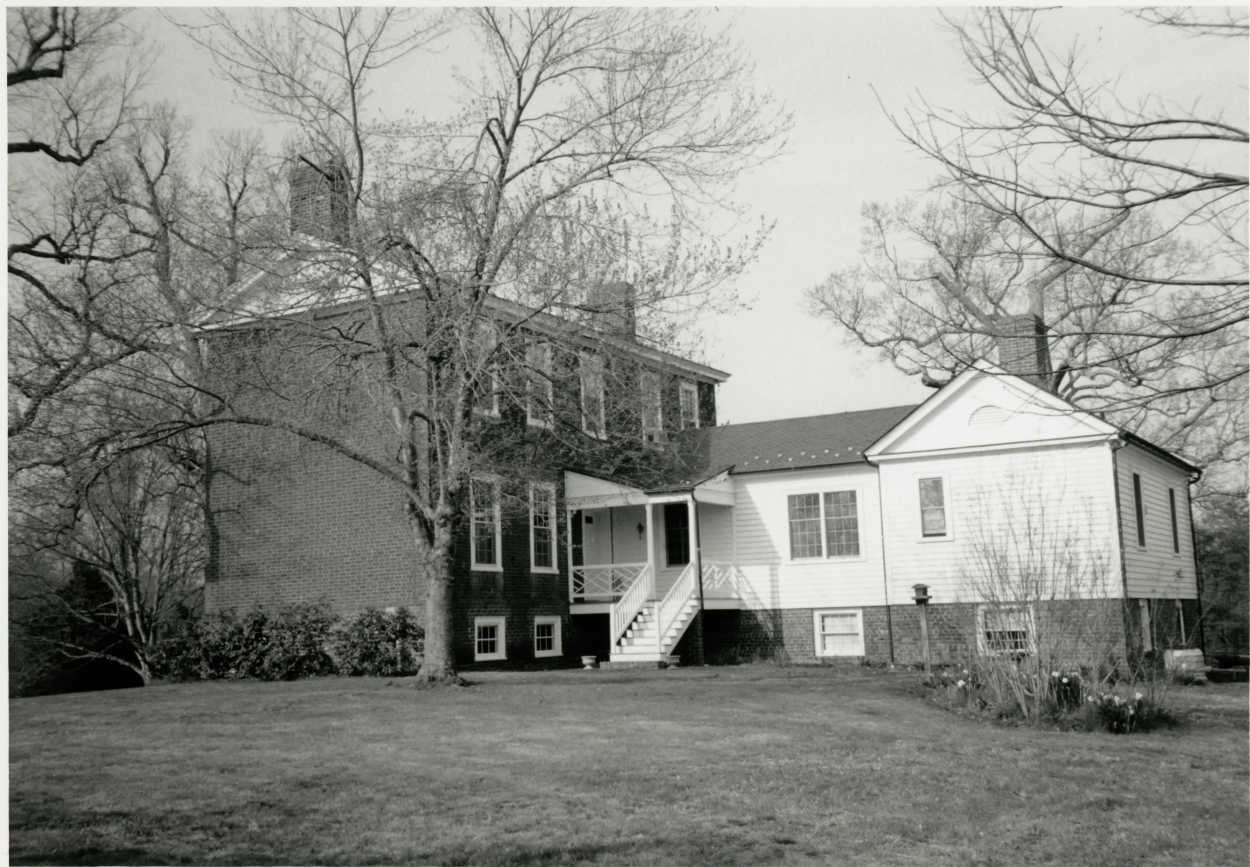
melrose Fluvanna Co, VA Photo 3 of 15

Date: 1995
View of east elevation, view looking west
Negative #18108
Photo 3 of 15

The east and west facades have triangular pediment gables with simple trim of cyma recta. Cornices are boxed with plain soffits and no friezes. The tympanums are flush boards, painted white. There are no openings in the east facade, but to the west there is a door on the right side and two steps descend to the basement. This small door is a recent replacement (using old materials) of one of similar size, which was also probably not original, although there was always a doorway in this location.

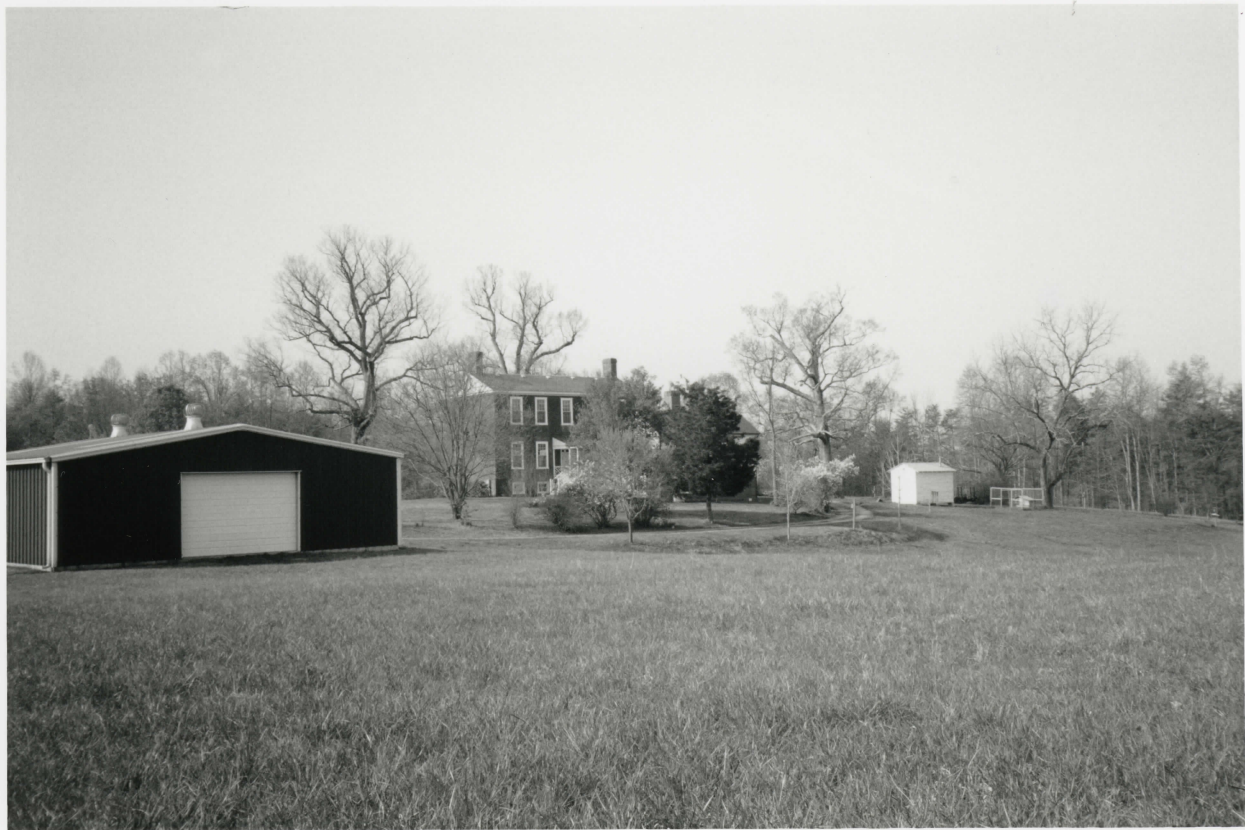
Date: 1995
View of main house north elevation, barn and shed, view looking southwest
Negative #18108
Photo 5 of 15

The north (or rear) facade would be identical to the south except for the addition of a wing built in the 1970s and designed by Floyd Johnson of Johnson, Craven, and Gibson. The wing is one story over a full basement. It has beaded weatherboards above a brick foundation, and a slate roof. It was joined to the old house between the rear center doors and the far western window, so that only the window immediately west of the doorway was covered. This window was changed to a doorway leading into the wing and the window was moved to the front facade to replace the door that hung in space. The basement window directly beneath was similarly altered to become a door leading into the wing basement.

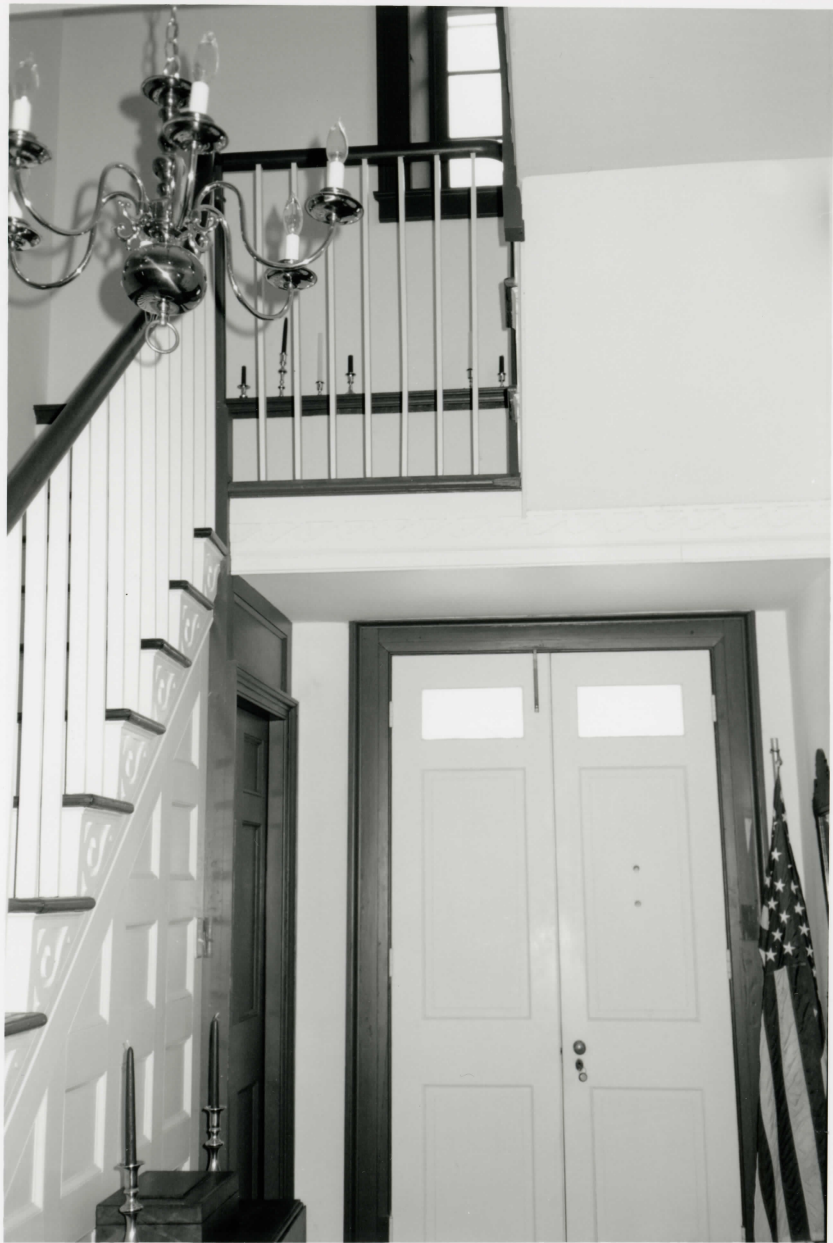
Date: 2000
View of first floor hall, front door and staircase, view looking south
Negative #18109
Photo 6 of 15

The stairway is an open well with two flights. Handrail and balusters are plain; newel post and corner posts are turned. There are ornamental brackets on the open-string stair. After the 1836 fire, the orientation of the staircase was changed. Rather than ascending from the front of the hall, the run now originates at the rear of the first floor hall, rises toward a landing below the center front window, turns and rises four more steps to the top floor. The original front doors had a transom, which now is in the area hidden from view by the stair landing. Therefore, the transom on the outside now is false, with muntins in a fan pattern and simulated panes painted on wood. In the rear of the hall the exterior double doors, which originally had the landing above them, have no fanlight; nor is there any sign that one ever existed. The other indication of the change in orientation is in the ceiling beams in the basement; holes for the original stair carriage axle are visible.

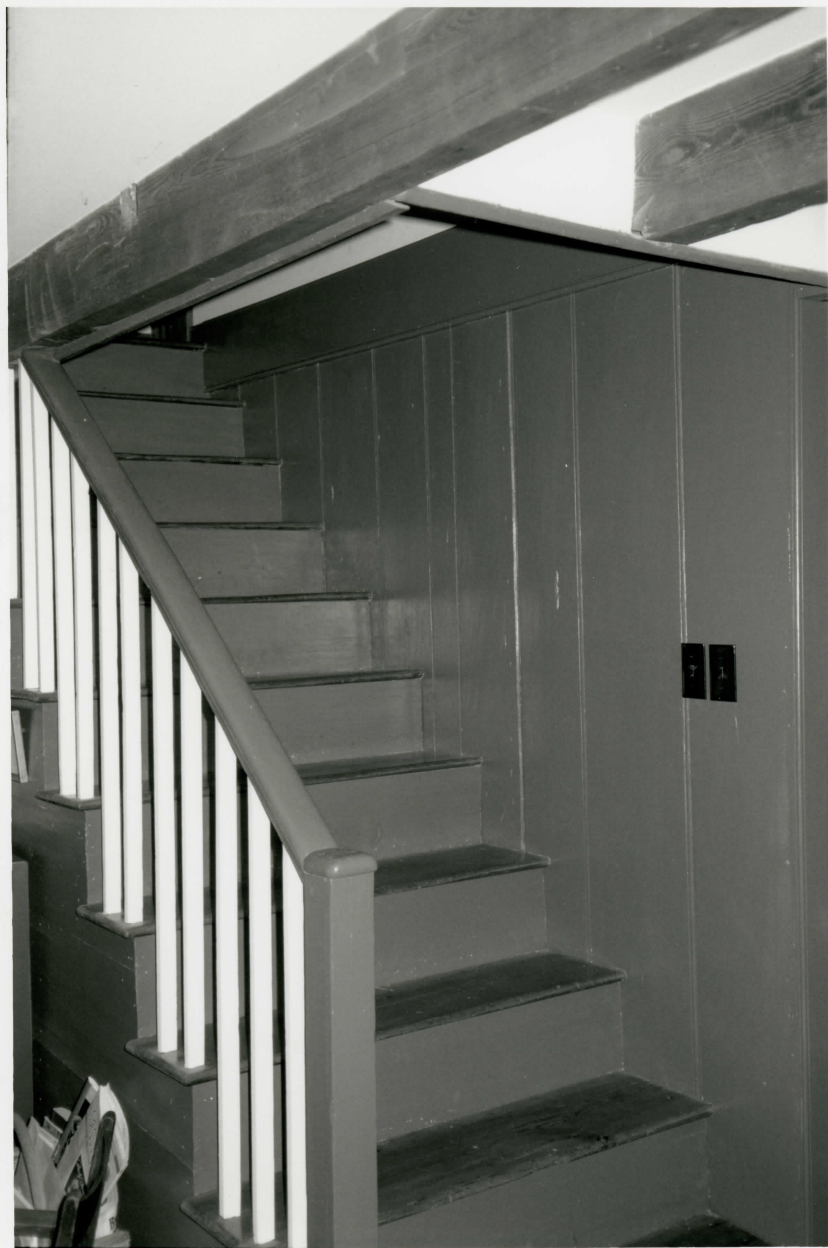
melrose, Fluvanna Co, VA Photo 13 of 15

Date: 1995
View of basement staircase, view looking southwest
Negative #18108
Photo 13 of 15

English basement: This level of the house has seen the most use and the most change. The room to the east, originally the dining room, contains the single-flight staircase, which ascends along the interior wall. The stairs are open with plain rectangular balusters and a simple newel post. The staircase wall is of wide, beaded, vertical pine boards, and originally extended as a single thickness wall to the north wall, dividing the basement space. The room to the west was the kitchen and contains the fireplace with its large arched opening. Iron loops in either side held a chain or bar from which pots were suspended over the cook fire. There was no mantel. There is an arched recess instead of a fireplace in the east room.
