NATIONAL REGISTER OF HISTORIC PLACES REGISTRATION FORM

historic name Mustoe House
other names/site number DHL file # 03-76

Mustoe House
Bath County, VA

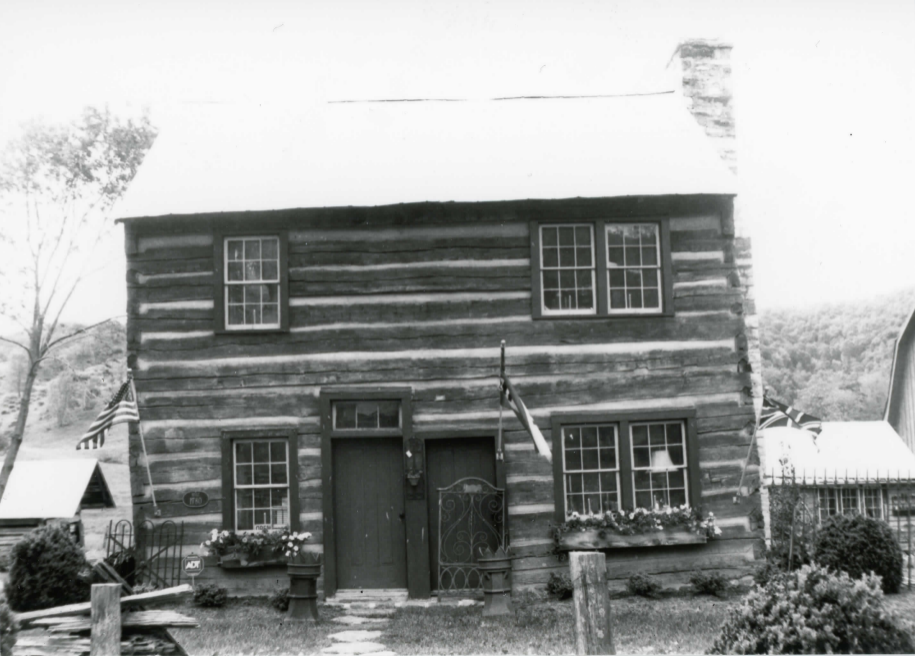
1 OF 10

1. VIEW OF: east elevation-main building; view looking west
PHOTO 1 of 10

The two-story log dwelling stands on the eastern edge of the site, facing the present road and appears to have been constructed in the mid-nineteenth-century. It has V-notching and a gabled, standing-seam metal roof. The main facade has two Greek Revival-style two-panel doors, with an original transom over the left one. To the left of these doors is a six-over-six double-hung window. To the right is a twentieth-century double window, also six-over-six. All of these windows are repeated on the second story. The front facade is about twenty-five feet in length and rises to about seventeen feet at the eave. The squared corners of the V-notching allowed the building to be covered, at one time, with weatherboards that were probably also whitewashed. The weatherboards were removed in the 1980s, and the log walls have since been re-chinked.

There is a large exterior-end limestone chimney on the north gable end of the main building. It consists of coursed rubble and, because of boards added on either side, shows signs of being rebuilt at a smaller size at some point in time. On the first floor there is a six-over-six double-hung window to the right of the chimney, which was probably added at the same time the chimney was rebuilt. The upper gabled ends, clad in flush weatherboards, have a six-pane casement window on each end, visible from inside the attic. While the north one is thought to be original, the south window appears to be a later addition.

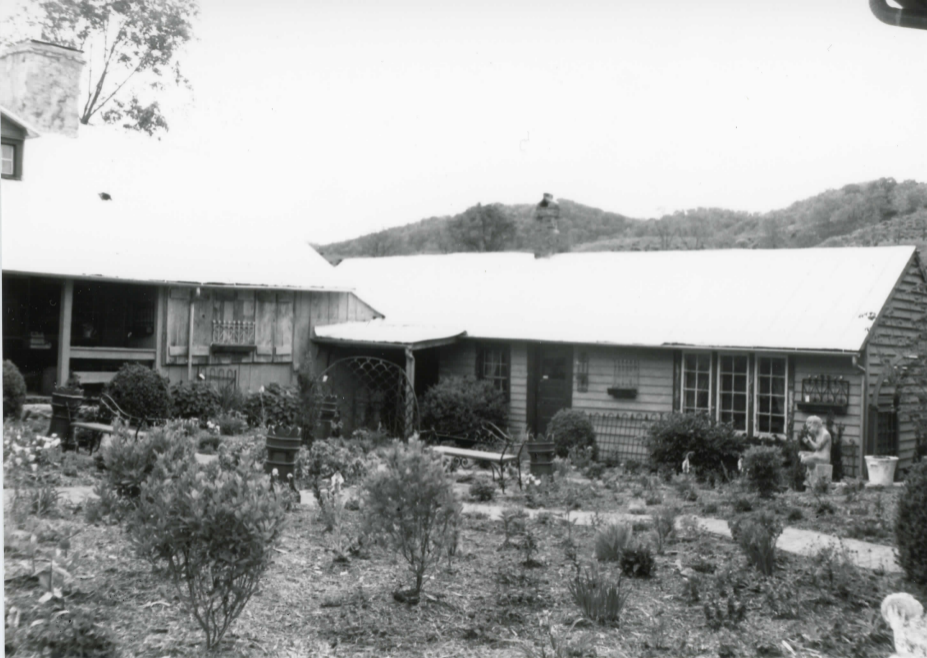
2 OF 10

2. VIEW OF: front of twentieth-century addition; view looking southwest
PHOTO 2 of 10

To the west of the rear building is a one-story, board-and-batten addition clad with bricktex underneath the siding. It has a six-over-six double-hung window on the south elevation and a shed standing-seam metal roof. Adjoining this addition is a 1940's

rectilinear wing with weatherboard siding that extends north-south. A small square room is attached to the rear of this wing. It has one single-paned, double-hung window on both the north and south elevations and a double window of the same type on the west elevation. The west elevation of the long wing has one six-over-six double-hung window and one set of eight-paned triple casement windows. The east elevation has both sets of these windows and a single-pane three-panel door. The wing has a gable metal roof with a centrally located brick flue and a small attached porch. Inside, this rear apartment wing contains four rooms with French type, glass-paned doors, pine floors and plain board molding.

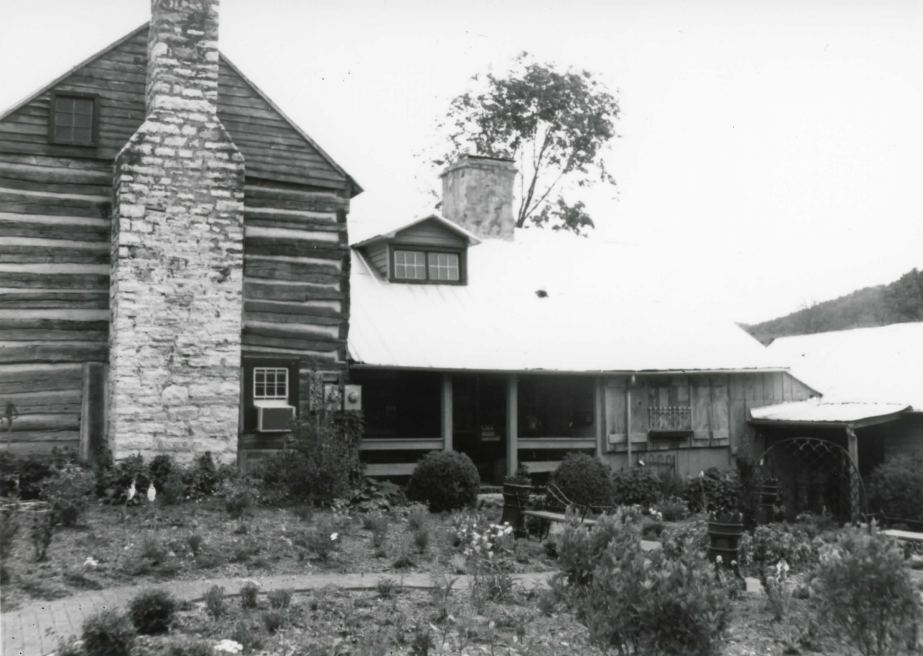
3 OF 10

3. VIEW OF: north elevation of log hyphen addition and main dwelling; view looking southwest
PHOTO 3 of 10

In between the original building and the rear building, stands a one-and-a-half-story log hyphen addition. The southern wall has a six-over-six double-hung window on the second floor and a newer double six-over-six double-hung example on the first floor. The second-floor floor joists are cut into a hewn beam on this elevation, in the same method found in the rear building. At the east edge of this ell, there is a vertical post into which the logs are tenoned to provide stability. The western edge of the ell has pegs through the horizontal logs with smaller pieces of wood serving as the tenons between them. On the west side there is a side porch that leads into the existing kitchen on the eastern end and has a storage shed at the western end. Above the porch is a twentieth-century, double-casement, dormer window with a shed roof.

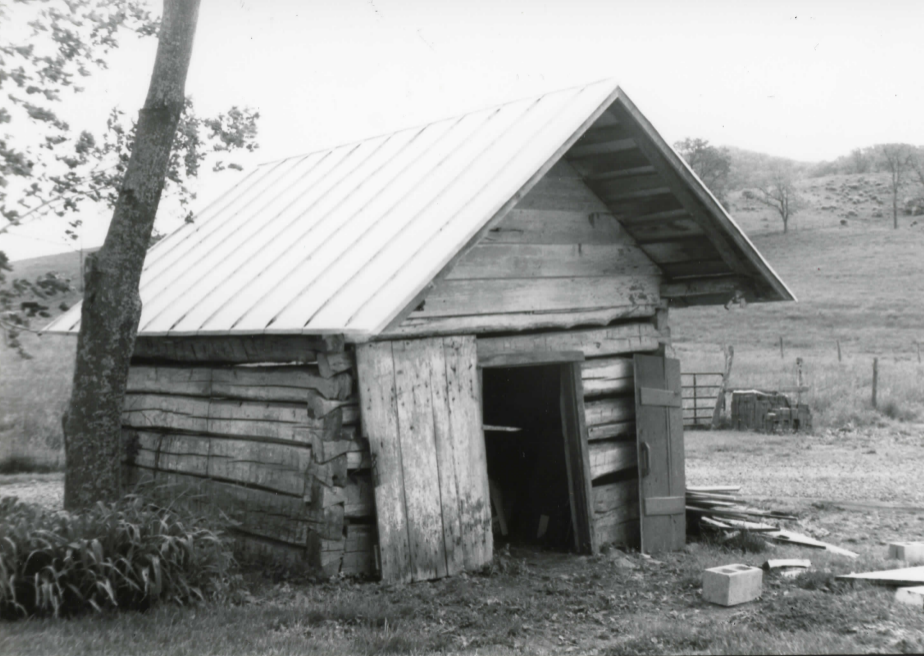
↑ OF 10

4. VIEW OF: log outbuilding; view looking southwest
PHOTO 4 of 10

Another small log building, possibly used as a springhouse or a meathouse, stands to the south of the log house. It is rectangular in shape and has half-dovetail notching and a standing-seam metal roof. Its batten door has strap hinges. While not on the same property, another vacant log structure stands across the road to the east of the site. It also has half-dovetail notching and still contains the original fireplace as well as the staircase and shed wings. It is possible this was used as the Mustoe early log home while the first was being built or was part of their original property.

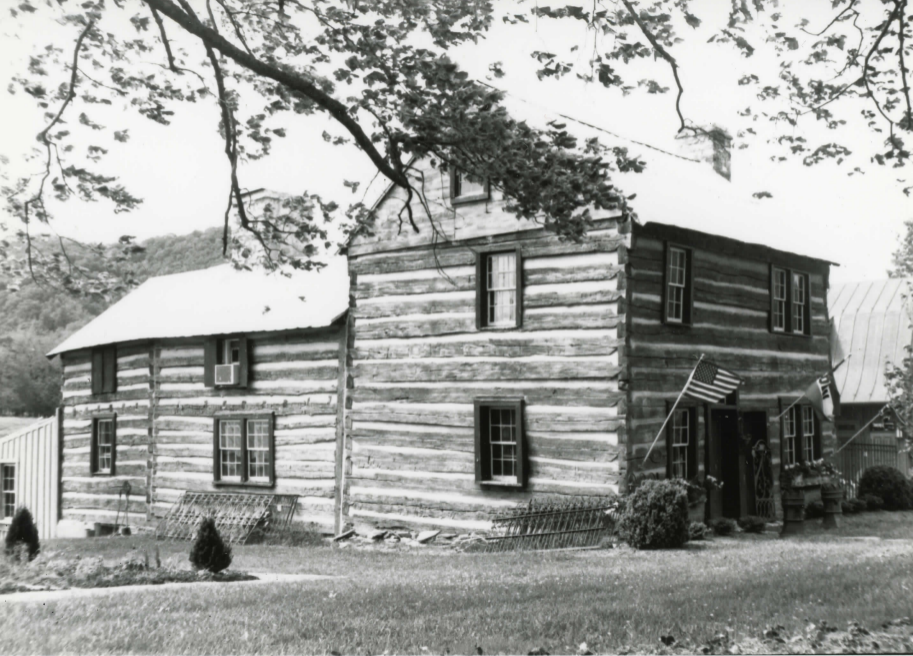
5 OF 10

5. VIEW OF: southeast corner of main dwelling; view looking northwest
PHOTO 5 of 10

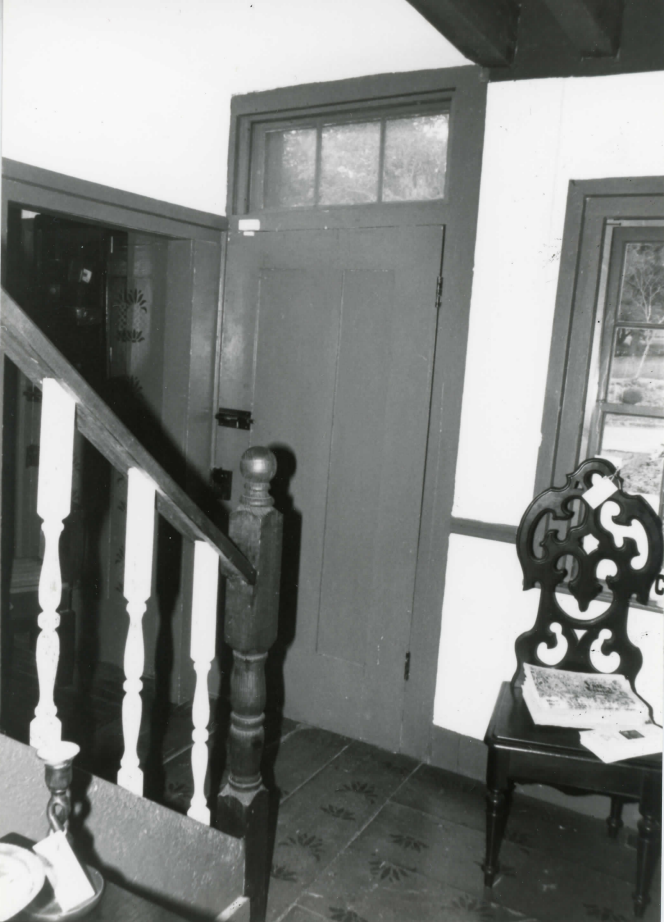
6 OF 10

6. VIEW OF: interior of front door and transom, first floor
PHOTO 6 of 10

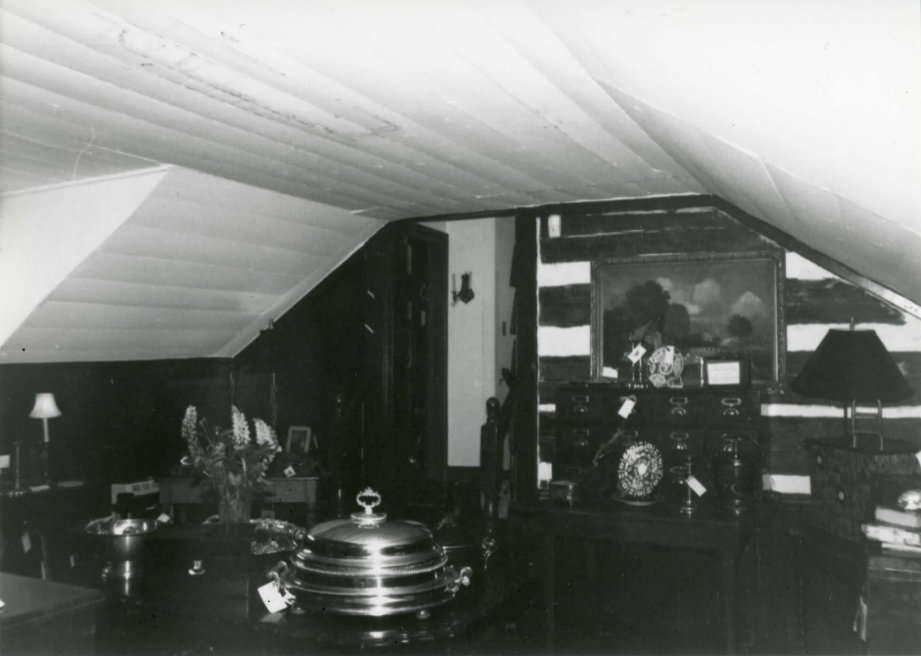
7 OF 10

7. VIEW OF: interior of hyphen addition, second floor looking east
PHOTO 7 of 10

Upstairs, the main room contains one window on the south wall and the dormer window on the north. On the west wall, the placement of the chimney is evident from its projection into the room. On the left side of the chimney is a beaded cased opening with a batten door that leads through a small hall into the upstairs of the rear building. This wall with the cased opening is constructed of vertical wood planking. The eastern wall is made of log construction with plaster chinking visible between the logs. This wall contains three steps up to the hallway opening of the main building.

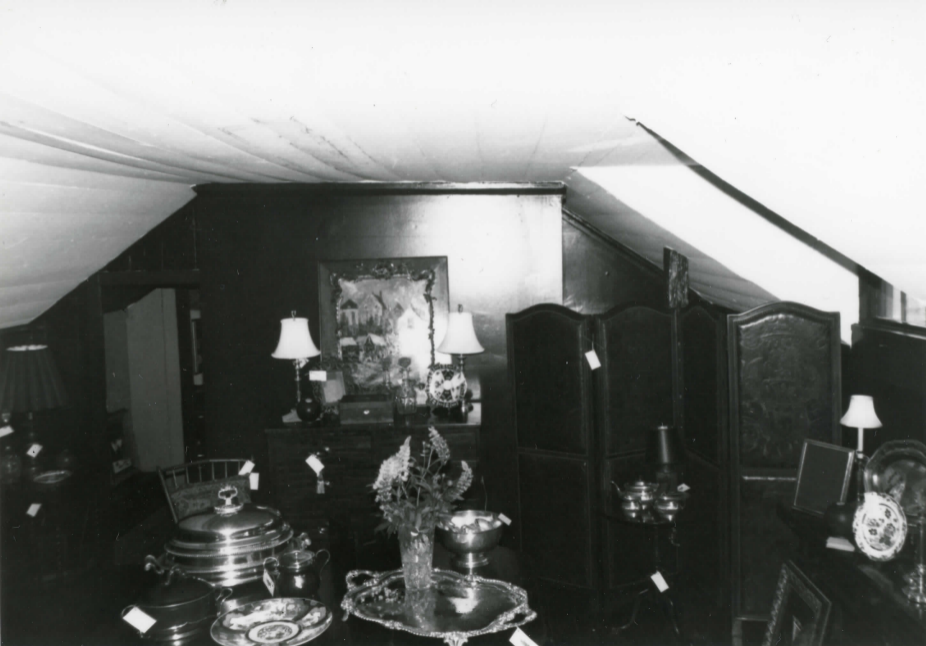
8 OF 10

8. VIEW OF: interior of hyphen addition, second floor looking west
PHOTO 8 of 10

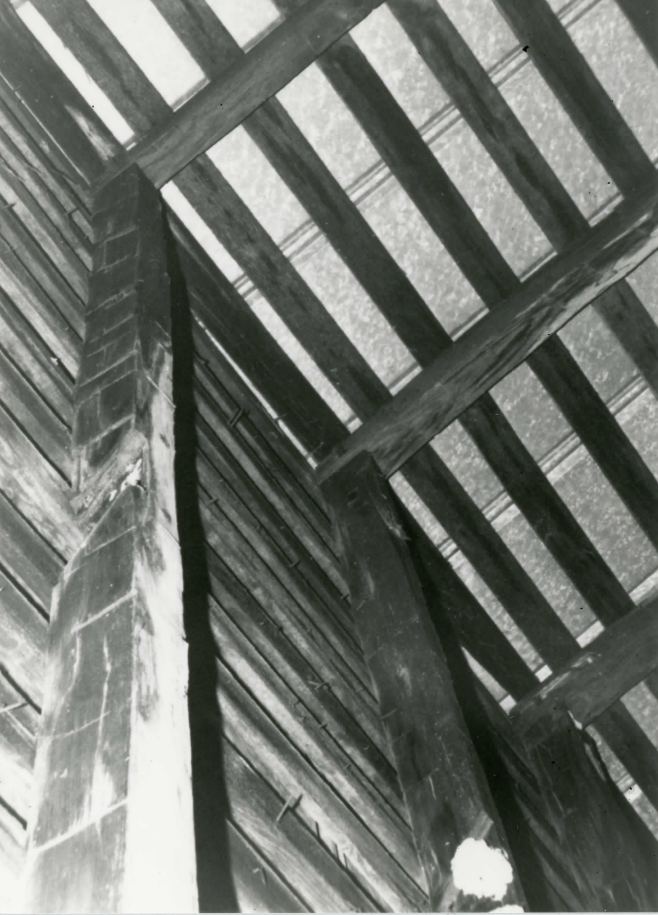
9 OF 10

9. VIEW OF: attic rafters
PHOTO 9 of 10

The southeast room contains two six-over-six double-hung windows, one on the east and one on the south. The attic runs the length of the building and is accessible from a trap door in the ceiling. The original thirteen hewn rafters are spaced two feet apart. A series of four-inch wide roof boards spaced about every four inches support the metal roofing. The rafters are pegged at the peak and the existing gable patching seems to suggest original pegged collar ties once existed.

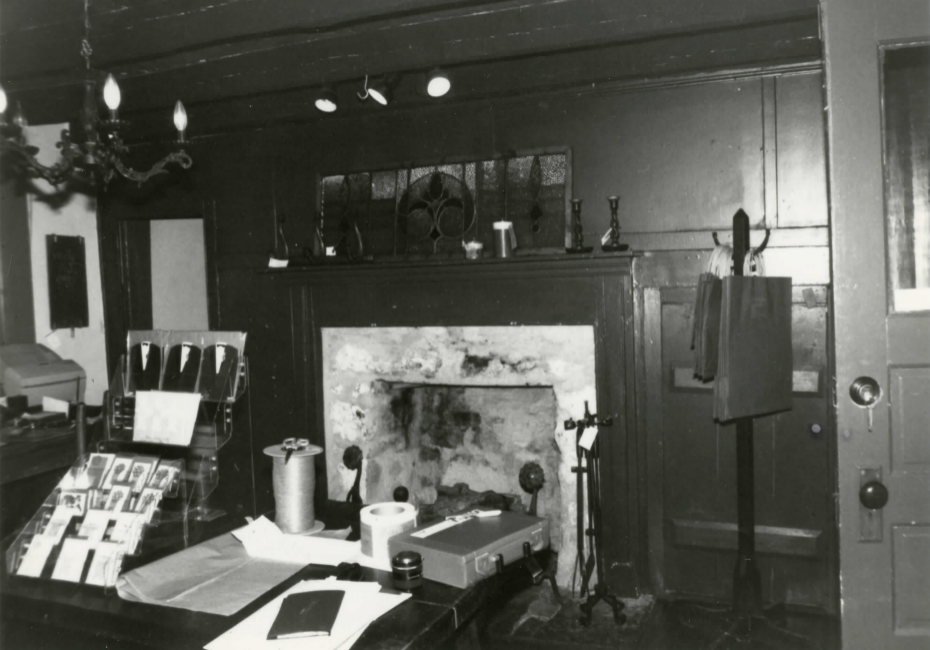
10. VIEW OF: paneled kitchen wall, first floor looking west
PHOTO 10 of 10

The main room of the hyphen addition has been remodeled to provide a modern kitchen. It contains a door on the north wall, double windows on the south wall and, two cased openings on the east wall that lead into the front rooms. The ceiling rafters are visible and the walls are a combination of plaster and wood paneling. The west wall is covered in wood paneling. The mantel has a beaded surround and beaded supports holding a narrow shelf. To the left of this fireplace is a beaded cased opening leading through a narrow hallway into the rear building.
