**NATIONAL REGISTER OF HISTORIC PLACES
REGISTRATION FORM**

historic name David and Catherine Driver Farm
other names/site number Driver Place; VDHR File No.: 082-0116

David and Catherine Driver Farm
Rockingham County

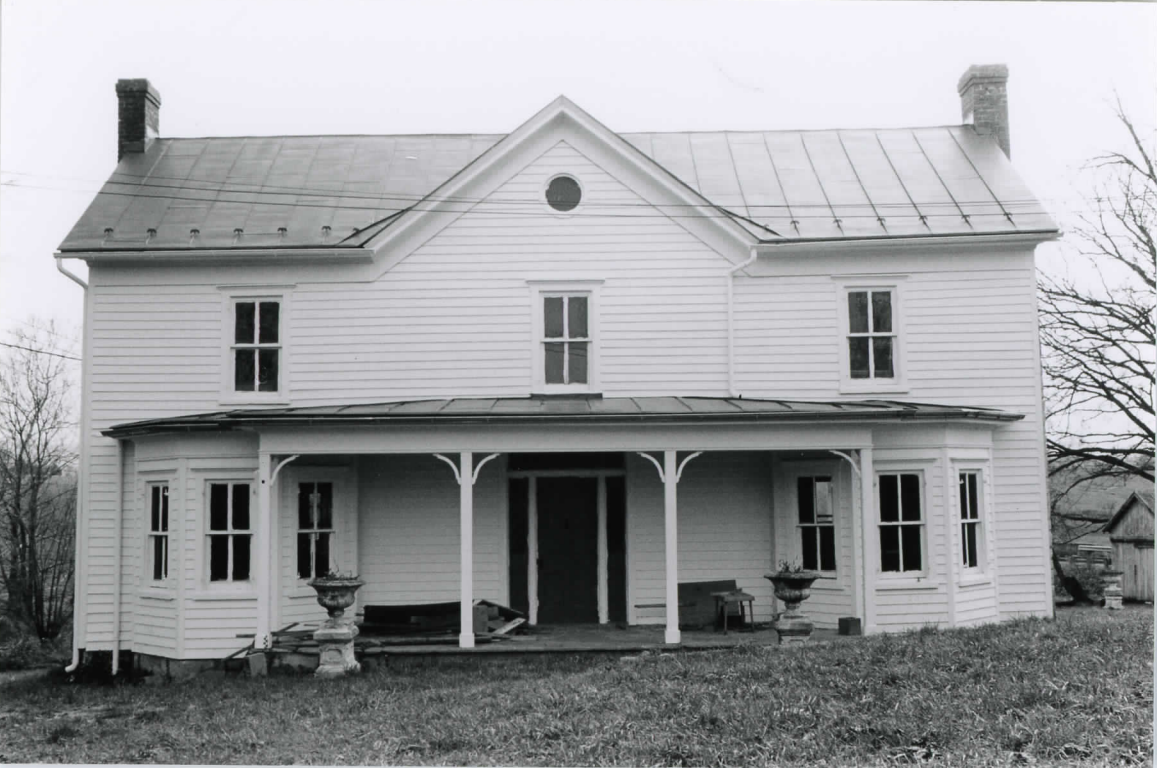
DAVID AND CATHERINE DRIVER FARM
ROCKINGHAM COUNTY, VA
PHOTO 1 OF 20

MAIN FACADE (WEST) MAIN HOUSE CIRCA 1890

Currently the west elevation, now the main façade, features a three-bay arrangement with the first floor being comprised of an original central entrance with a Late Victorian door flanked by sidelights and topped by a two-light transom. During the circa 1880 remodeling, two three-window bay projections were added to the first-floor façade. All of the windows in the front two-story section were replaced circa 1880 to reflect the current architectural trends of that period. The two-over-two, double-hung, wooden-sash windows were added, while the windows in the rear portion of the house retained its original six-over-six, double-hung, wooden-sash windows. The doors throughout the front portion were replaced with ones having four raised panels. Faux wood graining was added to the doors, and the patterns are still intact. The front portion of the house shows the replacement of mantels during the circa 1880 remodeling. All the mantels in the rear portion of the house are original and intact. There are also decorative wood carvings and beaded-board wainscoting throughout the house, which further show the wealth and prosperity of the Driver family. Another revealing factor about their wealth and status is the introduction of indoor plumbing into the house during the latter part of the nineteenth century. This plumbing system was based on the existing windmill and the cistern located to the southwest of the barn working together to facilitate the passage of water into the house to provide a bathtub with running water. The north elevation features a small porch, which replaced the original deteriorated porch, while portions of the original porch on the south elevation remain. The east elevation of the house has access to the basement, which served as a storage area for the family.

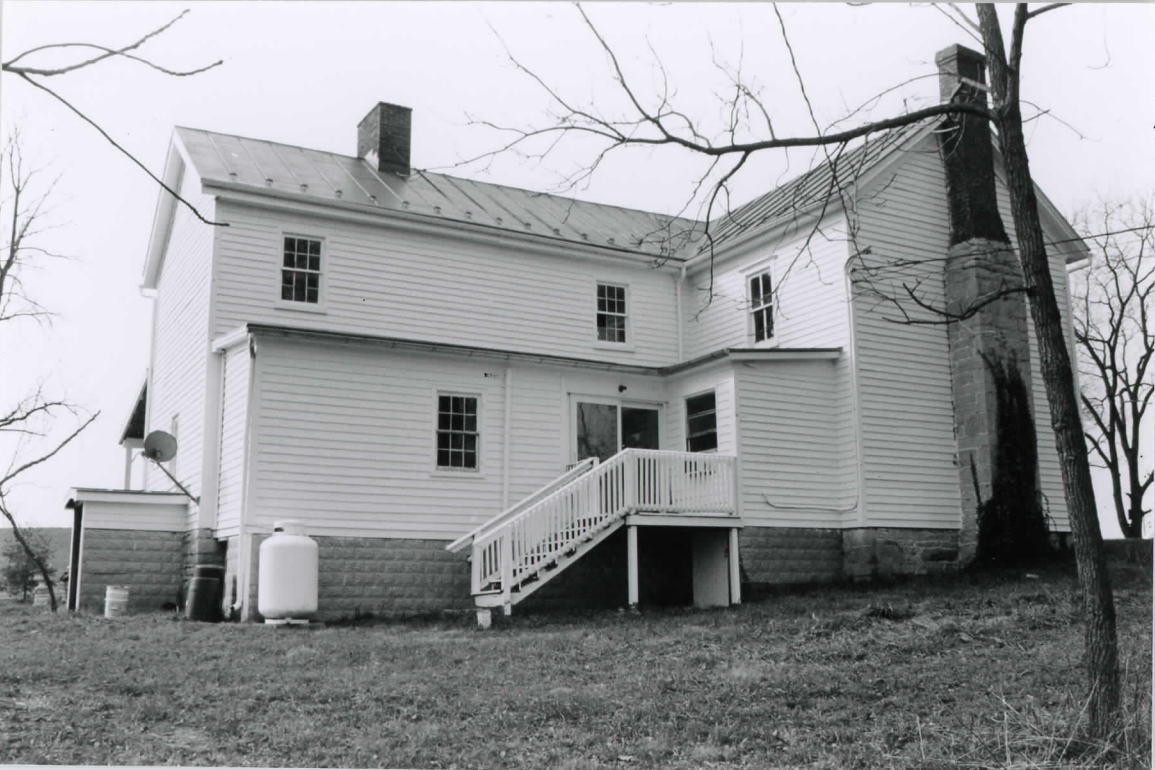
DAVID AND CATHERINE DRIVER FROM
ROCKINGHAM COUNTY, VA
PHOTO 2 OF 20

NORTH ELEVATION OF MAIN HOUSE

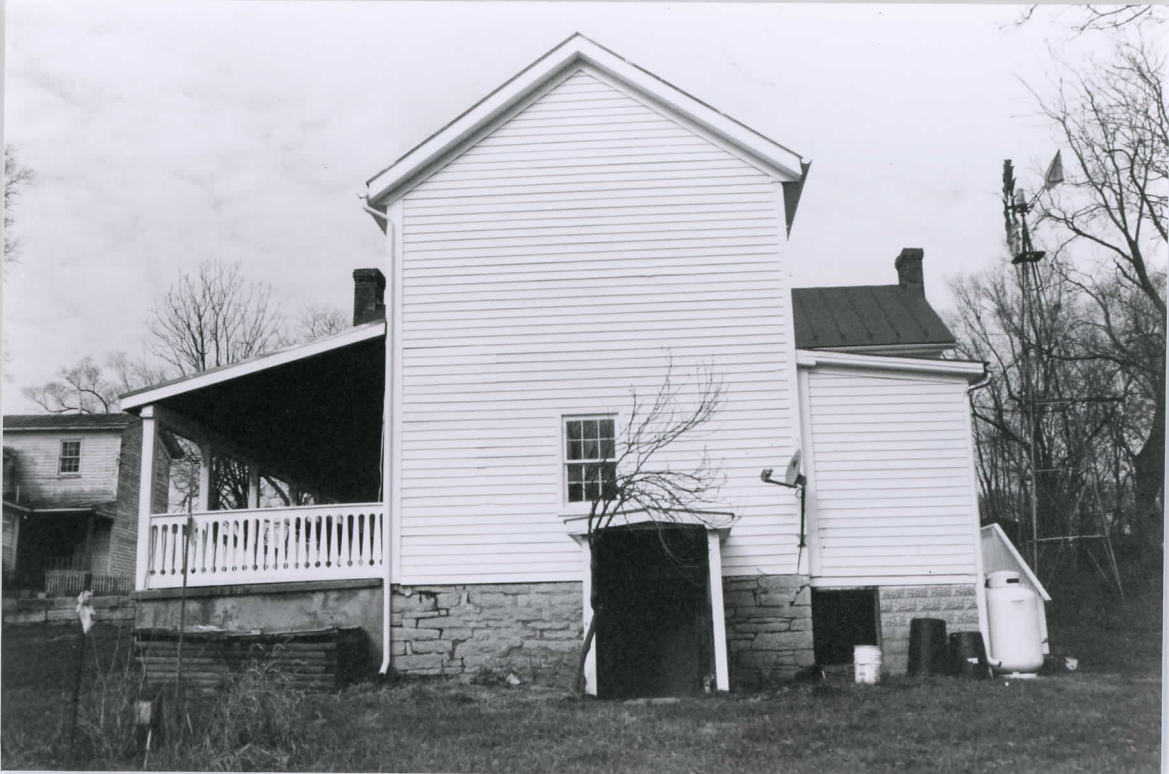
DAVID AND CATHERINE DAVEN FARM
ROCKINGHAM COUNTY, VA
PHOTO 3 OF 20

EAST ELEVATION MAIN HOUSE

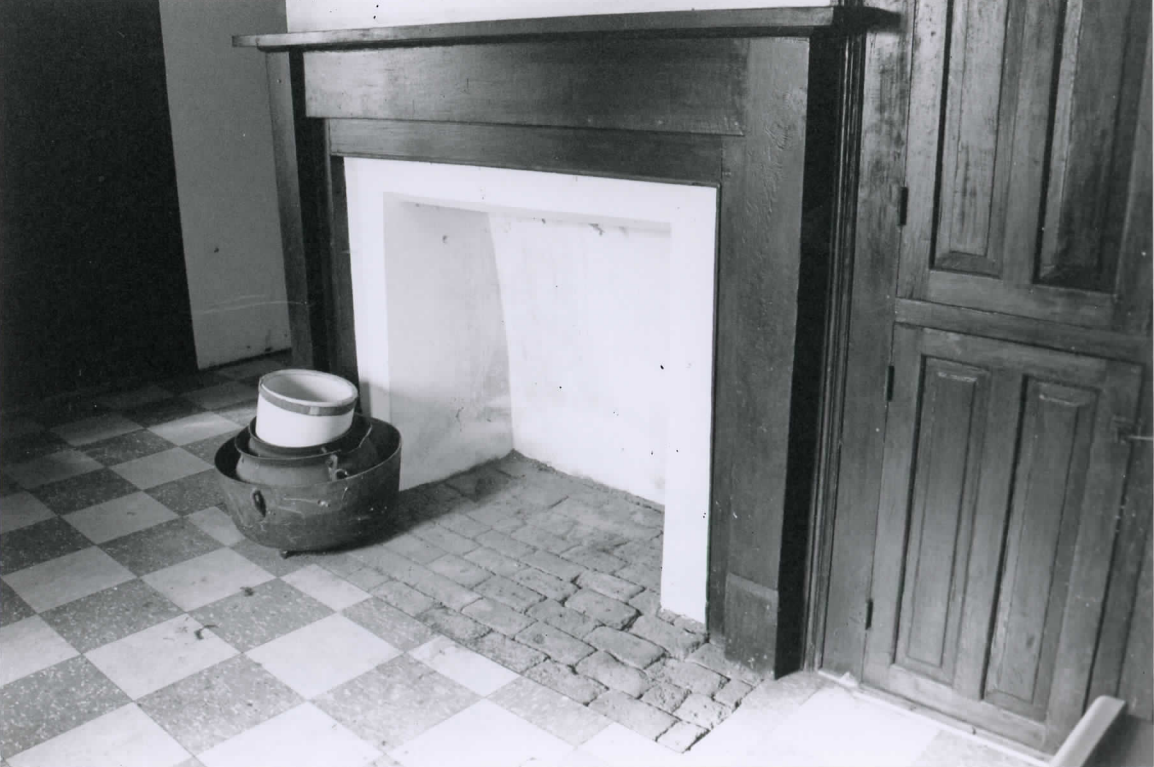
DAVID AND CATHERINE DRIVER FROM
ROCKINGHAM COUNTY, VA
PHOTO 6 OF 20

FIRST FLOOR INTERIOR LOOKING SOUTHWEST
SHOWING ORIGINAL FIREPLACE

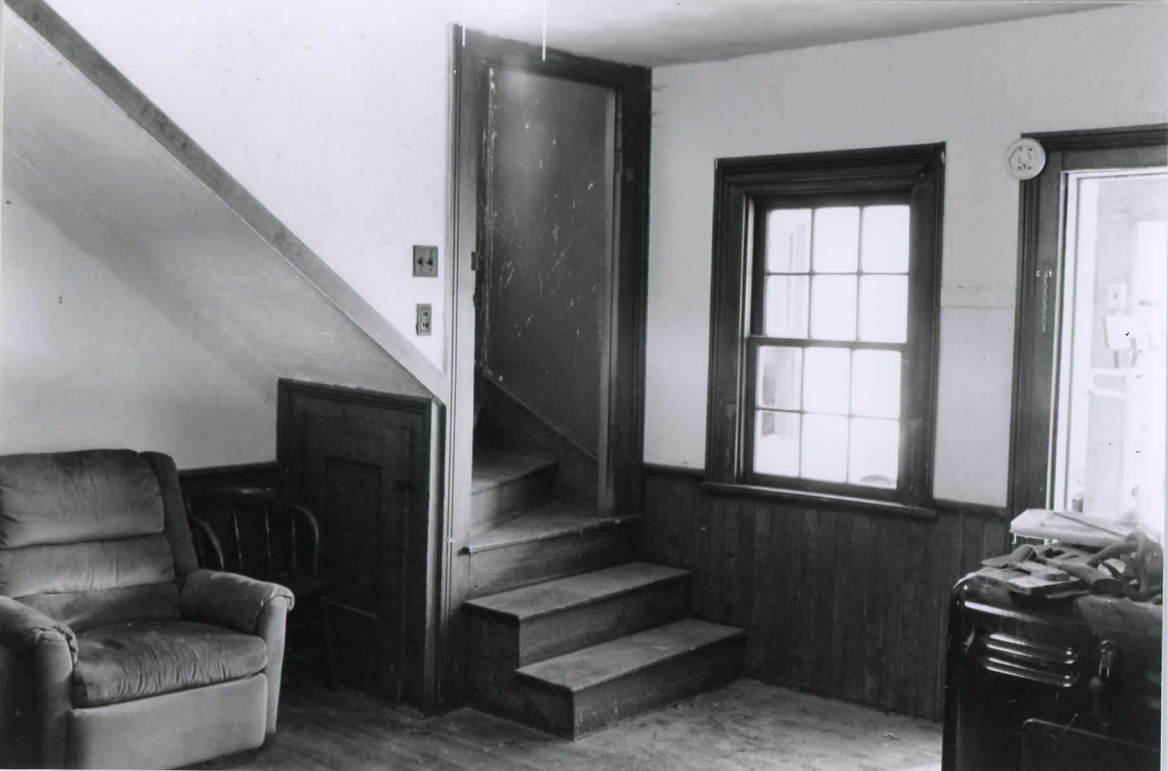
DAVID AND CATHERINE DRIVER FARM
ROCKINGHAM COUNTY, VA
PHOTO ? OF 20

FIRST FLOOR INTERIOR LOOKING NORTHWEST
IN ORIGINAL PORTION OF HOUSE

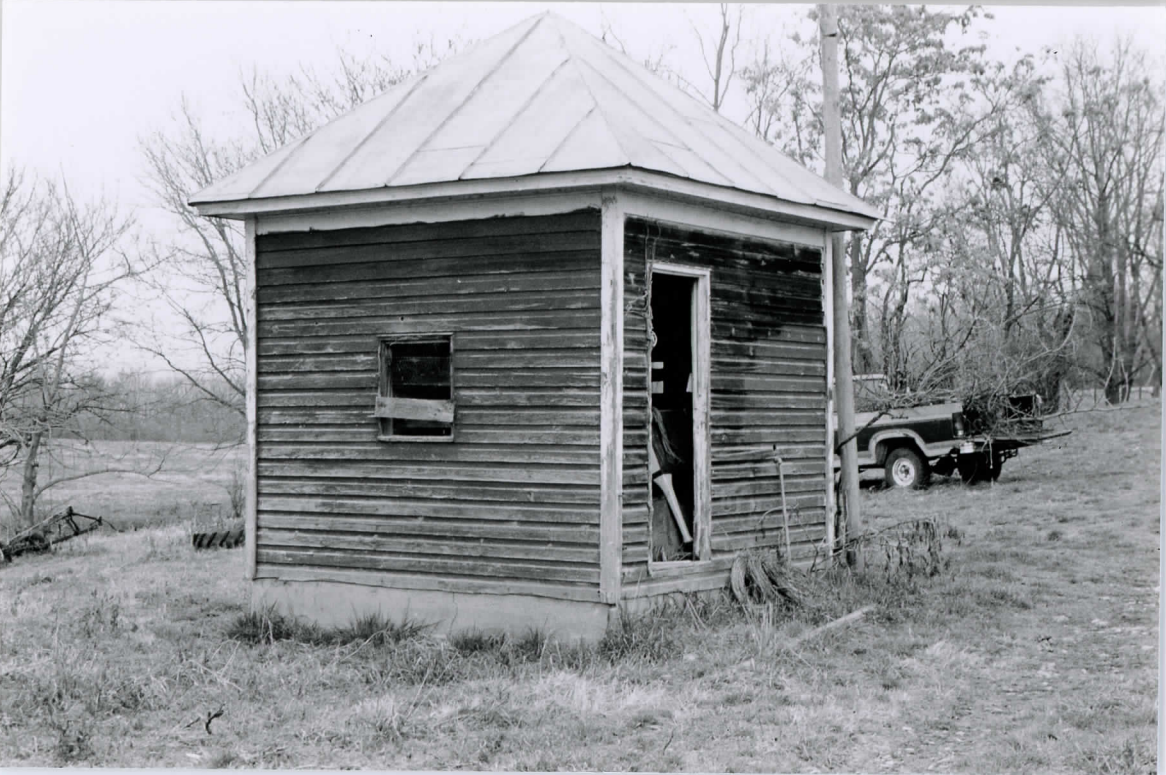
DAVID AND CATHERINE DRIVER FARM
ROCKINGHAM COUNTY, VA
PHOTO 14 OF 20

MILK HOUSE CIRCA 1920 LOOKING SOUTHWEST

4. The milk house, built circa 1920, is a small cubical wood-framed building with a pyramidal metal roof and German siding that stands to the west of the main house.

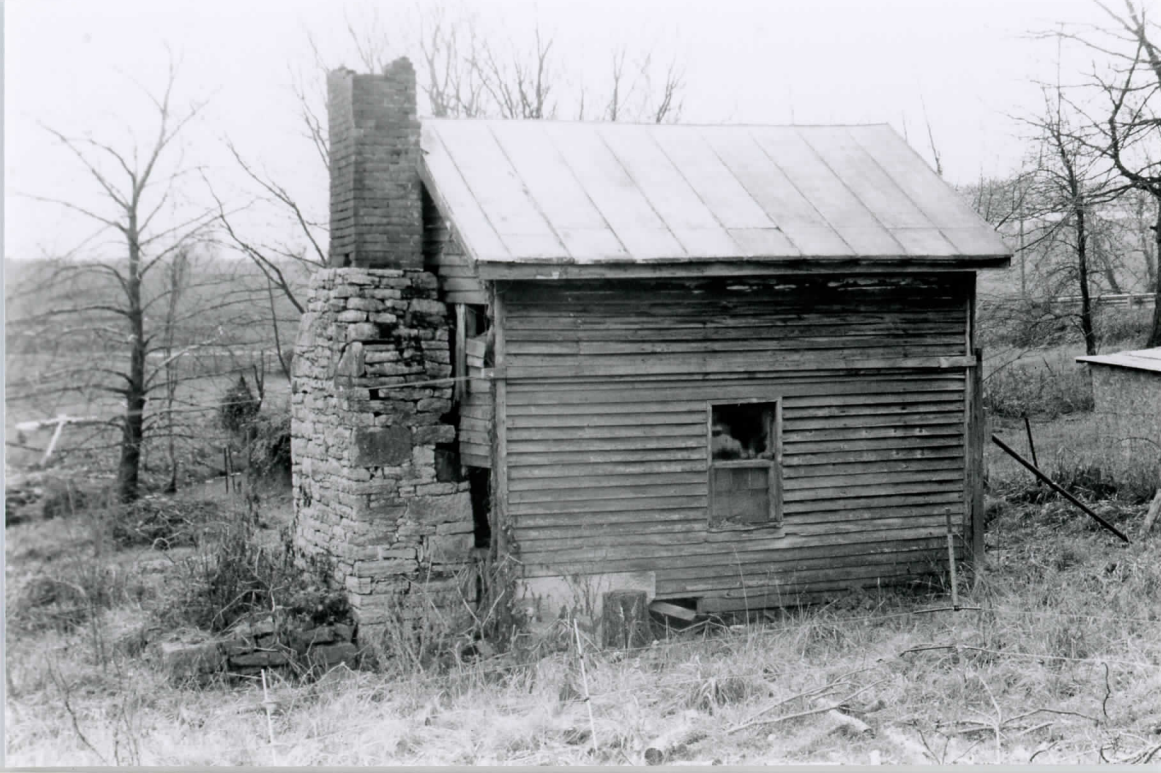
DAVID AND CATHERINE DRIVER FARM
ROCKINGHAM COUNTY, VA
PHOTO 19 OF 20

WASH HOUSE CIRCA 1890 LOOKING WEST

7. There is also a small one-and-one-half-story, wood-frame wash house clad in weatherboard that stands to the north of the main house and has an intact limestone chimney appearing to predate the existing structure.
