**NATIONAL REGISTER OF HISTORIC PLACES
REGISTRATION FORM**

historic name Floris Historic District

other names/site number DHR File No.: 029-5179

**Floris Historic District
Fairfax County, Virginia**

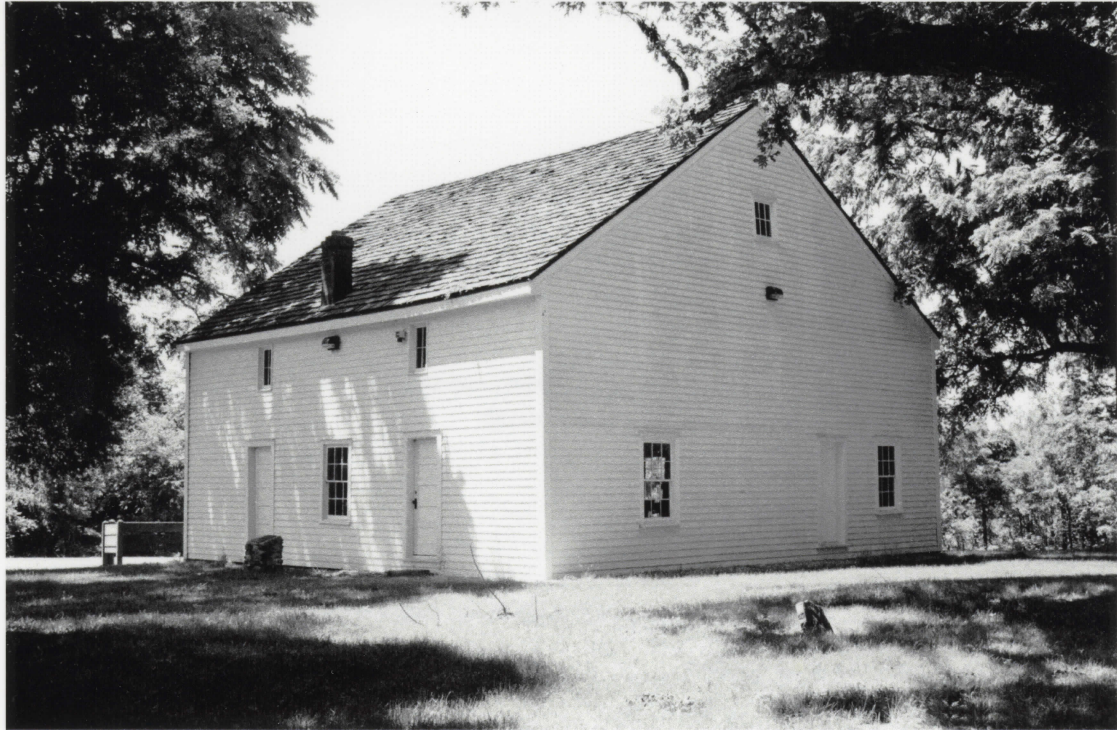
Negative at Virginia Department of Historic Resources
Meetinghouse, looking NW
Photo 1 of 15

Frying Pan Meetinghouse [029-5179-0012]
2615 Centreville Road [029-0015]

of the Baptist congregation who constructed it. The rectangular Frying Pan Meetinghouse consists of a one-room, one-and-a-half-story, post-and-beam building with an exterior sheathed in lapped pine clapboards painted white. A wood-framed, side-gabled roof, which is flush on the gable ends and overhangs slightly on the front and rear elevations, is covered with wood shingles. The building rests on a stone foundation. The front elevation features a centered six-over-six double-hung sash window flanked by two doors and two, replacement, symmetrical, four-light windows on the second story. Additional windows and doors appear on the other elevations. An interior brick chimney located at the middle edge of the front elevation is a replacement. Some of the building's features, such as windows and sheathing materials, were replaced in-kind during the aggressive restoration effort in 2005. Other renovations are documented throughout the life of the building.

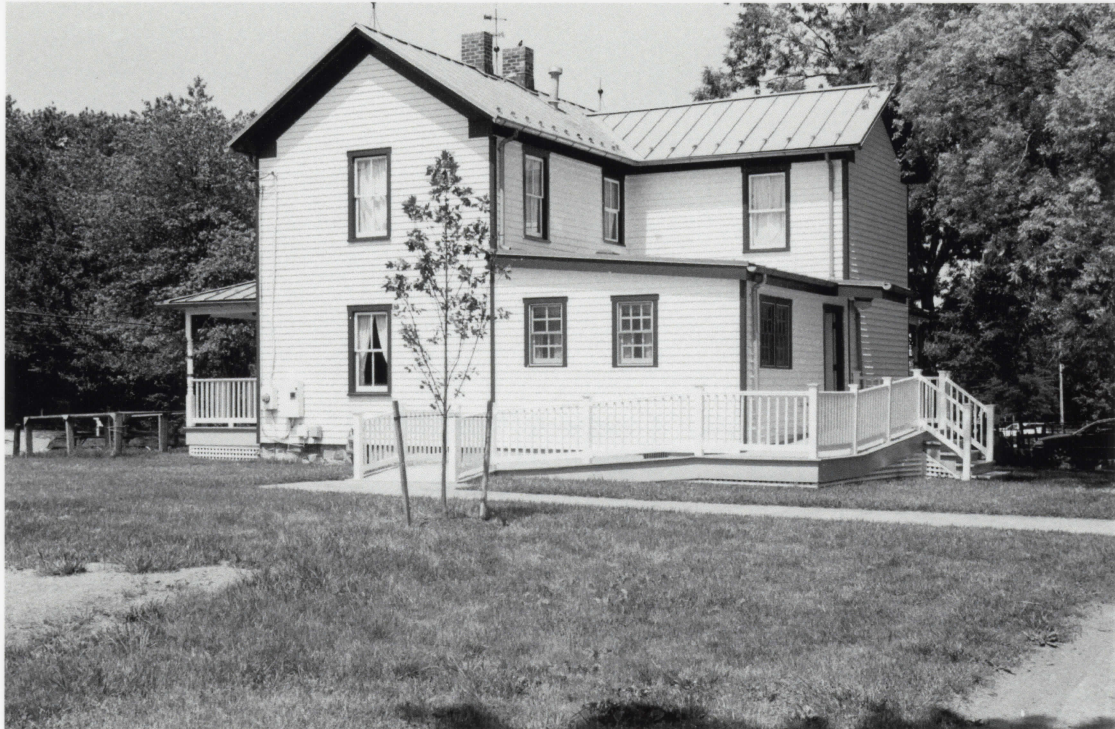
Photo 3 of 15

Kidwell Farmhouse, looking SW

9. The *Kidwell Farmhouse* consists of a side-gabled, two-story main block with a center gable front extension and a rear ell.⁷ A one-story shed-roofed addition attached to the rear of the house features a modern handicapped-accessible ramp. A wrap-around porch is located on the front elevation and one side elevation and features turned posts and brackets. Two central brick chimneys rise through the recent standing-seam metal roof. The frame, wood-sided house rests on a solid stone foundation. Wood, two-over-two double-hung sash windows light the house. Recent renovations removed stucco covering to reveal the original wood siding. A bathroom added c.1950 in the front porch area was also removed.

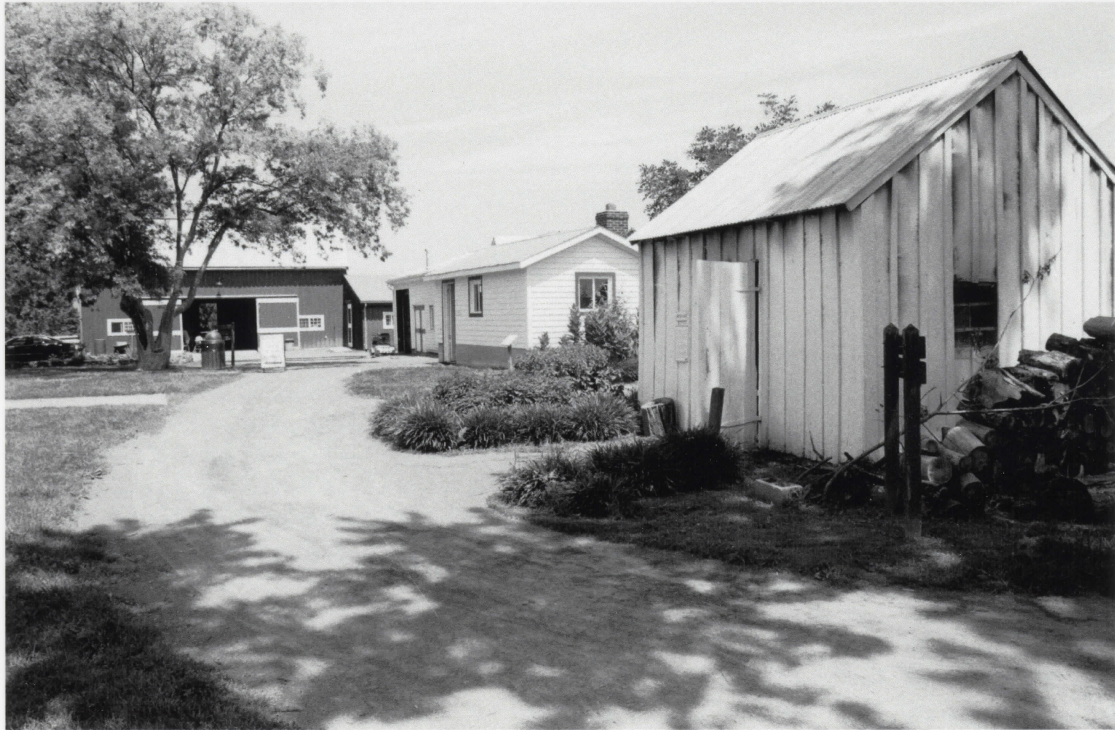
Photo 4 of 15

Kidwell Farm outbuildings, looking NW

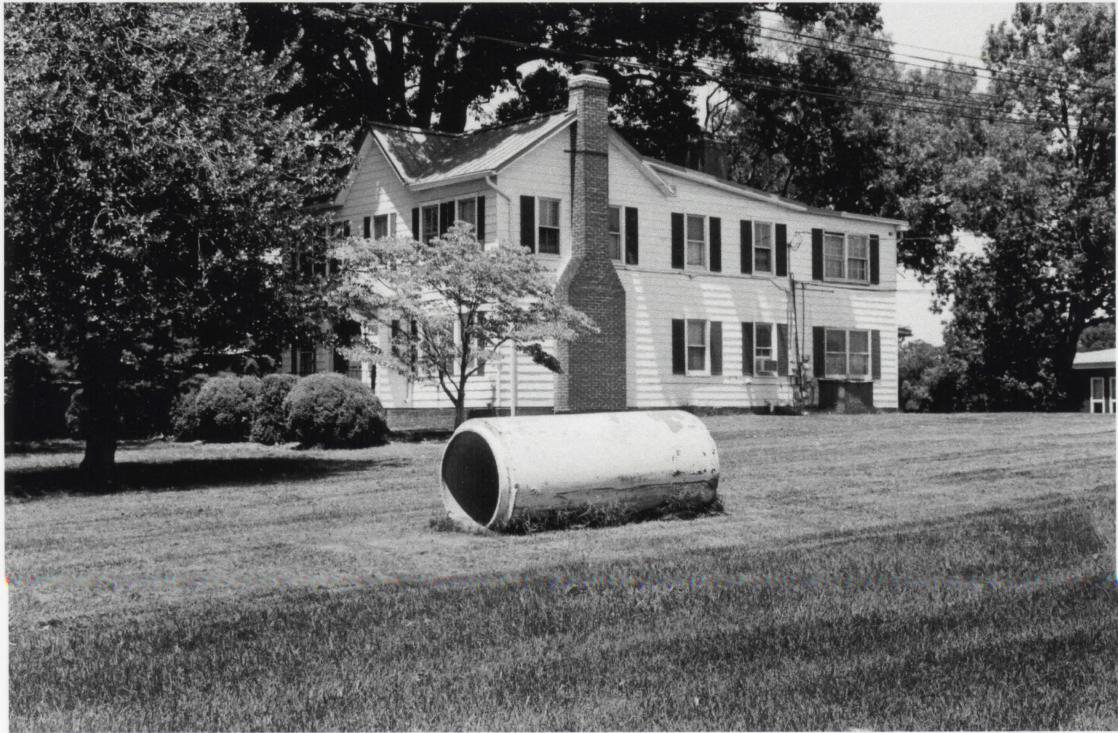
Photo 9 of 15

Ellmore Farm dwelling, looking NW

1. The *Ellmore Farmhouse* is a wood frame, two-story, side-gabled I-house sheathed in aluminum siding.⁵ The rear of the main block features three two-story additions: a rear gabled ell, a shed-roofed infill addition, and a full-width, flat-

roofed rear addition. An open shed-roofed porch that may have been screened at one time extends at the rear of the house. An enclosed staircase on the northwest side of the house was added in the twentieth century. The building rests on a solid, concrete-covered foundation and is topped by a recent standing-seam metal roof with overhanging eaves, aluminum soffit, fascia, and shutters. Two-over-two double-hung sash wood windows, light most of the house, however, paired and three-part six-over-six double-hung sash windows light the rear of the addition. An interior brick chimney rises on the rear ell and an exterior brick chimney rises on the southeast elevation of the main block. A post-1954 replacement front porch features Colonial Revival-style detailing.

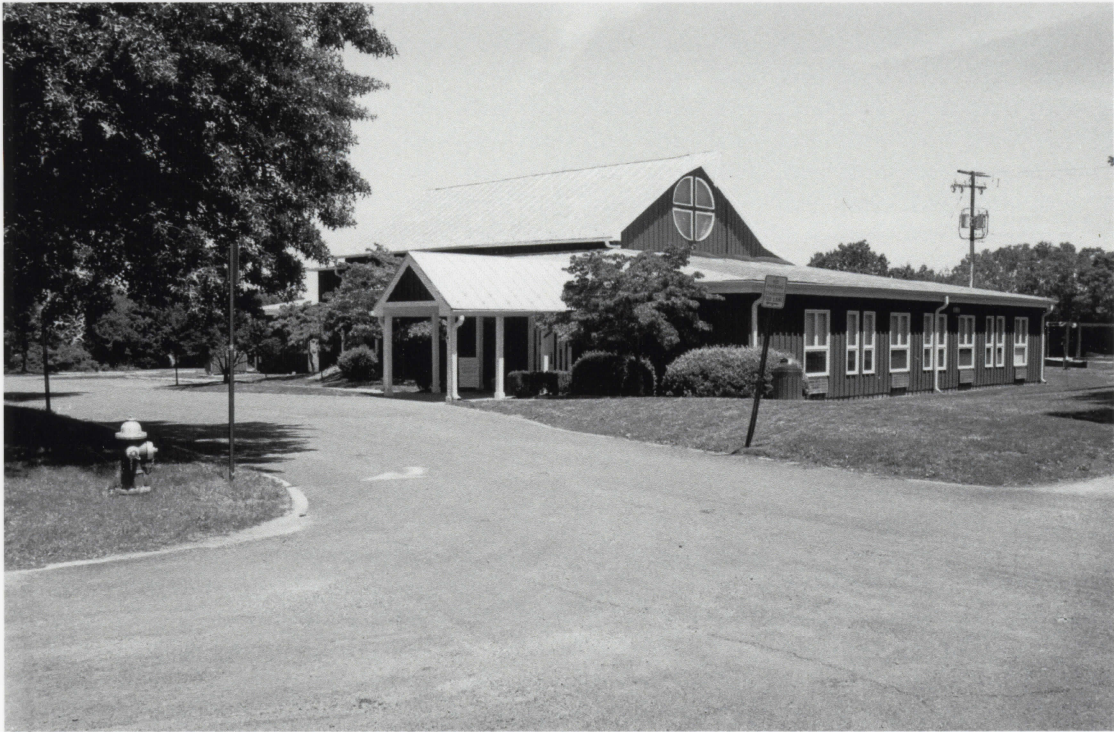
Photo 10 of 15

Ellmore Farm barn (current visitor center), looking NE

2. The **Ellmore barn** has been used as the park's visitor center since c.2005 and was previously converted from a barn into use as a church building in 1989 by the Chantilly Bible Church.⁶ These functional changes have resulted in additions and alterations to the original barn. The barn once consisted of a gabled main block with shed extensions on its north and east elevations. Today, additional extensions appear at the rear (north elevation) of the building with noticeable one-story additions on the front and west elevations to accommodate the visitor center. However, the window fenestration, sheathing materials, and paint color mimic the original main block. The wood frame building is sheathed in board-and-batten siding and topped by a standing-seam-metal roof. A second-story door in the front gable was converted into a large, four-part, circular window. A hay hood extension of the front gable remains. The interior of the main gabled block is used as an auditorium today, and consists of open space with exposed support members.

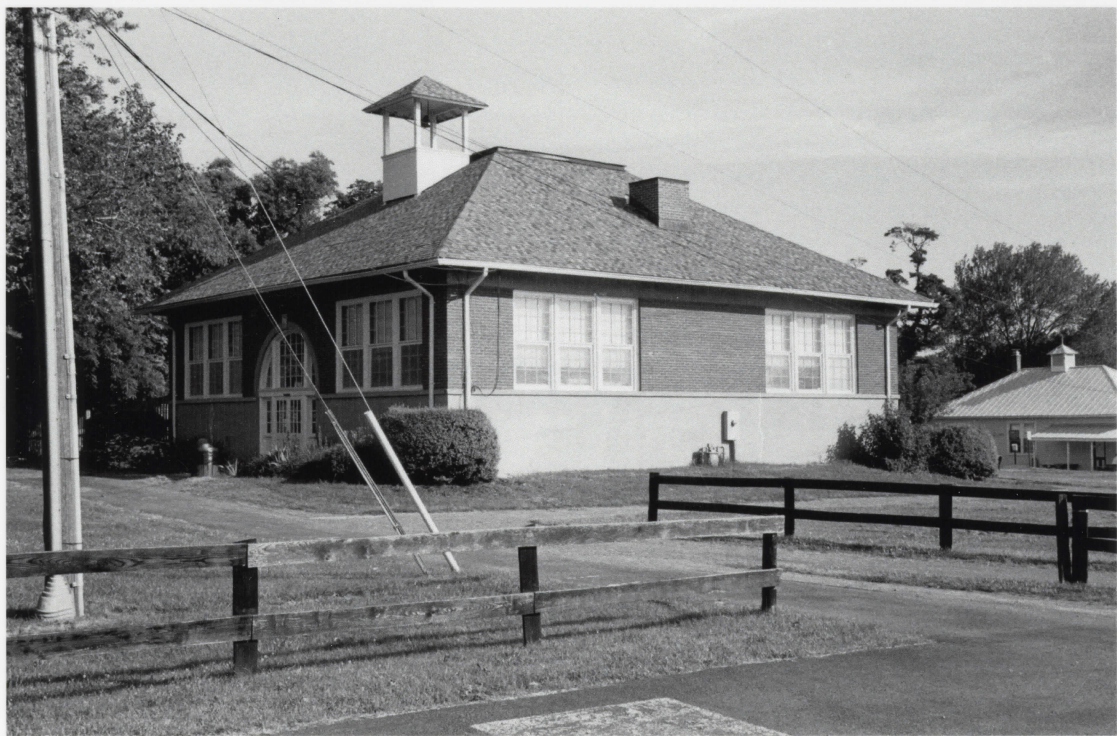
Photo 11 of 15

Floris Schoolhouse

41. The one-story **Floris School**, constructed in the Colonial Revival style, has a hipped roof with overhanging eaves and rests on a solid, poured-concrete foundation. Two, wide, brick, interior chimneys and a pyramid-roofed cupola rise through an asphalt-shingled roof. The stretcher-bond brick building's symmetrical front elevation features a tall concrete watertable and a concrete area near the roofline. A center, double-leaf front door with a large transom is flanked by two series of three nine-over-nine, double-hung sash windows. A large arch capped by a keystone dated 1911 and multi-light windows top the door. The interior of the building retains its basic room plan and its doorways have original transoms.

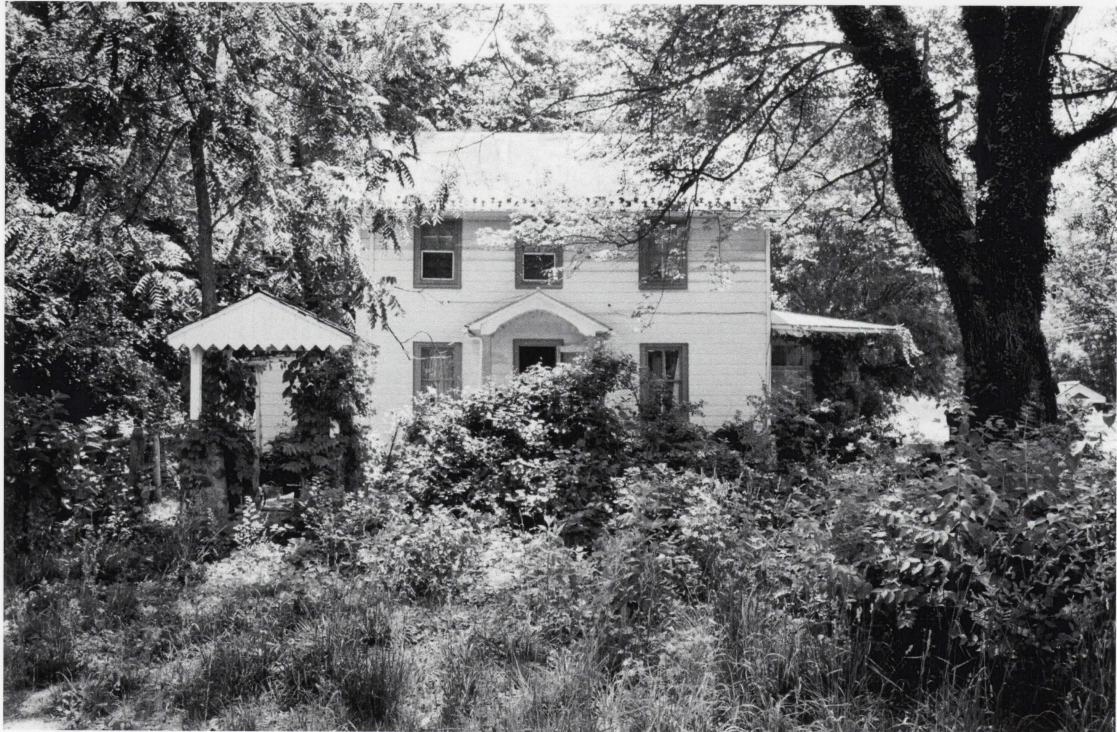
Photo 13 of 15

Fox House

=====
wood frame building, sheathed in aluminum siding, rests on a solid, stone foundation. The roof of the main block is covered in 5V metal and features overhanging eaves. Two-over-two, double-hung sash windows with wood surrounds light the house. The south gable end of the house facing West Ox Road includes an enclosed stone porch with multi-light wood windows and an exterior flower bed. A two-story, shed-roofed addition extends to the rear, and a one-story addition is attached on the north elevation of the rear addition.

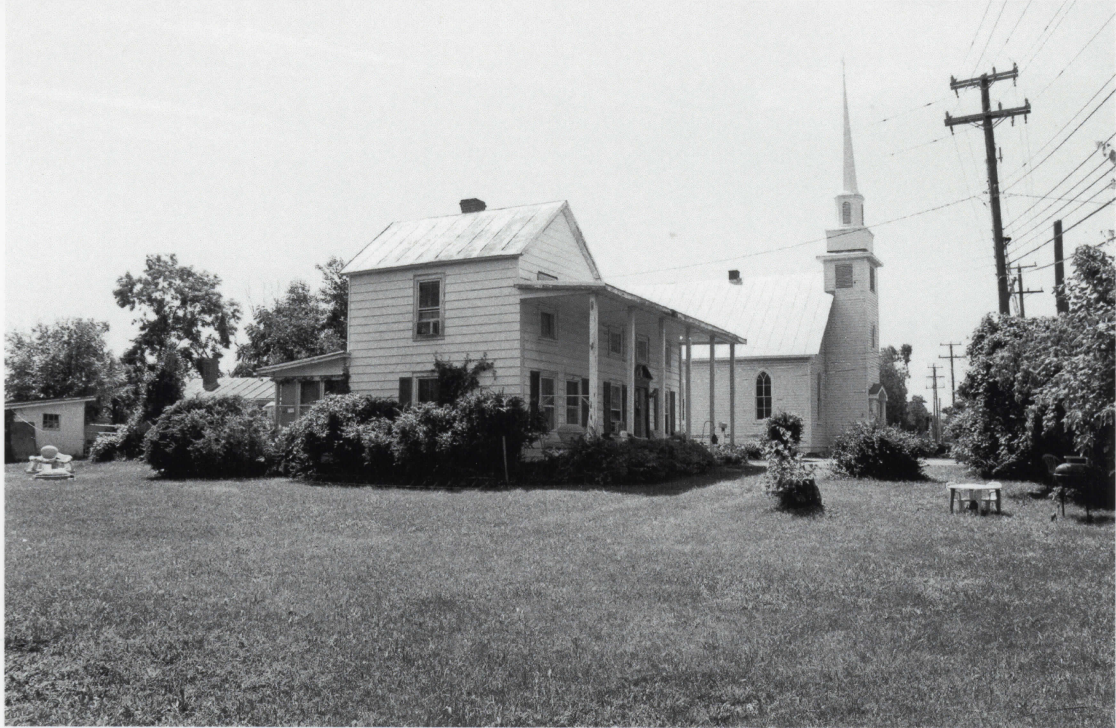
Photo 15 of 15

Stover House
