National Register of Historic Places  
Registration Form

historic name Mount Stirling

### Summary Description

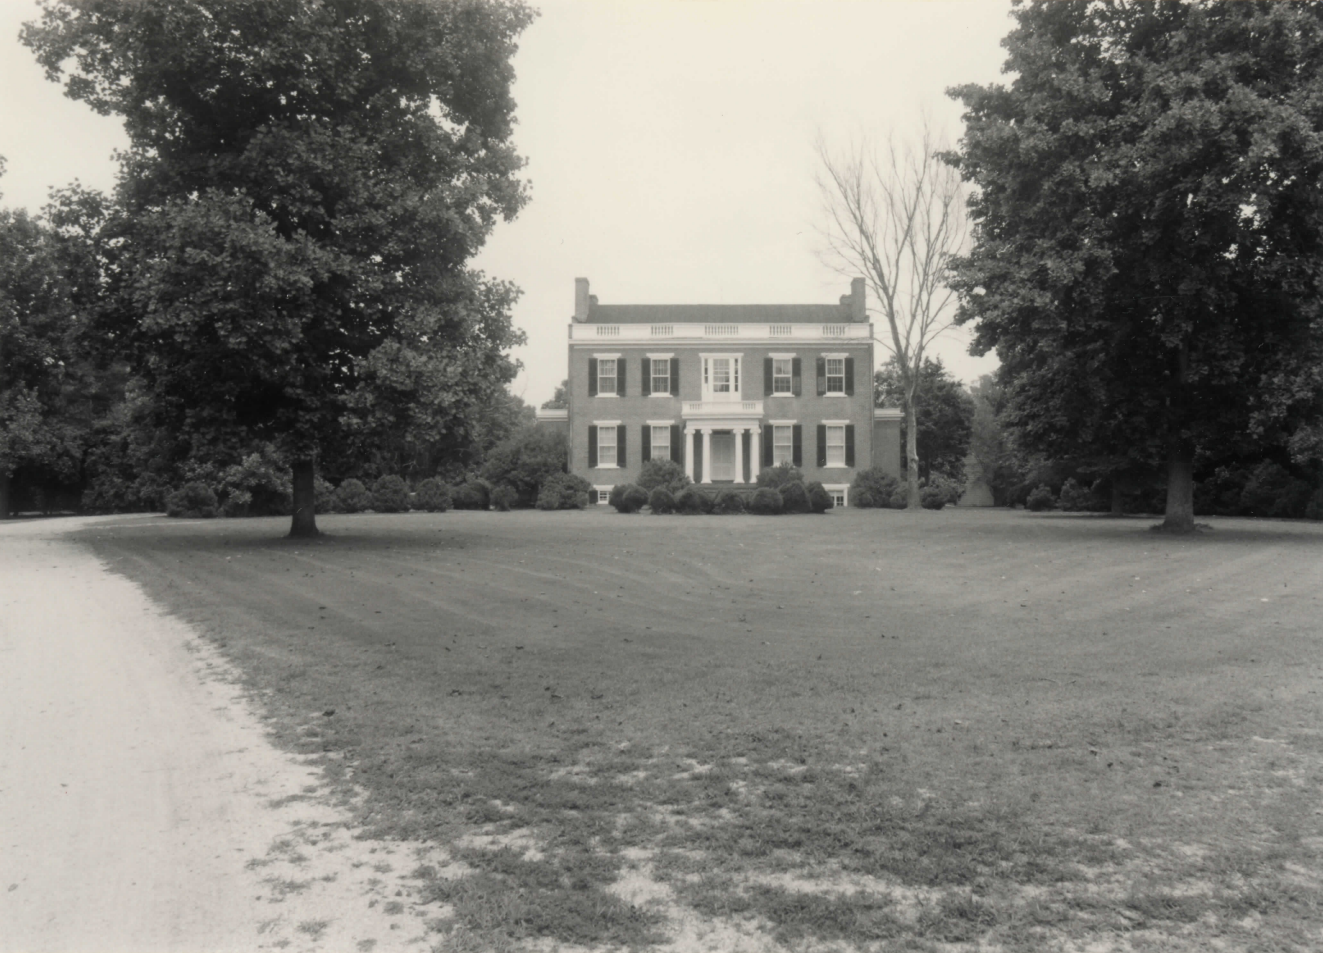
PHOTO 1 OF 16

1. Facade of Mount Stirling
3. David A. Edwards
6. View looking north
7. Photo 1 of 16

The front facade of the house is the most formal, as it faces the tree-lined approach. The central bay is ornamented by a three-bay, one-story portico of wood resting on brick piers. The portico is approached by a flight of full-width wooden steps. The paired Greek Ionic columns employ fluting and deeply carved volutes. These four columns, and two pilasters flanking the door, support the porch entablature consisting of a plain architrave and frieze surmounted by a cornice with dentils. The portico is ornamented by a balustrade around the roof with columns set over the columns below and turned balusters filling the spaces between the panels. The central bay is further emphasized by the entrance and tripartite window above. The entrance consists of a wide four-panel door flanked by sidelights and topped by a transom. The door is framed by paneled molding that extends above the height of the door, reducing the transom to a two-light element that extends only the width of the door, while the four-light sidelights rise to a height equal to the top of the transom. Carved panels fill the space below the sidelights, and the entire assembly is surmounted by a wooden lintel with end blocks. The tripartite window above echoes the details of the door but lacks a transom. The center opening is a jib window with double-hung, six-over-six sash and panels beneath that swing inward to allow access to the balustrade-enclosed portico roof. The sidelights contain four lights and rest on paneled aprons below. Originally, full-length louvered shutters flanked the sidelights.

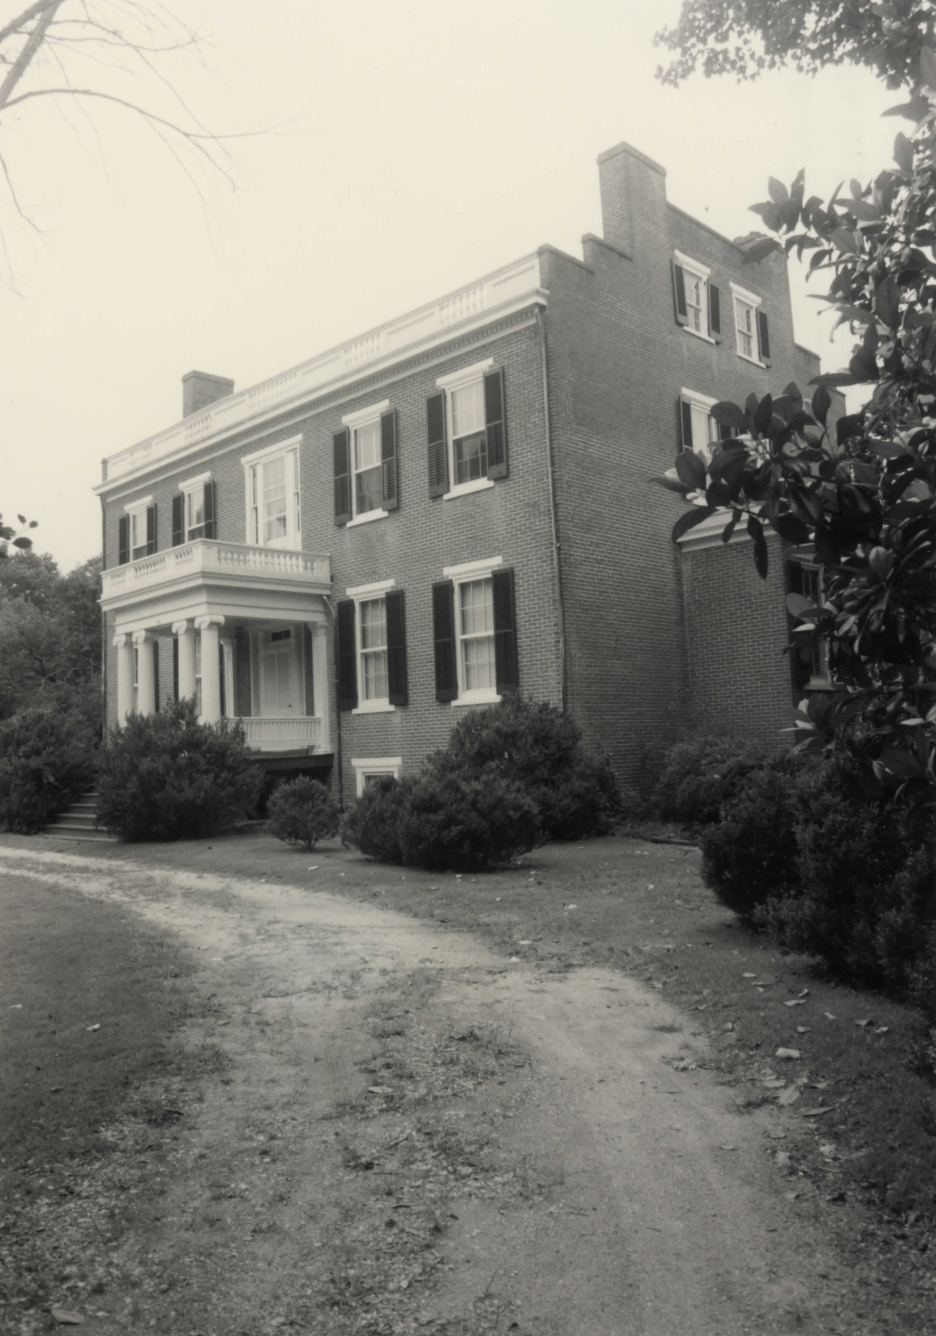
MOUNT STIRLING  
CHARLES CITY COUNTY, VA.  
PHOTO 2 OF 16

1. Facade and east side
3. Bryan L. Townes
6. View looking northwest
7. Photo 2 of 16

The side, or east and west, elevations of Mount Stirling are nearly identical, having two bays per floor. These bays are paired near the middle of the elevation. The first-floor levels of the side elevations are punctuated by small projecting wings. The front and rear elevations of the wings are blank, while the wider side elevations contain two windows. The front walls of these wings are laid in stretcher bond, while the sides and rear are laid in mixed garden wall bond. The wings are surmounted by a cornice with dentils that is similar in detail to the main cornice of the house, but is executed in a reduced scale. In addition to the small wing, the east elevation employs a second projection in the form of a one-story, two-bay, wooden porch on a partial brick foundation. This porch is approached by a flight of wooden steps with later railings and consists of two plain wooden piers with caps and bases and two pilasters supporting an entablature with a plain architrave, frieze, and cornice. The porch fills the ell created by the small wing and the main part of the house, and is sited toward the rear facade. This porch shelters a four-panel door that leads into the dining room. The height of the porch falls far short of the height of the small wing. Square-cut balusters form the porch balustrade.

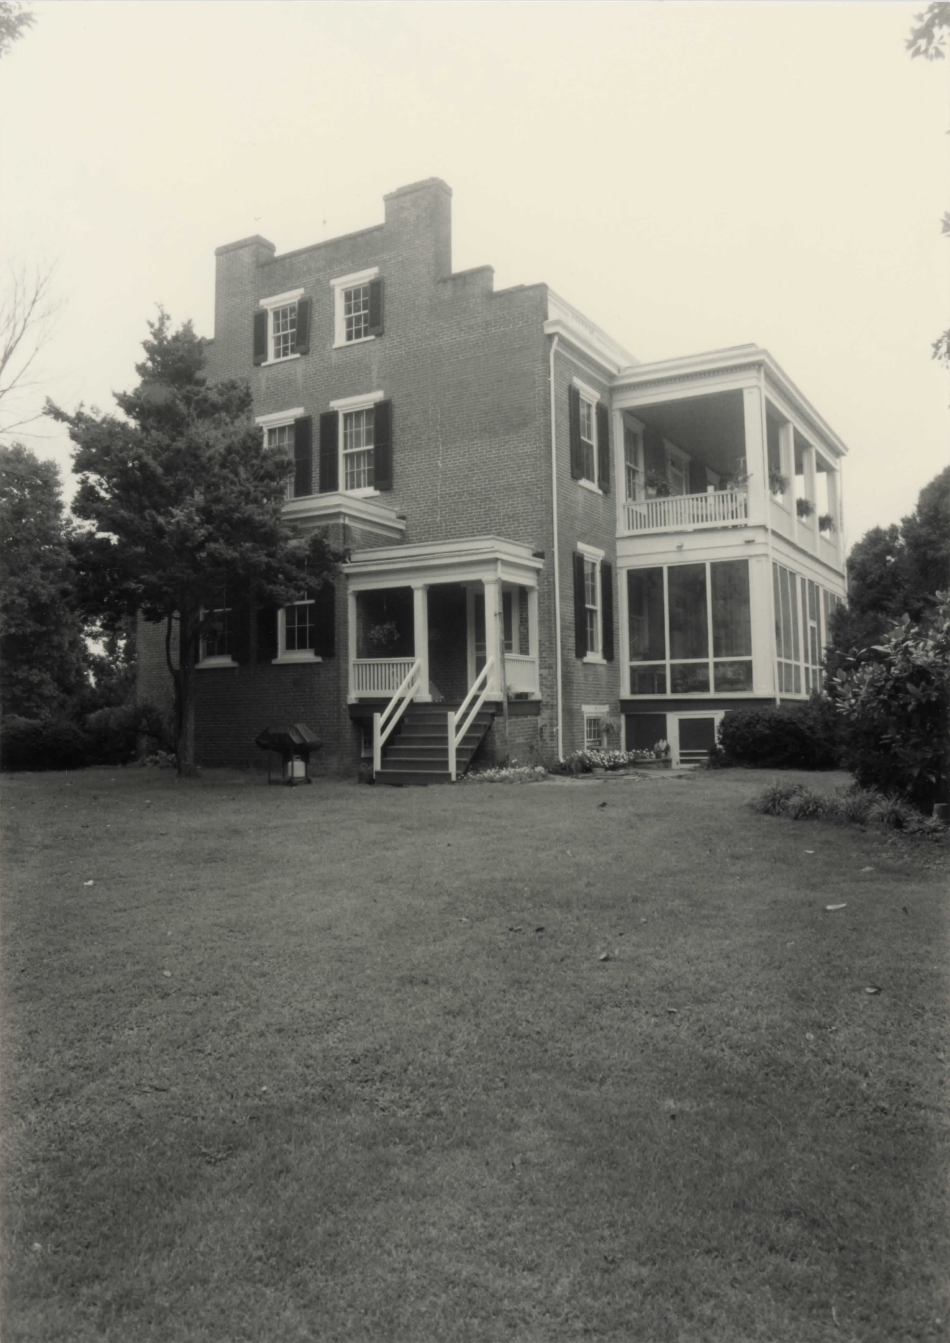
MOUNT STIRLING  
CHARLES CITY CO, VA.  
PHOTO 3 OF 16

1. East side and rear elevation
3. Bryan L. Townes
6. View looking southwest
7. Photo 3 of 16

The rear elevation of the house is dominated by a three-bay, two-story wooden porch on brick piers that shelters the central three bays of the house. This structure dates to the 1940s and consists of one-story, paneled, wooden piers and pilasters that support a plain architrave and frieze on both levels. The second level is topped by a cornice with dentils that is placed just below the cornice of the house and is similar in scale and details. The first level is screened, while the second level is open and features a simple balustrade with square-cut balusters connecting square wooden piers. The porch is approached by a flight of wooden steps, and a brick-lined areaway underneath the first level allows for basement access. Two doors, occupying the central bay of both levels of the elevation, provide access to the porch. These doorways are identical to the entry door on the facade.

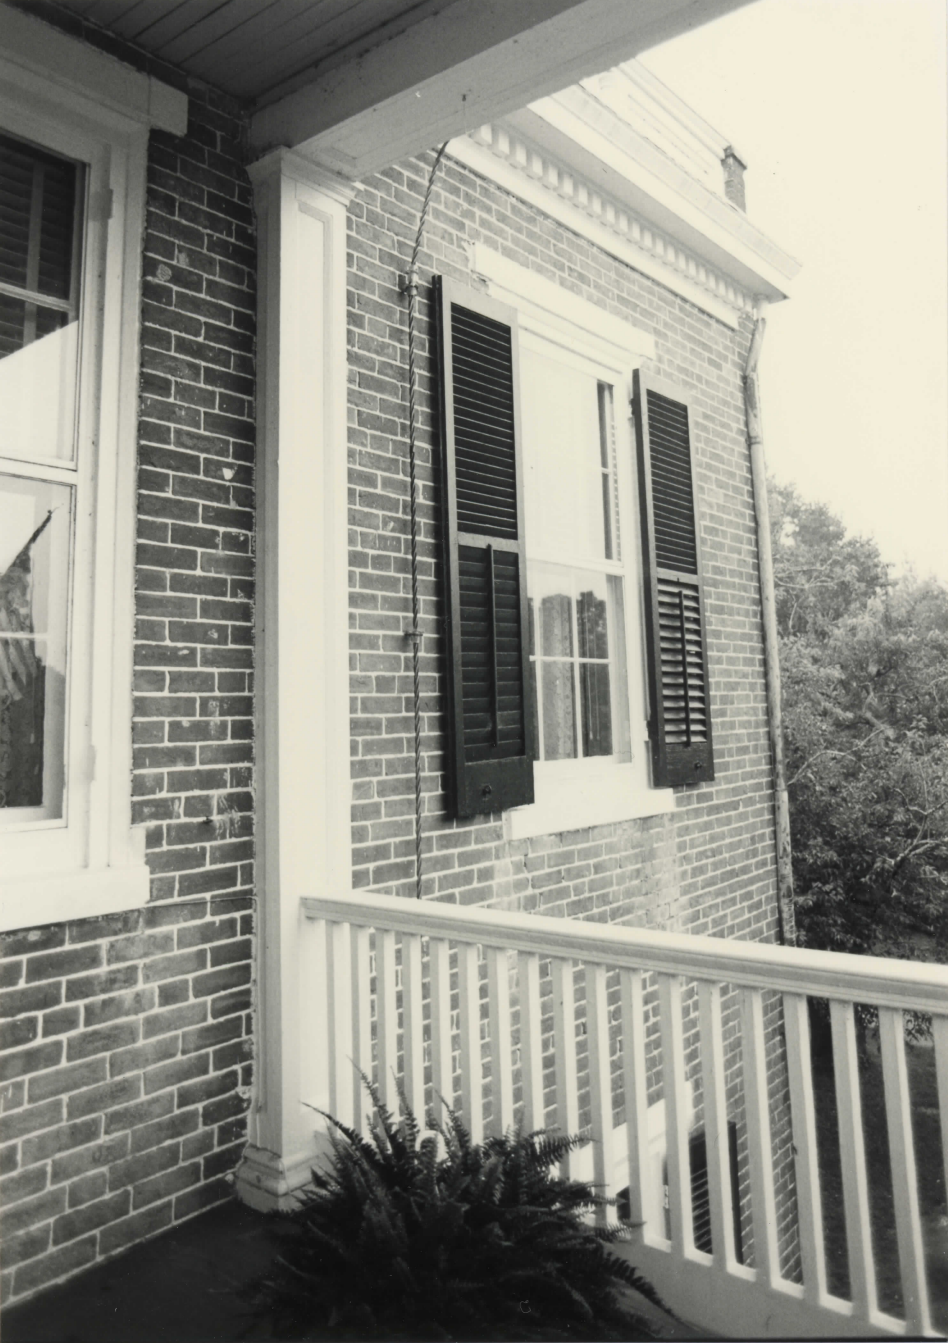
MOUNT STIRLING  
CHARLES CITY CO, VA.  
PHOTO 4 OF 16

1. Second level of rear porch detail
3. David A. Edwards
6. View looking southwest
7. Photo 4 of 16

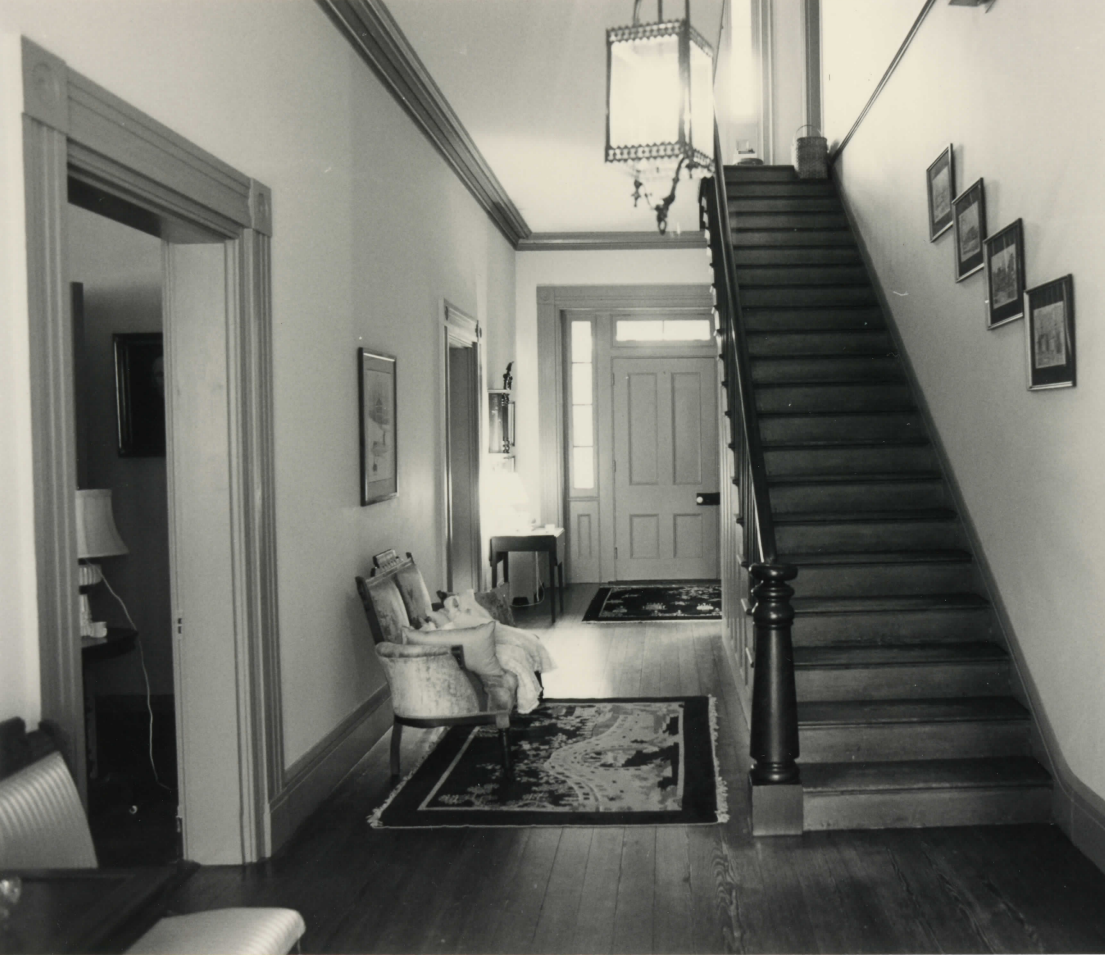
MOUNT STIRLING  
CHARLES CITY CO, VA.  
PHOTO 5 OF 16

1. First floor central passage
3. David A. Edwards
6. View looking north
7. Photo 5 of 16

The long central passage is dominated by a straight-run, open-string staircase that rises from the front of the hall along the right side. The stair balustrade is said to be constructed of native black walnut and consists of a heavy turned newel post and a round-cut handrail supported by square-cut balusters that are spaced two per tread. The woodwork of the stair is stained and polished, except for the vertical paneling that fills the space under the stringer and encloses a stair to the basement. The ceiling in the front half of the hall is ornamented by a plaster medallion of a radiating acanthus design. The drawing room is accented by an intricate plaster ceiling medallion that is centered in the room. From this detail hangs an oil light fixture, converted to electrical use, that is original to the house. Marbleized baseboards in this room match the Italian marble mantel, and it is believed that all major rooms originally had this treatment. The door to this room, as well as all interior doors on the two main floors, uses interior locks. Exterior doors are secured by box-type locks. Elaborately molded window valances in the drawing room are also original to the house. The library is located across the central passage from the drawing room, on the east side of the house. An original built-in cabinet with glazed doors fills the space to the right of the chimney breast, while to the left a door leads into a windowed closet that occupies half of the small east wing. The two back rooms on the main level are connected by doors to their front counterparts. These rooms lack cornices and have mantels of Georgia marble identical in design to the mantels in the front rooms. The dining room, north of the library, has a molded chair rail and a closet that occupies the other half of the small east wing. A door on the left side of the chimney breast leads to a small porch on the east side. Across the central passage, a bedroom contains a built-in closet on the right side of the chimney breast and a door that leads to a bathroom in the small west wing. This door provides the only access

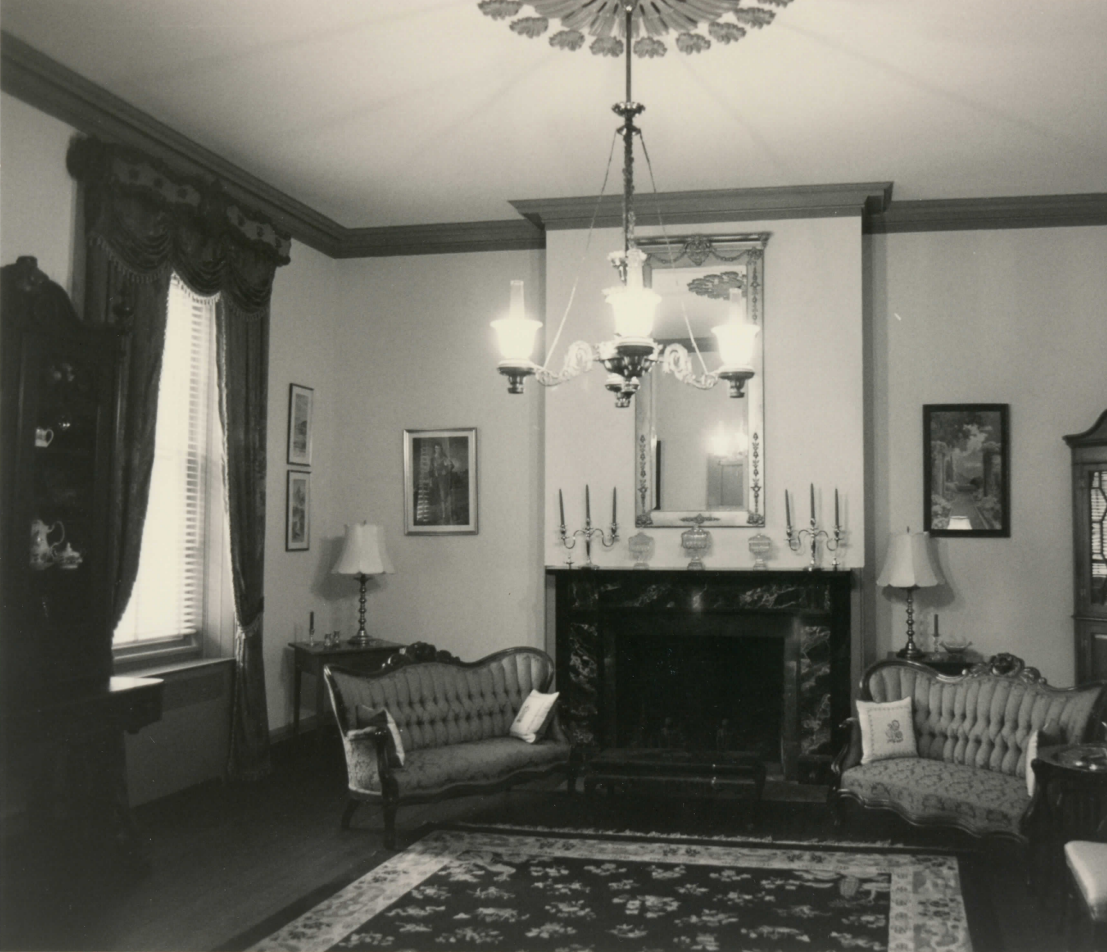
MOUNT STIRLING  
CHARLES CITY CO, VA.  
PHOTO 6 OF 16

1. Drawing room
3. David A. Edwards
6. View looking west
7. Photo 6 of 16

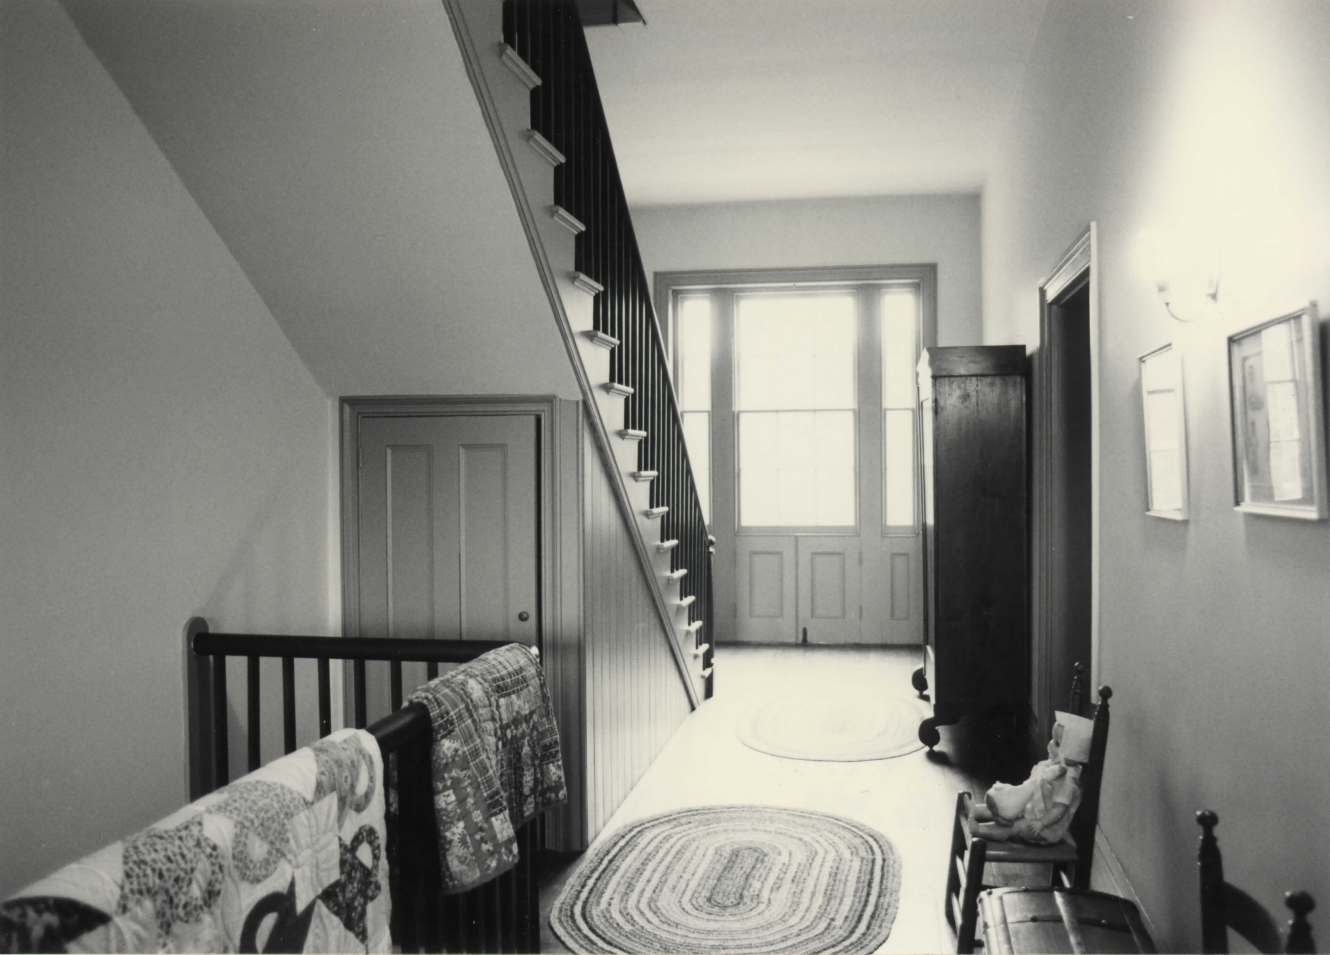
PHOTO 10 OF 16

1. Second floor central passage
3. David A. Edwards
6. View looking south
7. Photo 10 of 16

The second floor of the house was built to follow the floor plan of the main level; however, it was altered in the mid-twentieth century when the northwest corner bedroom was divided to form a bathroom and small sitting room. In the course of this renovation, a mantel was removed and the fireplace was sealed. The remaining rooms follow the dimensions of the corresponding rooms below. Details and materials are simplified on this floor and the rooms have a ceiling height of twelve feet, one foot lower than the ceiling height of the first floor. Certain elements of design and construction remain consistent between the first and second floors, including the presence of heart pine floors, tall baseboards, four-panel doors, and interior brick walls finished with plaster and lath. The doors on the second level are framed in simple architrave molding and the wooden mantels with slate hearths employ a plain Greek Revival design similar to the first-floor marble mantels. The three surviving bedrooms are identical in their use of moldings and details, and in the placement of a built-in closet placed flush with the chimney breast and occupying the space between the chimney and the outside wall. In each bedroom a window flanks the chimney on the opposite side of the built-in closet. The central passage that extends from the front to the back of the second floor has an opening at each end; the tripartite window that ornaments the facade and the door with sidelights and a transom that leads to the covered second level of the rear porch. The stair that rises to the attic level is placed directly above the stair from the first floor and is a slightly smaller version of it, but with a simpler newel post. The area below the stringer of the stair is partially enclosed with vertical tongue-and-groove boards to form a small closet.

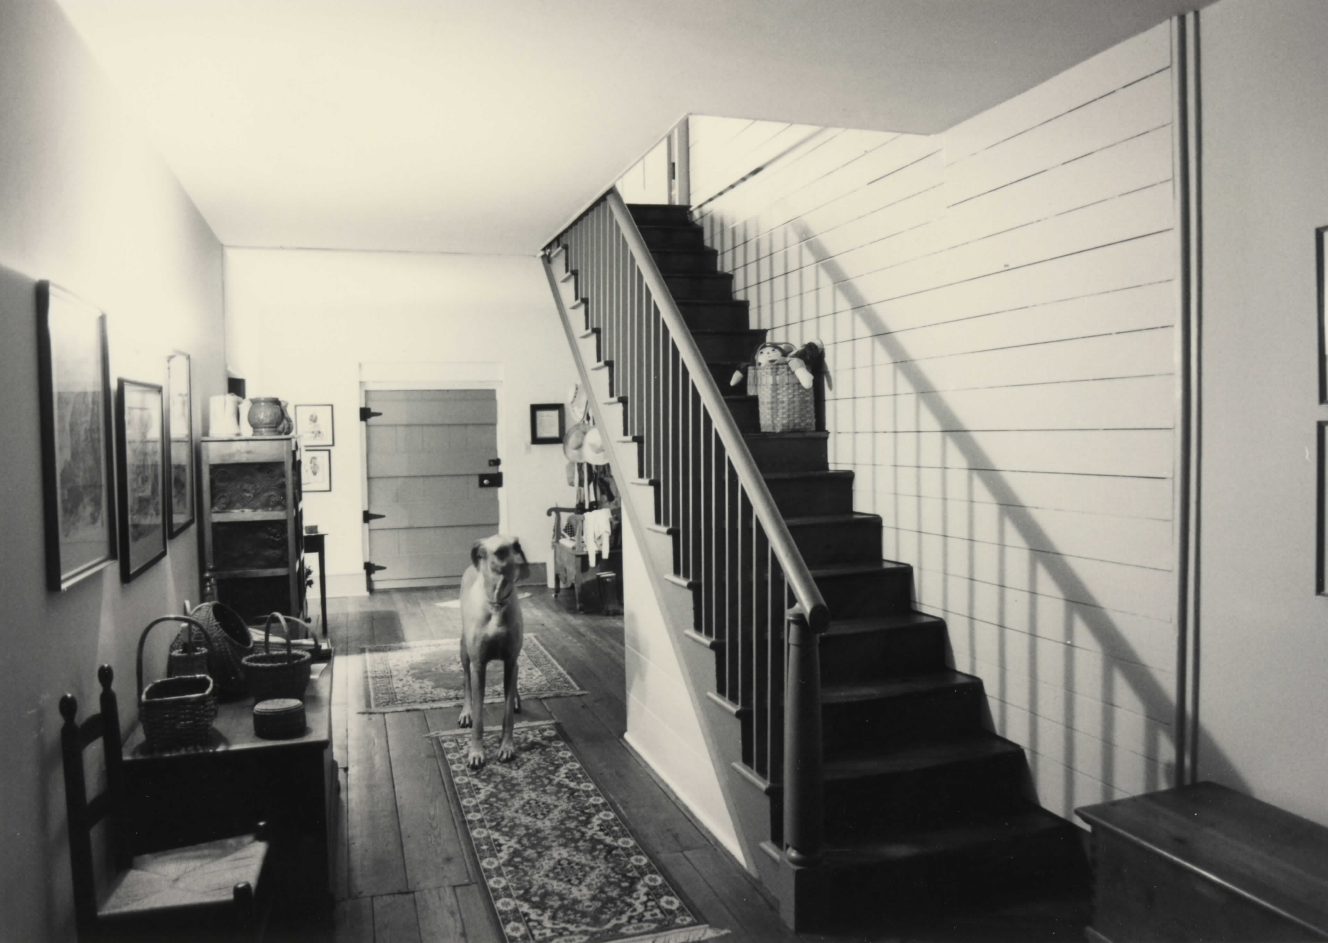
MOUNT STIRLING  
CHARLES CITY CO, VA  
PHOTO 12 OF 16

1. Basement central passage
3. David A. Edwards
6. View looking north
7. Photo 12 of 16

Service and storage areas were historically located in the basement of Mount Stirling. The central passage is balanced by two former food storage rooms on the west side and two rooms on the east side: the kitchen and a room that is said to have been the family dining room, now a den. The central passage, along with the old dining room, has flooring of heart pine. A casement window is located at the south end of the passage, under the front portico, and a batten door on the north end opens to the areaway under the rear porch. The stair to this level descends directly below the main staircase and can be

closed off from the first floor at the top of the stairs by a four-panel door with a box-type lock. Sections of walls in the basement central passage are covered with tongue-and-groove boards laid horizontally. The windows in the old dining room are wooden casements set in deep reveals, typical of the original windows on the basement level. This room also contains one of two basement fireplaces, consisting of a large brick-faced opening surrounded by a plain wooden mantel and a brick hearth. The overmantel is covered with wide wood planks set vertically and two glass-fronted cabinets flank the chimney. The cabinet to the right is said to be original; the one to the left, legend has it, was built during the Civil War to conceal the entrance to a closet where family valuables were hidden. This closet occupies the basement level of the small east wing. The walls of the old dining room are covered in drywall. The historic kitchen has been modernized; floor covering and new windows were part of this renovation. The basement's second fireplace is located in this room, as well as the entrance to the closet under the east wing. The two storage rooms across the hall originally may have had dirt floors; however, the floor of the front room was raised to the level of the central passage in the mid-twentieth century and surfaced in modern hardwood flooring. The floor of the rear room remains a step below the central passage and is now covered in cement. The walls of these rooms are exposed brick in three-course American bond. The high, small casement windows in the storage rooms are fronted on the exterior by iron bars that are laid horizontally. The floor joists and cross bridging of the main floor are visible in these rooms. The front storage room provides access to the basement level of the small west wing.

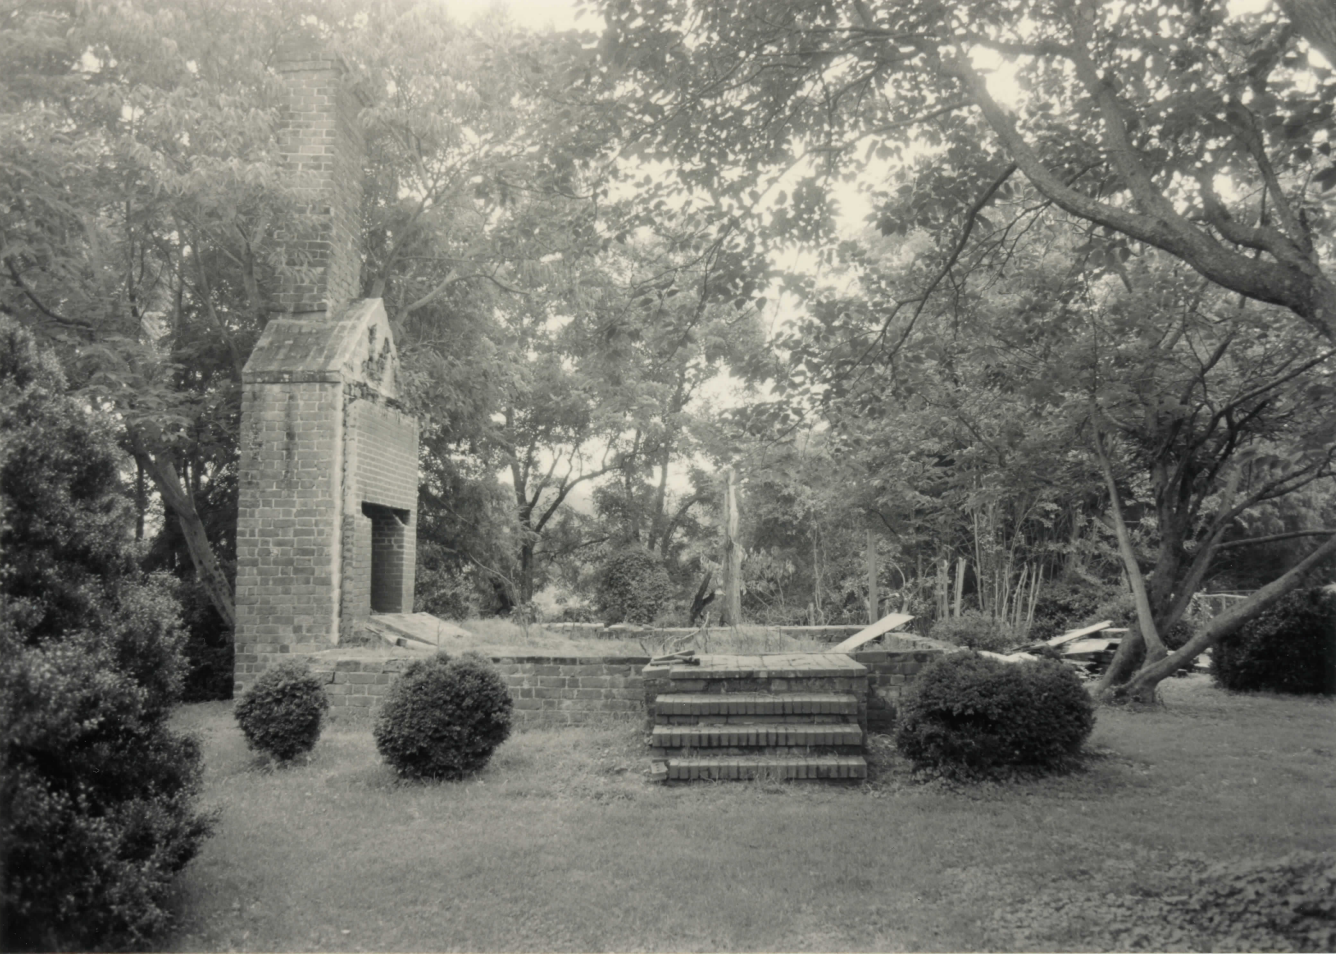
MOUNT STIRLING  
CHARLES CITY CO. VA.  
PHOTO 15 OF 16

1. Ruins of possible slave house
3. Bryan L. Townes
6. View looking east
7. Photo 15 of 16
