NATIONAL REGISTER OF HISTORIC PLACES
CONTINUATION SHEET

Farmington
King and Queen County, Virginia

SUMMARY PARAGRAPH

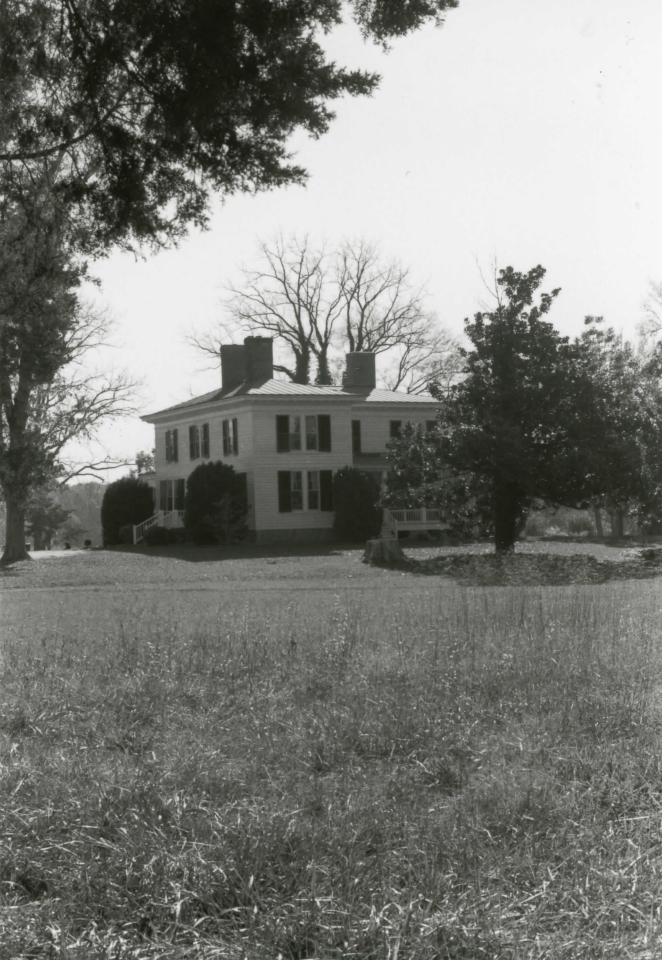
3 of 16

VIEW OF: North corner, view looking south
PHOTO 3 OF 16
