NATIONAL REGISTER OF HISTORIC PLACES
REGISTRATION FORM

historic name Hays Creek Mill
other names/site number McClung's Mill; Patterson's Mill; Steele's Mill;
VDHR File No. 81-159

street & number SR 724, .1 mi. N of jct. w/SR 726 not for publication N/A
city or town Brownsburg vicinity x
state Virginia code VA county Rockbridge code 163 zip code 24415

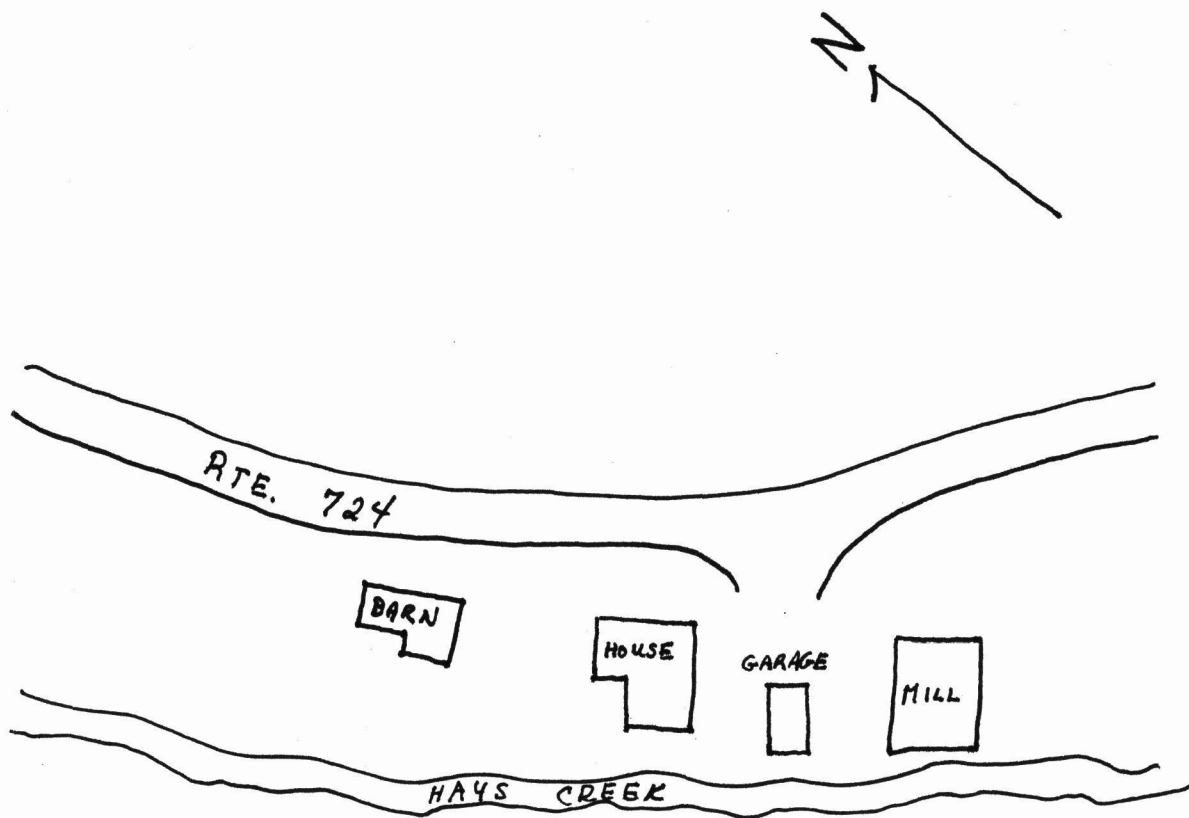
SITE PLAN

Between the house and mill is a one-story frame corncrib with vertical siding and a poured concrete foundation. The floor is elevated on the edges where the cribs once stood and grain was stored, but a large sliding door replaces the earlier entry and the building is now used as a garage.

South of the house an early-twentieth-century cow barn. It is a two-story frame building with horizontal weatherboard siding and a gable roof. Like the corncrib, it has a poured concrete foundation and probably is part of the same rebuilding. A chicken coop was added to the north side of the barn. The interior of the barn has a dirt floor and a loft. The chicken coop can be entered from the barn from a second-story loft that is now used to store hay.

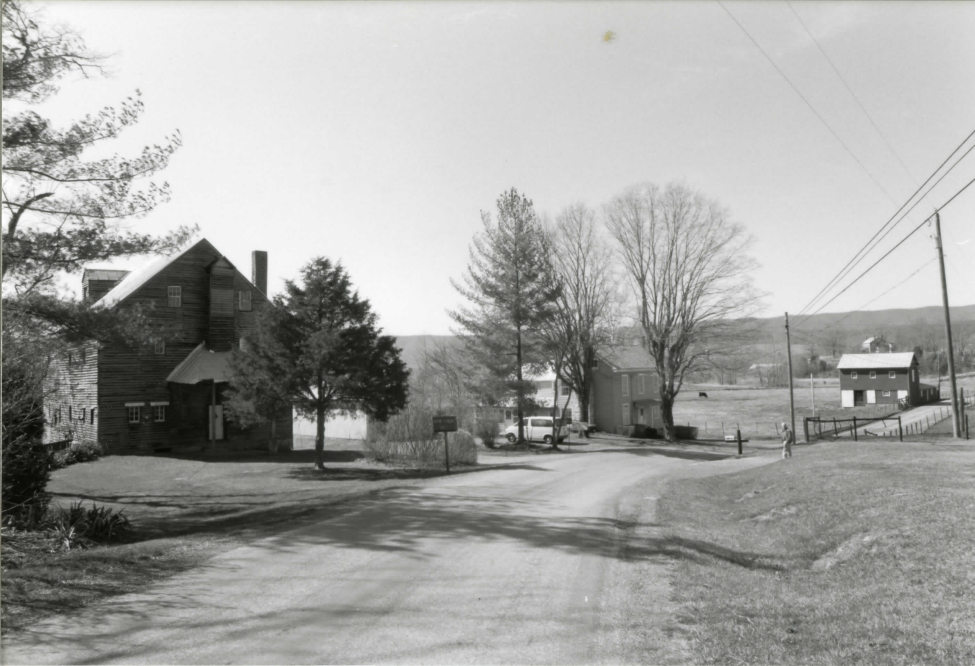
View of Mill, garage, house, barn; camera facing west
Photo 1 of 12

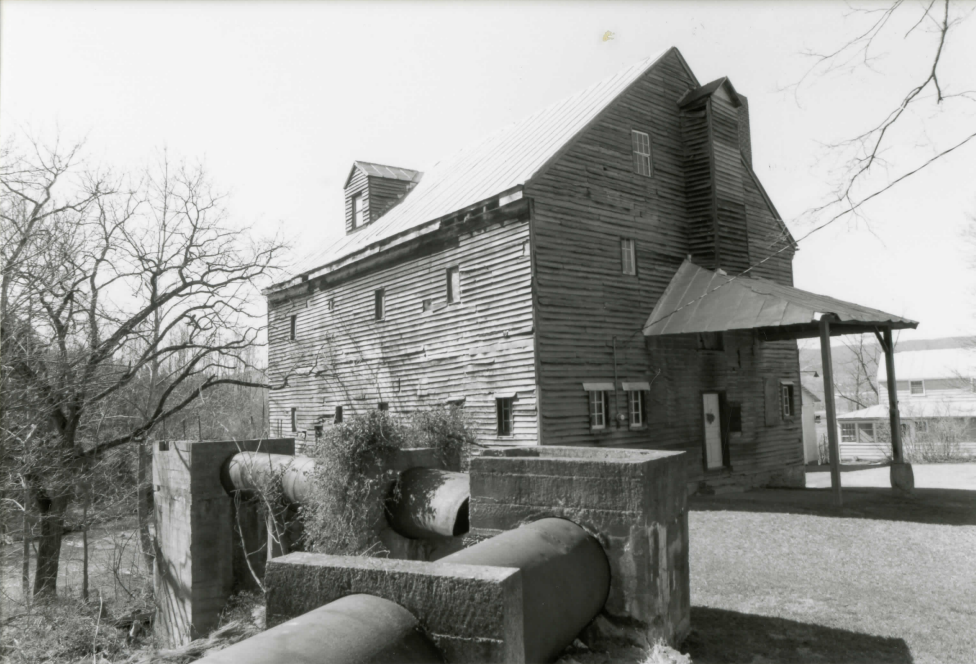
2 OF 12

View of Water pipes and mill; camera facing west
Photo 2 of 12

The south elevation faces the wheel and race. The wheel is surrounded by a concrete spillway. The millrace starts as a closed iron culvert supported by concrete blocks at intervals. Away from the mill it becomes an open concrete race upstream. The first floor of the south elevation has four bays, two of which are boarded up. The other two are wood-framed windows covered with screen and plastic. The three windows on the second floor are six-light casement windows. The attic has two double-hung dormer windows with six-over-six lights in each.

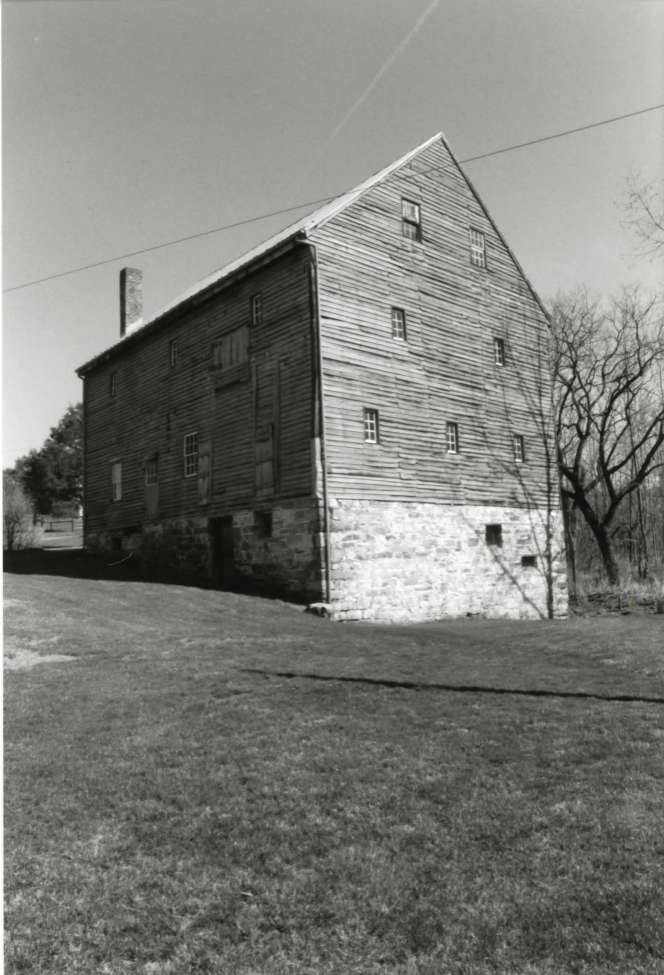
View of Mill; camera facing east
Photo 3 of 12

The principal facade is the east gable elevation. There is one window bay in the foundation. It is an unglazed window with metal bars. Two log steps, each about four feet three inches wide, lead to the five-panel front door. Three windows on the first floor are six-light casement windows. Another bay on this floor appears in the 1902 photograph as a drop box that now is boarded up. There are two windows on the second floor, also six-light casement windows. The attic floor has two windows that are double-hung, six-over-six windows. The interior end chimney rises on this facade. Also on the east elevation is a wooden porch overhang. The porch has a tin hipped roof and one square support column set in a round concrete mold. There is also a wooden-shaft drop chute from the attic floor to the ground that was used to transport grain from outside the mill to the attic floor. The gable roof of the mill is covered with galvanized tin.

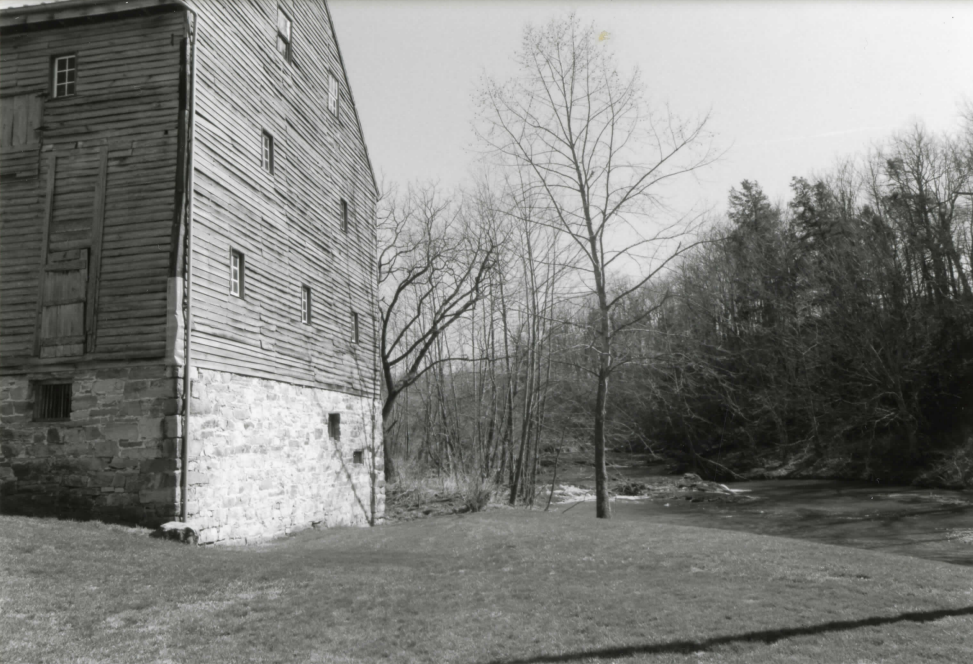
4 OF 12

View of Mill and Hays Creek; camera facing southeast
Photo 4 of 12

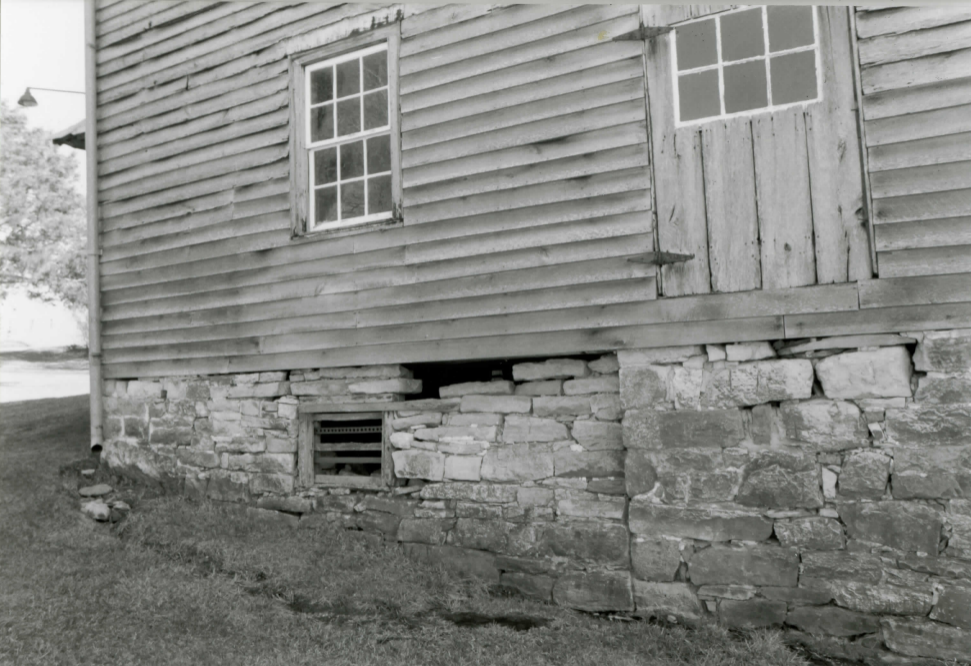
View of west elevation of mill showing addition to foundation
Photo 5 of 12

The west elevation, part of the earliest portion of the mill, faces Hays Creek. There are two window bays in the foundation of this elevation, which contain pegged windows with wooden bars. On the first floor there are three window bays, while the second floor has two bays, each with six-light casement windows. The attic gable has two double-hung, six-over-six windows.

Access to the basement is gained through the door in the foundation on the north elevation and through a room on the first floor. The foundation wall thickness differs, depending on which stage of building is represented. The older part of the foundation is two feet five inches thick, while the newer part is one foot thick. The original basement was 35'6" x 32'2". The floor of this portion of the basement was at one time wood and some wood remnants can still be seen today. The jack arch of a fireplace that no longer exists remains in the fragment of a wall that was removed. The place where the wall was torn down and foundation extended can clearly be

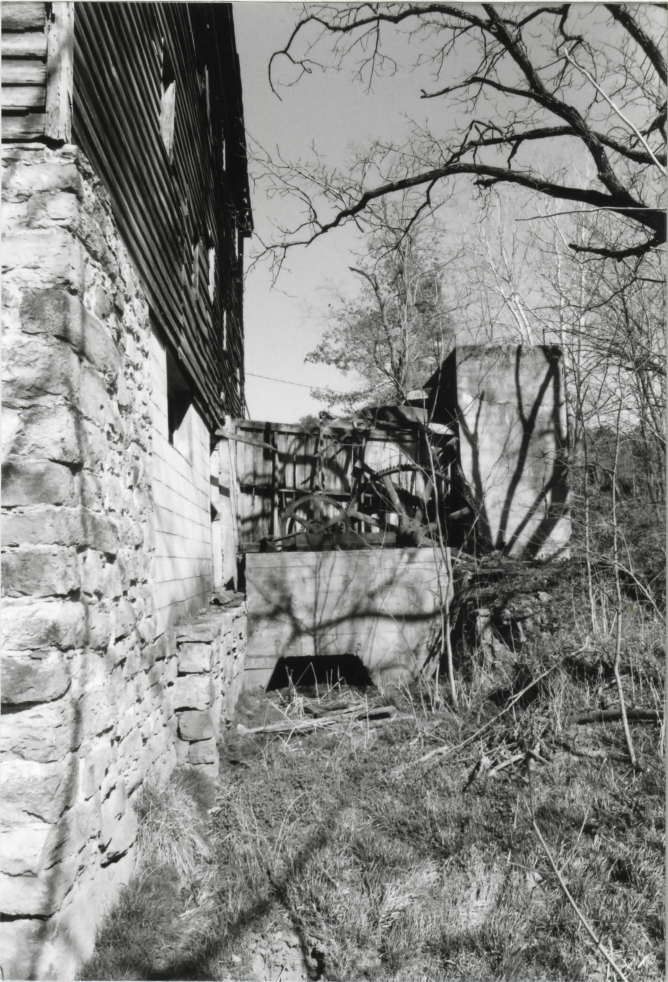
View of east elevation of mill with mill equipment
Photo 6 of 12

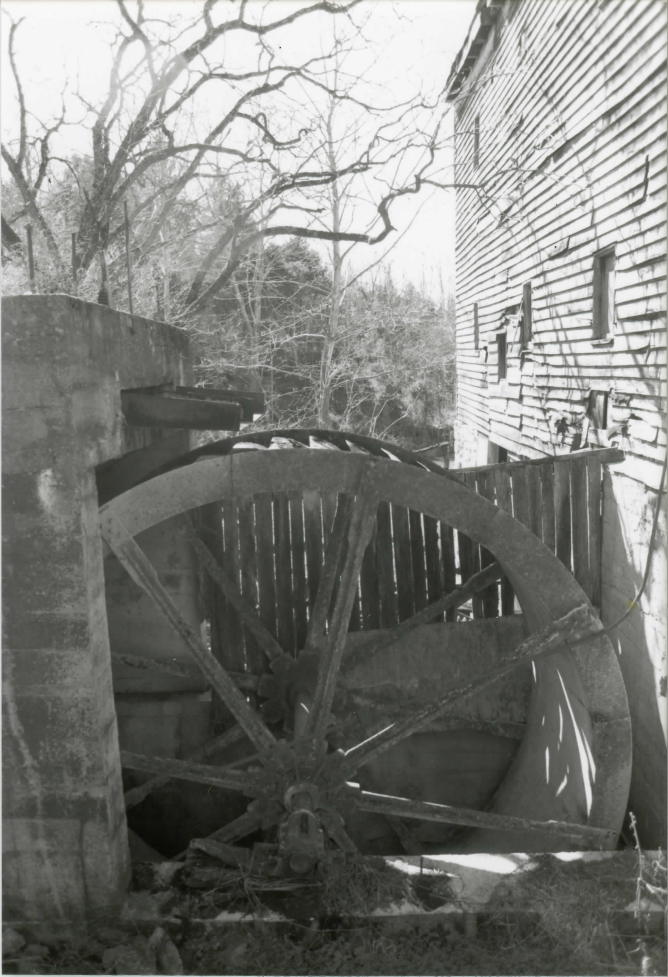
View of east elevation of mill with water wheel
Photo 7 of 12

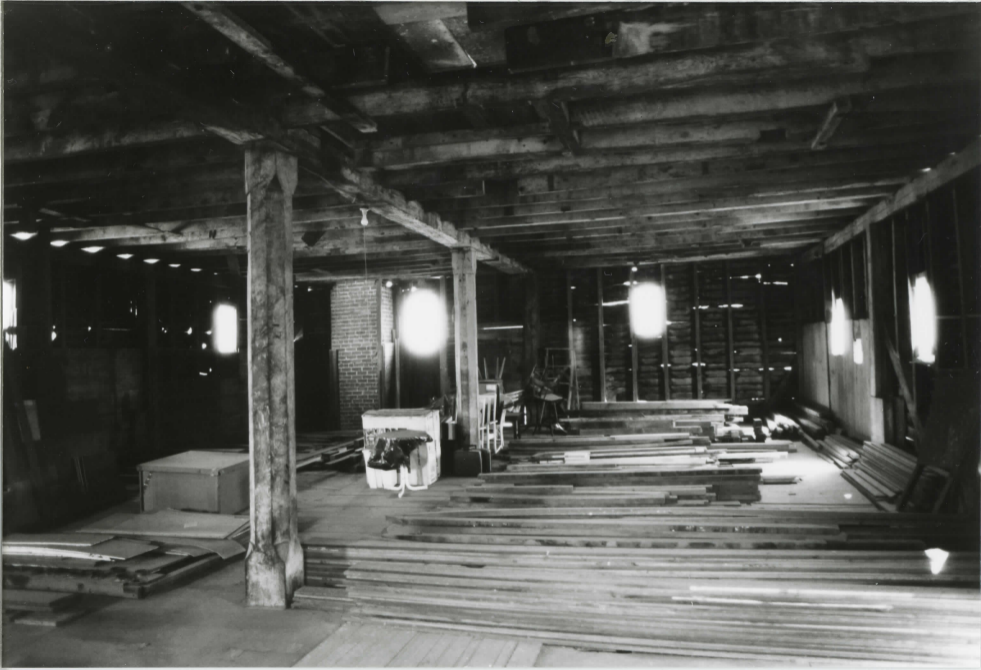
10 OF 12

View of second floor of mill
Photo 10 of 12

The second floor consists of a single large room. Evenly spaced holes in the floor remain from chutes that once transported grain between the floors. The summer beam runs in a east-west direction and does not appear to have been spliced or replaced. This means that this portion of

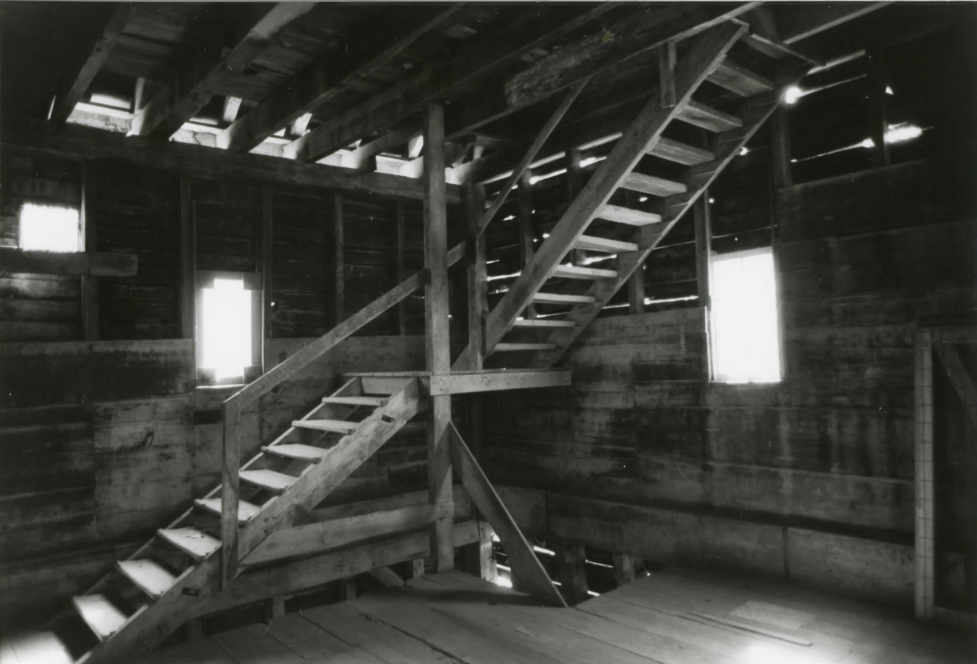
11 OF 12

View of second floor of mill with stair to third floor
Photo 11 of 12

the structure could have been built (or rebuilt) at the time that the foundation and basement were enlarged. This room is partially clad with interior siding, but most of the walls resemble the exposed walls found in the third principal room on the first floor. Two octagonal intermediate posts similar to those found on the first floor carry the load of the floor.

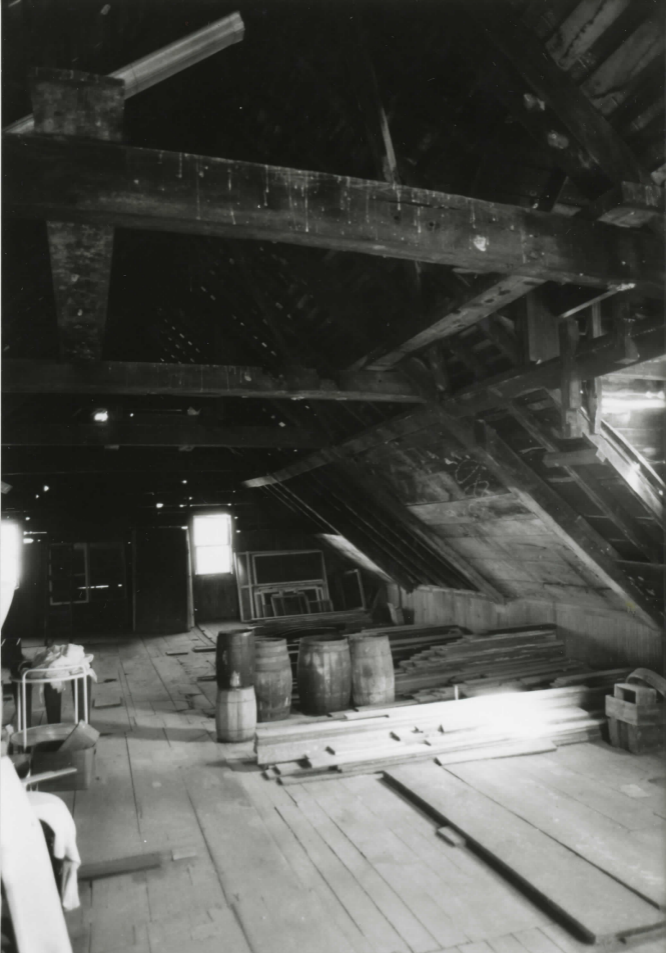
12 OF 12

View of third floor of mill
Photo 12 of 12

The attic floor is also a single large room. The roof is framed with four secondary rafters between each primary rafter. There are heavy purlins and collar beams with no ridge pole. The secondary rafters are three by five inches and the primary rafters are four inches square. The 1902 photograph shows a wooden roof that was replaced in the early 1970s with galvanized tin because of structural damage. On the east wall of the attic is a chute that is covered by a wooden encasement that drops down to the outside of the building and is located behind the wooden porch overhang. Although most of the machinery was sold off by a previous owner, the attic floor contains an old flour dresser and horsehair brushes that were used to sift the flour.
