National Register of Historic Places
Registration Form

historic name King-Neimeyer-Mathis House

street & number 2145 Malvern Road

city or town Hot Springs

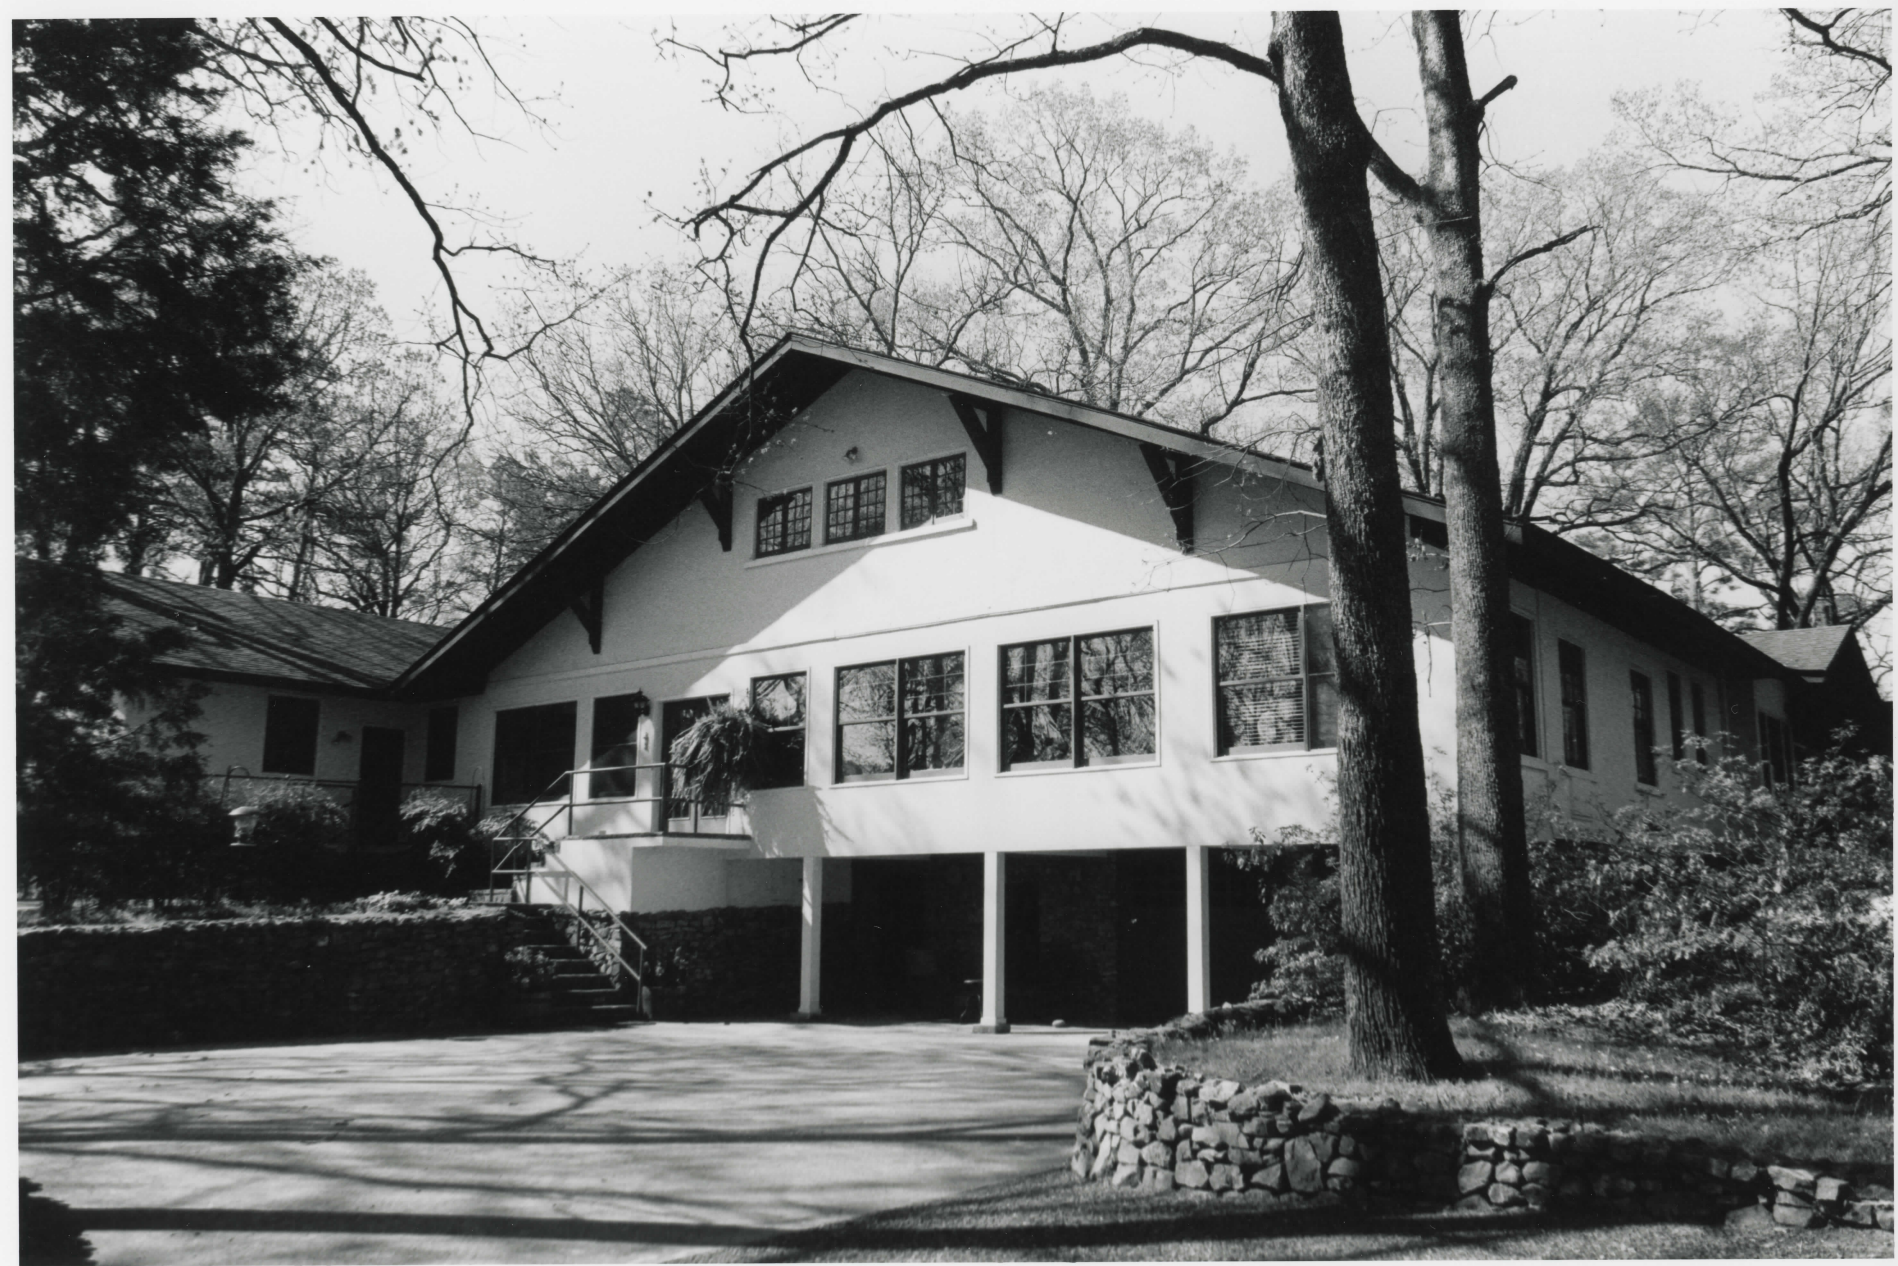
Northeast facade facing south

House: Northeast/Rear Elevation

On the right of the basement level of the rear of the house is a two-car garage. The basement level is recessed, and square wood posts support the upper stories. Each garage bay has the two original garage doors, which are made of wood and hinged at the outer edges. Each door features diagonal wood paneling in the bottom half and nine rectangular window panes in the top half. To the left of the garage door is a wood door that enters into the basement space. Original stone retaining walls border the parking area outside the garage, and a set of steps leads to the first floor from the parking area.

On the first floor of the main façade, on the right side, are three grouped pairs of modern, false nine-over-one, windows. To the left of the grouped pairs of windows is a set of French doors, each with fifteen panes of glass. The French doors are flanked by a single modern, false nine-over-one window. To the left of this is a single grouped pair of modern, false nine-over-one windows.

The second floor of the rear façade, like the front façade, has three casement windows in a row in the center. Each sash of the casement windows has twelve panes. The eave above the rear façade is supported by four knee brackets, two on each slope. Unlike the front façade, a knee bracket is not present in the gable peak.

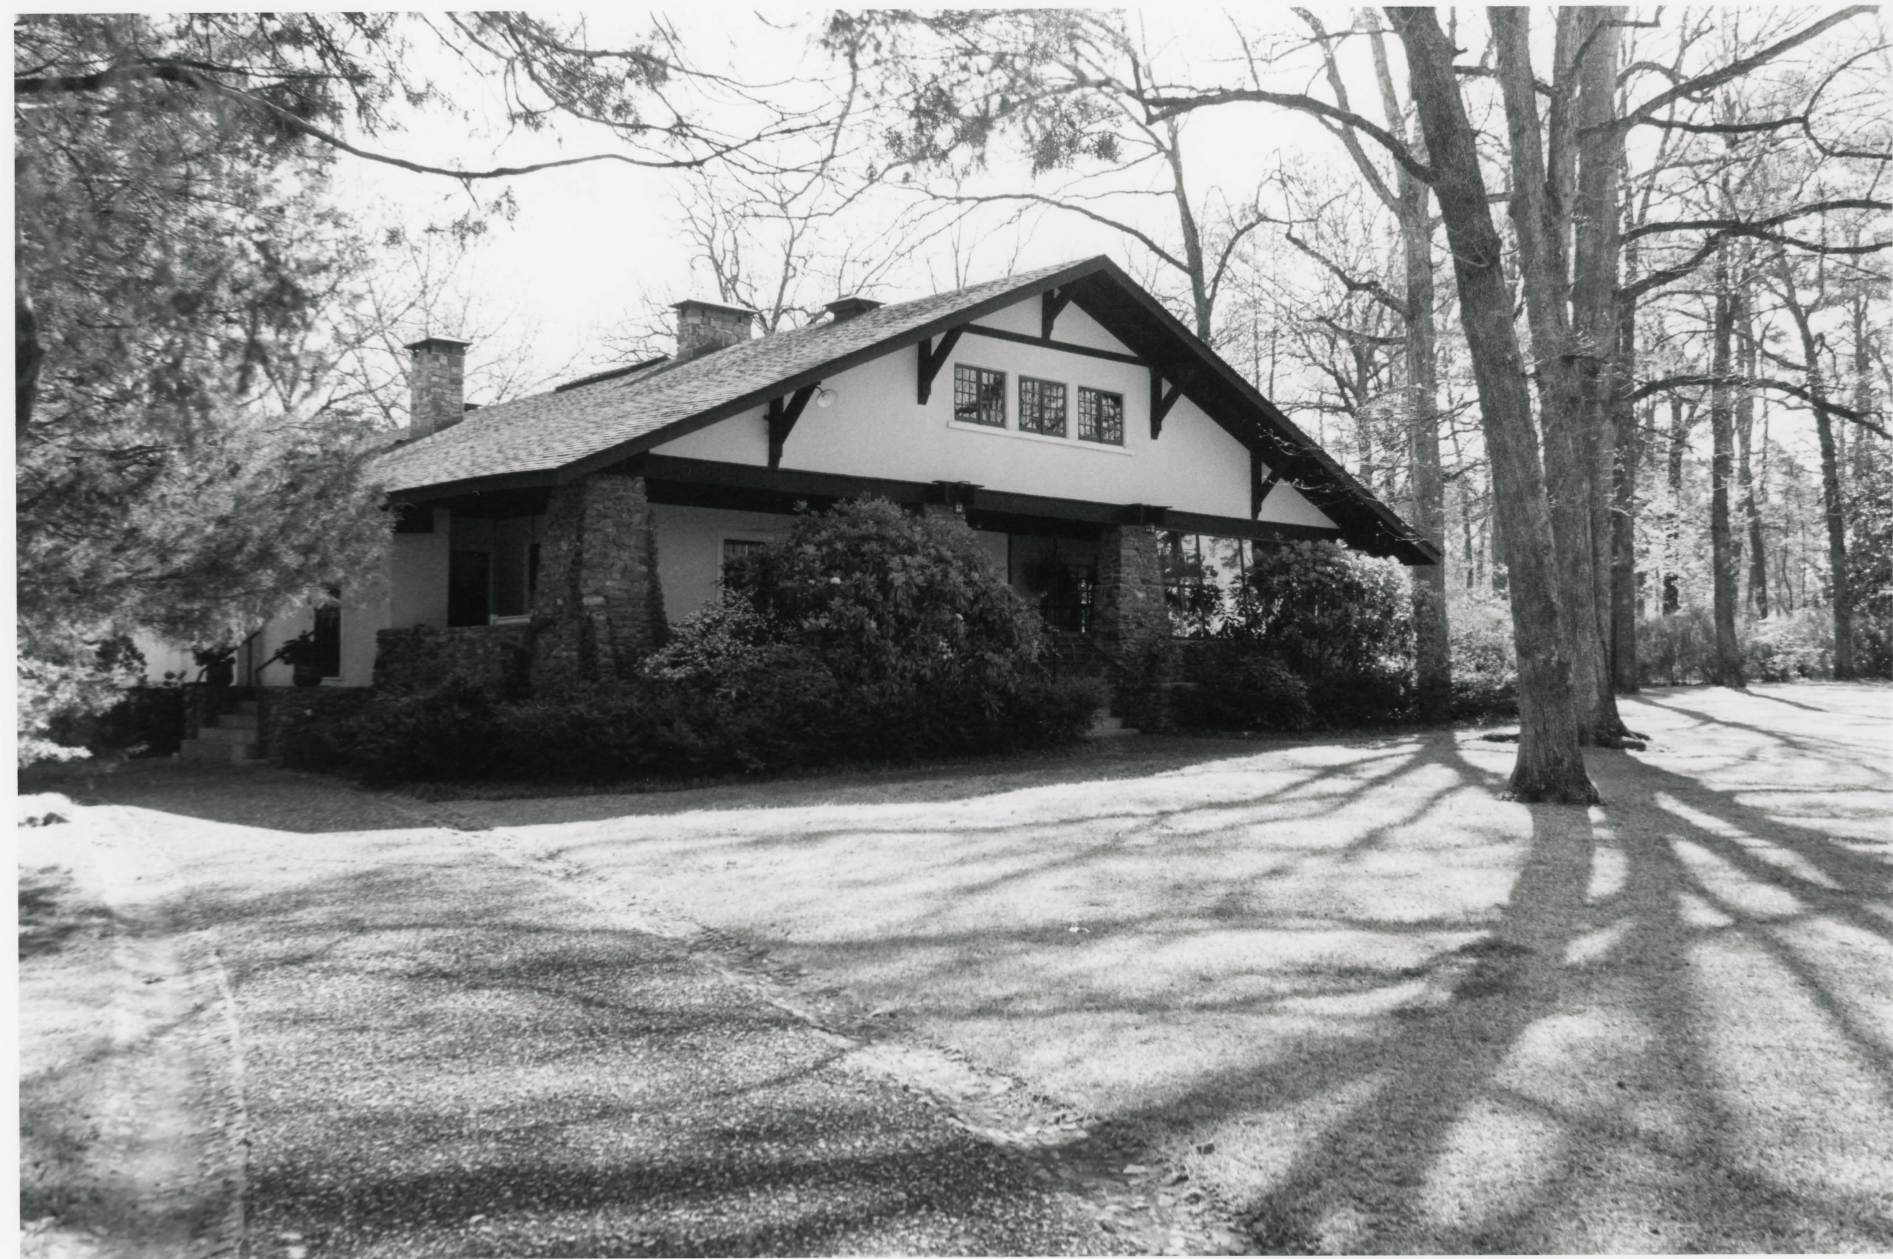
Southwest facade looking east

House: Southwest/Front Elevation

The southwest elevation is the main façade of the house. In the center of the façade on the first floor is the main entrance, which has a set of wood French doors with twelve panes of beveled glass in each door. The entrance is flanked by wood sidelights each having six panes of beveled glass. On each side of the entrance is one double-hung wood eighteen-over-seven window. The top sash has eighteen square panes while the bottom sash has a large center pane flanked on each side by three small square panes. In the center of the gable peak is a row of three casement windows, and each sash has twelve small square panes. A dark wood board crosses the gable just above the windows. The roof eave is supported by five knee brackets, one in the gable peak and two on each slope.

A porch extends across the entire front façade of the property, and wraps around both sides. The gable of the second floor is supported by four battered piers constructed of fieldstone, and wood beams cross the porch on top of the piers. On top of the two middle piers are small wood extensions with glass and metal porch lights. Concrete steps ascend to the porch in the center bay. The right bay of the porch is now enclosed with glass panels.

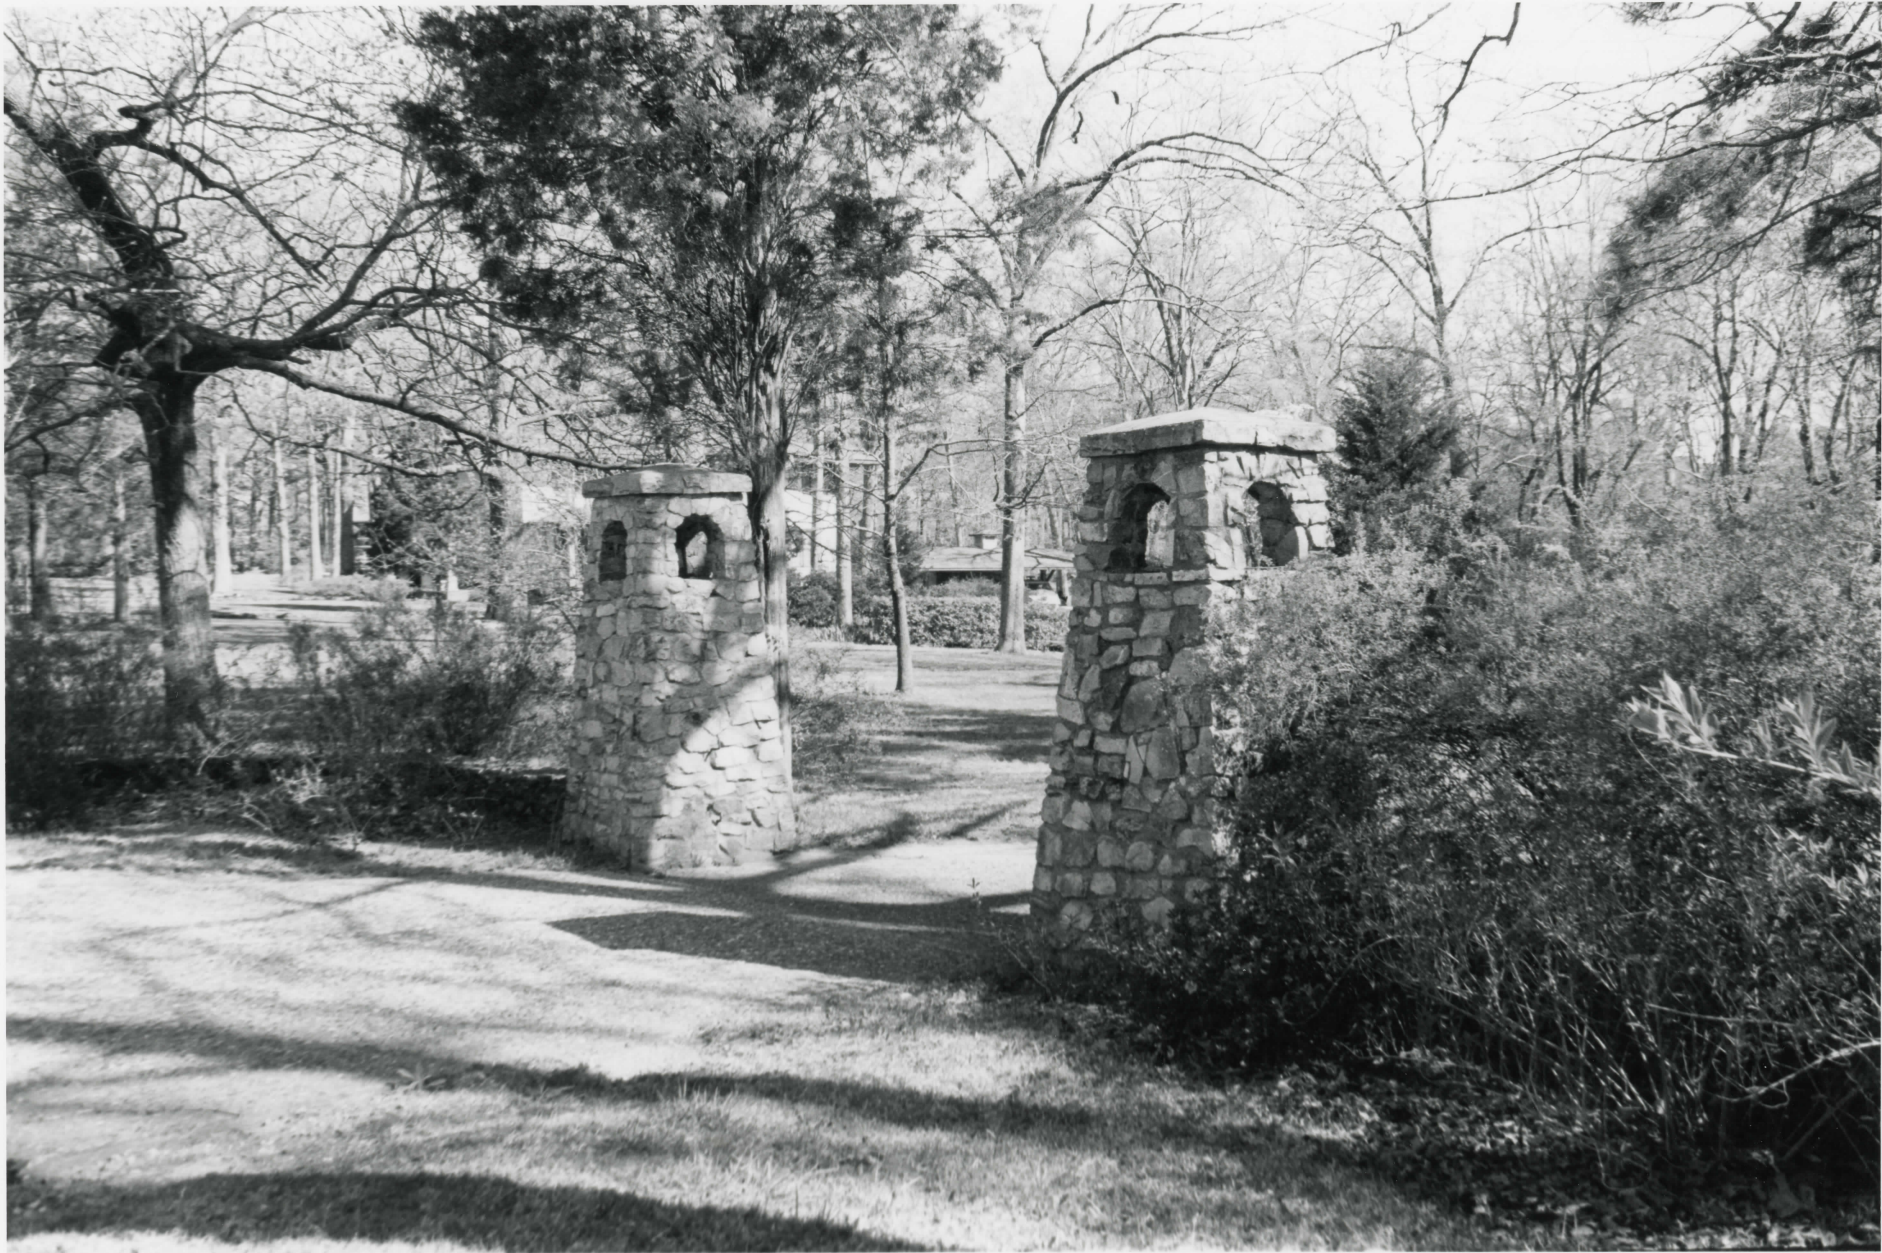
Entrance pillars facing north

The stone wall terminates in decorative stone pillars at the entrance to the driveway. They are battered in form and built out of fieldstone to match the front columns of the main house. Near the top of each pillar, arched openings exist on all four sides of the pillars forming a groined vault-like cavity in the pillars. Both pillars are topped with shallow fieldstone pyramidal caps. Although metal hardware for mounting iron gates exists on the pillars, any gates that were present were removed within twenty years after the house was built.

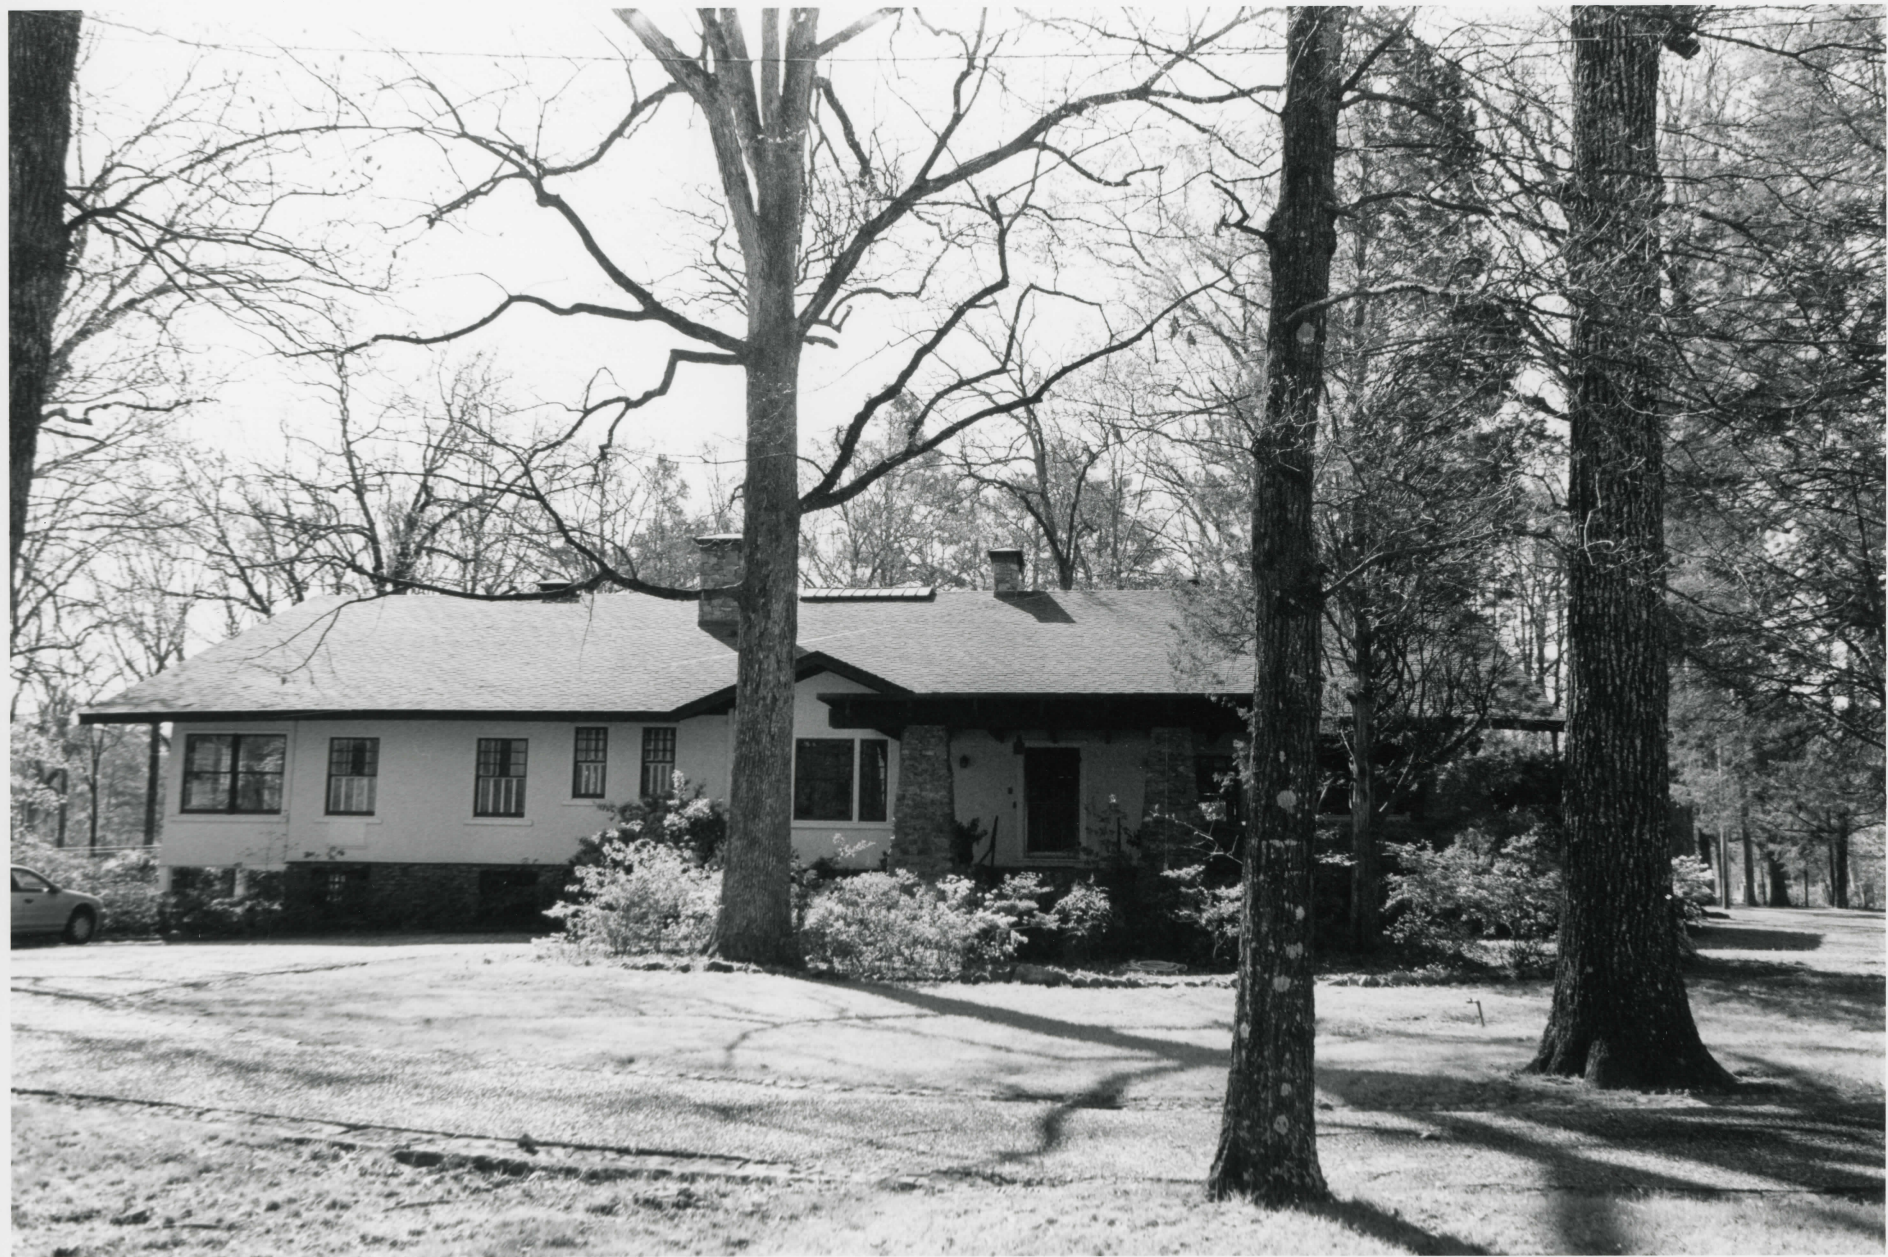
Northwest facade facing southeast

House: Northwest/Side Elevation

The northwest façade towards the front of the house is dominated by the wrap around porch that ends at a porte-cochere. On the side of the house, looking out onto the porch, is another wood, double-hung, eighteen-over-seven window like those on the front façade. The porte-cochere has a shed roof supported by two battered fieldstone piers. Concrete steps lead from the driveway under the porte-cochere to the side entrance, which has a wood door with panels in the bottom half, and ten panes of glass in the top half.

As one proceeds towards the rear of the house, there is a tripartite window under a small gable. The window is wood frame with an eight-over-one center section flanked by a twelve-pane casement window on each side. To the left of the tripartite window are two, wood frame, double hung windows set high in the wall. Each window has a nine-over-one pane arrangement. Proceeding to the rear of the house there are two more nine-over-one, wood frame double hung windows that are larger and set lower in the wall. Finally, at the rear of the house is a grouped pair of modern, false nine-over-one, windows.

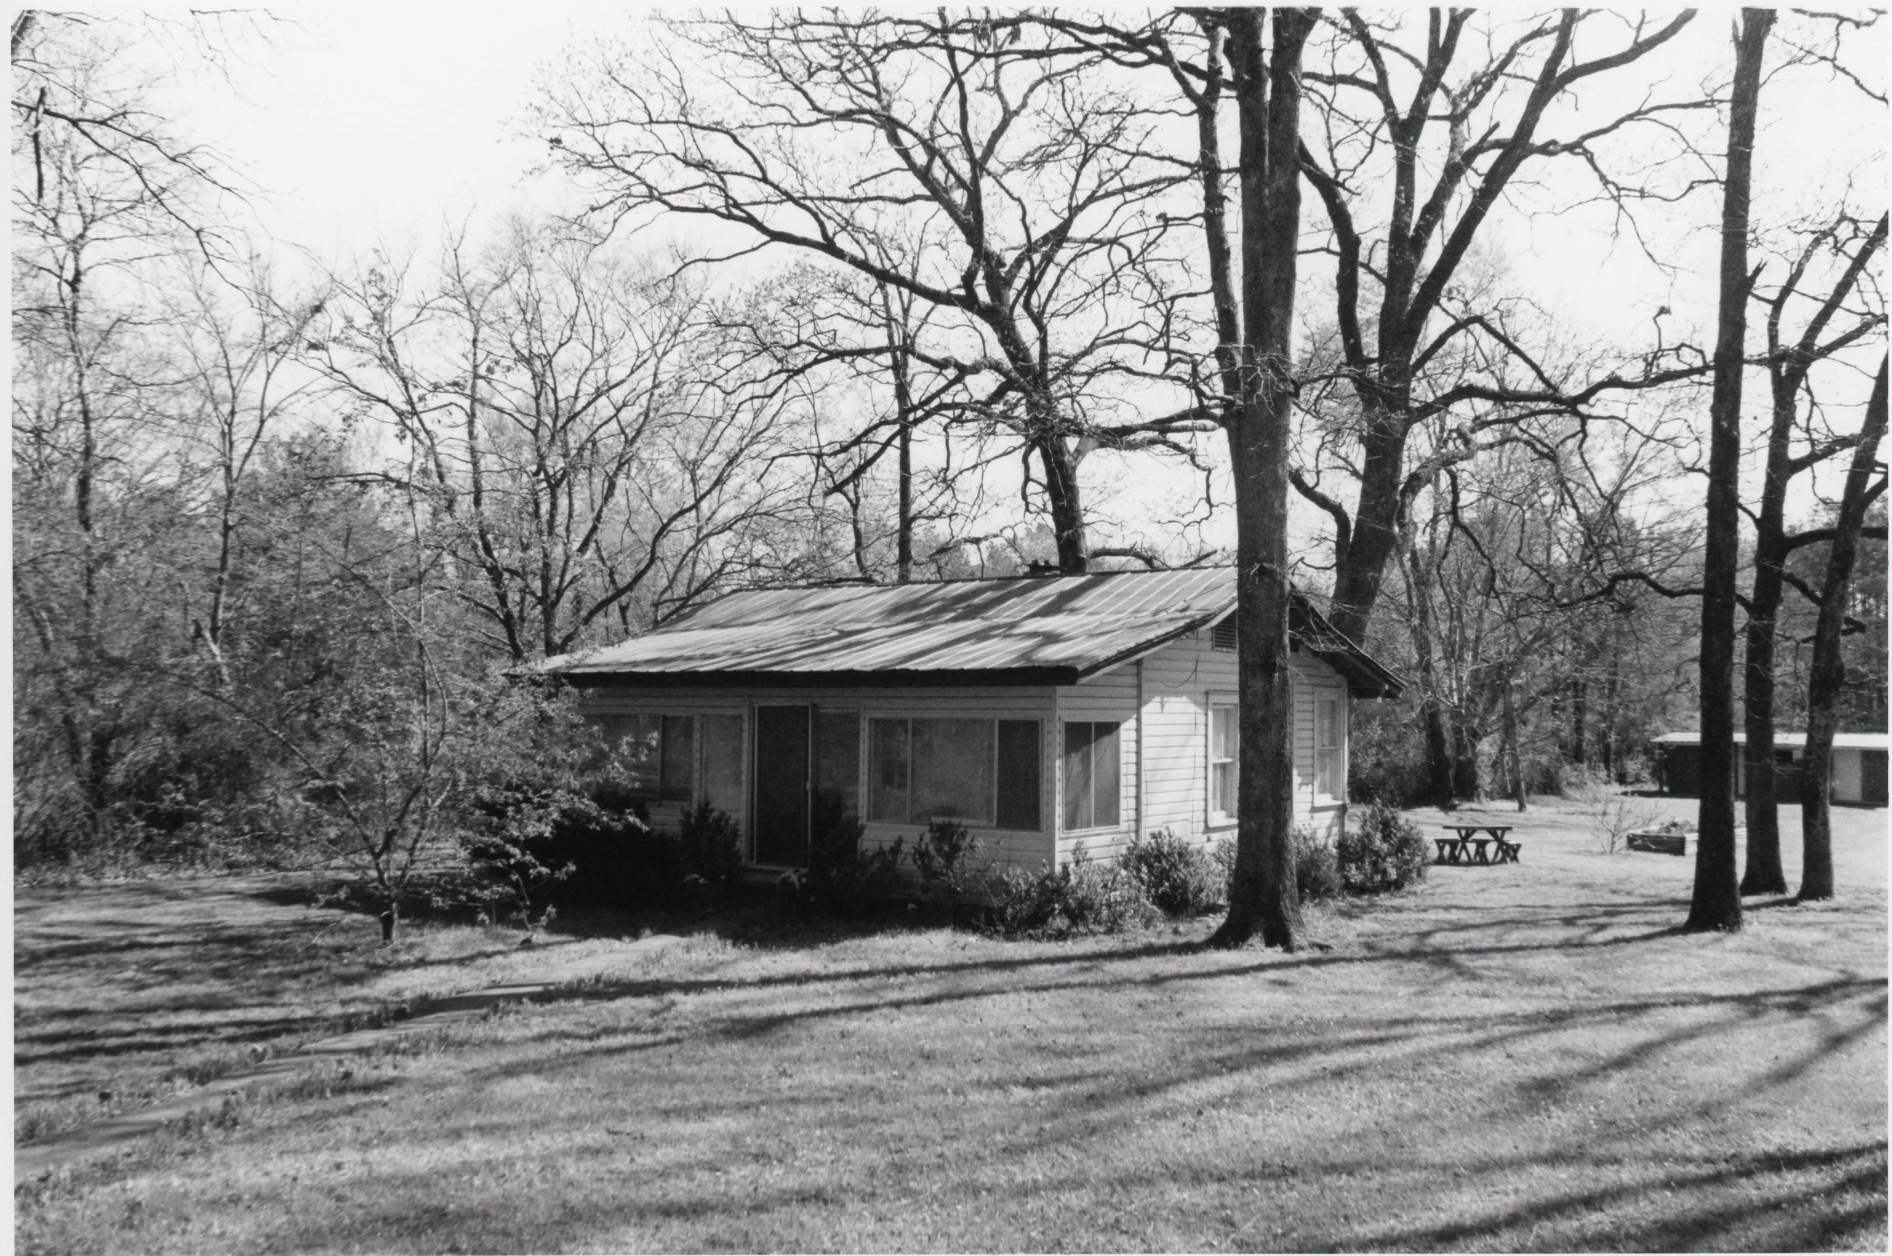
Servants' Quarters facing northeast

Servants' Quarters

To the northeast of the main house and pump house is the servants' quarters. The building is a one-story wood frame building with a fieldstone foundation and a standing seam metal roof with a side gable. The stone on the foundation, however, was added after the building's construction. The front porch of the building was enclosed in 1969, and one now enters through a sliding glass door in the center of the southwest façade. The door is flanked on each side by large glass picture windows. The northwest façade has a two-over-two wood frame double hung window in the center and a picture window in the side of the original porch. The rear or northeast façade has a central entrance with a wood panel door with a window in the top half and a modern metal screen door. A brick chimney is present in the middle of the rear roof slope. To the left of the entrance is a wood frame, double hung nine-over-one window at the corner. The southeast façade has a wood frame, double hung nine-over-one window at the right corner. A two-over-two, double hung wood frame window is located in the center of the façade, and a picture window is in the end of the original open porch.

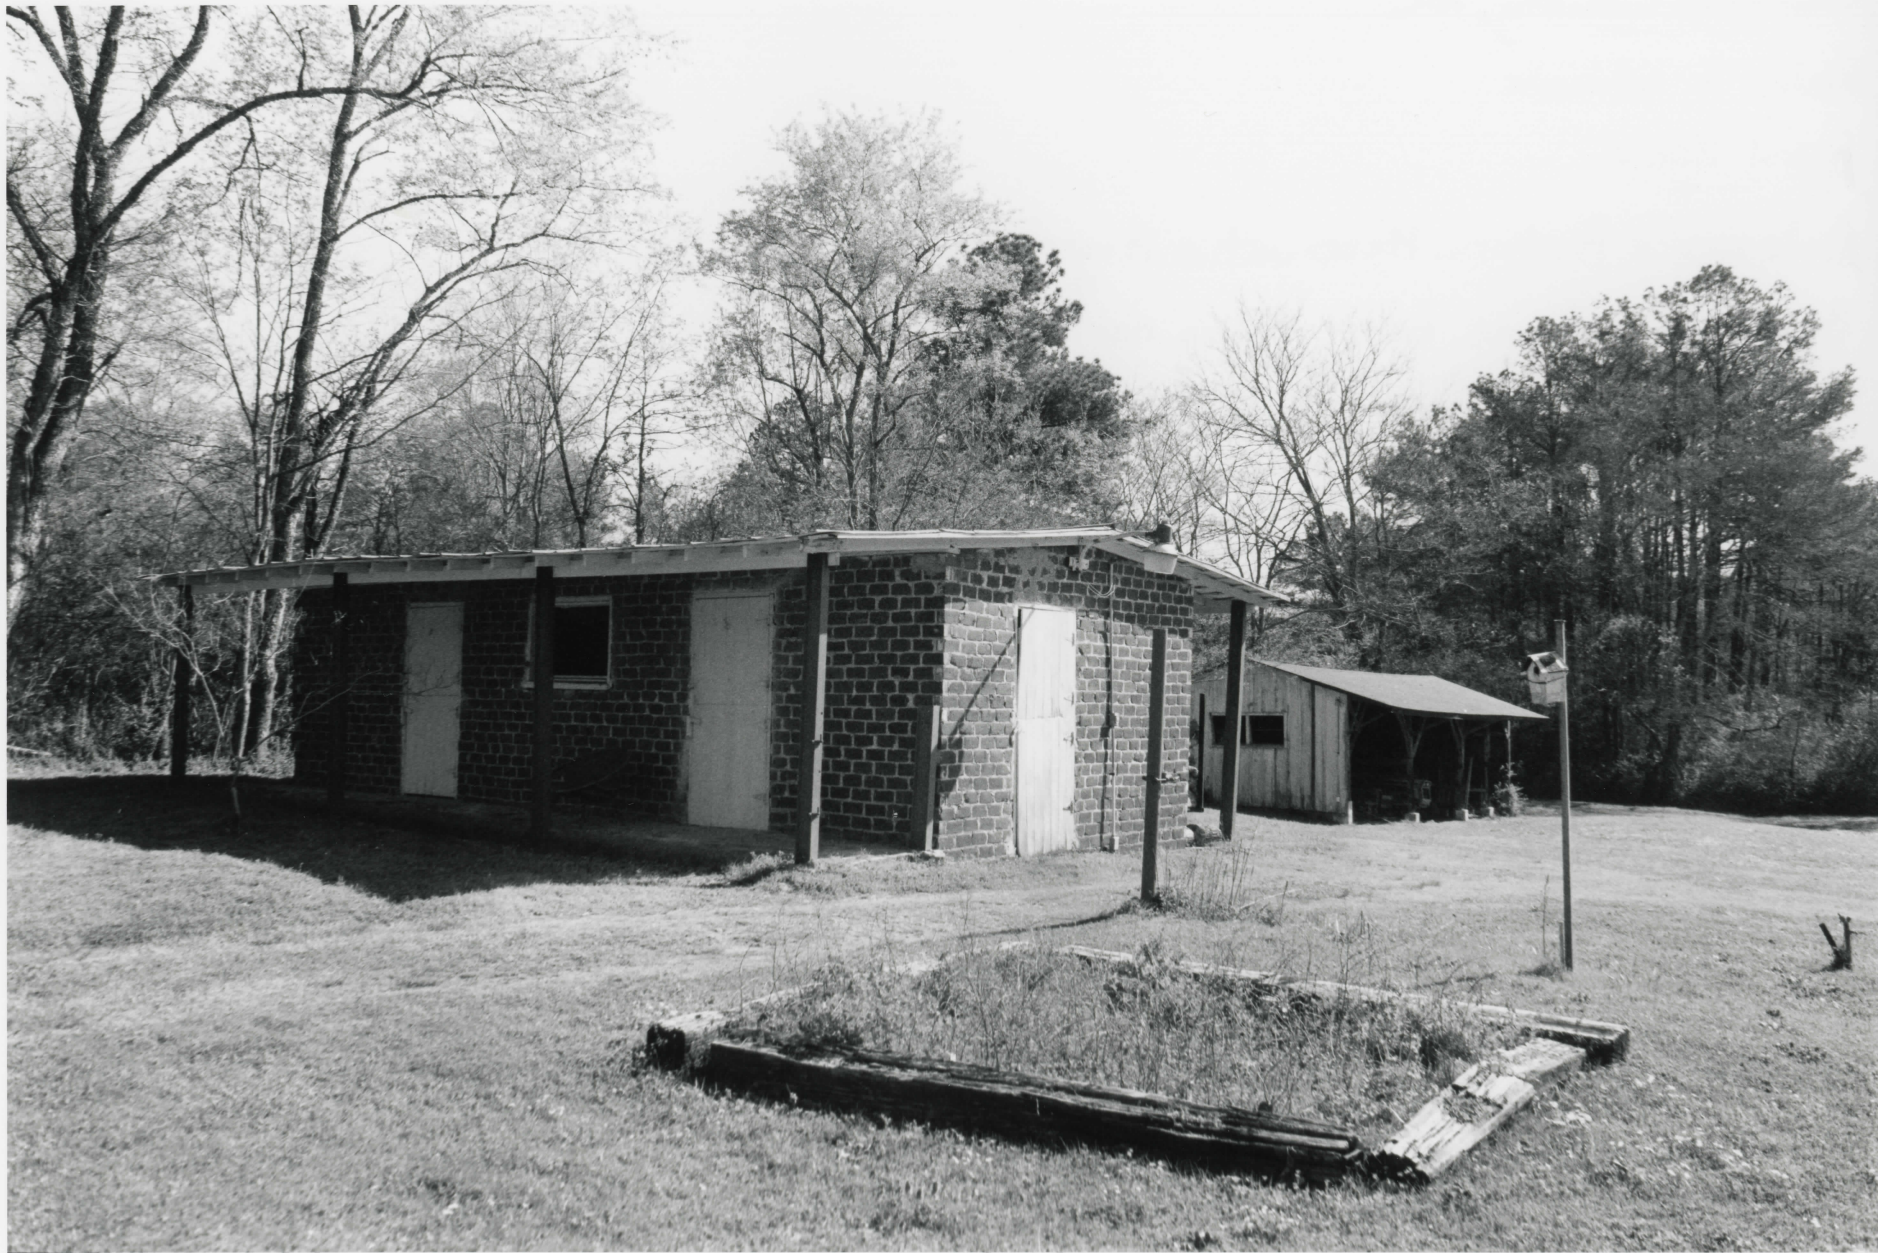
Brick and frame barns facing northeast

Brick Barn

To the north of the greenhouse is the brick barn, which was built circa 1940, and used to house two cows and a horse. The barn is one story tall and constructed out of large red bricks. The building has a metal shallow-pitched gable roof. The roof extends out on the longer northwest and southeast façades of the building to form porches running the length of the barn. Each porch roof is supported by four wood posts. Both the northwest and southeast façades of the building have two wood Dutch doors towards each end of the building. In the center of the façades is a wood frame rectangular opening. The southeast façade also has a wood Dutch door slightly left of the center.

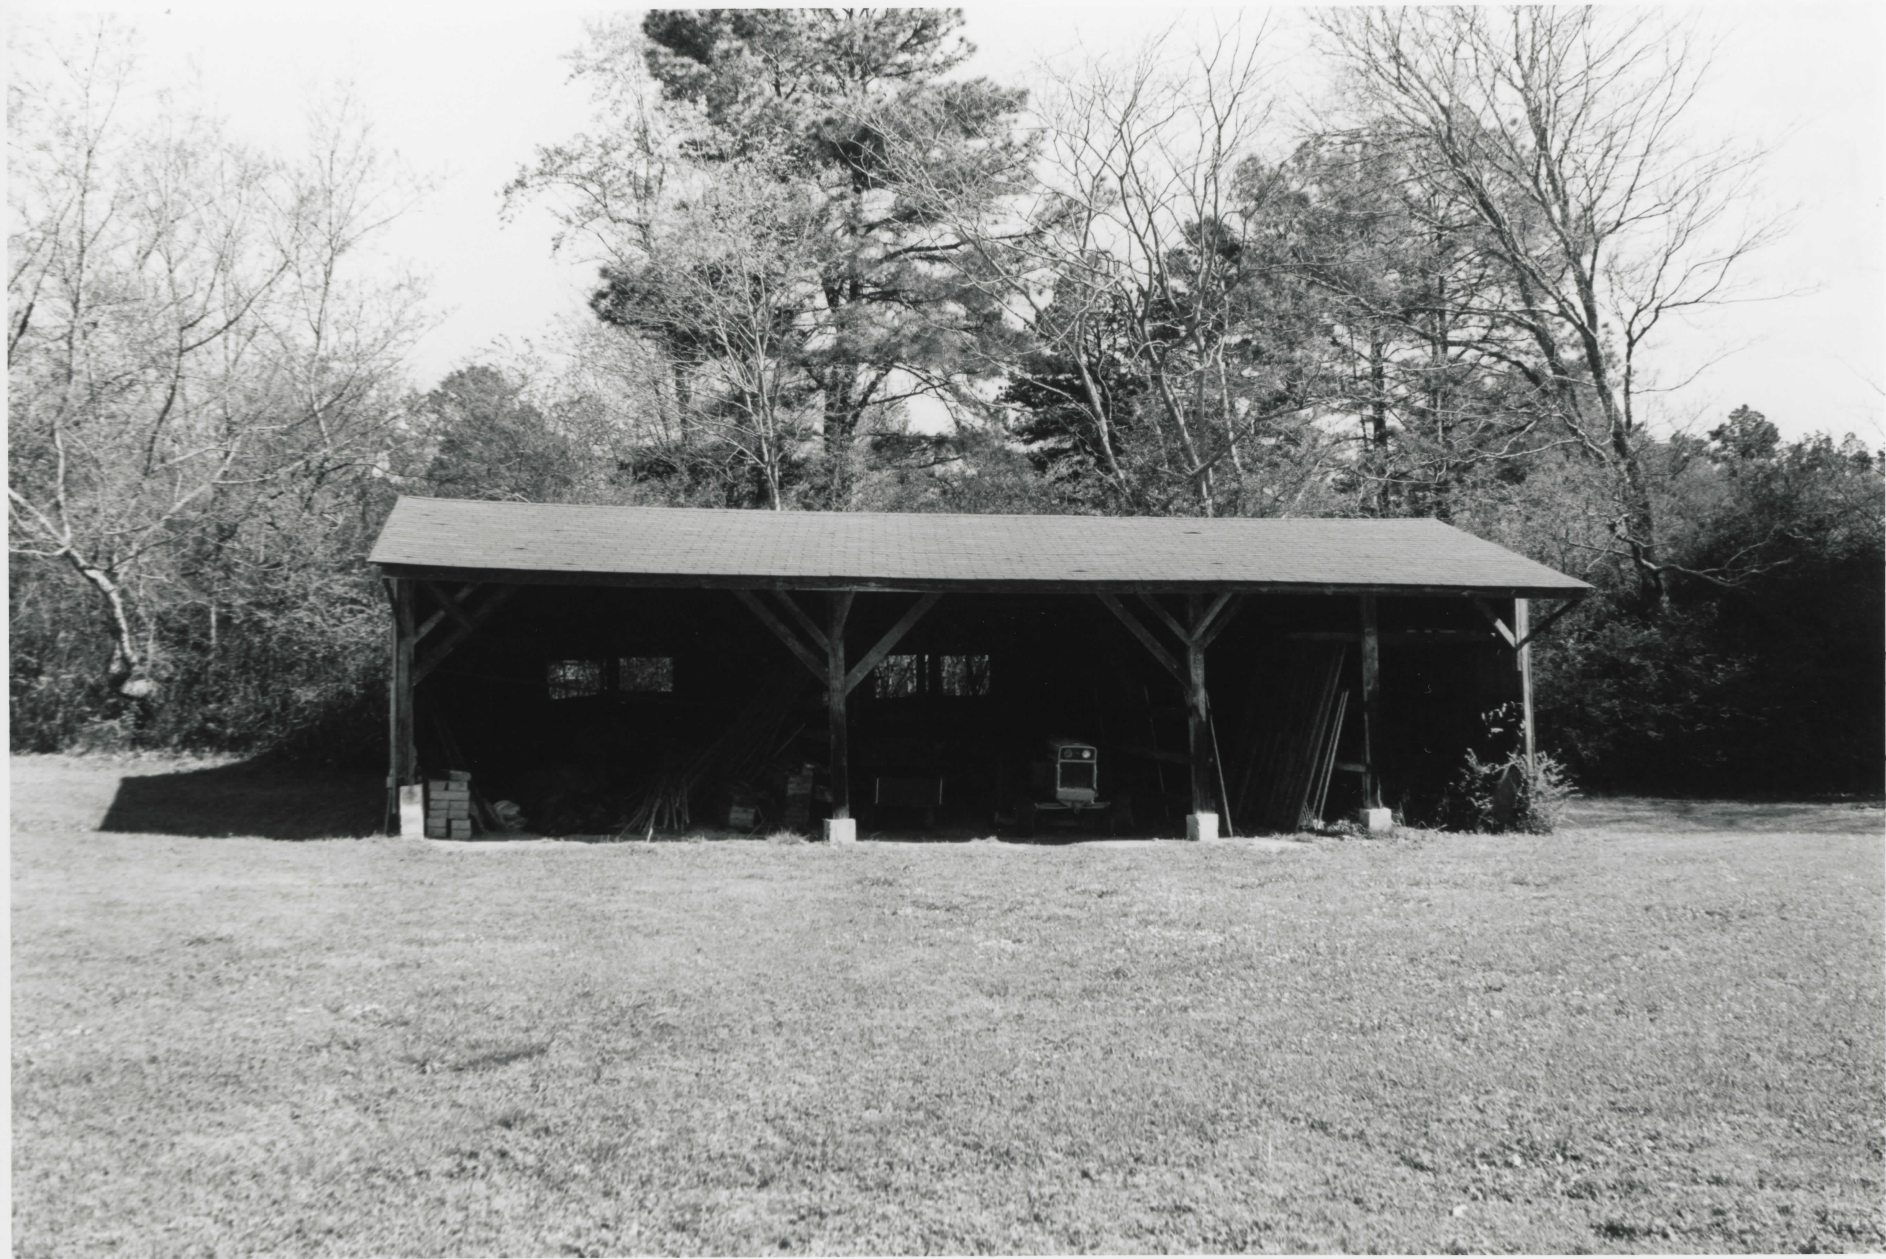
Frame barn facing northeast

Frame Barn

The frame barn stands to the northeast of the brick barn, and was constructed circa 1945. The barn is of wood frame construction with vertical board siding. The building rests on concrete piers, and is capped by a composition shingle side gable roof. The southwest façade of the building has a wood frame grouped pair of openings in the center of the façade. In addition, a vertical wood board door is present on the left side of the façade towards the rear of the building. The northwest façade, which is the rear of the building, has two grouped pair of wood frame openings, one in each of the southwestern two bays. The northeast façade of the building has no openings. The southeast façade is open with three stalls for housing animals. The bays are divided by wood posts with knee braces on top on the exterior and by horizontal boards on the interior.

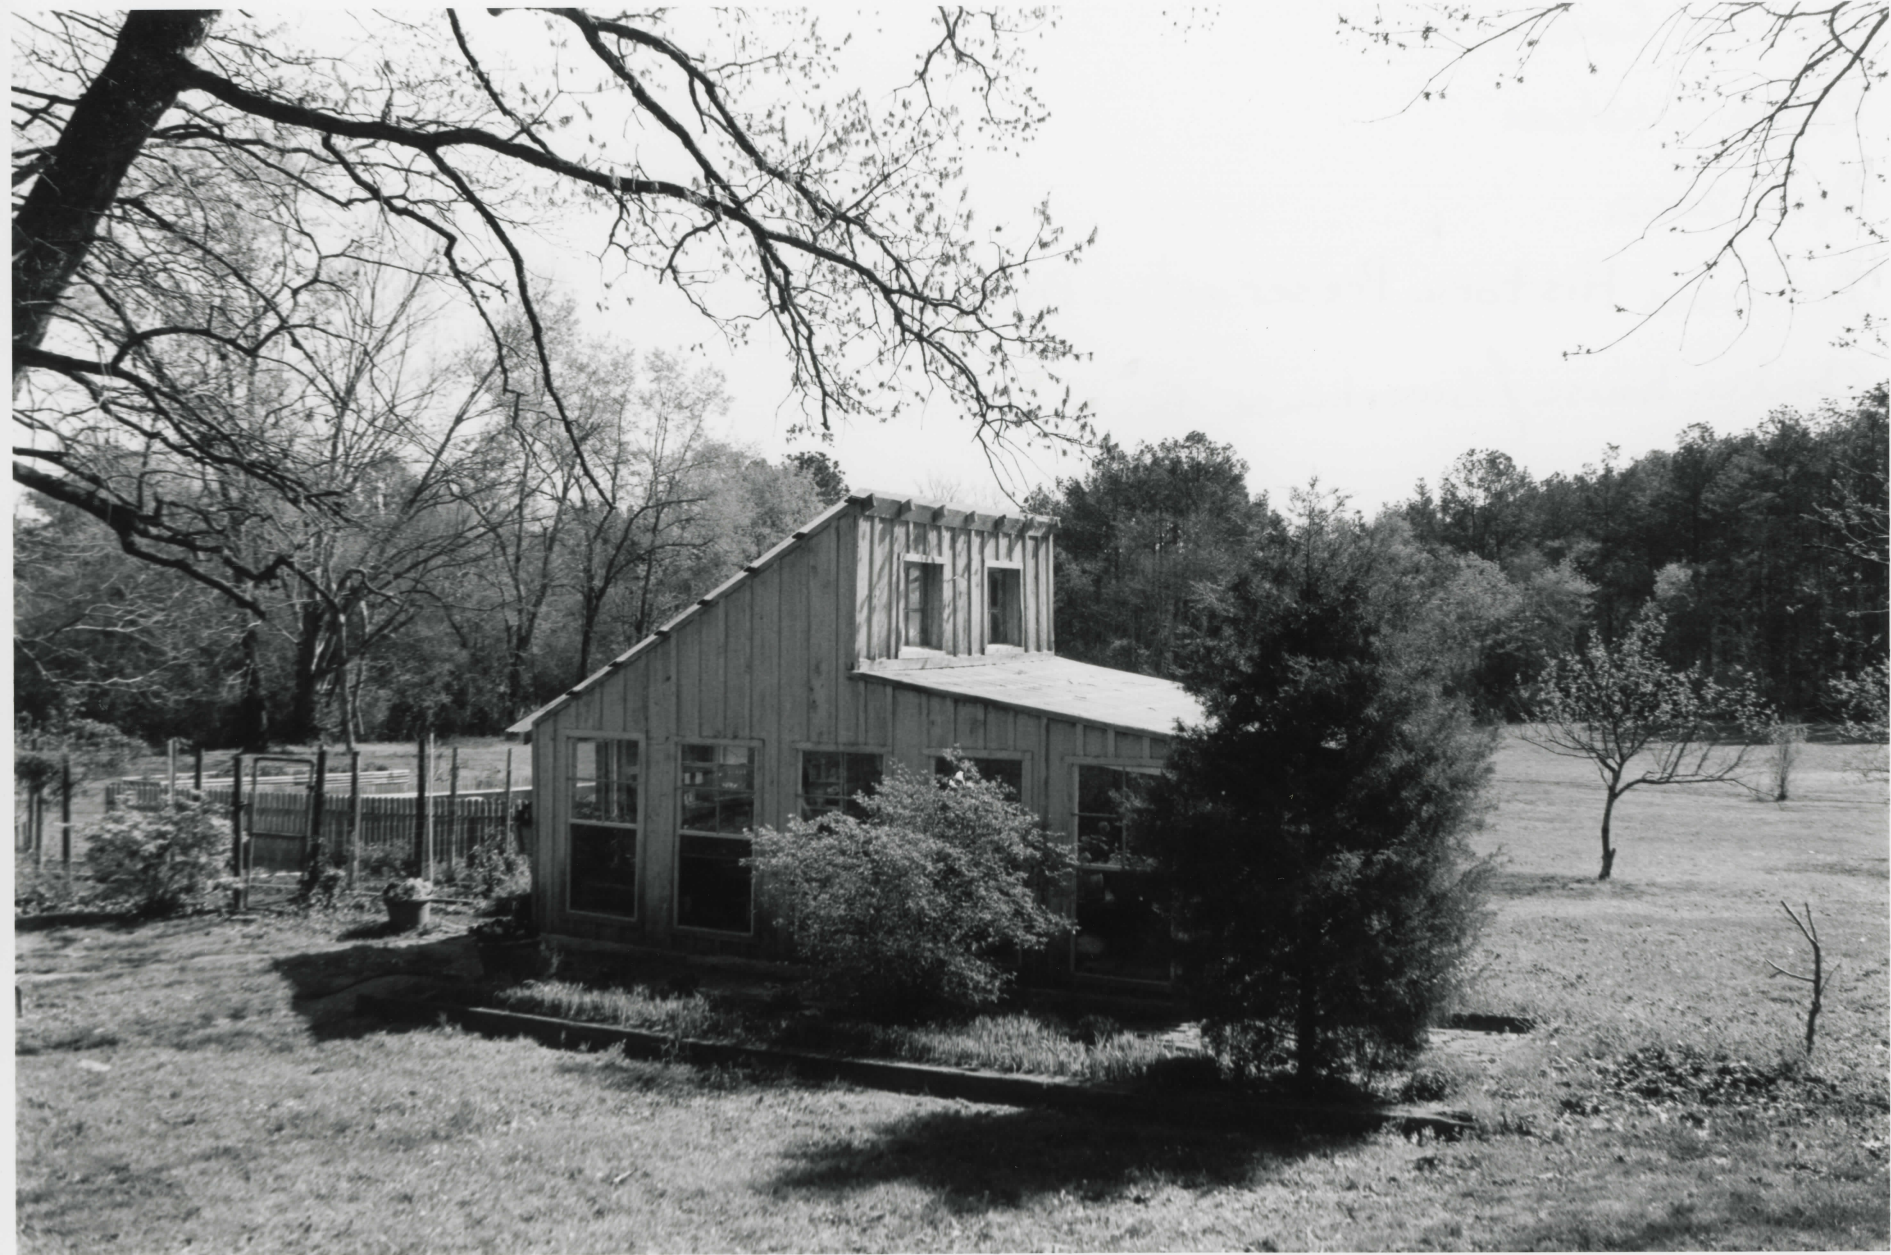
Chicken house / Greenhouse facing northeast

Chicken House/Greenhouse

To the east of the servants' quarters is the original chicken house, which was converted to a greenhouse circa 1985. The building is one story tall with board-and-batten siding and two corrugated fiberglass shed roofs, one sloping to the southeast and one sloping to the northwest. The building rests on a continuous cast concrete foundation. The southwest façade has five large four-over-one windows equally spaced along the façade that were installed circa 1985. The northwest façade has two stationary, four-pane windows set somewhat high in the wall. The northeast façade has the entrance door. The southeast façade has three large four-over-one windows equally spaced along the façade in the lower wall plane. These windows were also installed circa 1985. The upper wall plane has two stationary, four-pane windows. A large rectangular garden plot with a wood picket fence is at the northern corner of the building.
