National Register of Historic Places
Registration Form

historic name King-Neimeyer-Mathis House

street & number 2145 Malvern Road

city or town Hot Springs

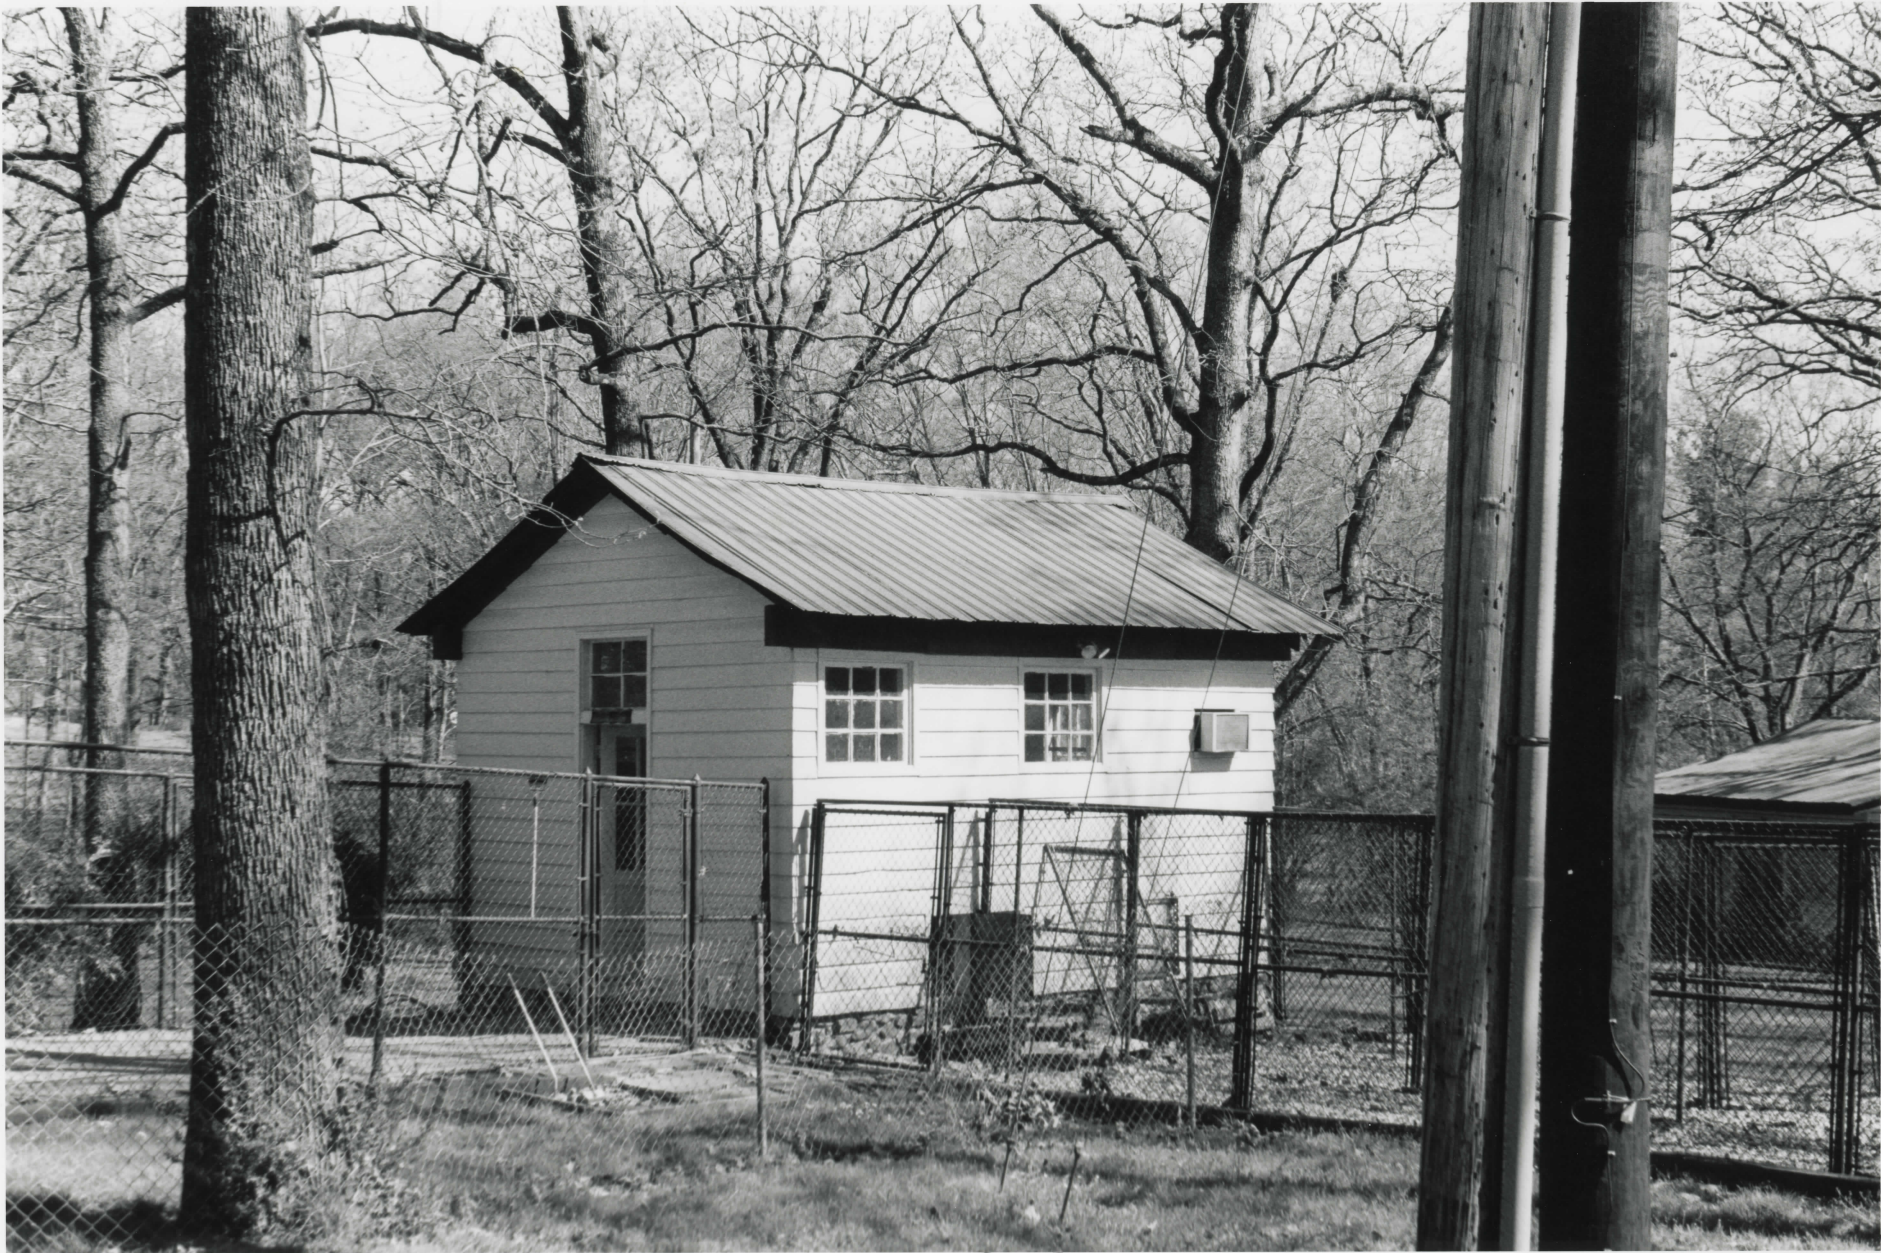
Pumphouse facing northeast

Pump House

Just to the northeast of the main house stands the pump house, which is also used today as a kennel. The building is a simple rectangular wood frame building on a fieldstone foundation. The building is crowned by a metal front gable roof. The entrance is on the southwest façade of the building and consists of a wood door with two horizontal panels in the bottom half and four windowpanes in the top half. It is surmounted by a four-pane transom window. On the southeast side of the building are two nine-pane windows, one in the center of the façade and one to the left. A window unit air-conditioner is to the right of the windows. The northeast and northwest façades each have a twelve-pane window in the center. Dog runs are present on the southeast side of the building, and also connecting the building to the main house to the southwest.

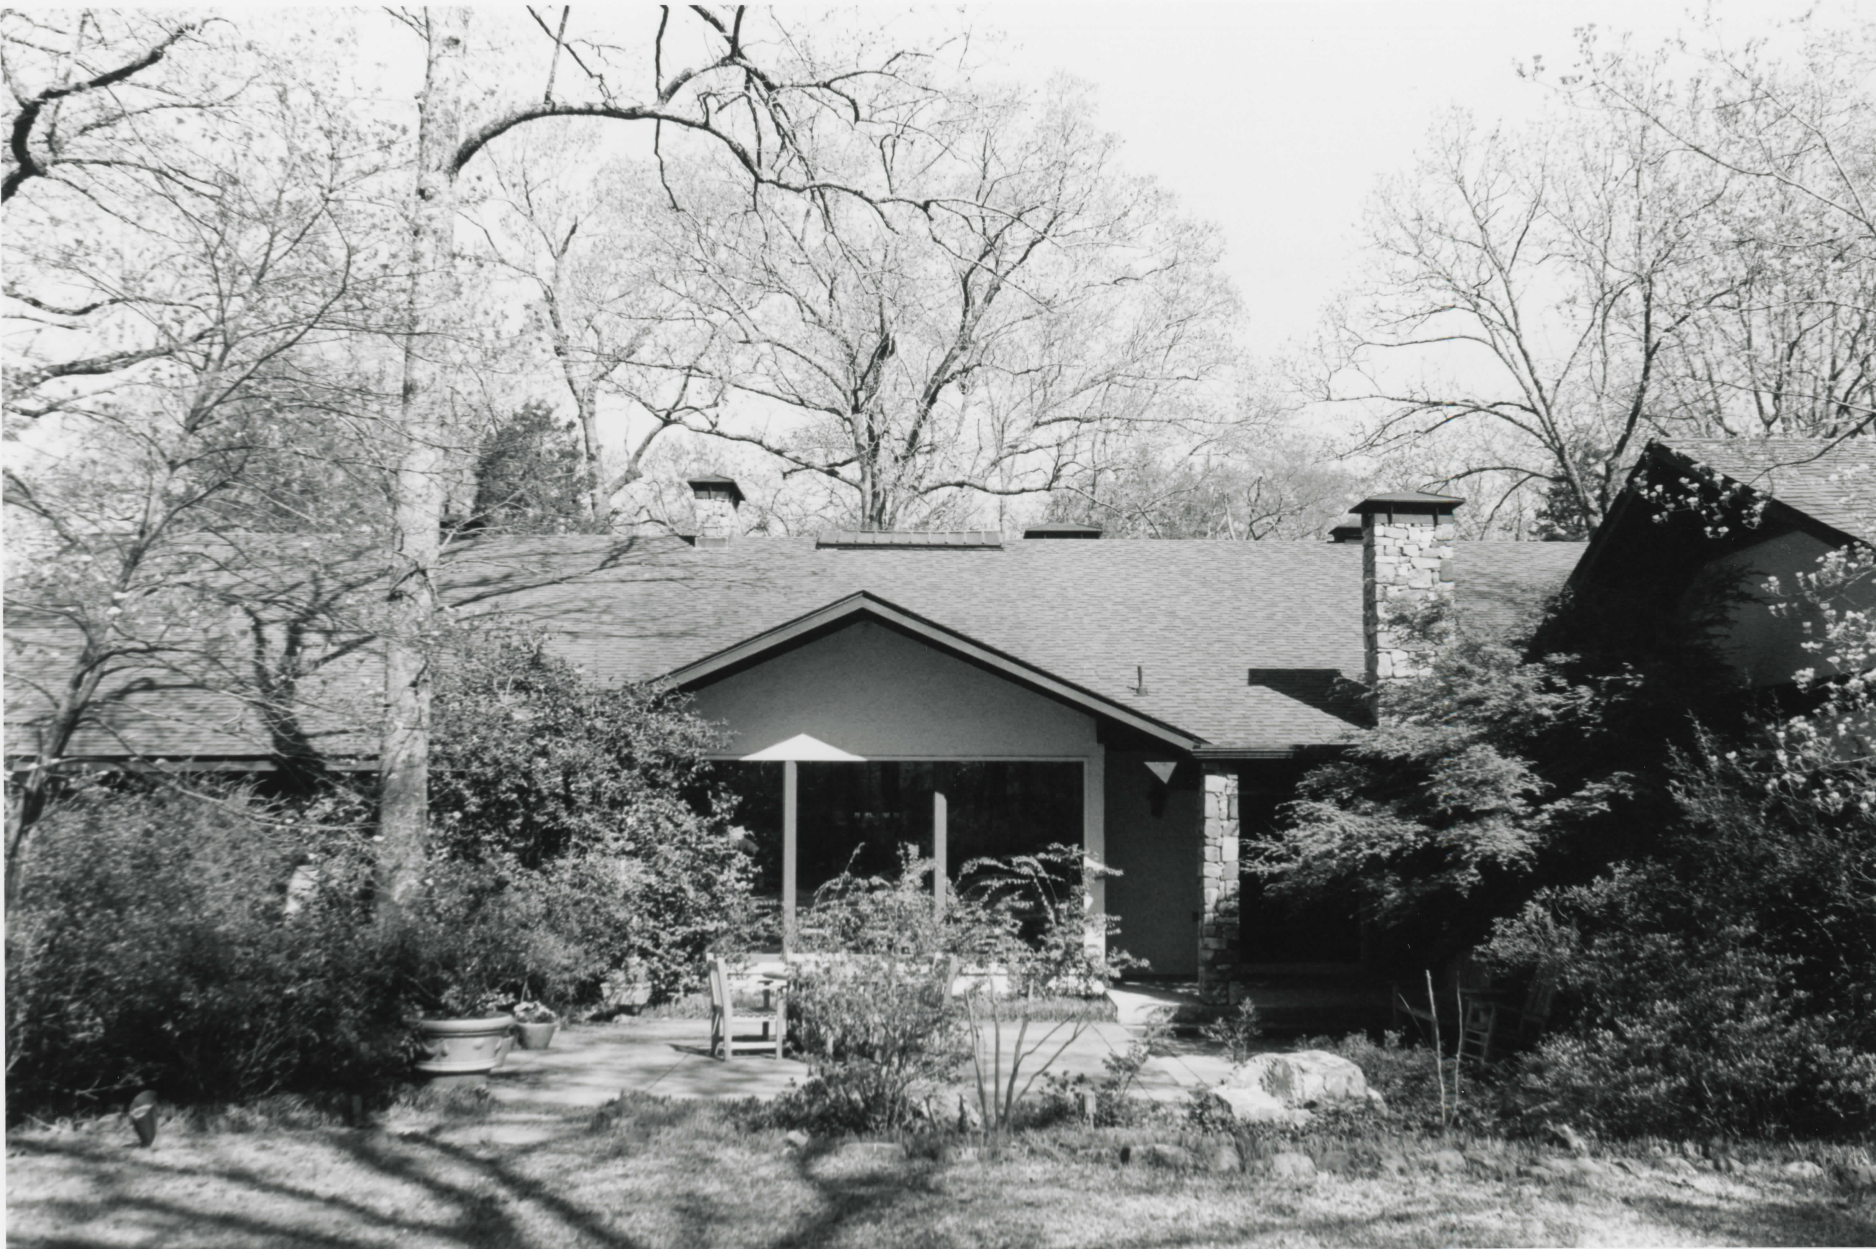
Southeast facade facing northwest

House: Southeast/Side Elevation

To the left of where the new addition connects to the original house, there is a small covered porch with a shed roof supported by a square fieldstone column. A set of French doors, each with 15 panes of glass, opens onto the side patio. To the left of the covered porch is a bay projection under a small gable roof. The northeast side of the bay has a set of French doors, each with 21 panes of glass. The southeast side of the bay has three large glass picture windows, while the southwest side of the bay has a twelve-over-one window. To the left of the bay projection is the enclosed portion of the wrap-around porch.

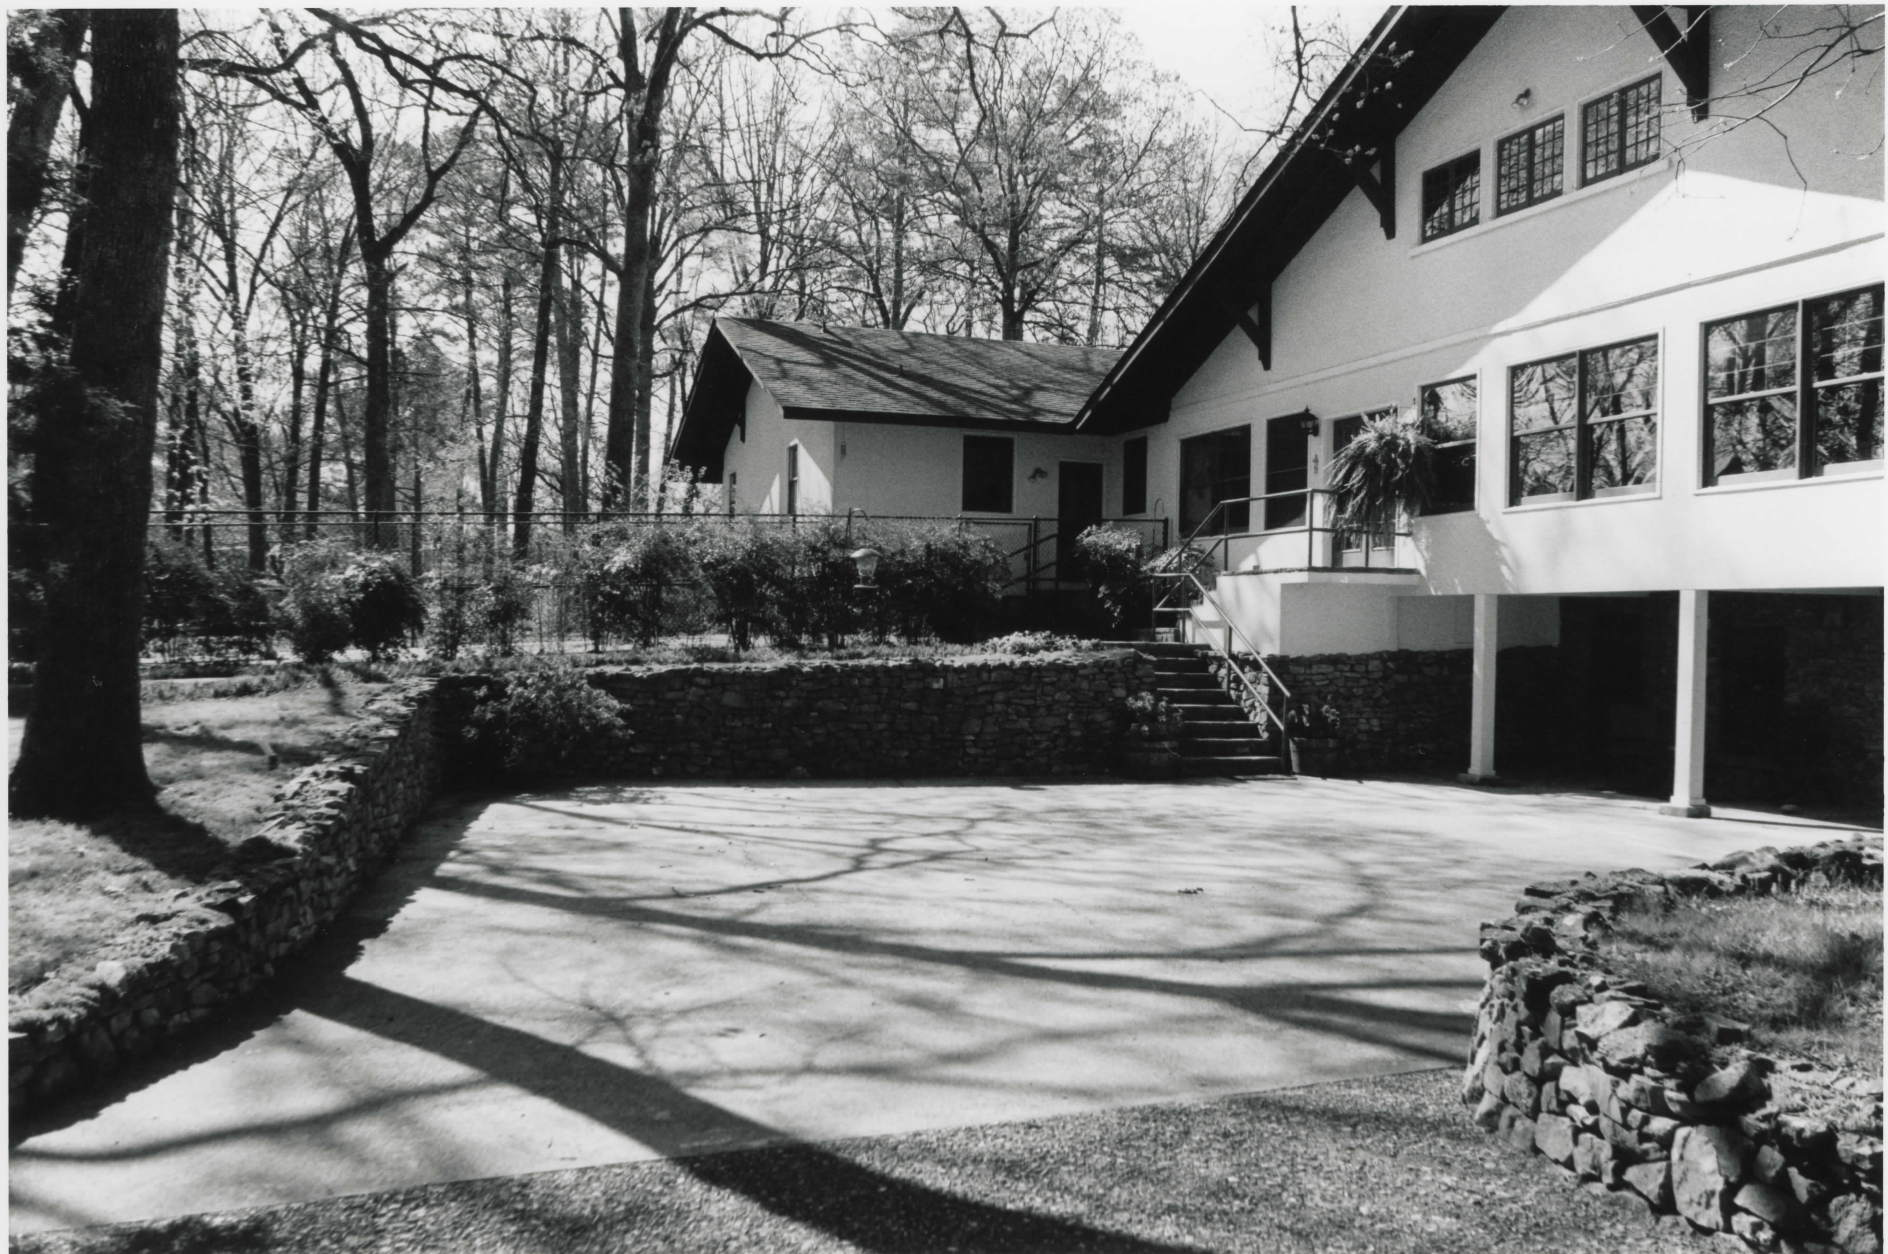
Stone retaining walls facing south

The last contributing landscape features are the stone retaining walls found at the rear of the house. The parking area at the garage is surrounded by retaining walls given the fact that the garage is in the basement level of the house. Like the other stonework found on the property, the retaining walls are constructed out of fieldstone.

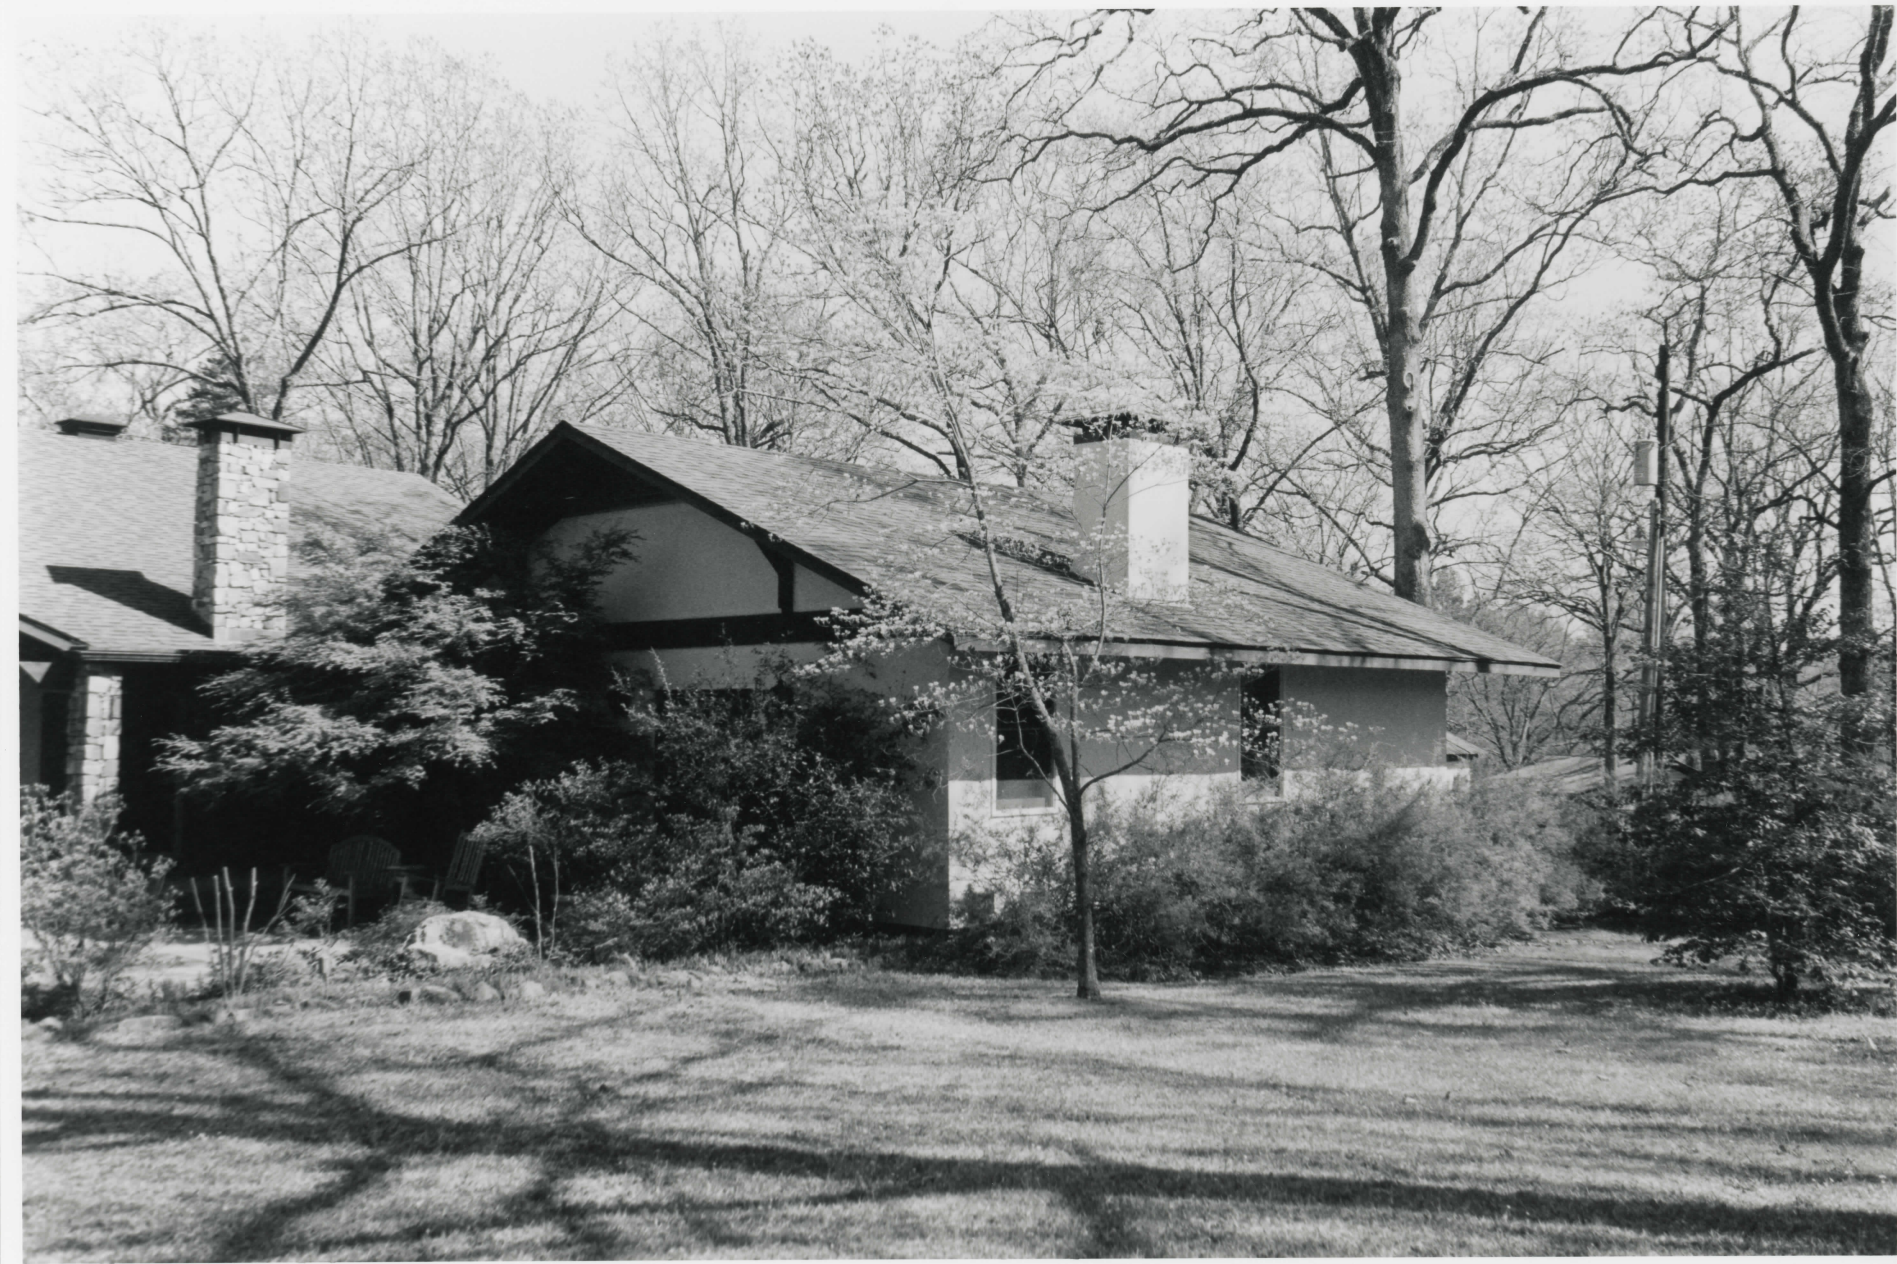
1982 addition facing northeast

House: Addition

At the northeast corner of the house is the location of the 1982 addition, which comprises approximately 1,000 square feet. On the northwest side of the addition is an eight-over-one window. On the northeast façade of the addition are two eight-over-one windows located towards each end of the façade. In addition, two knee brackets, one on each slope of the gable, are found under the eaves. On the southeast façade of the addition are two eight-over-one windows, one towards the center of the wall, and one towards the southwestern end. On the southwest façade, towards the east end, is a set of French doors. Each door has fifteen panes of glass. To the left of the French doors is an eight-over-one window. In the gable peak is a vent, and two knee brackets support the eaves. In addition, a dark wood beam runs across the bottom of the gable, mimicking the dark beam on the front façade of the main house.

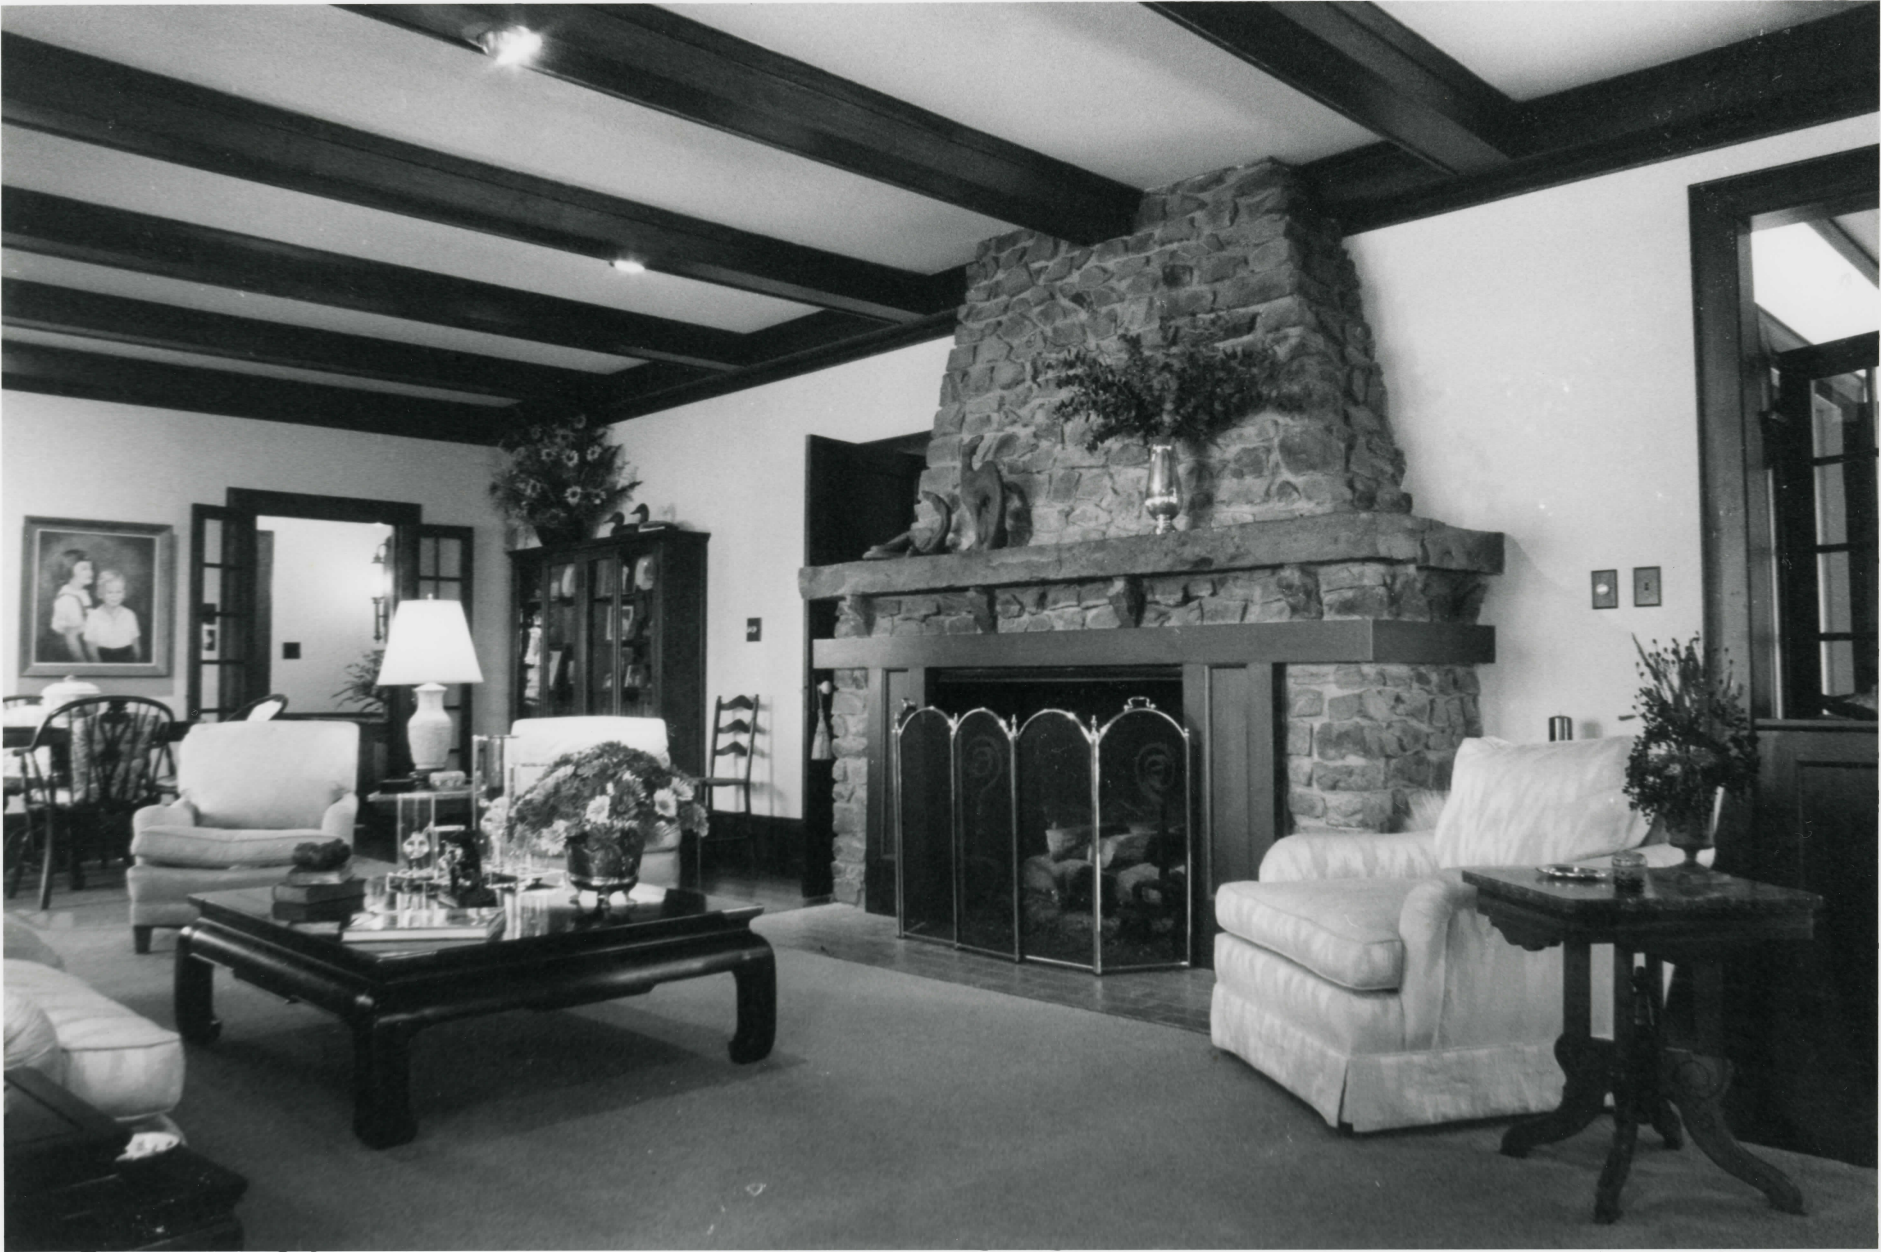
Living room facing north

The interior of the house still retains many of its original features. The house retains its original pine floors in many of the rooms and the living and dining rooms have original box beam ceilings. The living room also has a large fieldstone fireplace. The dining room has a large built-in buffet and cabinet with beveled glass doors that match the other woodwork and beveled glass in the house. Most of the rooms retain their original doors, and almost all of the original hardware remains. The main hall in the center of the house also features skylights that allow light from the rooftop skylight to filter into the central spaces of the house.

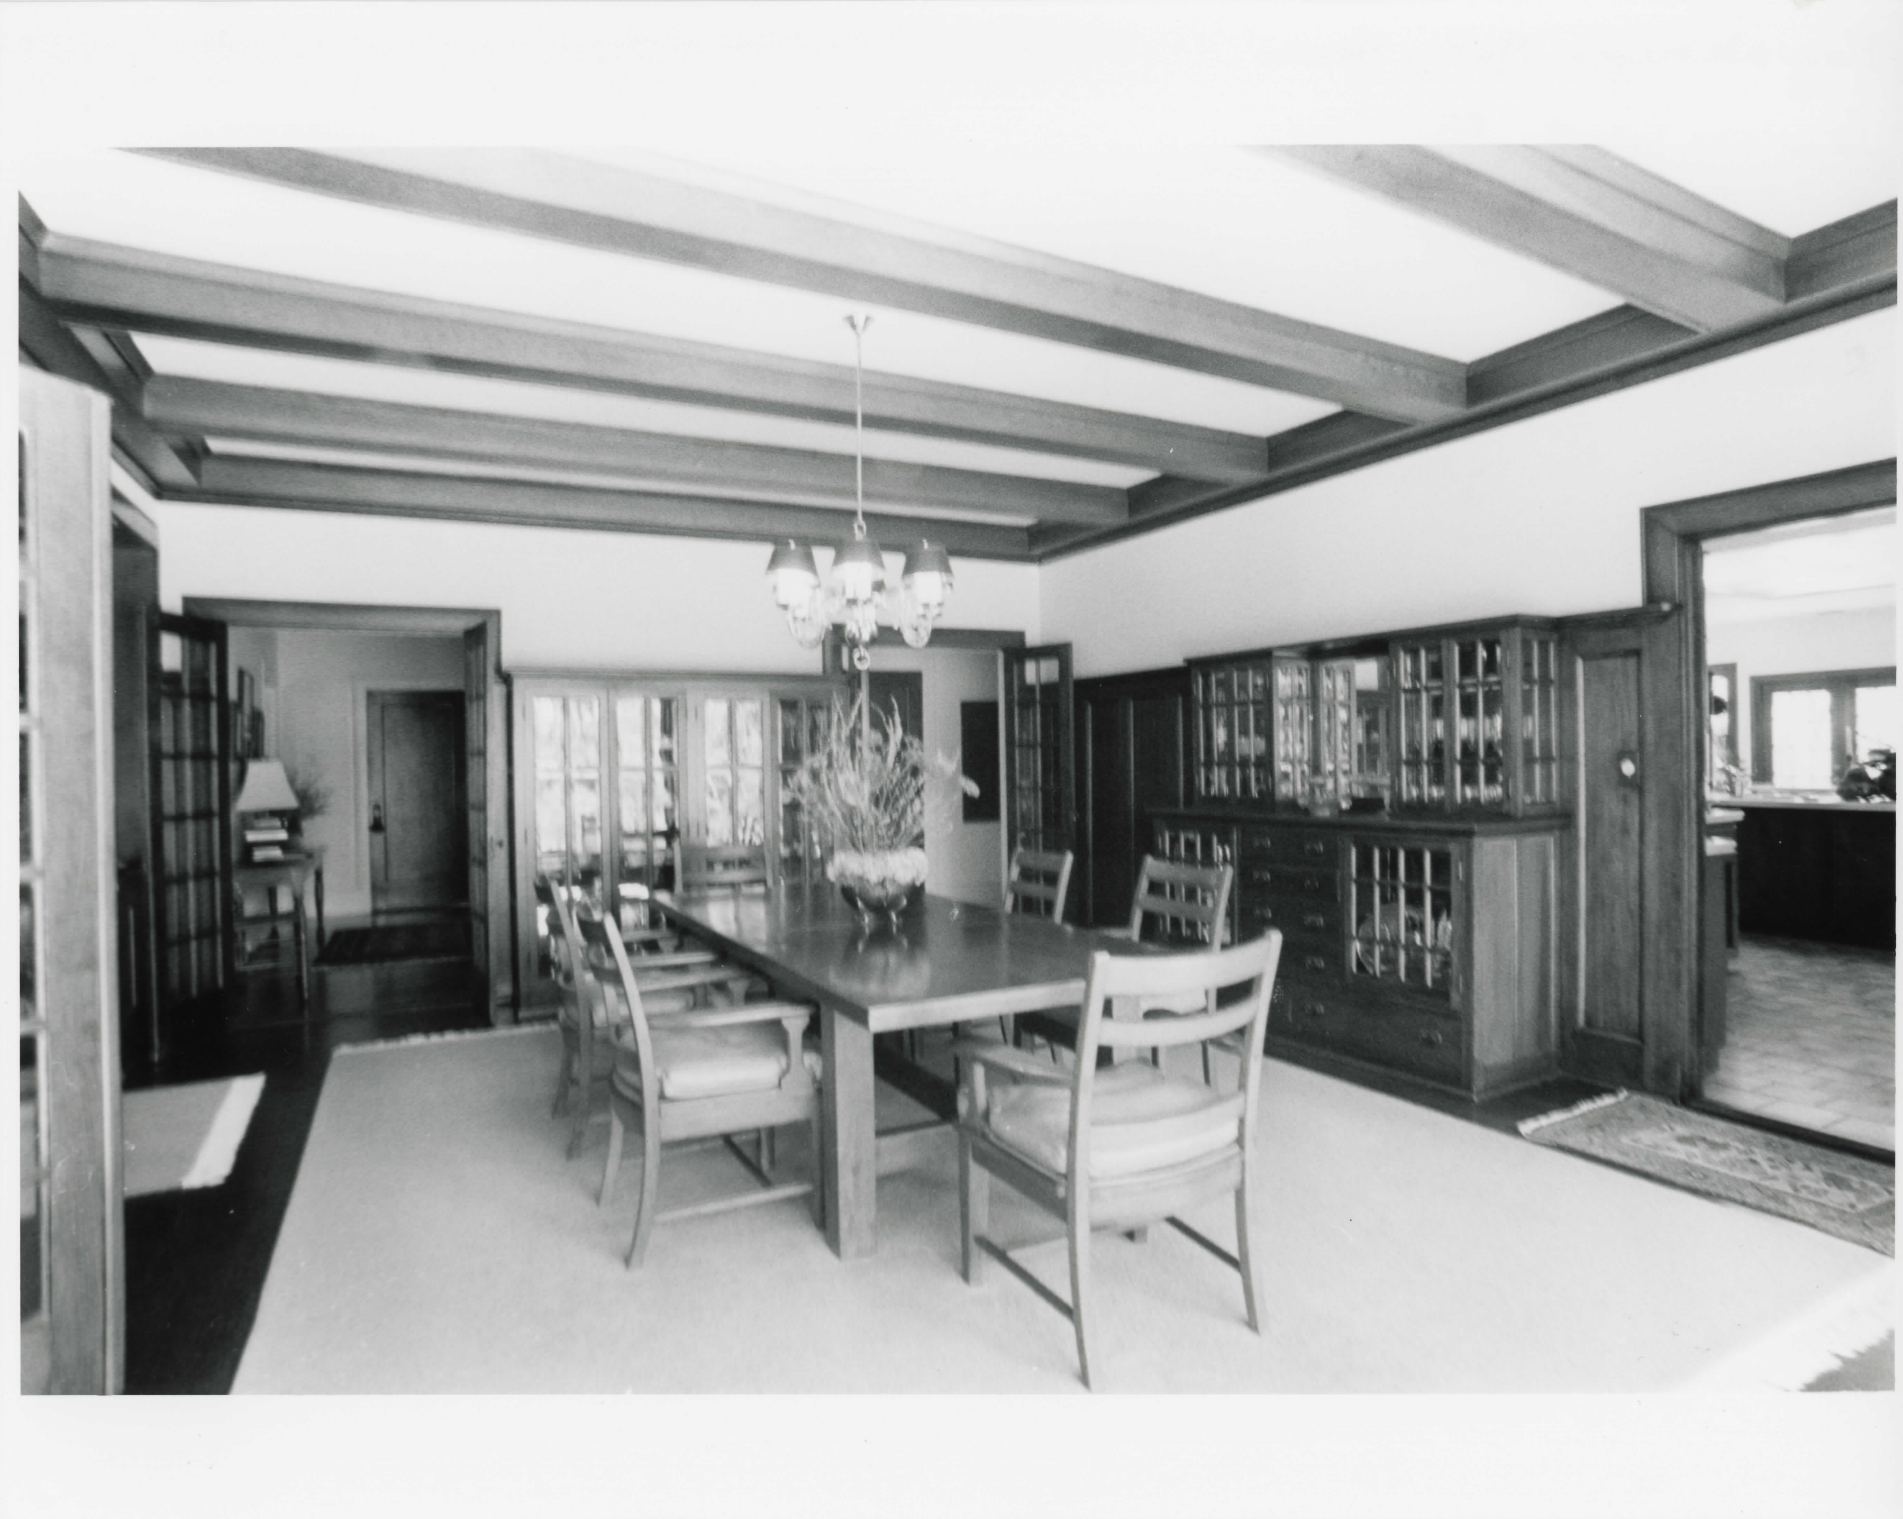
Dining room facing north
