Situated on a prominent corner site, the Shaw House is a two-story, red brick residence constructed about 1909 by Tillman Shaw. The house has undergone few alterations since its construction, and its original design--which combines elements of several early-20th century architectural styles--remains largely intact.

National Register of Historic Places
Continuation Sheet

Shaw, Tillman, House
Sebastian County
ARKANSAS

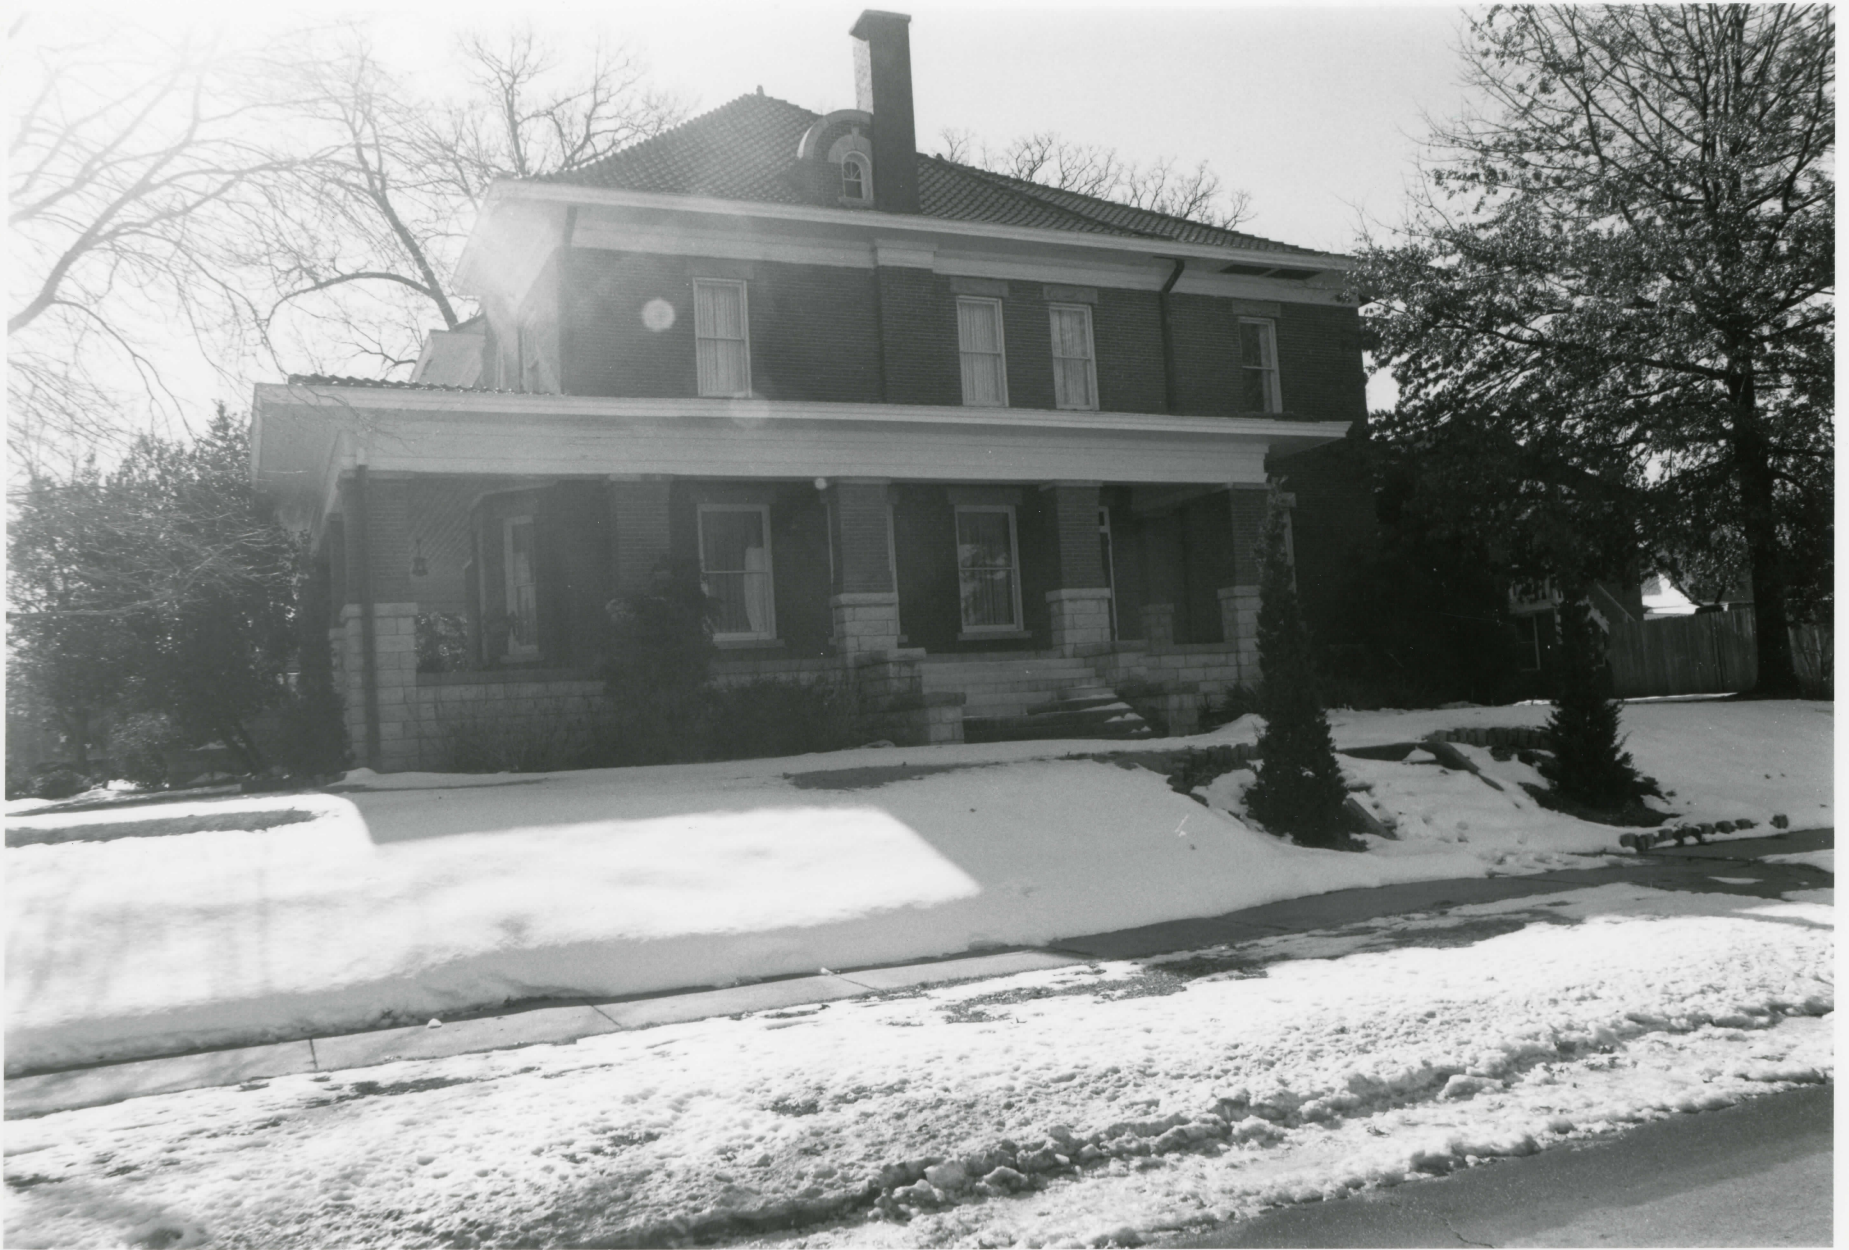
NORTH ELEVATION

Another flight of broad concrete steps leads to the porch on the north facade, the second street facade. On this side of the house, the porch shelters three one-over-one, double-hung windows and another glazed oak door, all opening into what now is one long living room. Originally, however, a chimney--now seen only at the second-floor level and above--rose from the basement, through the porch floor, and up the side of the house at the first-floor level. The chimney marked the location of an interior wall that was removed--along with a corner fireplace and the first-floor section of chimney--around 1925. The removal of this interior wall created the existing large living room where originally there had been two smaller rooms (probably double parlors or a parlor and library).

These alterations were accomplished in a manner that left remarkably few telltale signs of change. On the exterior, a new window (the middle one of the three existing windows) evidently was inserted near where the chimney had been. Brick removed to make way for the window may have been used to patch the wall area where the chimney was dismantled. There is no discernible difference in the brickwork at this point, and the newer window is identical to the originals. Only a patch in the porch floor and seams in the pressed tin ceiling indicate where the chimney once stood.

Above the porch, the second story of the north facade is defined by three one-over-one, double-hung windows and the chimney, which rises through the roofline. An arched dormer, containing a limestone-trimmed, arched window, adjoins the chimney at the roofline.

At the west end of the north elevation, the section of the house not encompassed by the porch contains a single one-over-one, double-hung window on each of the two floors. It is the presence of this rear section that makes the floorplan of the house rectangular rather than square.

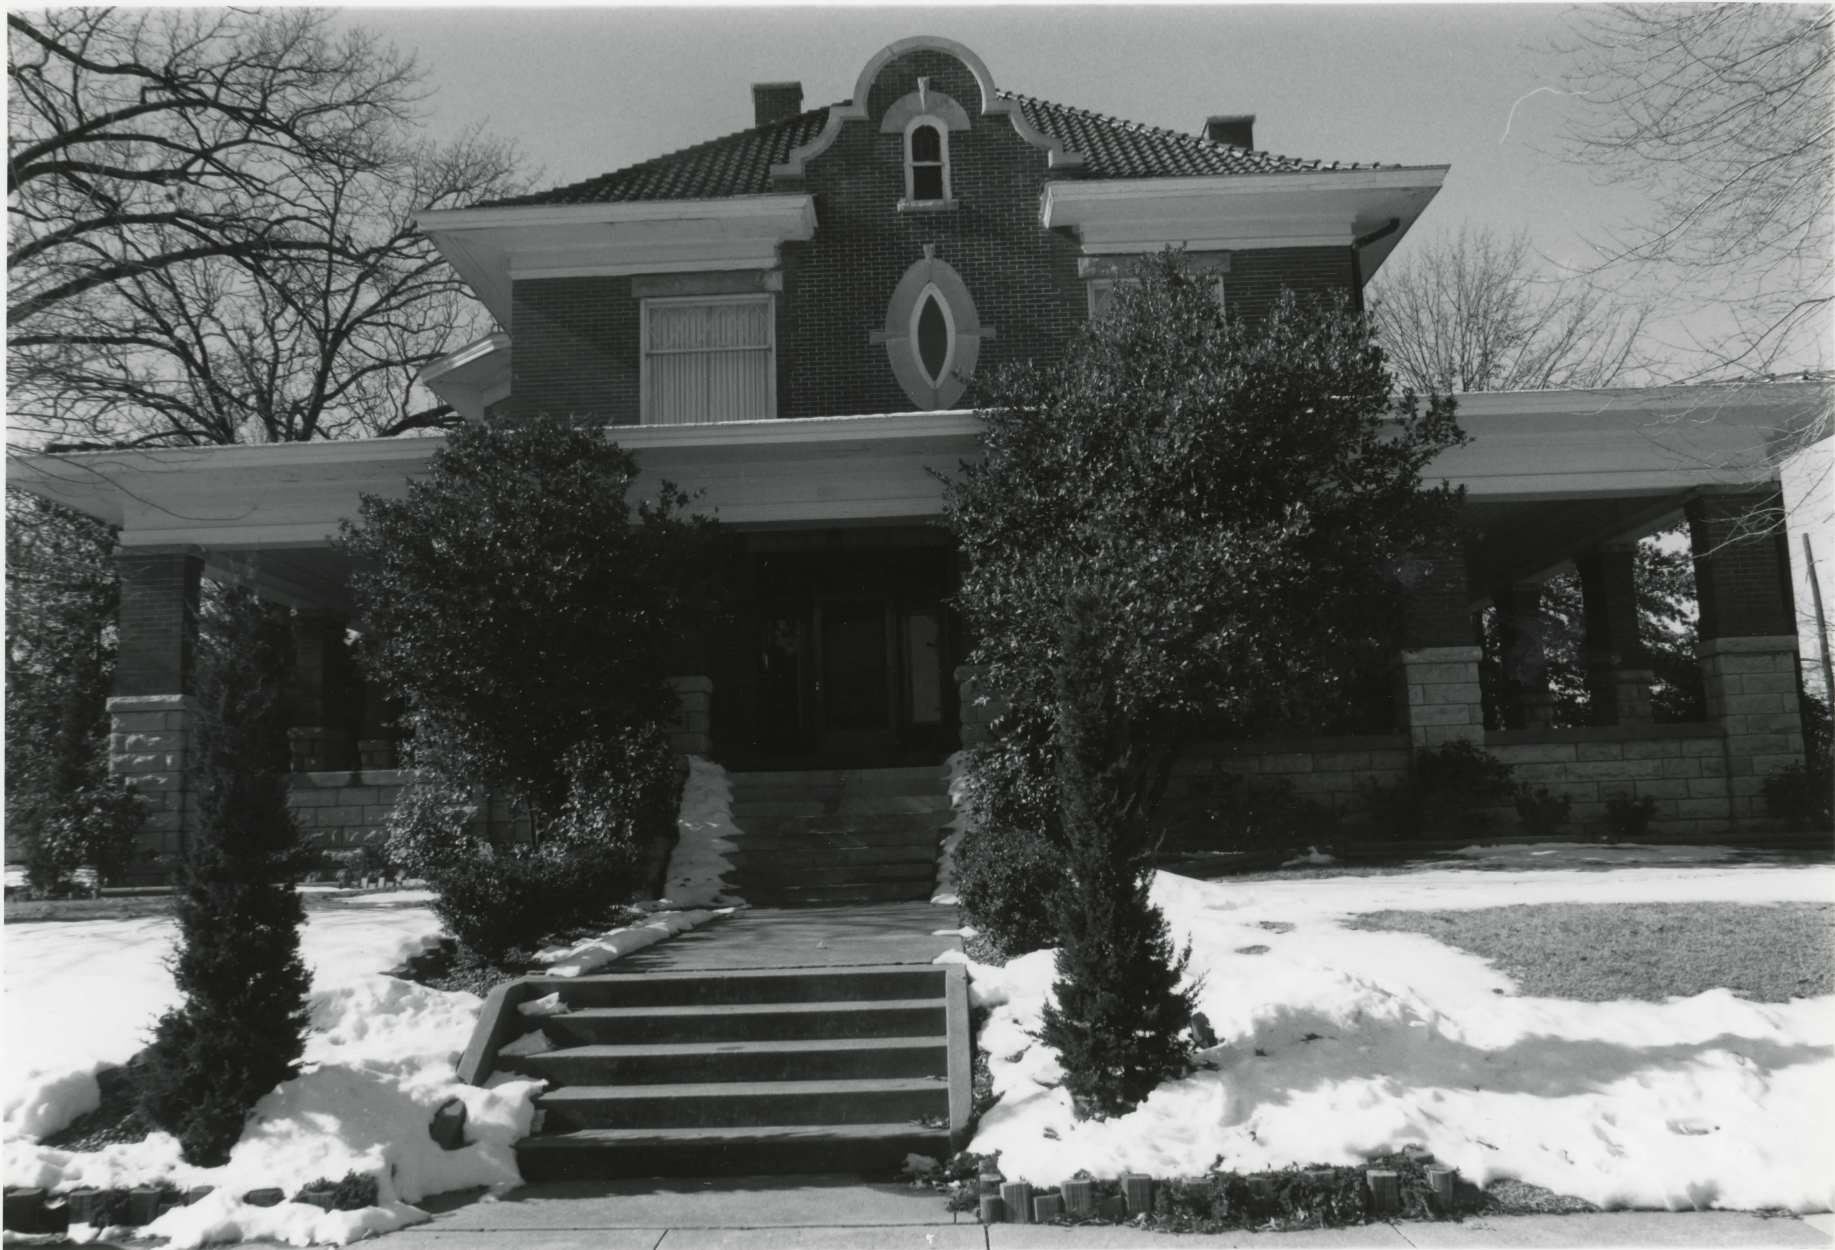
FACADE (EAST ELEVATION)

The main (east) facade is distinguished by a Mission-style shaped parapet that rises through the cornice in the center of the facade. The parapet has limestone coping and contains an arched, leaded-glass window, also trimmed with limestone.

Directly below the parapet, at the second-floor level, is an oval, leaded-glass window with limestone trim. Tall, wide windows with diamond-paned transoms are located on either side of the oval window.

Broad concrete steps lead up to the porch at the main entrance, located just south of the center of the main facade. The entrance consists of a glazed oak door and sidelights, all containing beveled glass, topped by a leaded and beveled glass transom. In the Colonial Revival vein, narrow Corinthian columns frame the door, which still is protected by what appears to be the original oak screen door.

Just south of the main entrance is a small double-hung stairway window with leaded glass in its upper sash. A bay window projects from the facade just north of the main entrance.

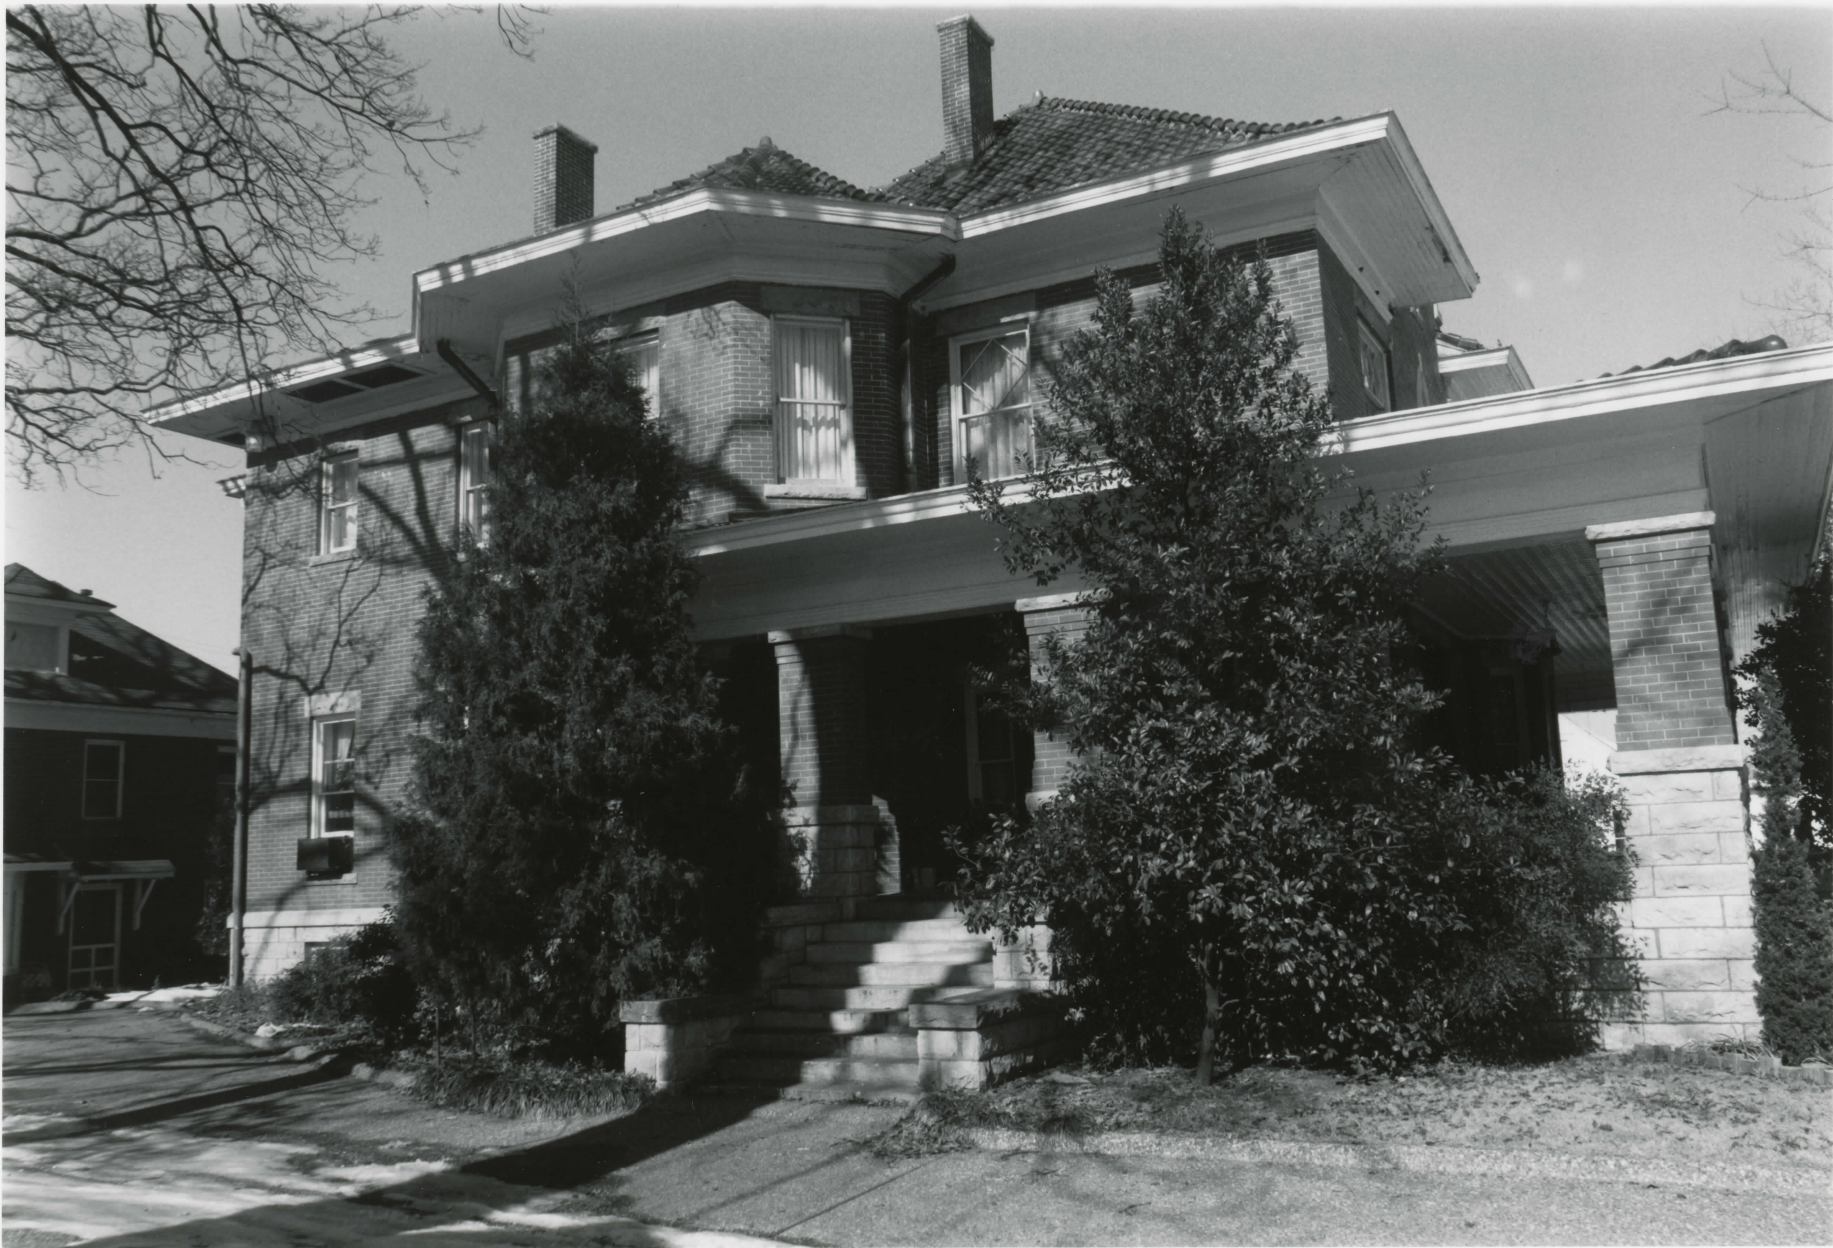
SOUTH ELEVATION

At the center of the south facade is the two-story, projecting bay with hipped roof that marks the beginning of the wraparound porch. Each level of the bay contains three windows, five of which are of the one-over-one, double-hung variety. The sixth window, located in the center on the first floor of the bay, contains leaded glass. It is a wide, short window set high in the wall that comprises the south end of the dining room.

Also on the south facade, a third flight of steps leads to the porch, though there is no corresponding door into the house at this location. Rather, the porch shelters two windows, one opening onto the main staircase and the other under the staircase, and both containing leaded glass. Above the porch roof is a double-hung window with a diamond-shaped pattern created by wooden muntins in its upper sash. At the west end of the south facade, on the other side of the projecting bay from the porch, the rear section of the house contains two one-over-one, double-hung windows on each floor.

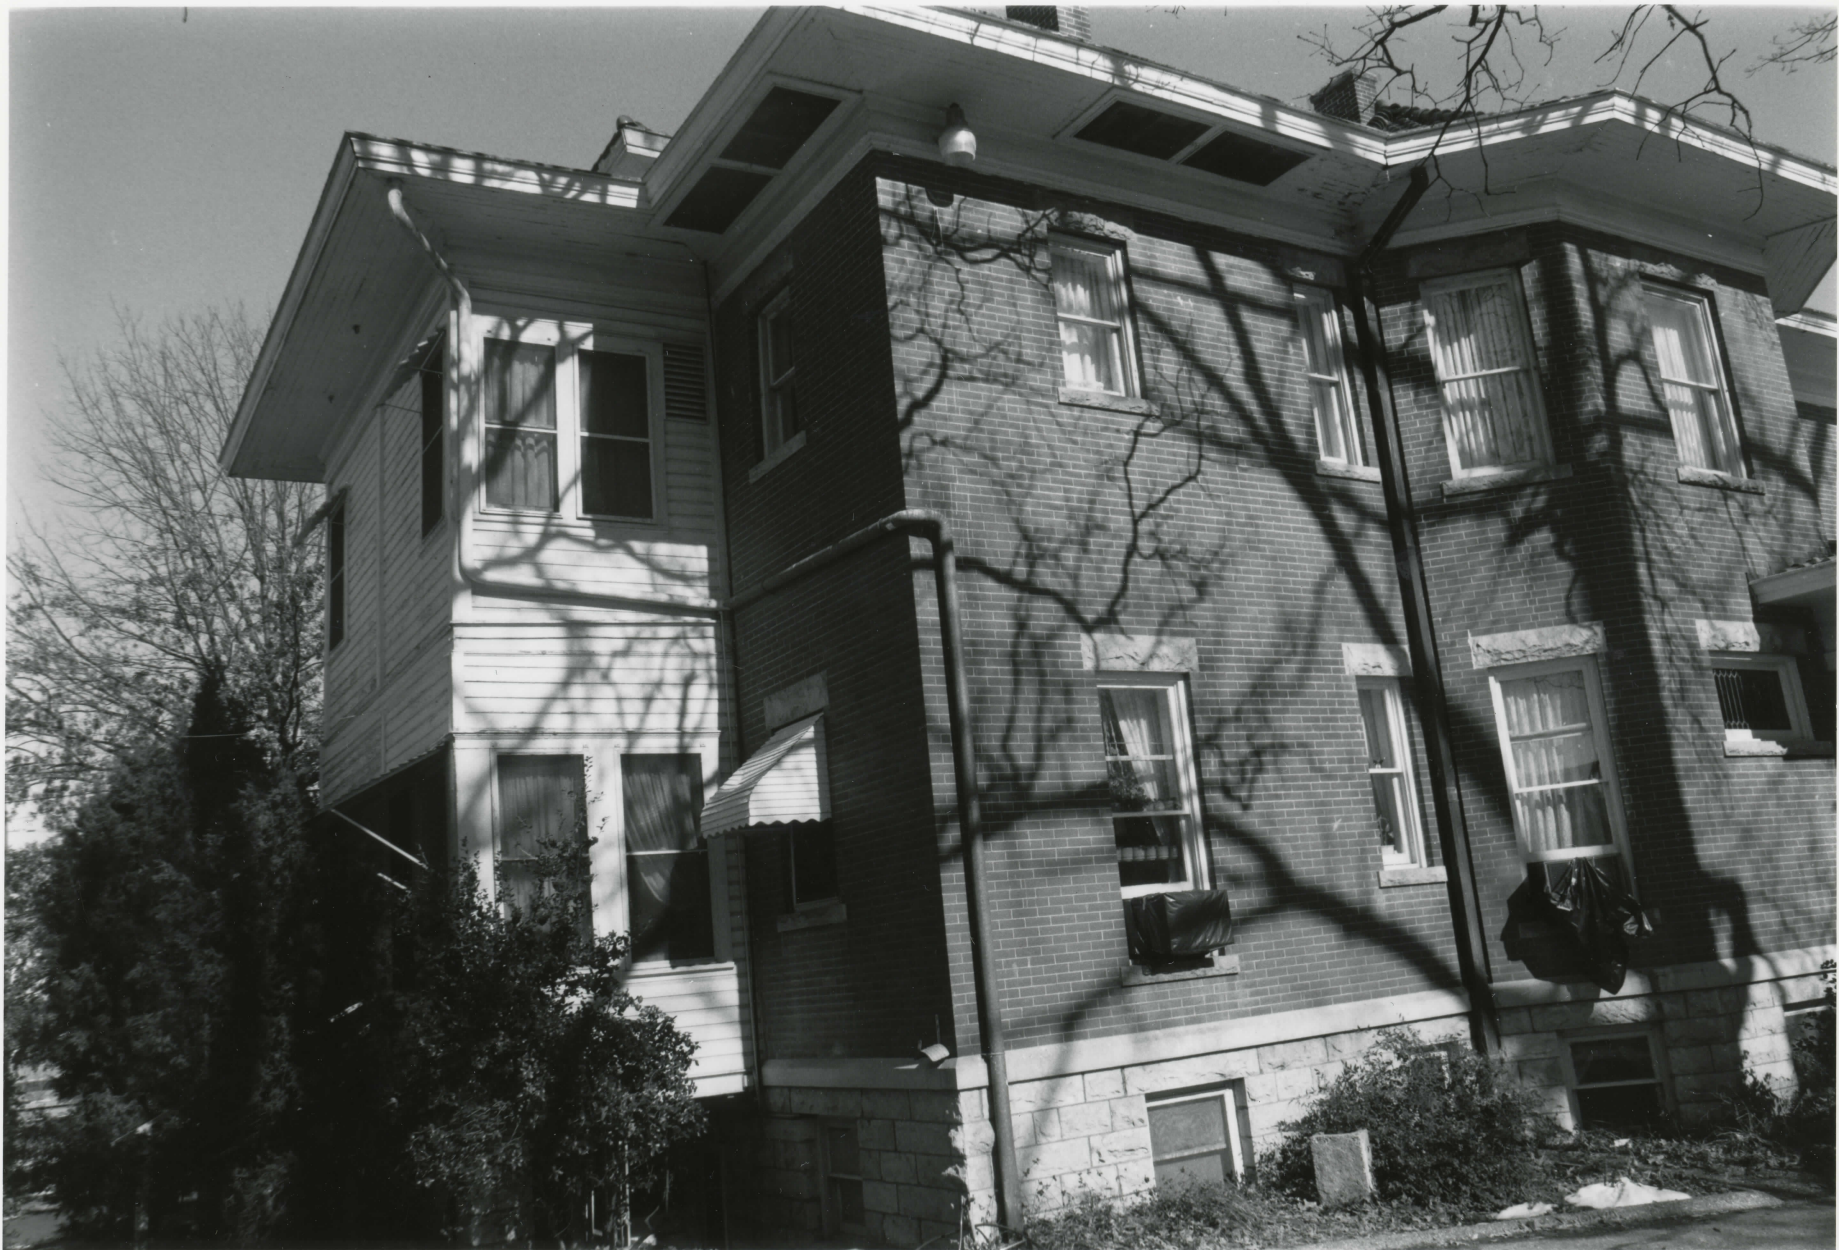
TILLMAN SHAW HOUSE
FT. SMITH, SEBASTIAN CO.
PHOTOGRAPHED BY T. JONES
JANUARY 1988
NEGATIVES ON FILE AT AHPP
VIEWED FROM THE SOUTHWEST

On the rear (west) facade of the Shaw House, what originally was a two-story screened porch has been enclosed with clapboard siding. A hipped dormer projects through the main roof above the porch, as does the kitchen chimney.

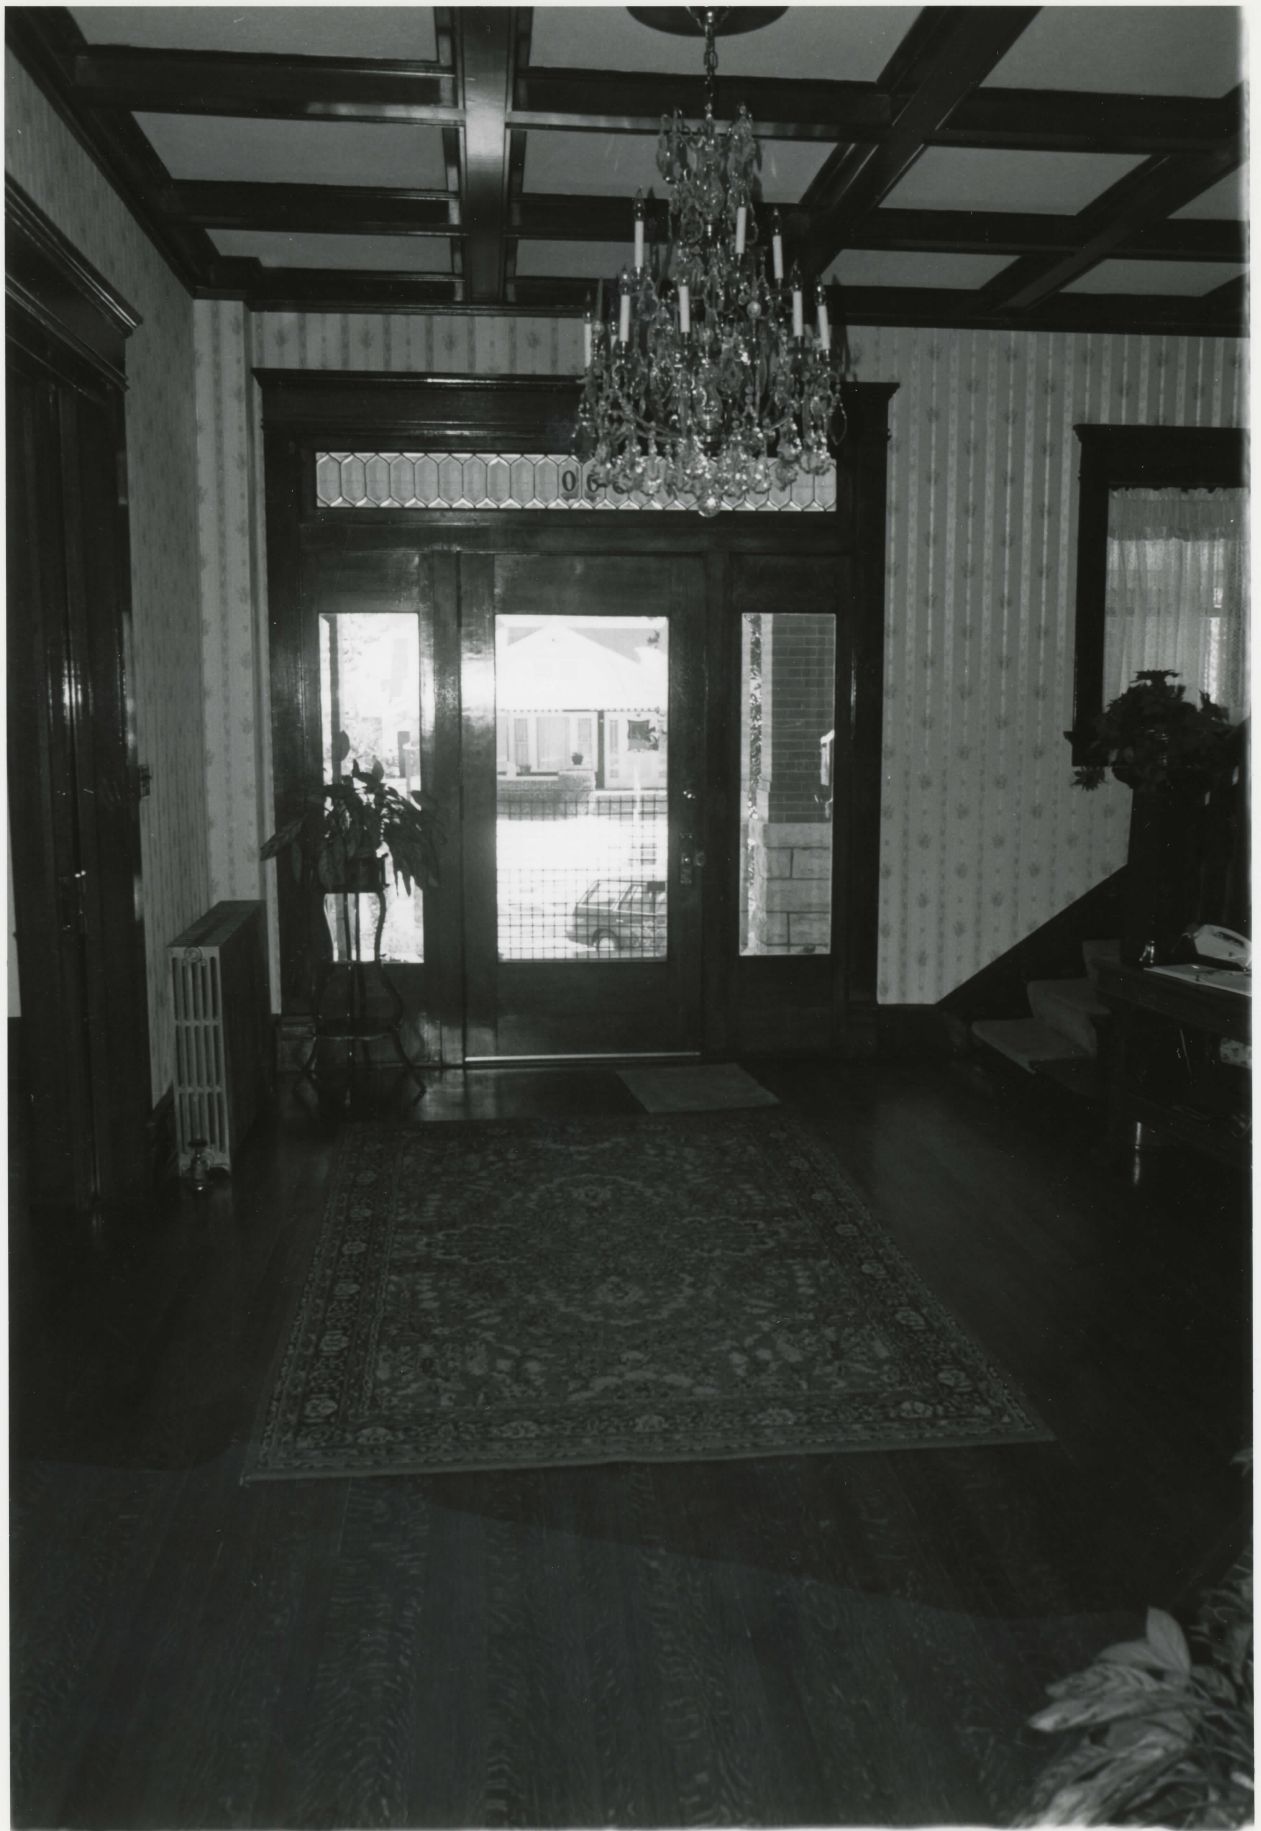
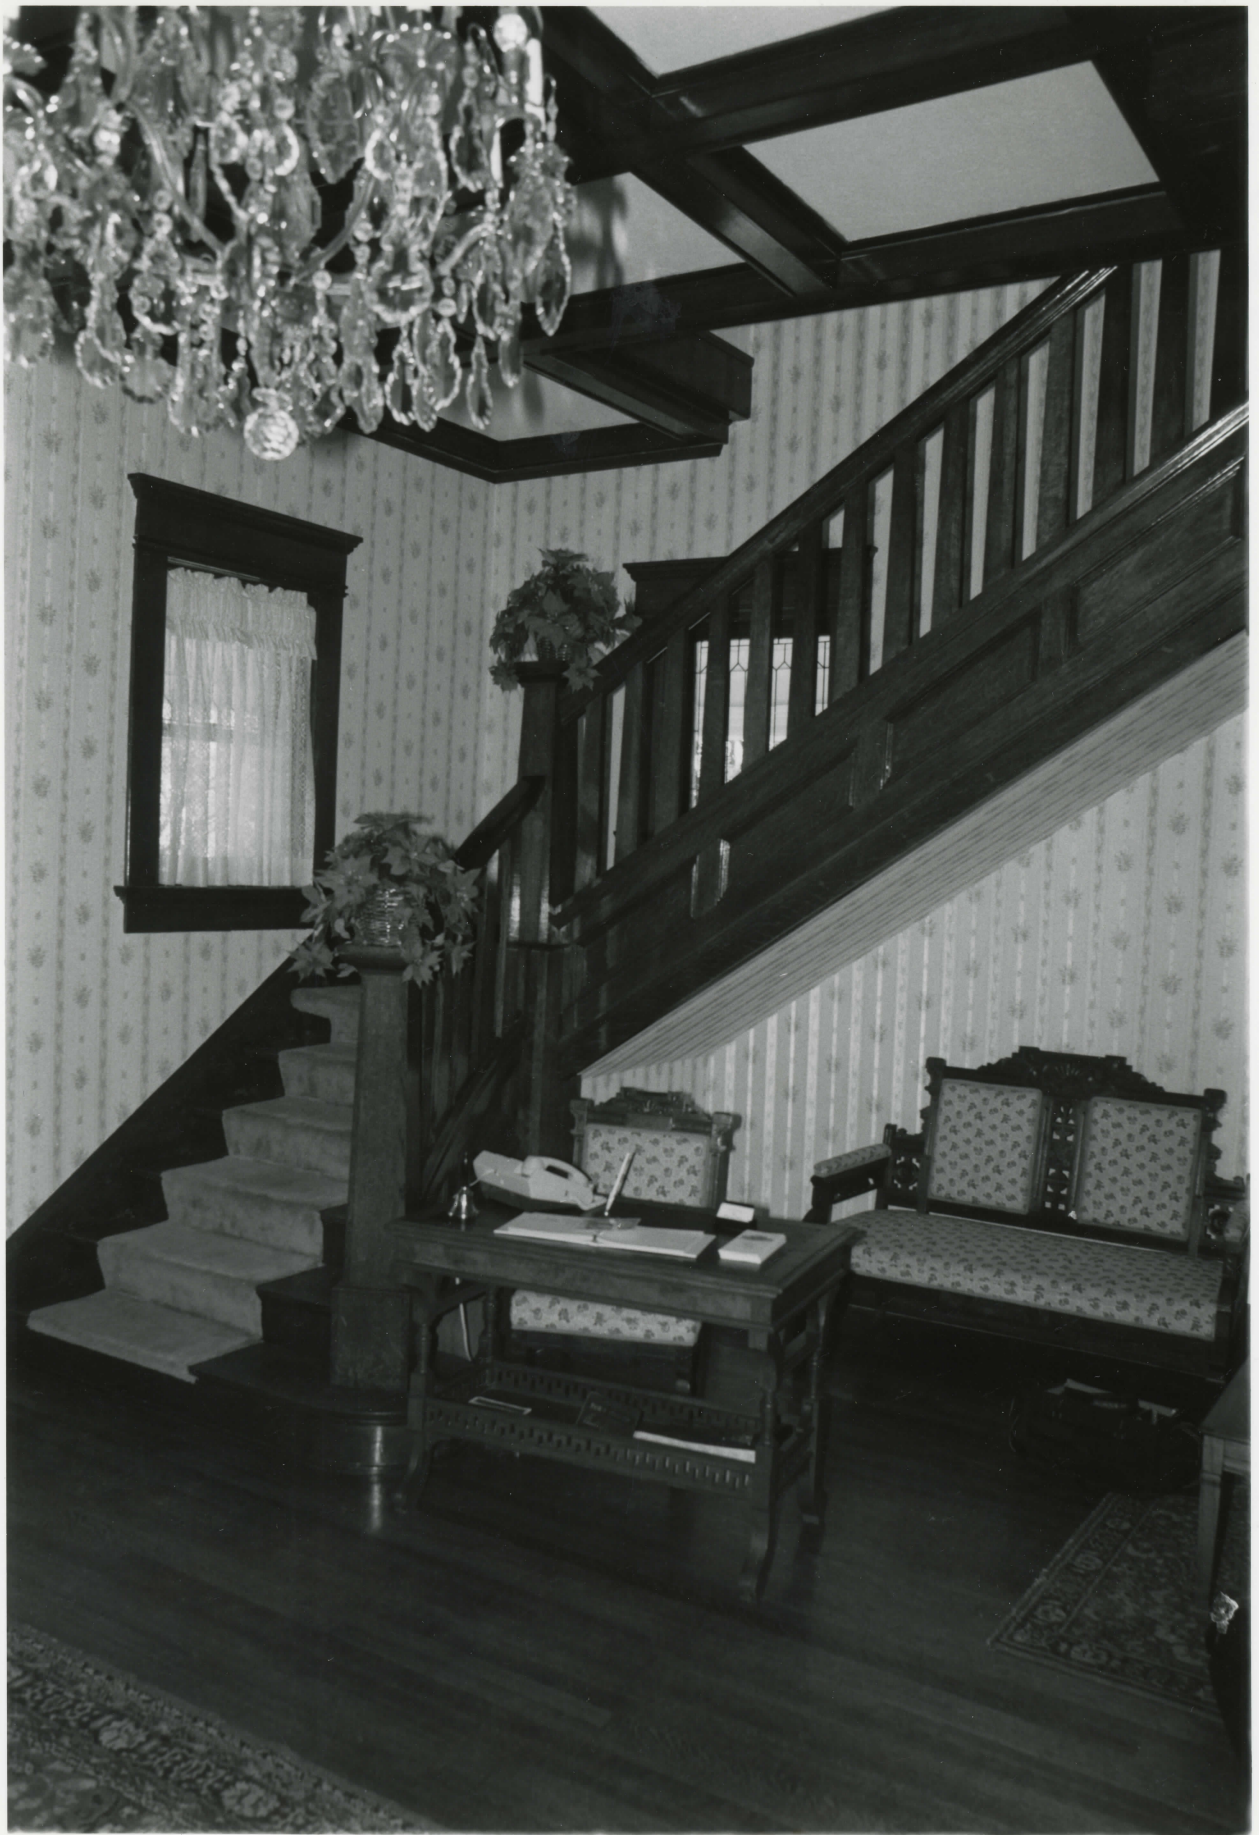
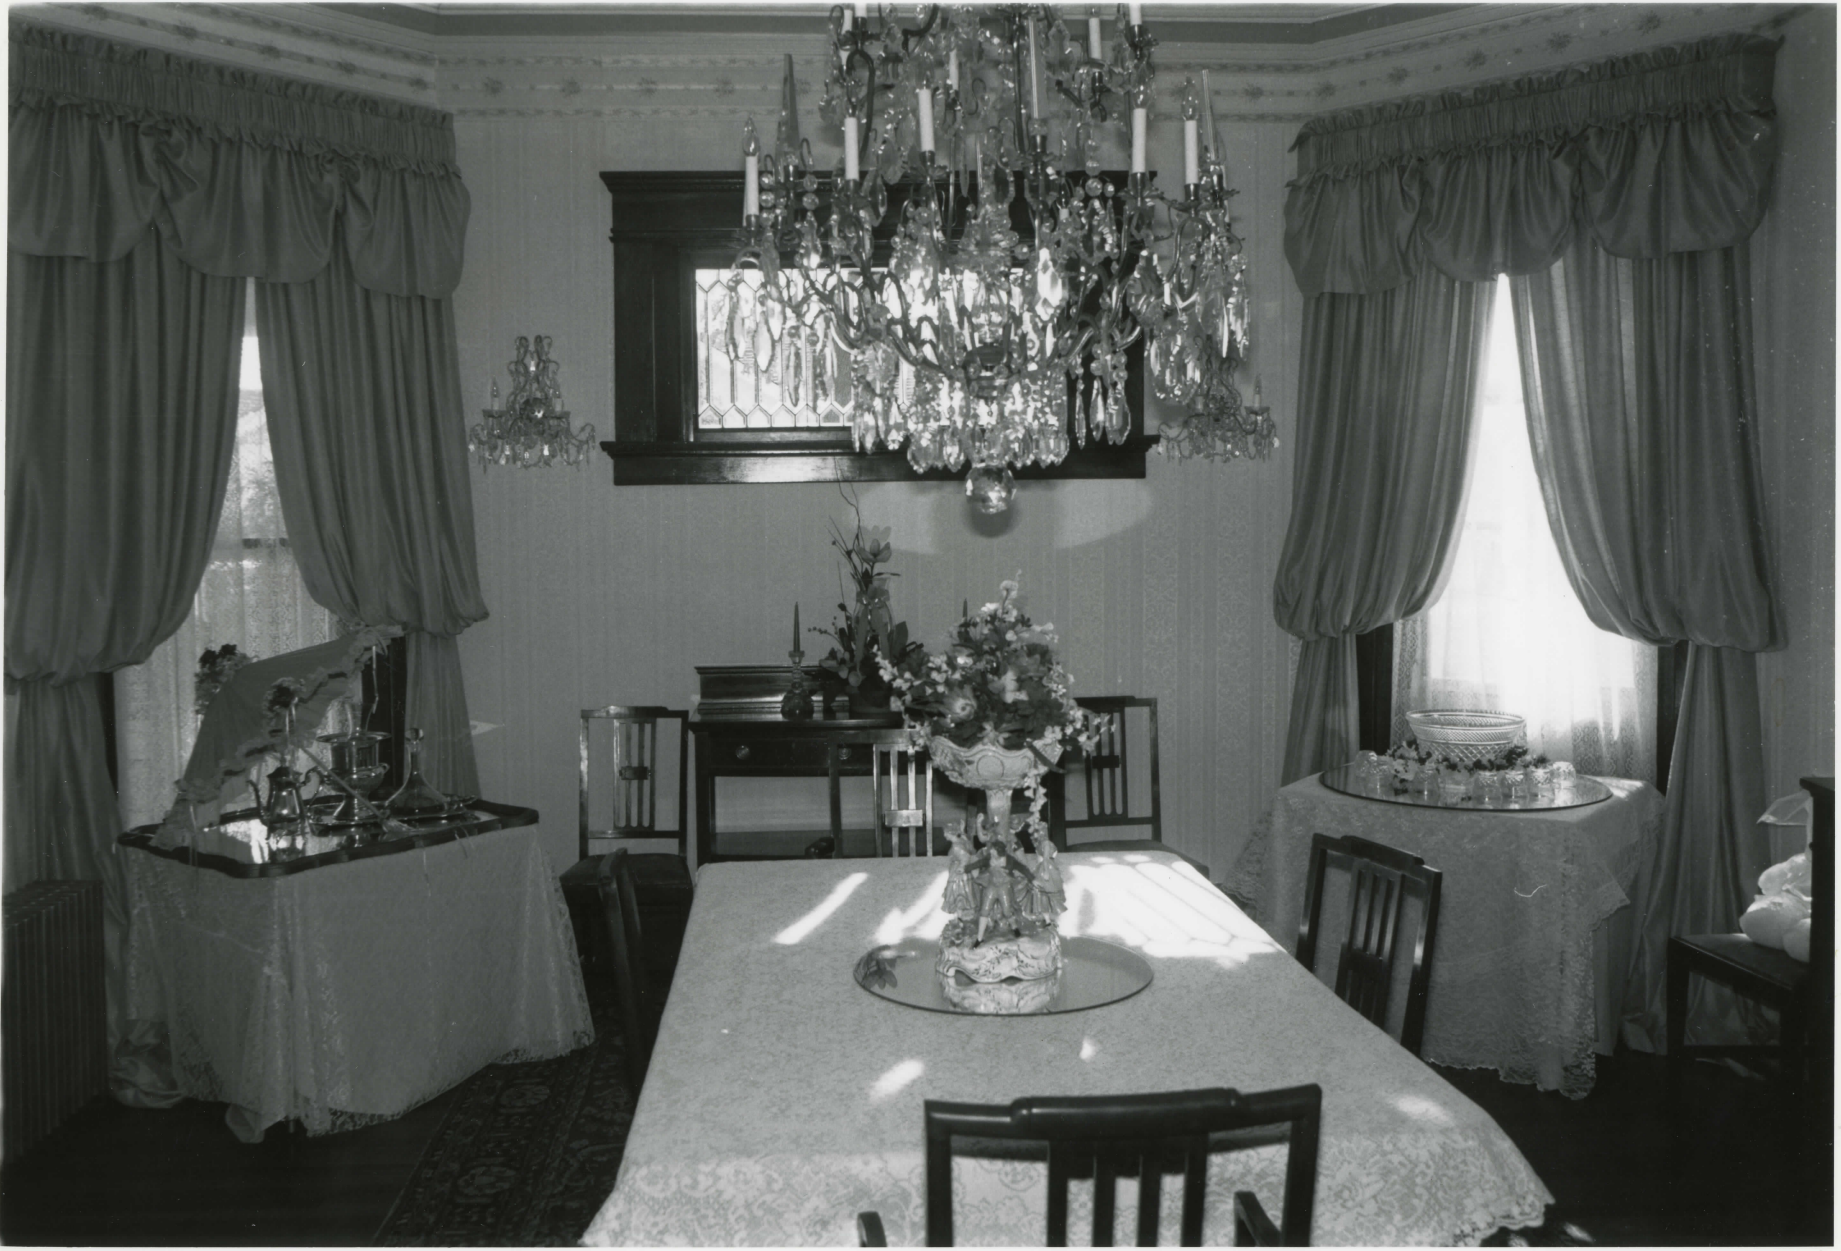
INTERIOR DETAIL

The interior of the Shaw House is distinguished by the oak woodwork found through the main rooms--entry hall, living room, and dining room--on the first floor. Door and window casings are Colonial Revival in character, with a band of egg-and-dart molding forming part of the cornice across the top of each door and window opening. The balustrade of the main staircase, however, shows the Craftsman influence, as do the mantels in the entry hall and dining room. (It is theorized that the dining room fireplace is not original but was created using the corner mantel removed c. 1925 from the original front parlor fireplace).

Oak ceiling beams, used in the entry hall and living room, evidently were added during the c. 1925 remodeling that created the present living room, but they are in harmony with the original oak woodwork.

Five-panel, oak pocket doors open from the entry hall into the living room and into the dining room. The original Craftsman-style brass door hardware is intact throughout the house.
