National Register of Historic Places Continuation Sheet

The Wilburn House is a single story, wood frame Greek Revival residence decorated with ornate Italianate cornice brackets. In its present configuration it displays an irregular plan, composed of a gable roof principal component with a rear or southern gable roof ell projecting from its eastern end and a gable roof wing which is set back from the northern or front elevation and which projects to the west. A gable roof ell addition projects to the south from the rear of the western wing, forming another partial ell on the back of the main house, and thus creates a corner on the back of the house in which has been built another adjoining gable roof addition. Two exterior end brick chimneys survive on the gable ends of the main house and another exterior end brick chimney finishes the end of the western gable wing. The entire roof is covered in composition shingle, the exterior is sheathed in weatherboard, and the continuous foundation is constructed of brick.

PROPERTY NAME: Wilburn House

MULTIPLE NAME: White County MPS

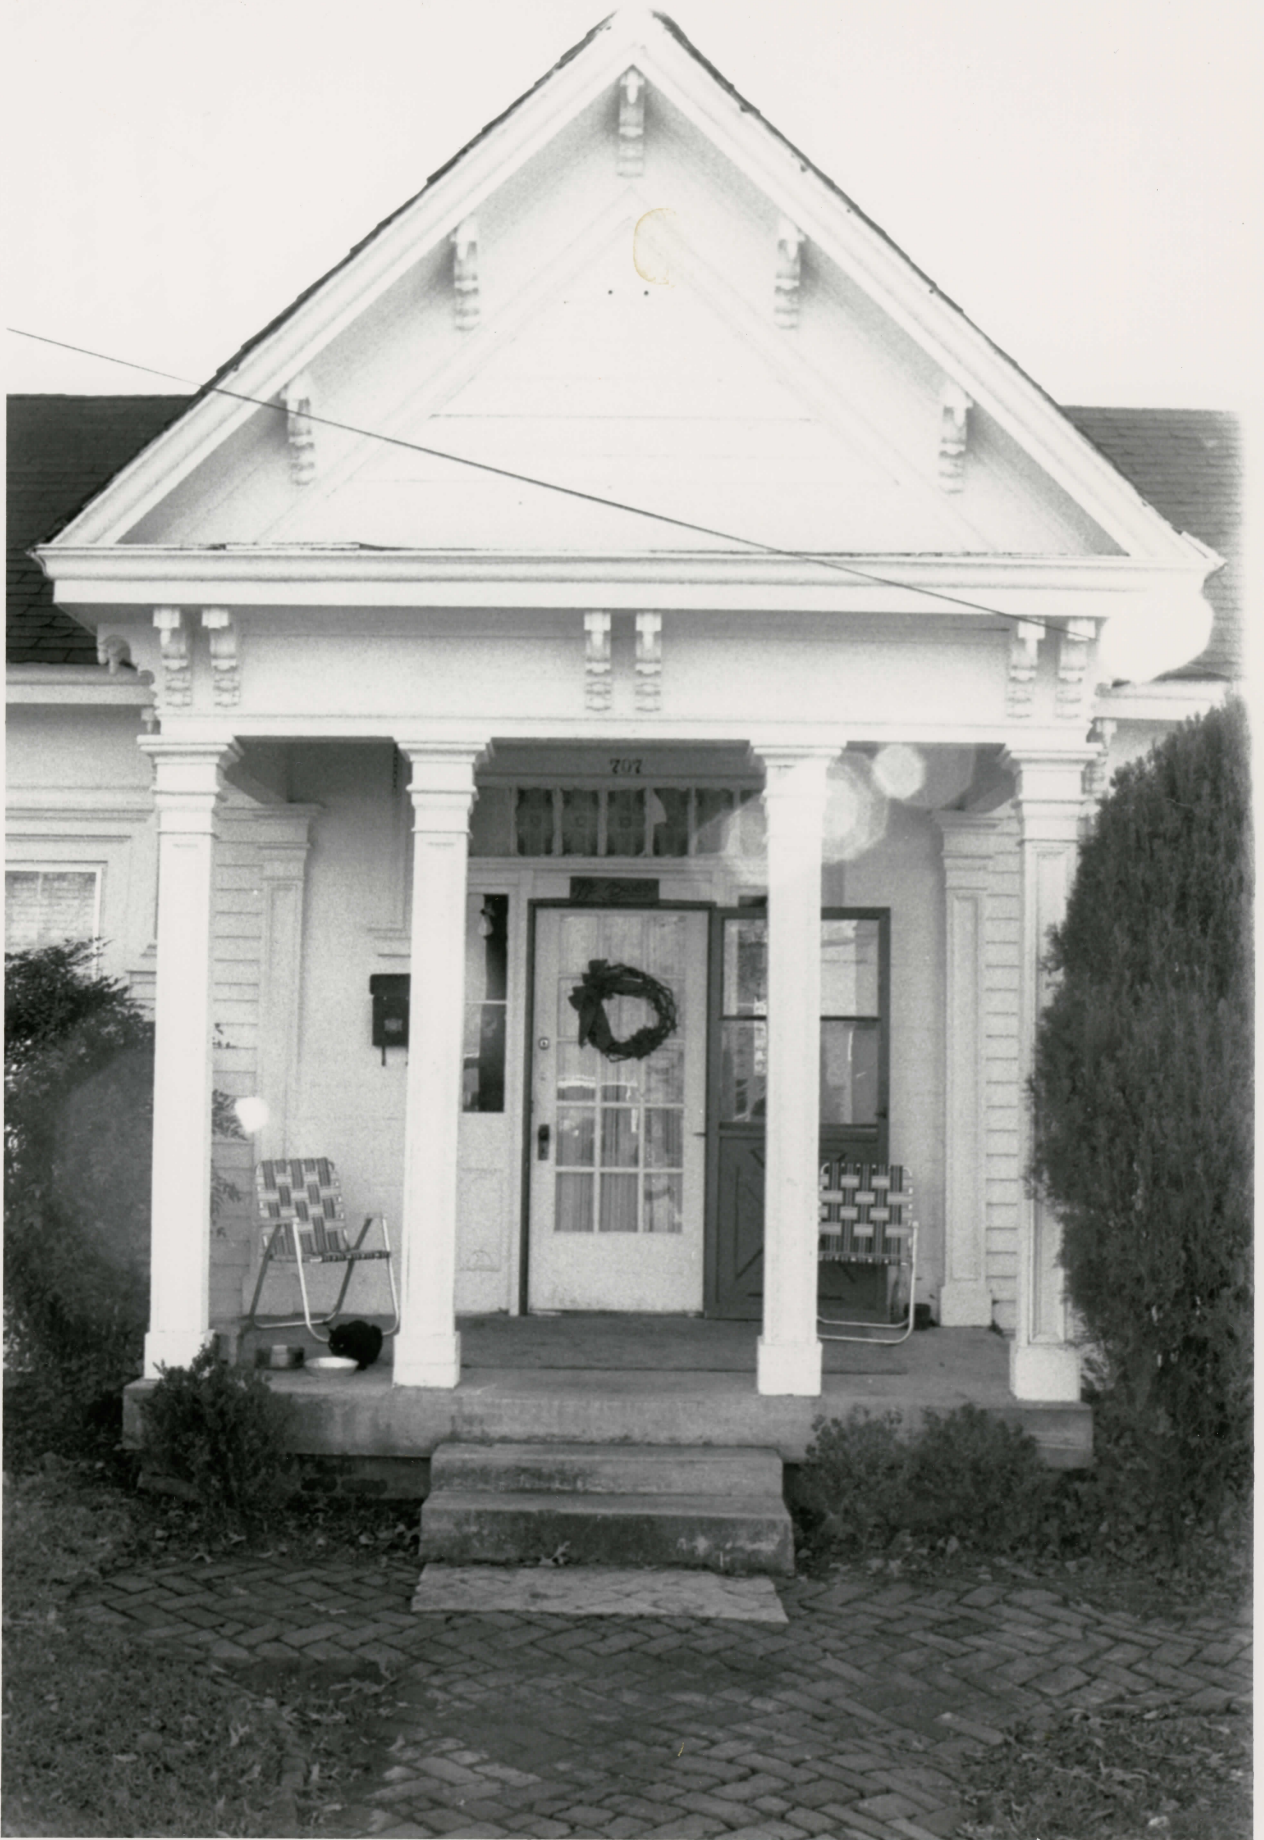
WILBURN HOUSE White
SEARCY, ARKANSAS
PHOTOGRAPHED BY J. BAYLES
NOVEMBER, 1988
NEGATIVE ON FILE AT ANPP
FRONT PORTICO DETAIL

The northern or front elevation of the main portion of the house is five bays in length, with a central pedimented portico flanked by four four-over-four double-hung wood sash windows. The windows are decorated with elegant, molded decorative crowns designed in a drip molding pattern. The portico features a broad frieze both below the pediment and within the pediment, and both are ornamented with elaborate Italianate brackets. The tympanum of the pediment is finished with flush planks as is the house wall beneath the pediment. The portico box columns are decorated with elegantly molded capitals and simpler bases, and are spaced so that slightly more room is allowed for access to the entrance. The entrance is a single panelled door surrounded by two-pane half-sidelights and a seven-pane transom. A decorative drip molding identical to that around the windows adorns the entrance also. Attached pilasters of the same decorative configuration as the columns complete the entry.

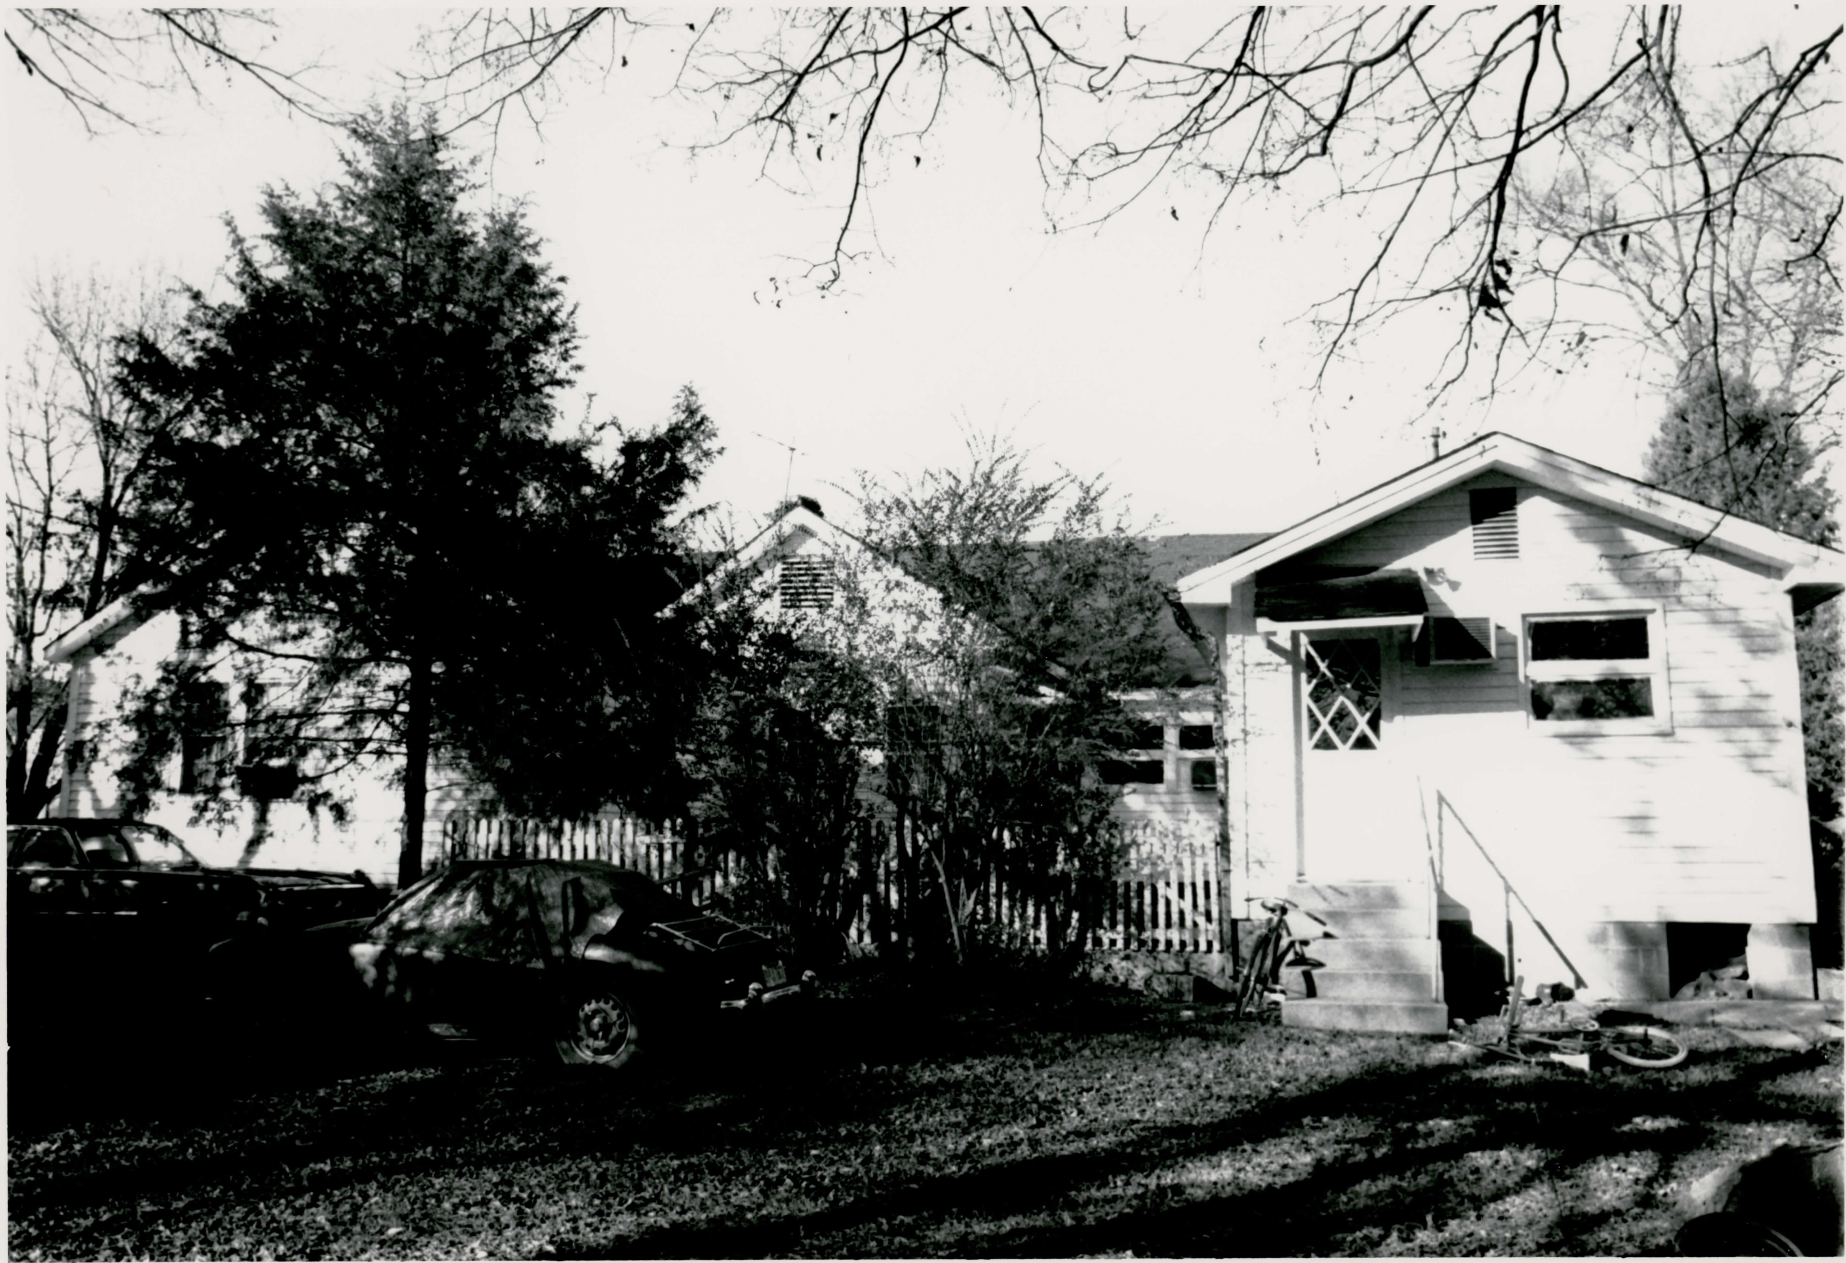
WILBURN HOUSE whiteca
SEARCY, ARKANSAS
PHOTOGRAPHED BY J. BAYLES
NOVEMBER, 1988
NEGATIVE ON FILE AT AHPP
VIEW FROM SOUTH

The southern elevation is composed of the projecting rear gable ell to the west, the adjoining gabled addition to the east, a short portion of the rear of the main building, and the gable end of the eastern ell. The western gable end is fenestrated with a pair of central four-over-four double-hung wood sash windows. The adjoining gable addition features two one-over-one double-hung wood sash windows. The rear portion of the main house is lighted with a pair of recent one-over-one wood awning windows, and the eastern gable features a new single-pane entrance door to the west (covered by a simple shed porch roof) and a one-over-one wood awning window to the east.

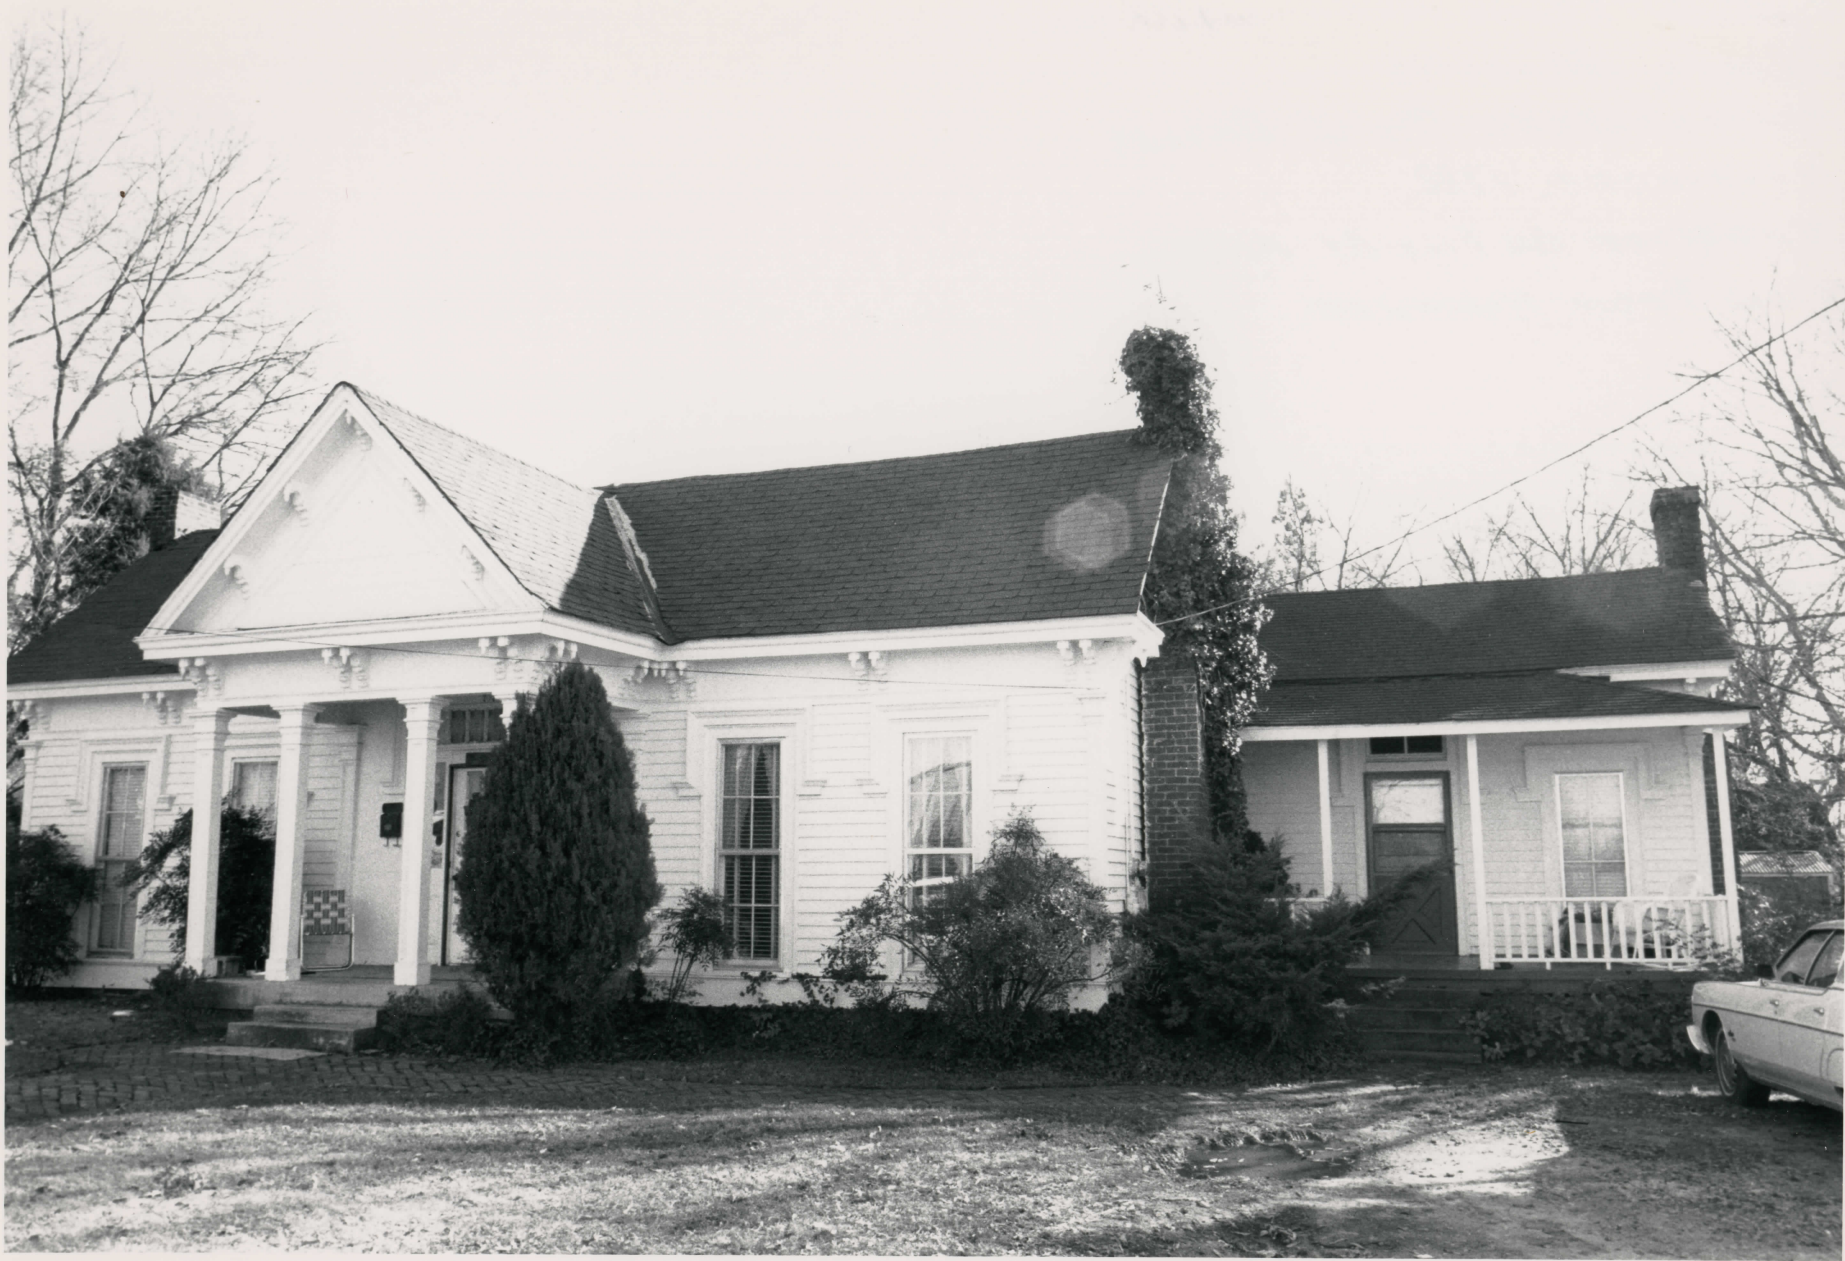
THE WILBURN HOUSE white w
SEARCY, ARKANSAS.
PHOTOGRAPHED BY J. BAYLES
NOVEMBER, 1988
NEGATIVE ON FILE AT AHPP
VIEW FROM NORTHWEST

The western elevation of the house is relieved only by a single window to the south of the chimney, beneath the porch on the front of the western wing, and a four-over-four double-hung wood sash window toward the southern end of the wing addition. The eastern elevation features a single six-over-six double-hung wood sash window to the south of the chimney and three grouped one-over-one wood awning windows in the center of the ell wall.
