National Register of Historic Places  
Inventory—Nomination Form

historic 4606 North Hermitage Avenue

and/or common \* Hermitage Apartments

street & number 4606 North Hermitage Avenue N/A not for publication

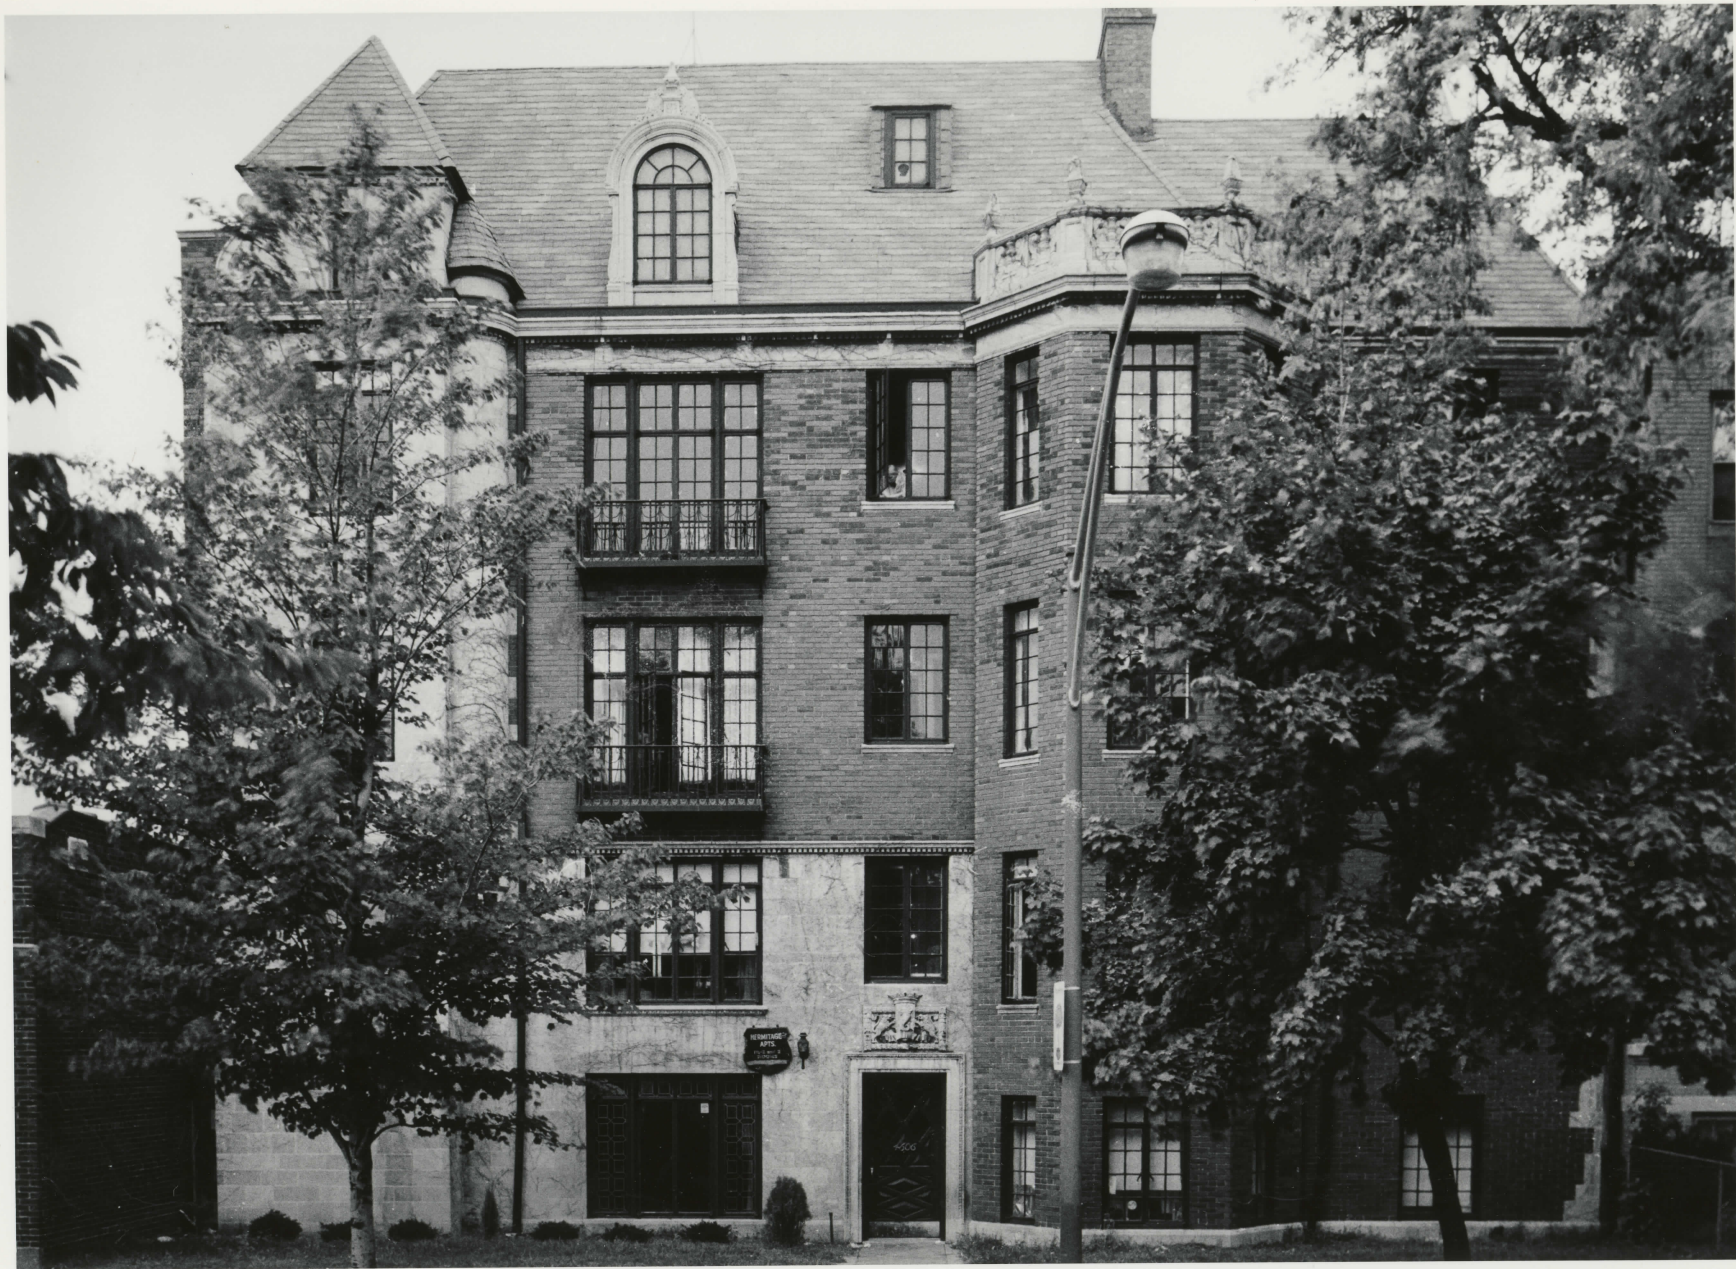
4606 N. Hermitage Ave.  
Chicago, Illinois  
Dennis Pratt - October 1984  
Photo No. 1: Facade,  
camera facing due west

The facade is of pressed brick in varying shades of red, and in gray limestone. It is surmounted by a fourth-floor mansarded attic. Casement windows are used throughout, in varying sizes.

Reading the facade from left to right (south to north): The first of the five bays forms a rectangular projection and reads as a stone tower, surmounted on the attic level by a smaller rectangular dormer with a hip roof, and decorated on the right side with a quarter-cylindrical turret engaged in the angle with the main elevation. This turret begins just below the second floor and terminates in a conical roof.

The second and third bays are flat, and are finished with stone up to the lintels over the first-floor windows, and brick above. The second bay has the largest windows, and in the second and third floors these windows have wrought-iron balcony grilles.

The entrance is in the "basement" or ground level of the third, central bay. It has a simple rectangular frame and is surmounted by an ornamental tablet like a coat-of-arms. In the attic above the second bay, a large dormer has an arched window crowned with elaborate stone trim. A tiny dormer high above the third bay gives a suggestion of a fifth floor.

The fourth bay is a trapezoidal projection, finished in brick, capped at the attic level by an elaborate stone parapet. At each floor, vertically elongated windows are laid into each of the three faces of the trapezoid. At the roofline a brick chimney can be seen above this bay.

The fifth bay is a flat brick bay, in the same principal plane as the second and third. Irregular stone quoins are used at the corner of the building, and are cut at a 45-degree angle except at the cornice where they are corbeled out to a right angle.

One extraordinary feature: set behind the mansard attic above the fifth bay, where it can hardly be seen except from a distance (since the construction of the adjacent building), is a nearly conical metallic spire, surmounted by a tall finial with a weather vane.

A light stone cornice runs across the building between the third floor and the attic, consisting of a plain frieze, dentils, and a crown molding.

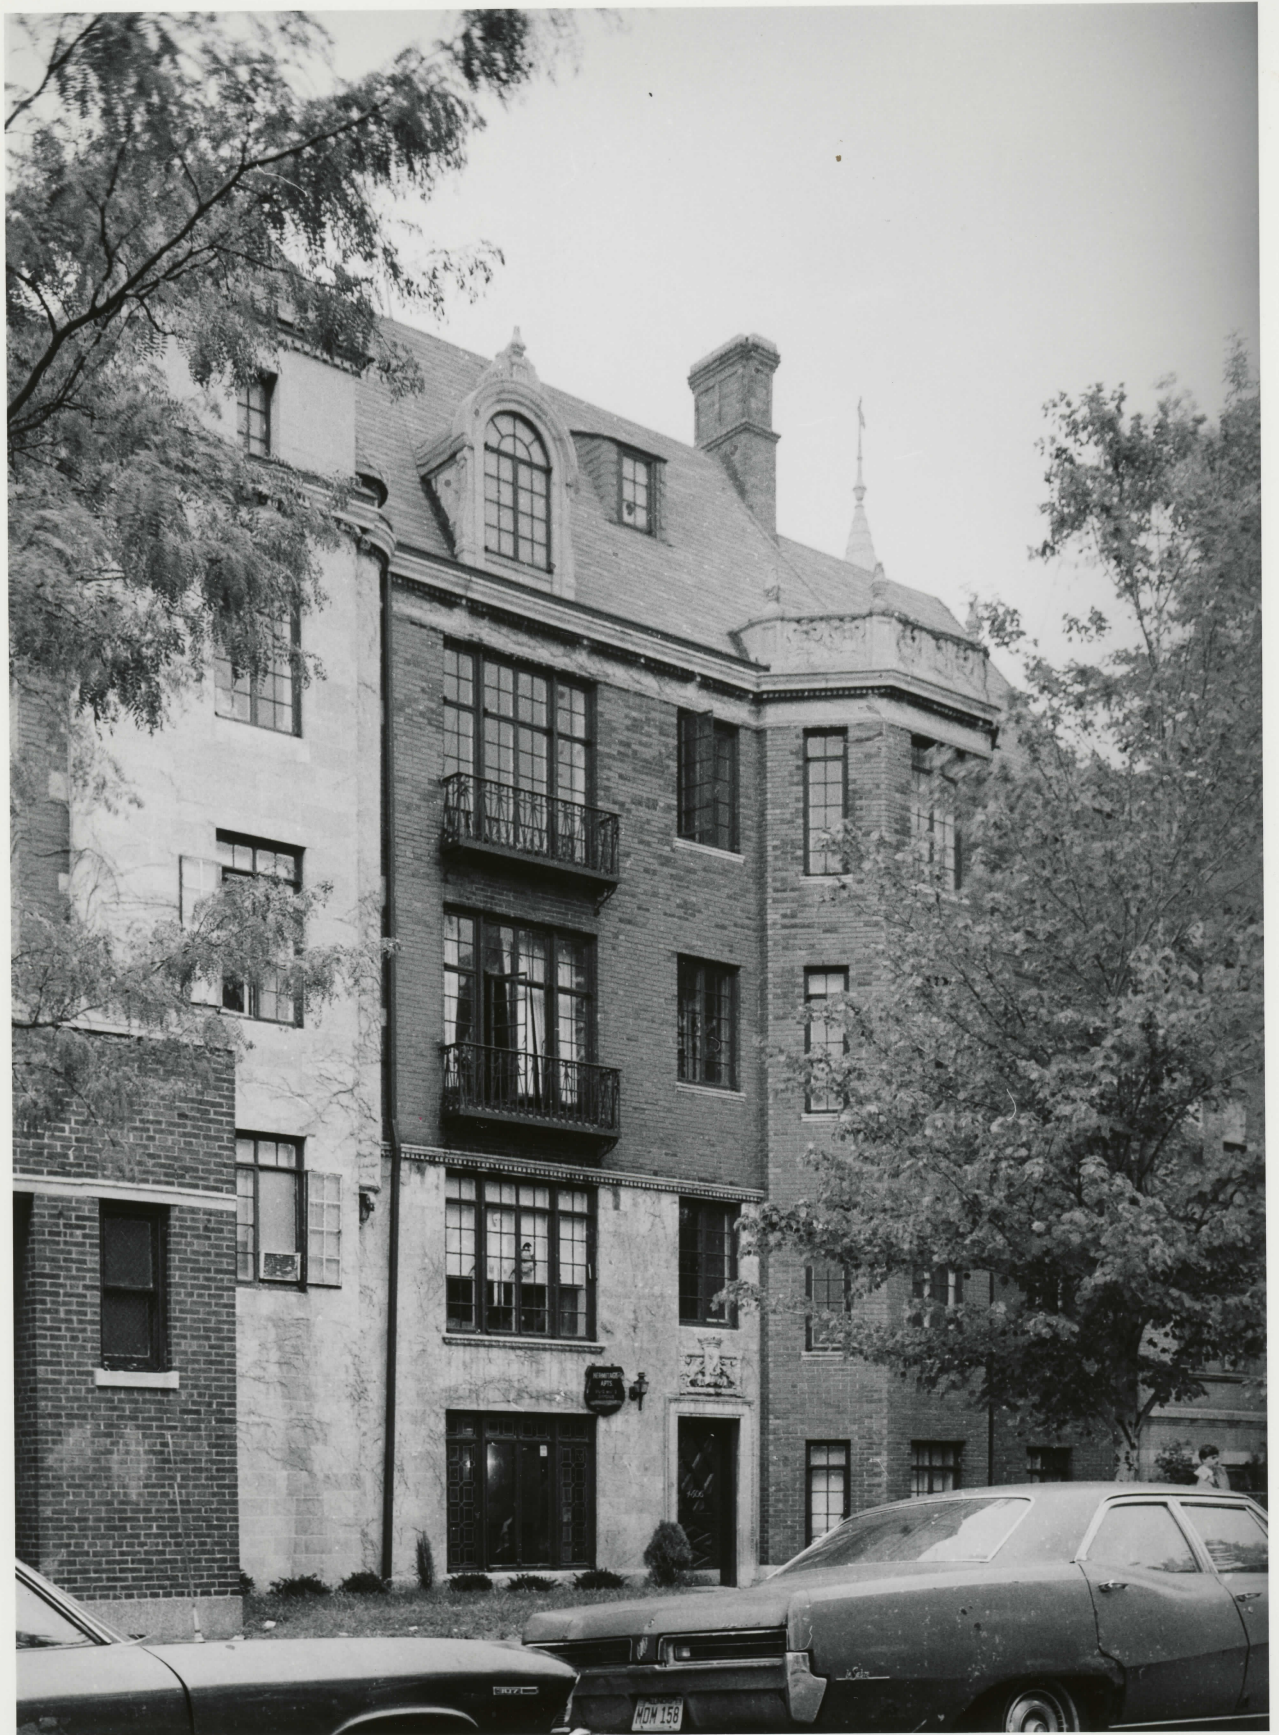
4606 N. Hermitage Ave.  
Chicago, Illinois  
Dennis Pratt - October 1984  
Photo No. 2: Facade,  
camera facing northwest

Jensen goes to great lengths to break up the symmetry of his facade, to make it informal and irregular. Of the five bays, no two are alike. The first and fourth are projecting, but in different profiles, different materials, different fenestration. The entry is central, but this element of symmetry is concealed by the emphatically asymmetrical surrounding area. The limestone is carried all the way up in the first bay, only to the top of the first floor in the second and third bays, and then abandoned except for the corner quoins at the right end. Balcony grilles are used only in the upper floors of the second bay. Each bay has different size windows.

The roof is handled with the same freedom: three different dormers in the first three bays, then a parapet and a chimney, and finally the surprising conical tower and weather vane placed quietly behind the attic in the fifth bay.
