National Register of Historic Places
Registration Form

historic name Zion Lutheran Church
other names/site number N/A

Zion Lutheran Church
Cole County, Missouri

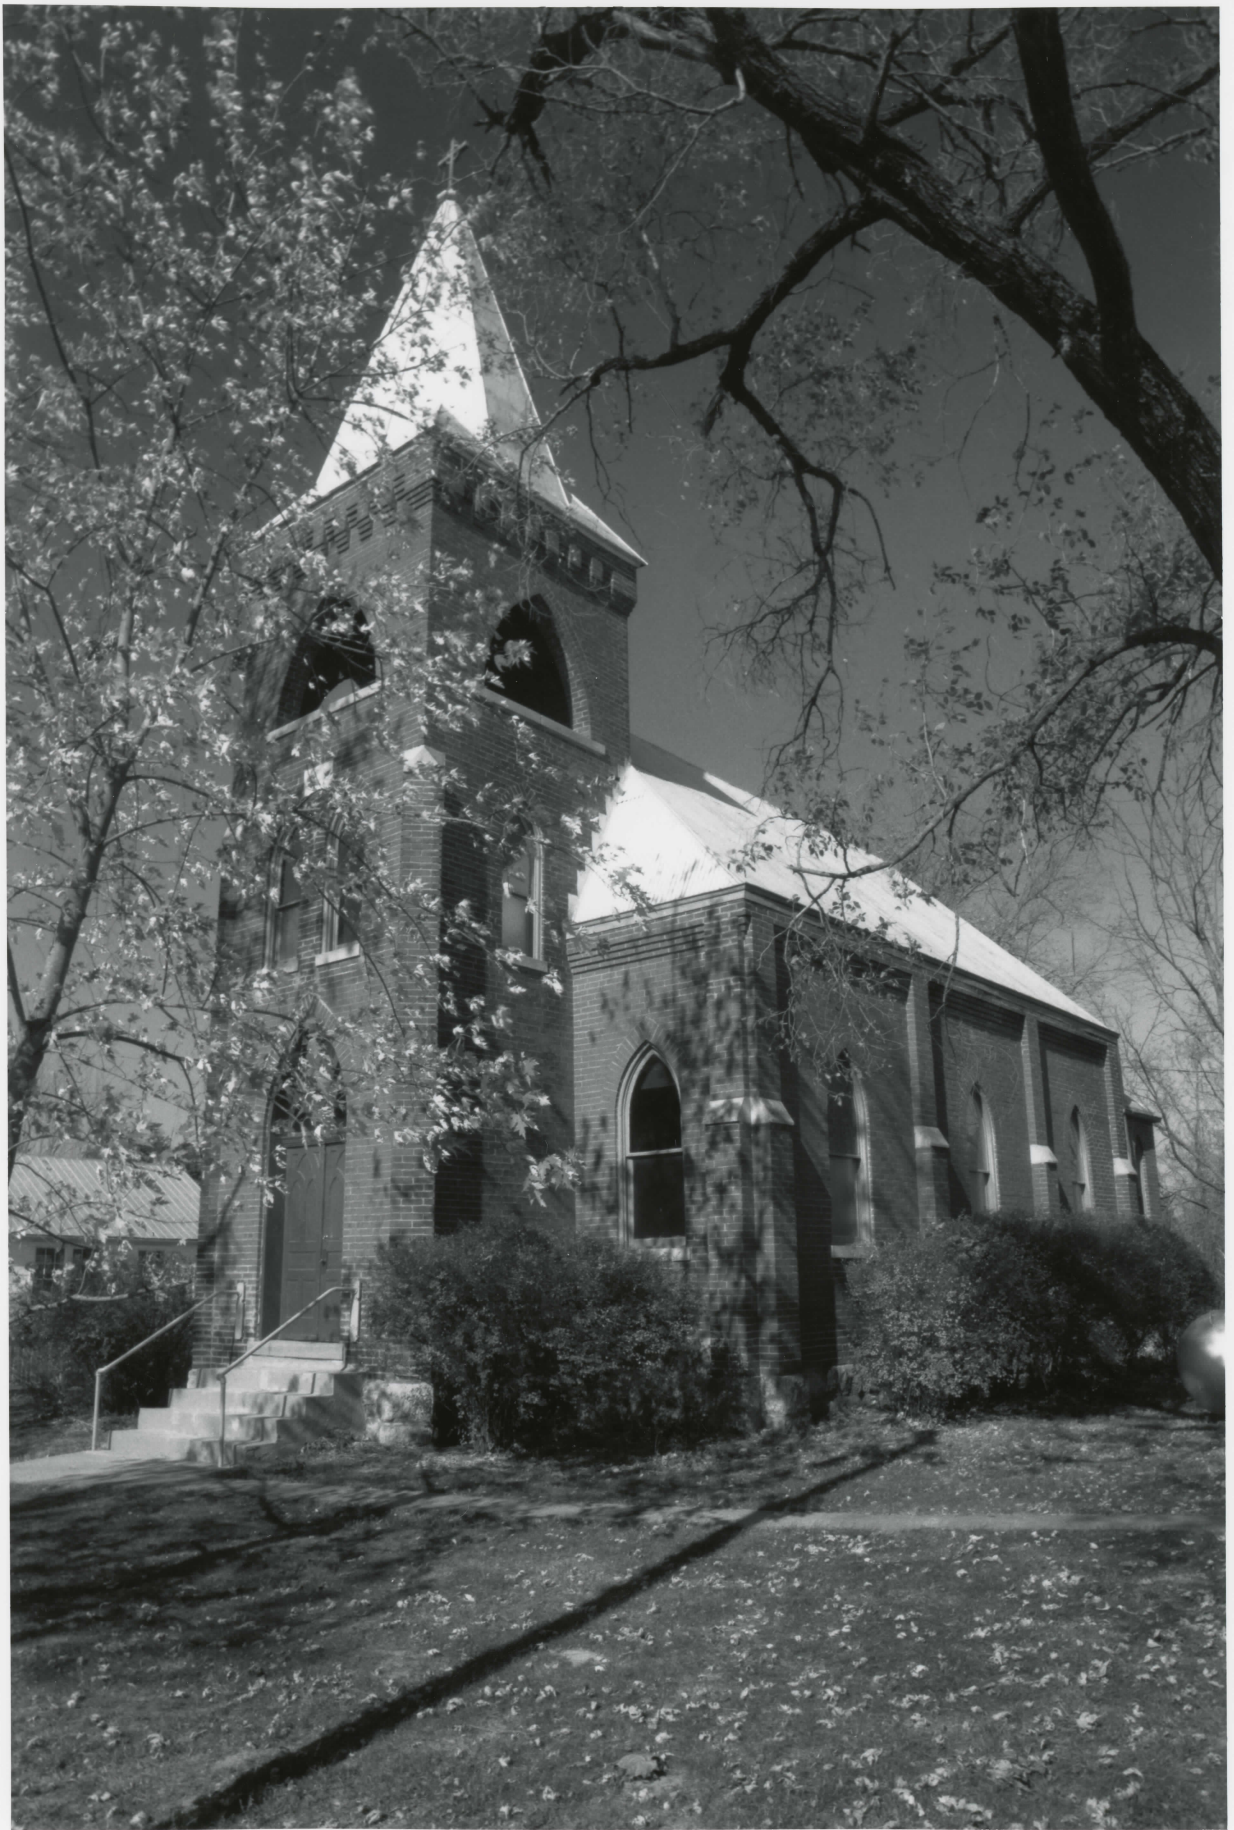
Photo #1

North facade and West side Elevation,
• looking Southeast

The east and west facades are nearly identical and carry out several of the design characteristics seen on the south (primary) facade. The walls are divided into three bays by four evenly spaced buttresses. As on the front facade, the buttresses extend to the roofline of the church and are divided roughly in half by limestone coping. These buttresses segment the plain, corbeled brick cornice. Centered in each bay is a double hung, 1/1 lancet window with green and blue glazing. The only noticeable difference between the east and west facades is the location of a small chimney on the northwest corner of the building.

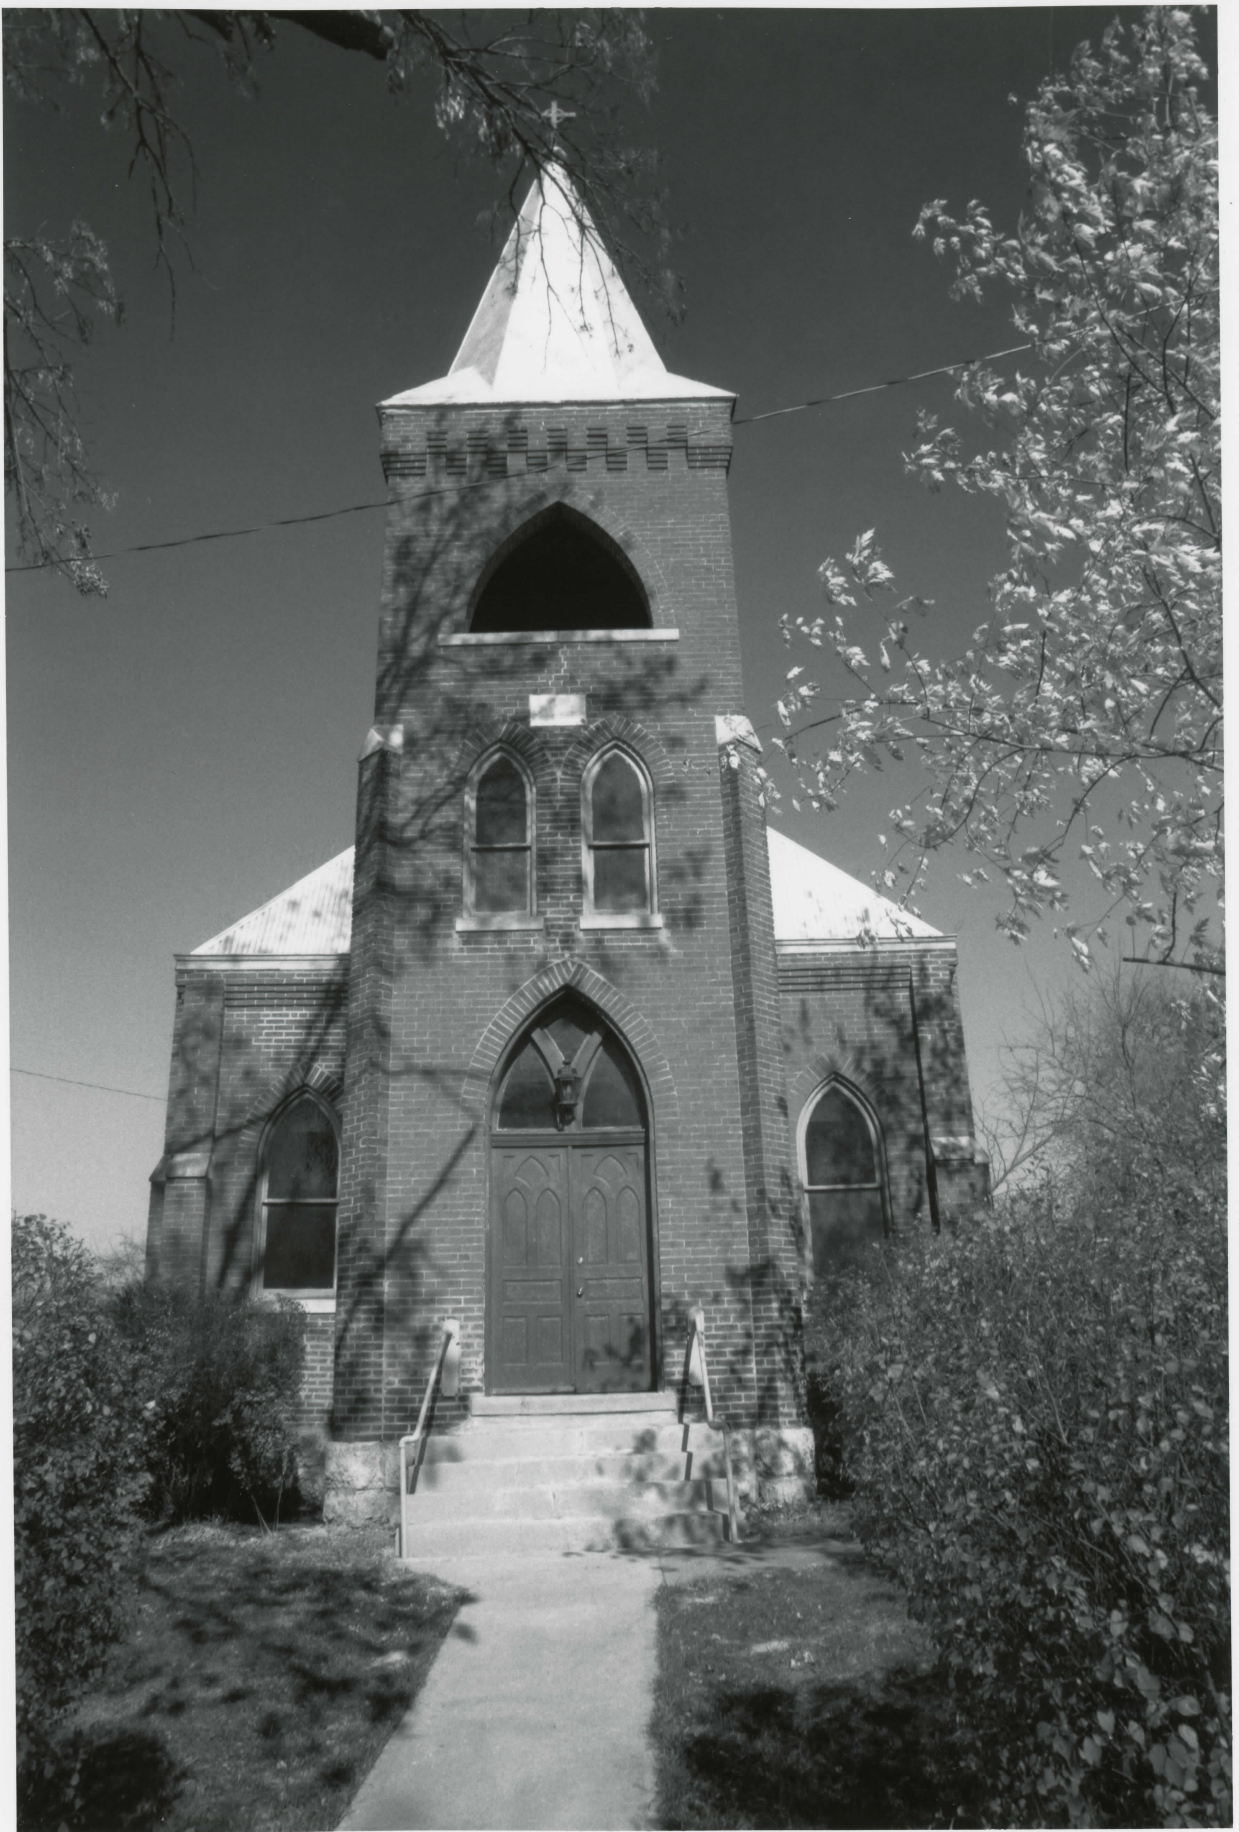
Photo # 2

North facade, looking South

The primary (south) facade is three bay and displays many architectural details that are repeated throughout the church. The tower is the center bay and is the tallest part of the church, rising several feet above the ridge of the building's main roof. The tower is flanked by the exposed south wall of the church sanctuary. Buttresses with limestone coping mark the corners of the sanctuary wall and extend to the building's roofline. Centered on the walls on either side of the tower are lancet windows. These double-hung arched windows have one over one sashes glazed with blue and green glass. The windows have limestone sills and the curve and point of the arches are outlined by soldier bricks. The lancet windows seen on the south facade characterize those seen throughout the church and are repeated on the tower and east and west facades of the building. Above the windows are simple brick cornices consisting of four straight rows of corbeled brick that terminate at the buttress.

The projecting tower dominates the south facade and the entire church. The three story tower serves multiple purposes and these uses are reflected in the design. The first floor acts as the entrance foyer. Four steps lead up to the large pointed arched doorway. The point of the arch is filled by glass divided by curved mullions, creating the effect of paired lancet windows within a larger arch. This design effect is repeated in the shaped panels of the double doors. Brick buttresses flank the entrance at the two corners of the tower. These buttresses reach the top of the tower's second floor and terminate in triangular limestone caps. Two closely spaced lancet windows mark the second floor of the tower. Centered above these windows is a small limestone block carved with the name of the church written in German. There are two more pointed arched windows at the second floor level on the east and west side of the tower. These windows illuminate the stairway and the access to the balcony. There is an open air belfry on the tower's third floor. The belfry is denoted by wide lancet openings with limestone sills. Above the belfry fenestration is a corbeled brick cornice designed to look like stylized versions of crenellations (castellations) found in Gothic era castles and fortresses. A steeply pitched, metal-clad spire tops the tower. The eight sided spire comes to a point and is capped by a Celtic cross.

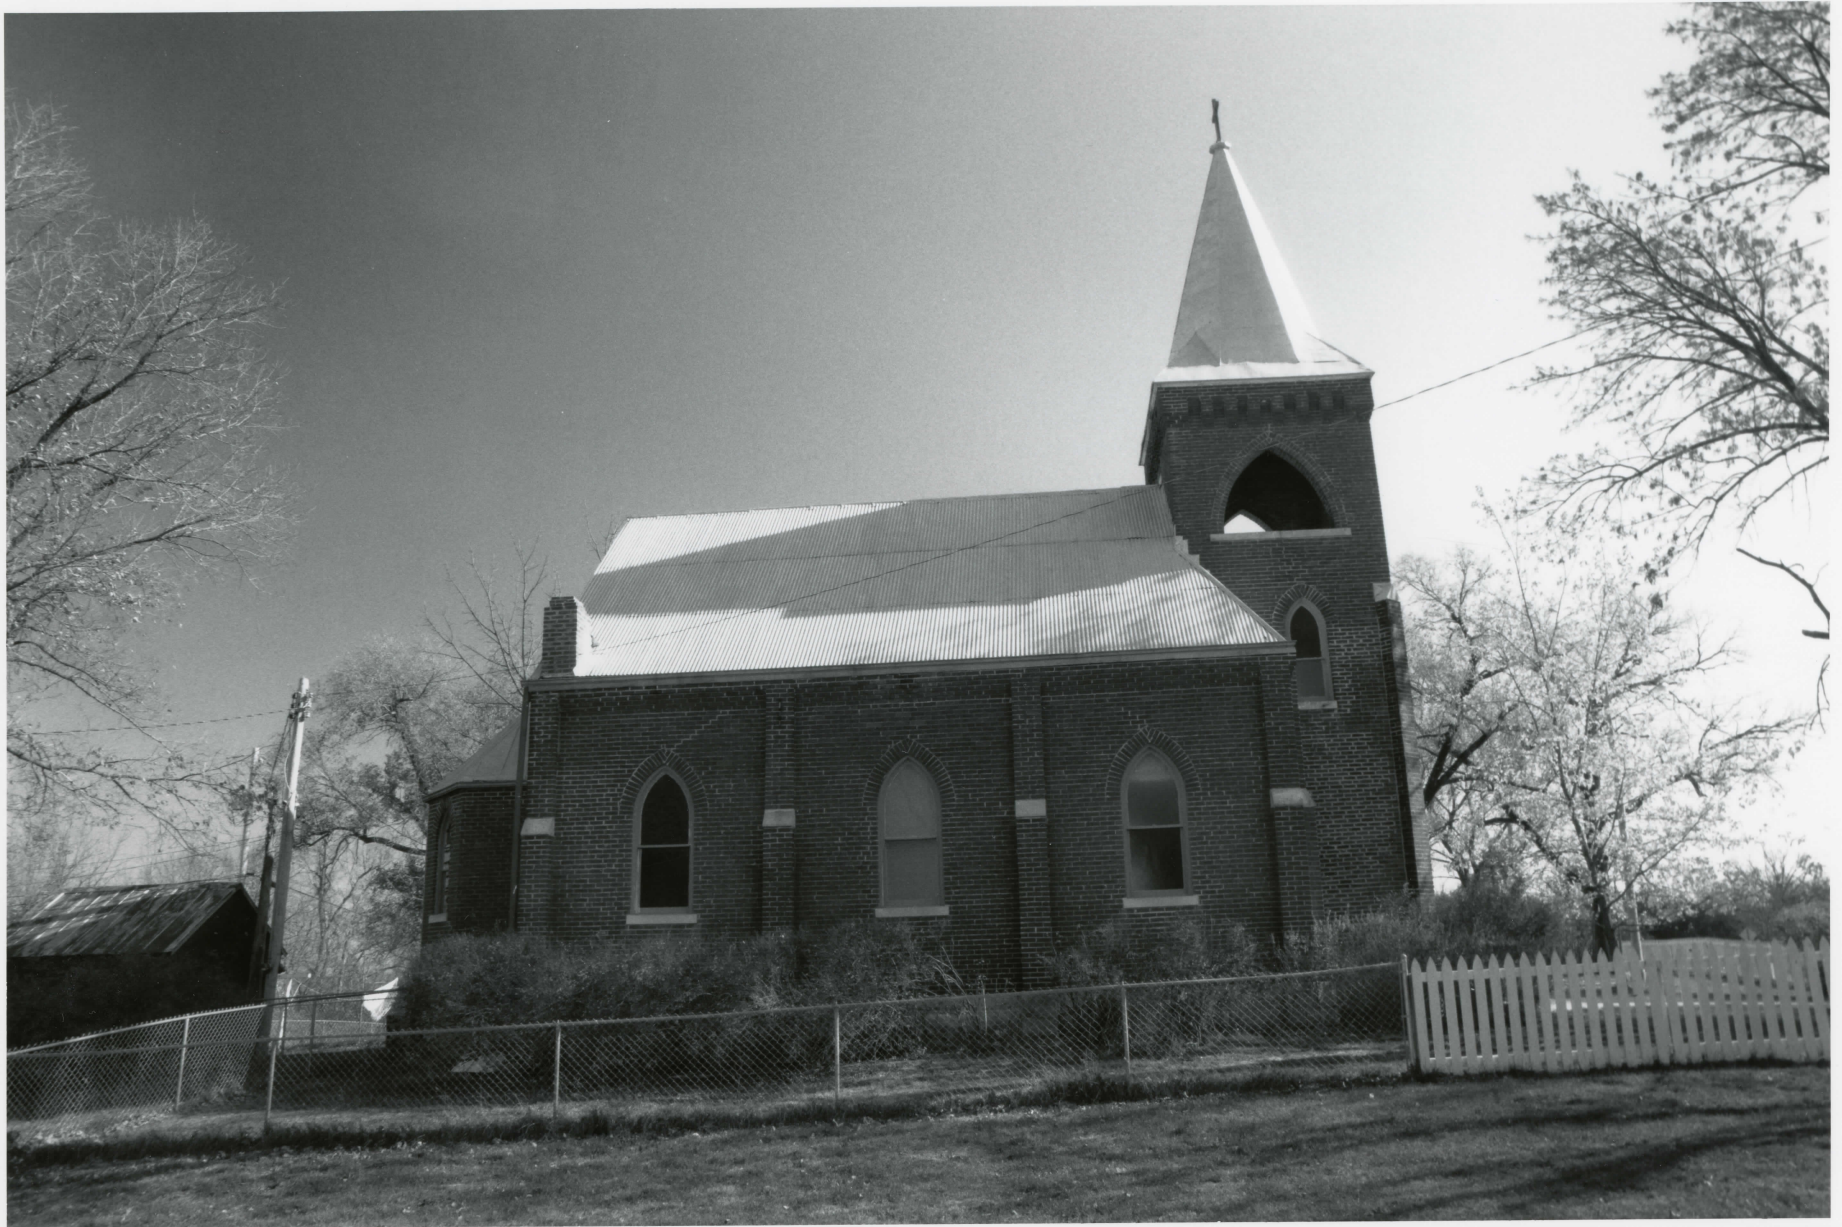
Photo #3

East facade, looking West

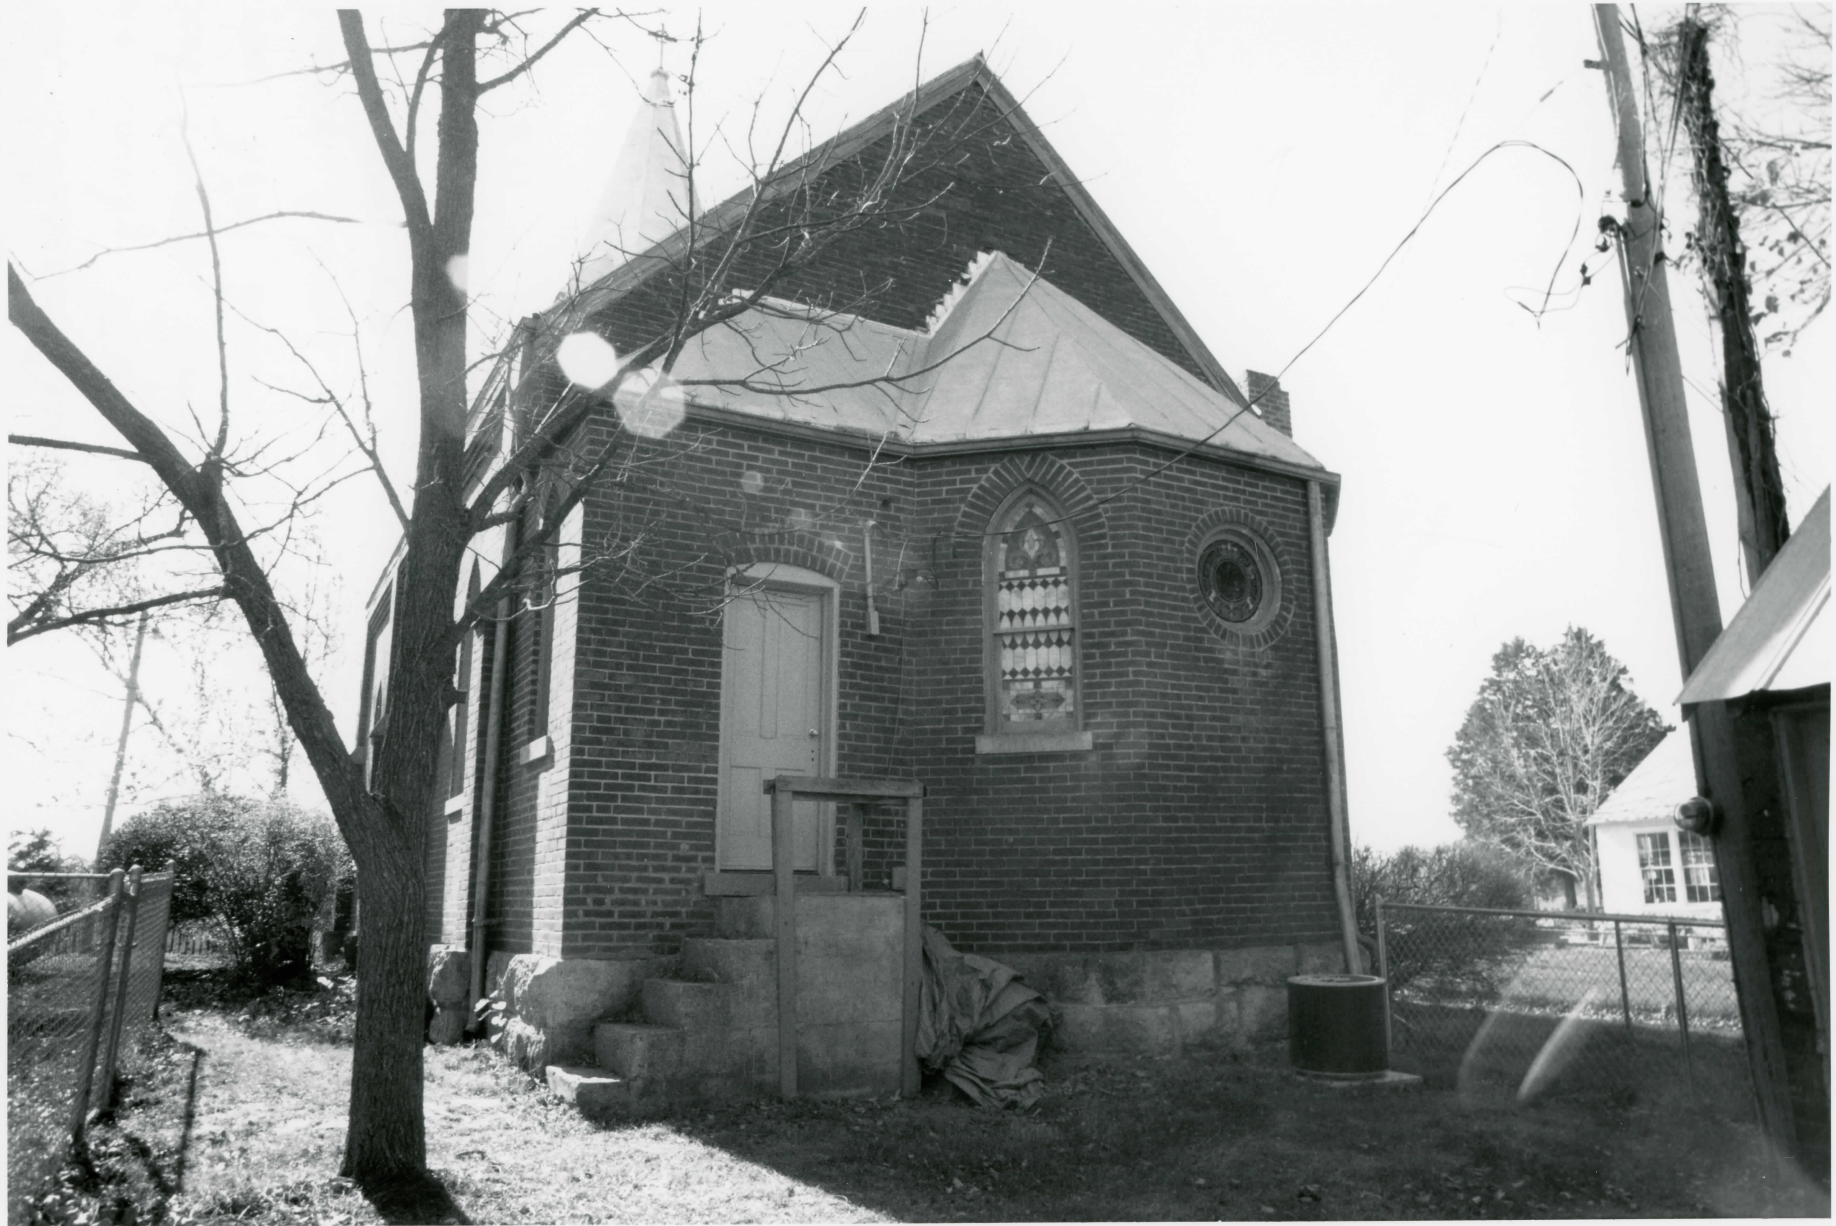
South facade, apse and vestry, looking Northeast
Photo #4

The dominant elements of the rear (north) elevation are the intersecting apse and sacristy. Roughly centered in the back is a polygonal apse with a medium pitched five sided roof. The northern most wall of the apse has a small, round stained glass communion window. On the angled walls on either side of the round window are stained glass, double-hung, lancet windows. The sacristy connects to the east side of the apse. The small rectangular room has a lancet window on the east side and an entrance in the north wall. The entrance is reached by a set of concrete steps.

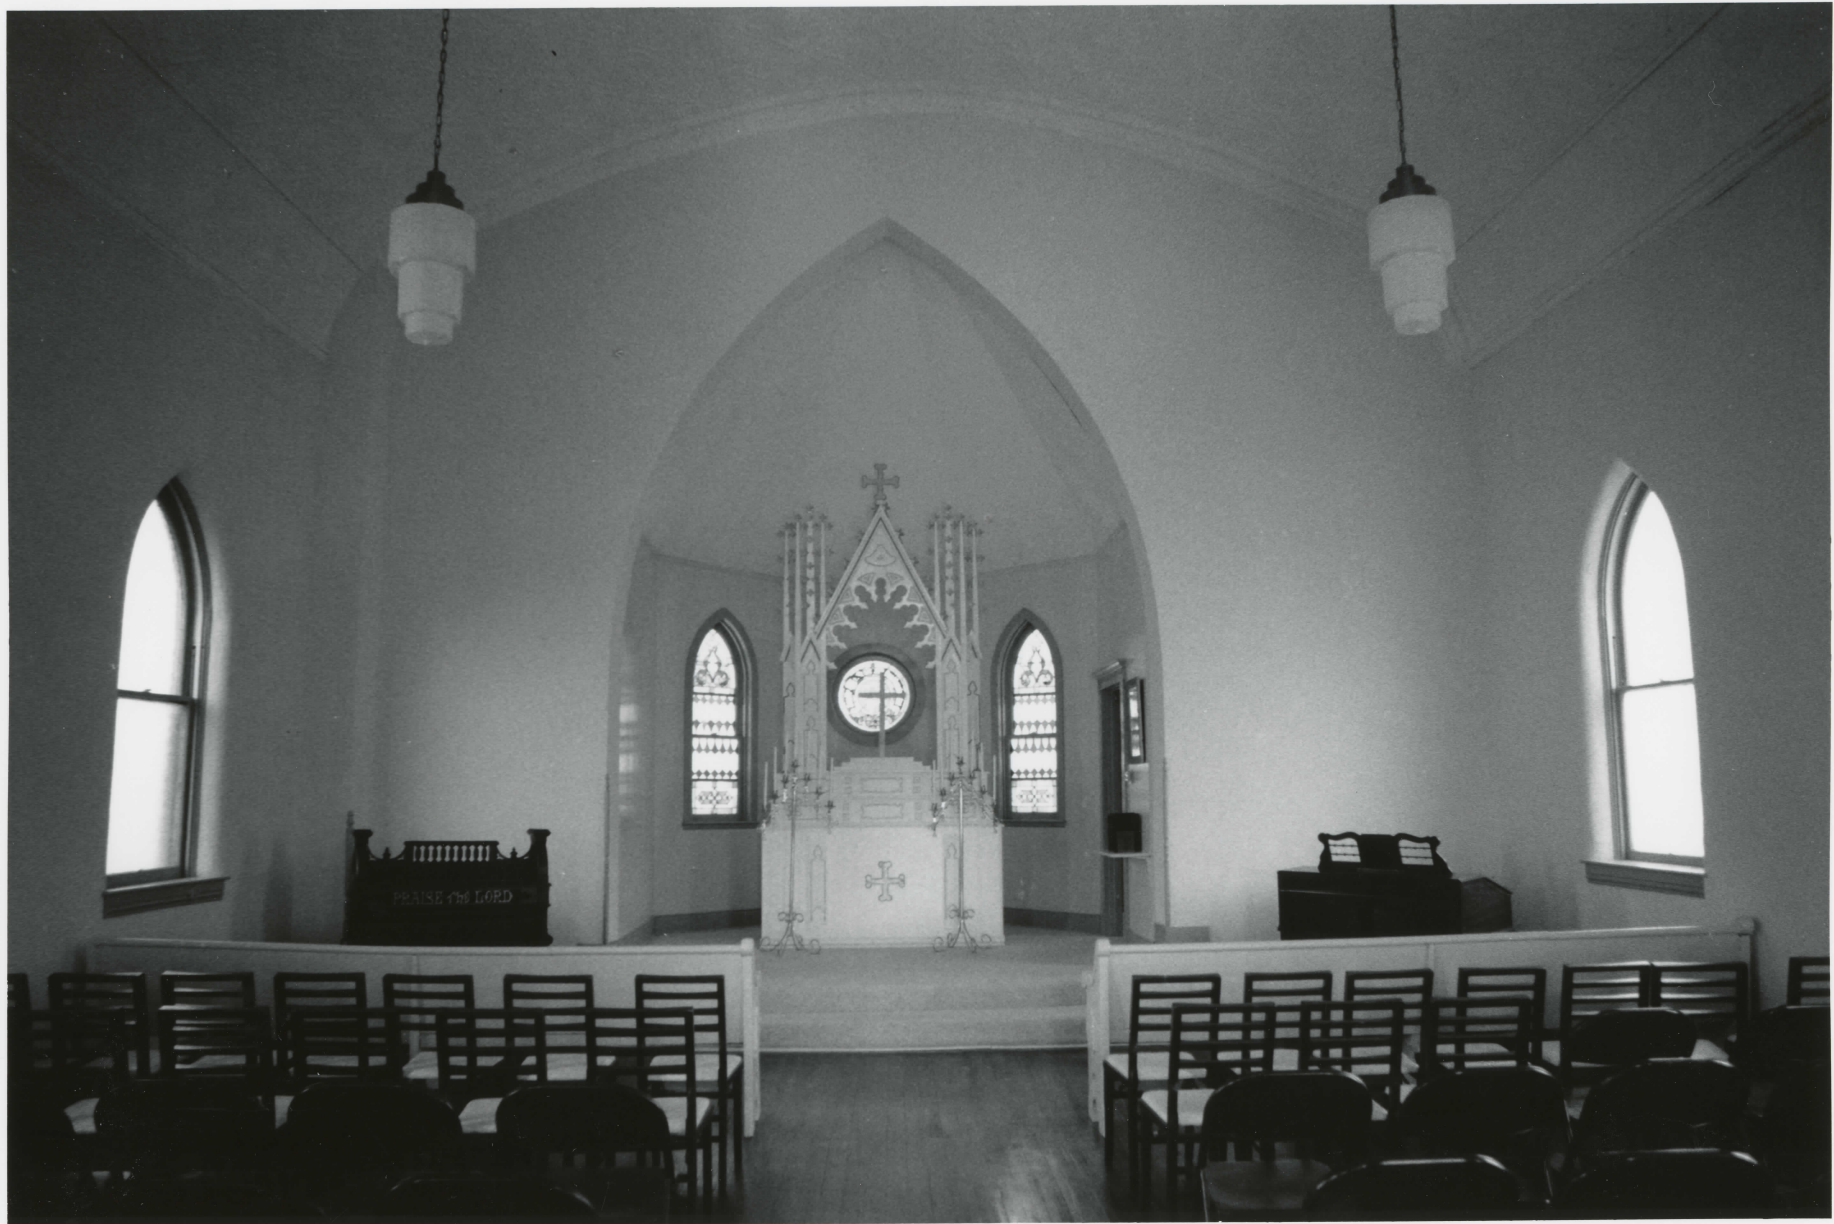
Photo #6

Photo 6: Interior View: Looking south toward altar

A large Gothic arch opens into the apse. The apse holds the raised chancel and a replica of the original altar. Also located in the apse are the three stained glass windows previously mentioned. The round communion window has a central panel decorated with slices of bread circled by wheat stalks and grape vines. A wider boarder around the window has an organic design with "Das ist mein [?] Das ist mein blut" written around the parameter. The lancet windows mix organic design with geometric patterns. A paneled wood door on the east side of the apse leads into the sacristy.

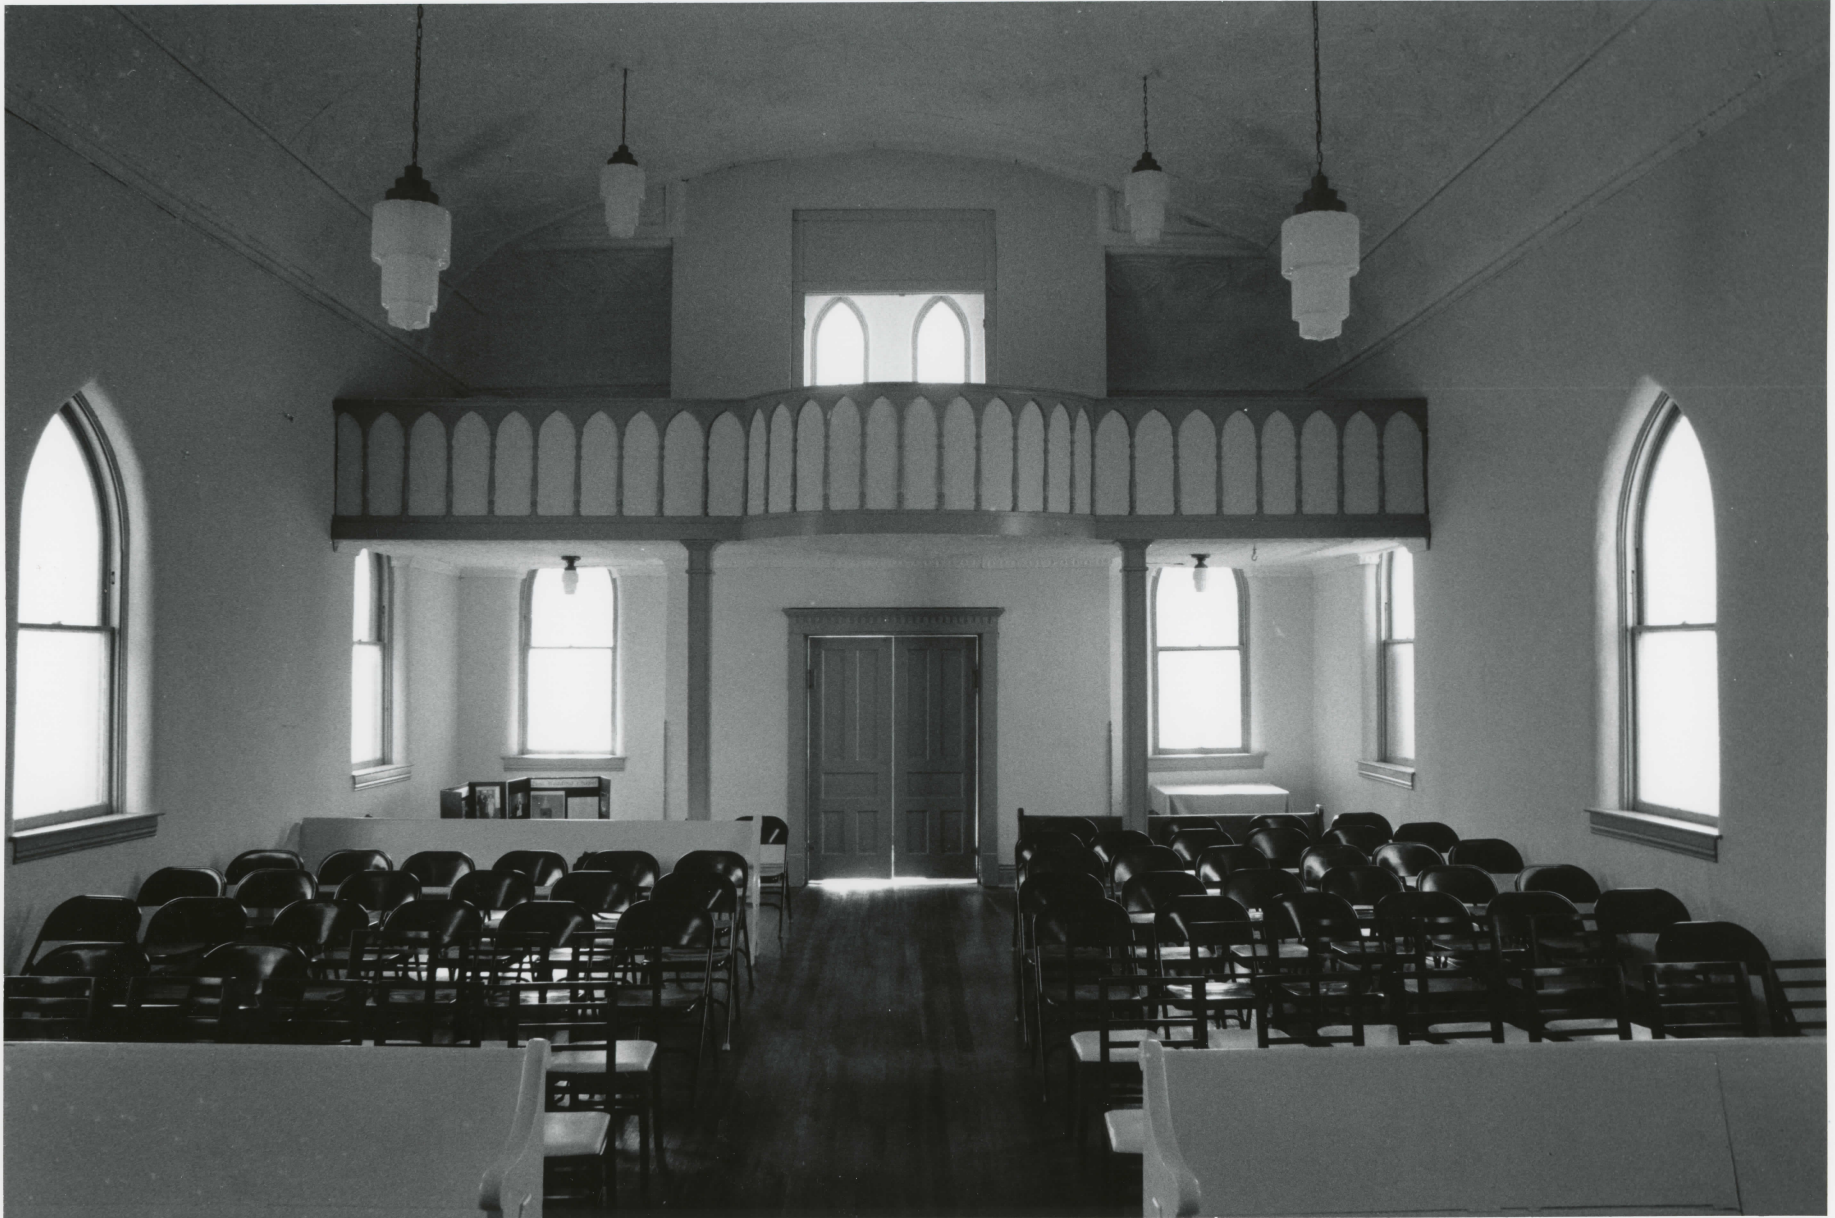
Photo # 7

Interior, looking north toward
entrance and balcony

The two most prominent features of the nave are the ceiling and balcony. The ceiling is elliptical with pressed tin panels. The panels have circular rosette medallion designs on a checked background. The balcony is accessed through the tower. The pine floor of the balcony extends past the first set of windows and has a semi circular extension in the middle. A wood rail, decorated with a Gothic blind arcade, runs along the edge of the balcony. The balcony is supported by two square Tuscan columns.

Other than the pressed metal panels on the ceiling and under the balcony, there is little decoration in the nave. The floor is wood and the walls are plain plaster. Six Art Deco milk glass light fixtures hang from the ceiling, two over the balcony and four over the main seating area. The light fixtures hang from chains and have a reverse waterfall design with three tiers that taper as they go down. Two small light fixtures under the balcony are of similar design.

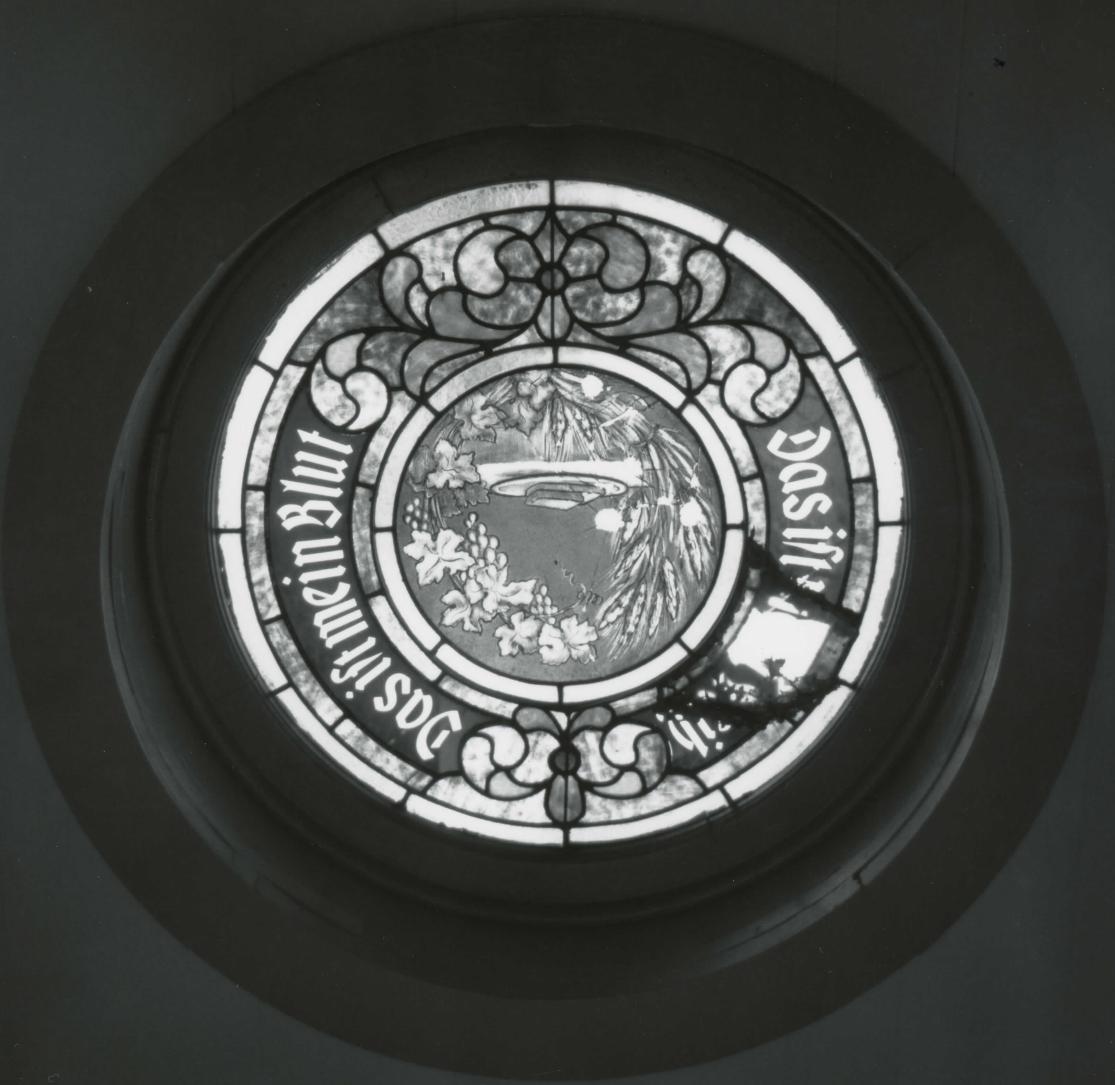
Photo # 8

Interior, Communion window detail,
in apse, looking south.
