National Register of Historic Places
Inventory—Nomination Form

historic name Dauwalter, John S., House
other names/site number 0-42

street & number 817 Seventh Street N/A not for publication
city, town Boonville N/A vicinity
state Missouri code MO county Cooper code 053 zip code 65233

JOHN S. DAUWALTER HOUSE

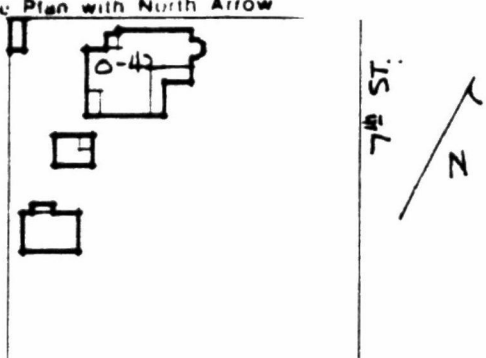
7. City or Town If Rural, Township & Vicinity Boonville		16. Thematic Category	
8. Site Plan with North Arrow

18. Description of Environment and Outbuildings The residence sits at the rear of the lot which rises to the W. It is a double lot-vacant to the E., except for 3 sheds. A small cow shed built of wide vertical boards and having a pent roof is along the W. alley. A gable roofed building is to the SW. It has a brick foundation and is clapboard over frame. (see attachment)		27. Other Surveys in Which Included

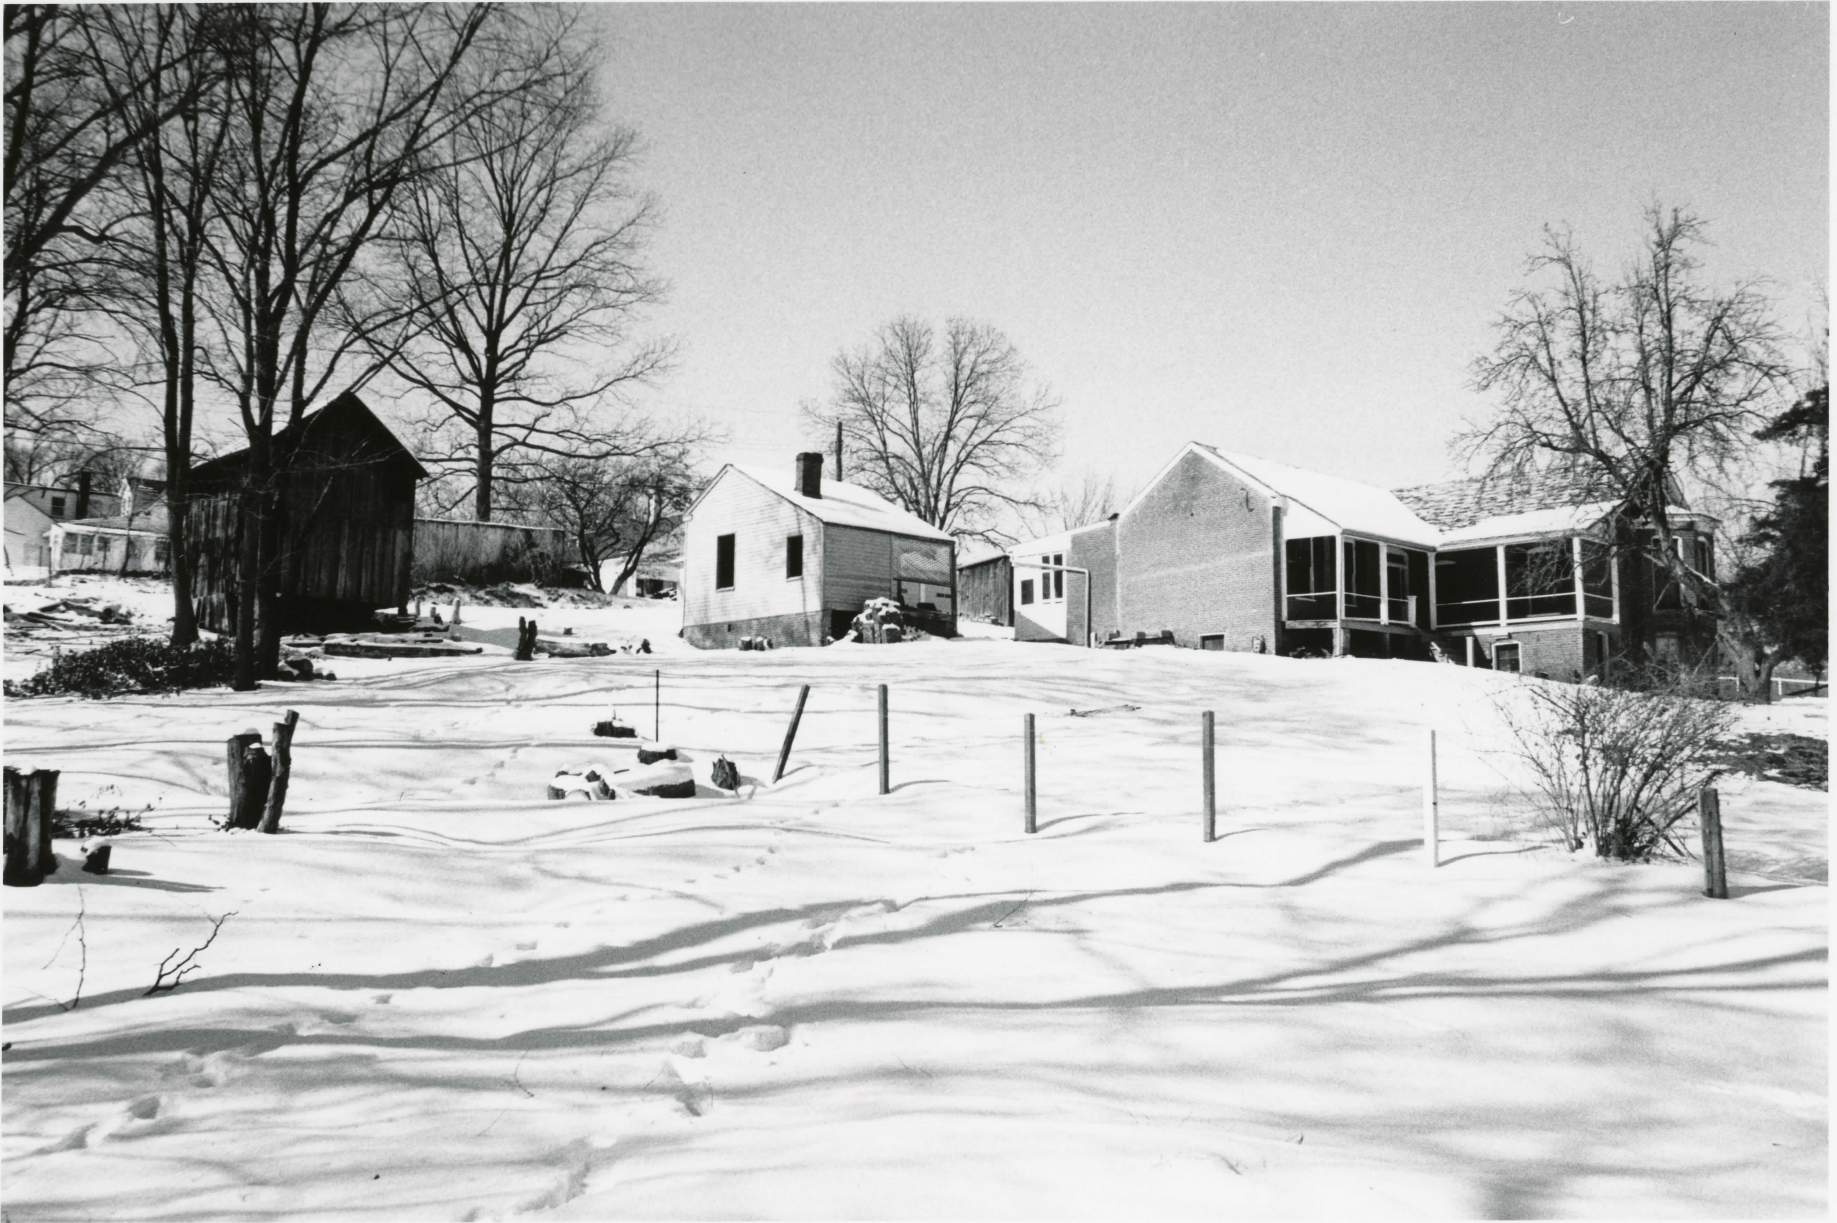
#1 of 10

View from Southeast

ELABORATION: The facade, or east-northeast elevation, was originally divided into five bays. The central bay and the two southern bays remain. The central bay contains a door flanked by sidelights and surmounted by an arched rowlock lintel, wooden cut-out, and transom, while the two bays contain two-over-two, double hung sash with arched rowlock lintels. The northern bays were covered and altered by the addition of the circa 1880 gable ell, which projects east from the facade. A two story, hipped roof bay projects on the gable end of the ell. A single, two-over-two, double hung sash with arched rowlock lintel is set in each of the bay's three planar surfaces on each story. The arched lintels on the basement level are formed by a brick soldier course, while those on the first floor are set in a rowlock course. The southeast elevation of the gable ell contains a door in the west half of the elevation and a window with two-over-two, double hung sash in the east half of the elevation. Shed roofed, wooden porches extend across the facade of the original house and the southeast elevation of the ell, forming an L-shaped gallery. The facade porch is supported by brick piers, while the ell porch is supported by a brick enclosure with a door in its northeast elevation and a single four pane window in its southeast elevation. Because of the sloping nature of the terrain, the entry level of the house is raised and the basement under the gable ell addition is exposed. Wooden steps provide access to the facade porch, but the ground level enclosure beneath the ell porch conceals a stairway aligned with the facade's central bay. Now sealed by the porch flooring, this stairway suggests the

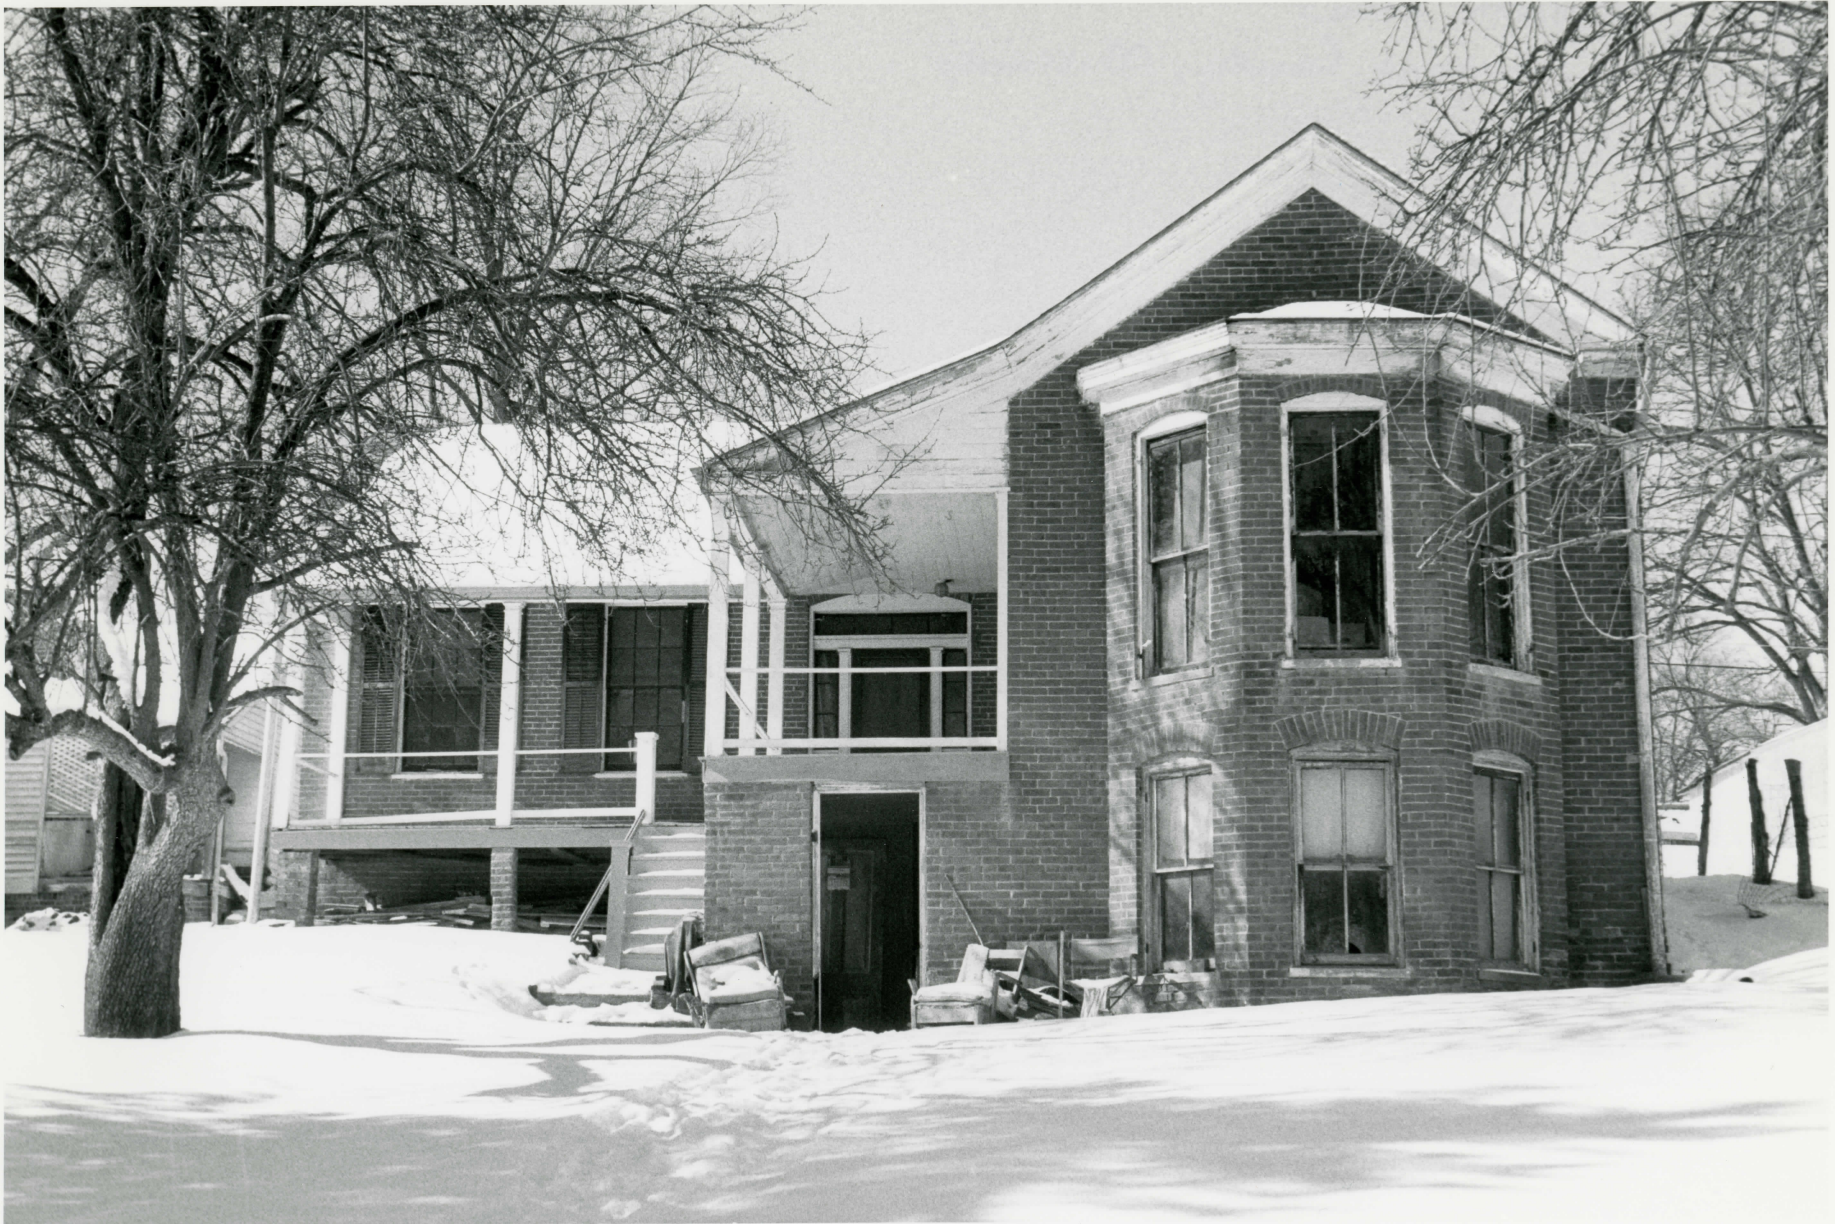
2 of 10

View from Northeast

The northeast elevation of the gable ell contains a single two-over-two, double hung sash on each level, while the gable end of the original house contains paired one-over-one, double hung sash in its single bay with an arched rowlock lintel. A two-over-two, double hung sash set in a bay with a flat rowlock lintel is centered in the upper story.

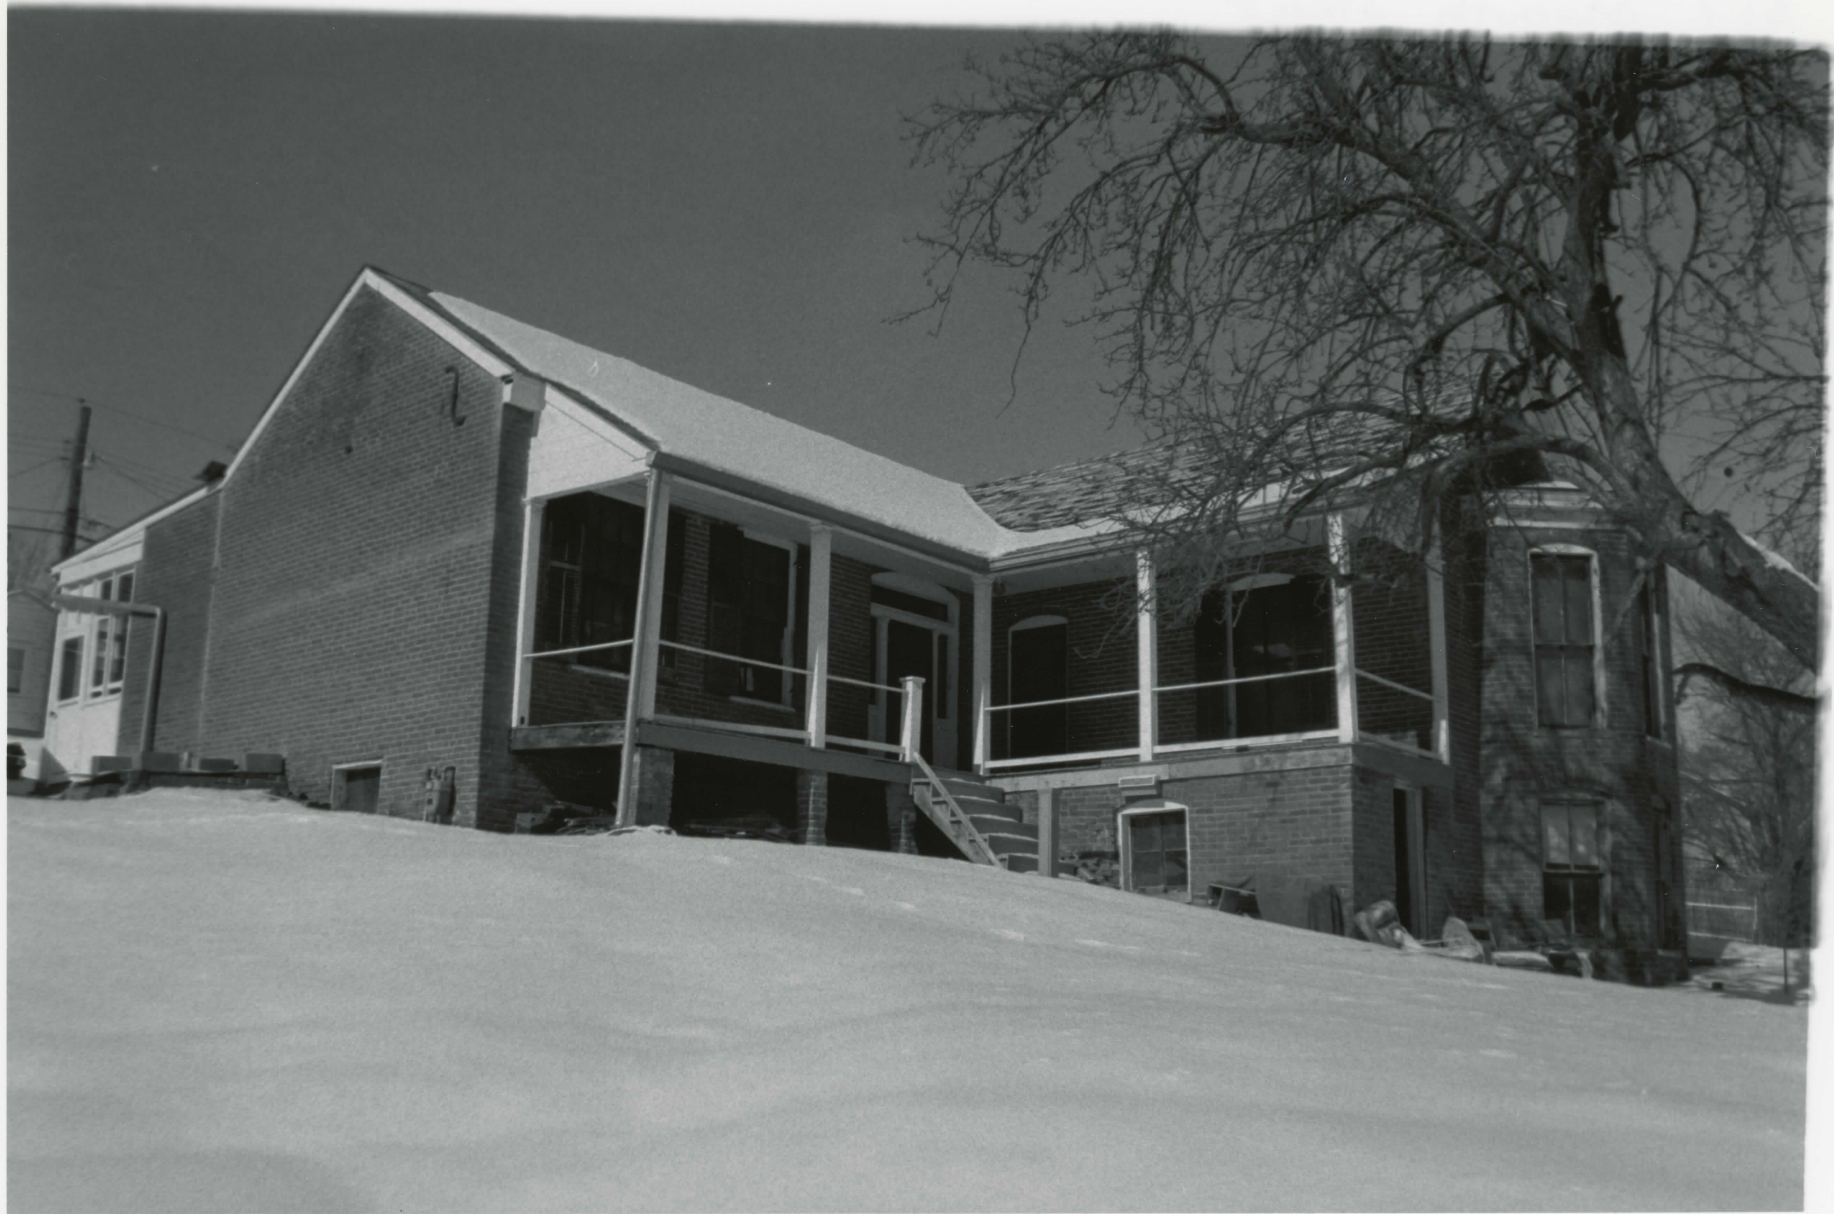
3 of 10

View from Southeast

The end of the southeast elevation contains no bays. A rear, shed roofed, brick addition was constructed circa 1920 and extends across much of the southwest elevation. A small porch, formed by the extension of the slope of the original house roof, remains at the west end of this elevation and shelters a door in the northwest elevation of the circa 1920 addition. Wood framing and vertical board siding enclose the lower half of a recessed porch located at the eastern corner of the addition. Two awning windows with transoms and a door with a single fixed pane in its upper half are set in the southeast elevation of the porch, while three identical windows and an identical door complete the porch's northwest elevation. In the brick portion of the southeast elevation, three one-over-one, double hung sash with arched rowlock headers are symmetrically arranged. The westernmost bay, however, is smaller than the other bays. The roof is broken by a gable dormer over the eastern room of the original house and a corbelled chimney to the west of the dormer. An additional corbelled chimney also rises from the shed roofed addition.

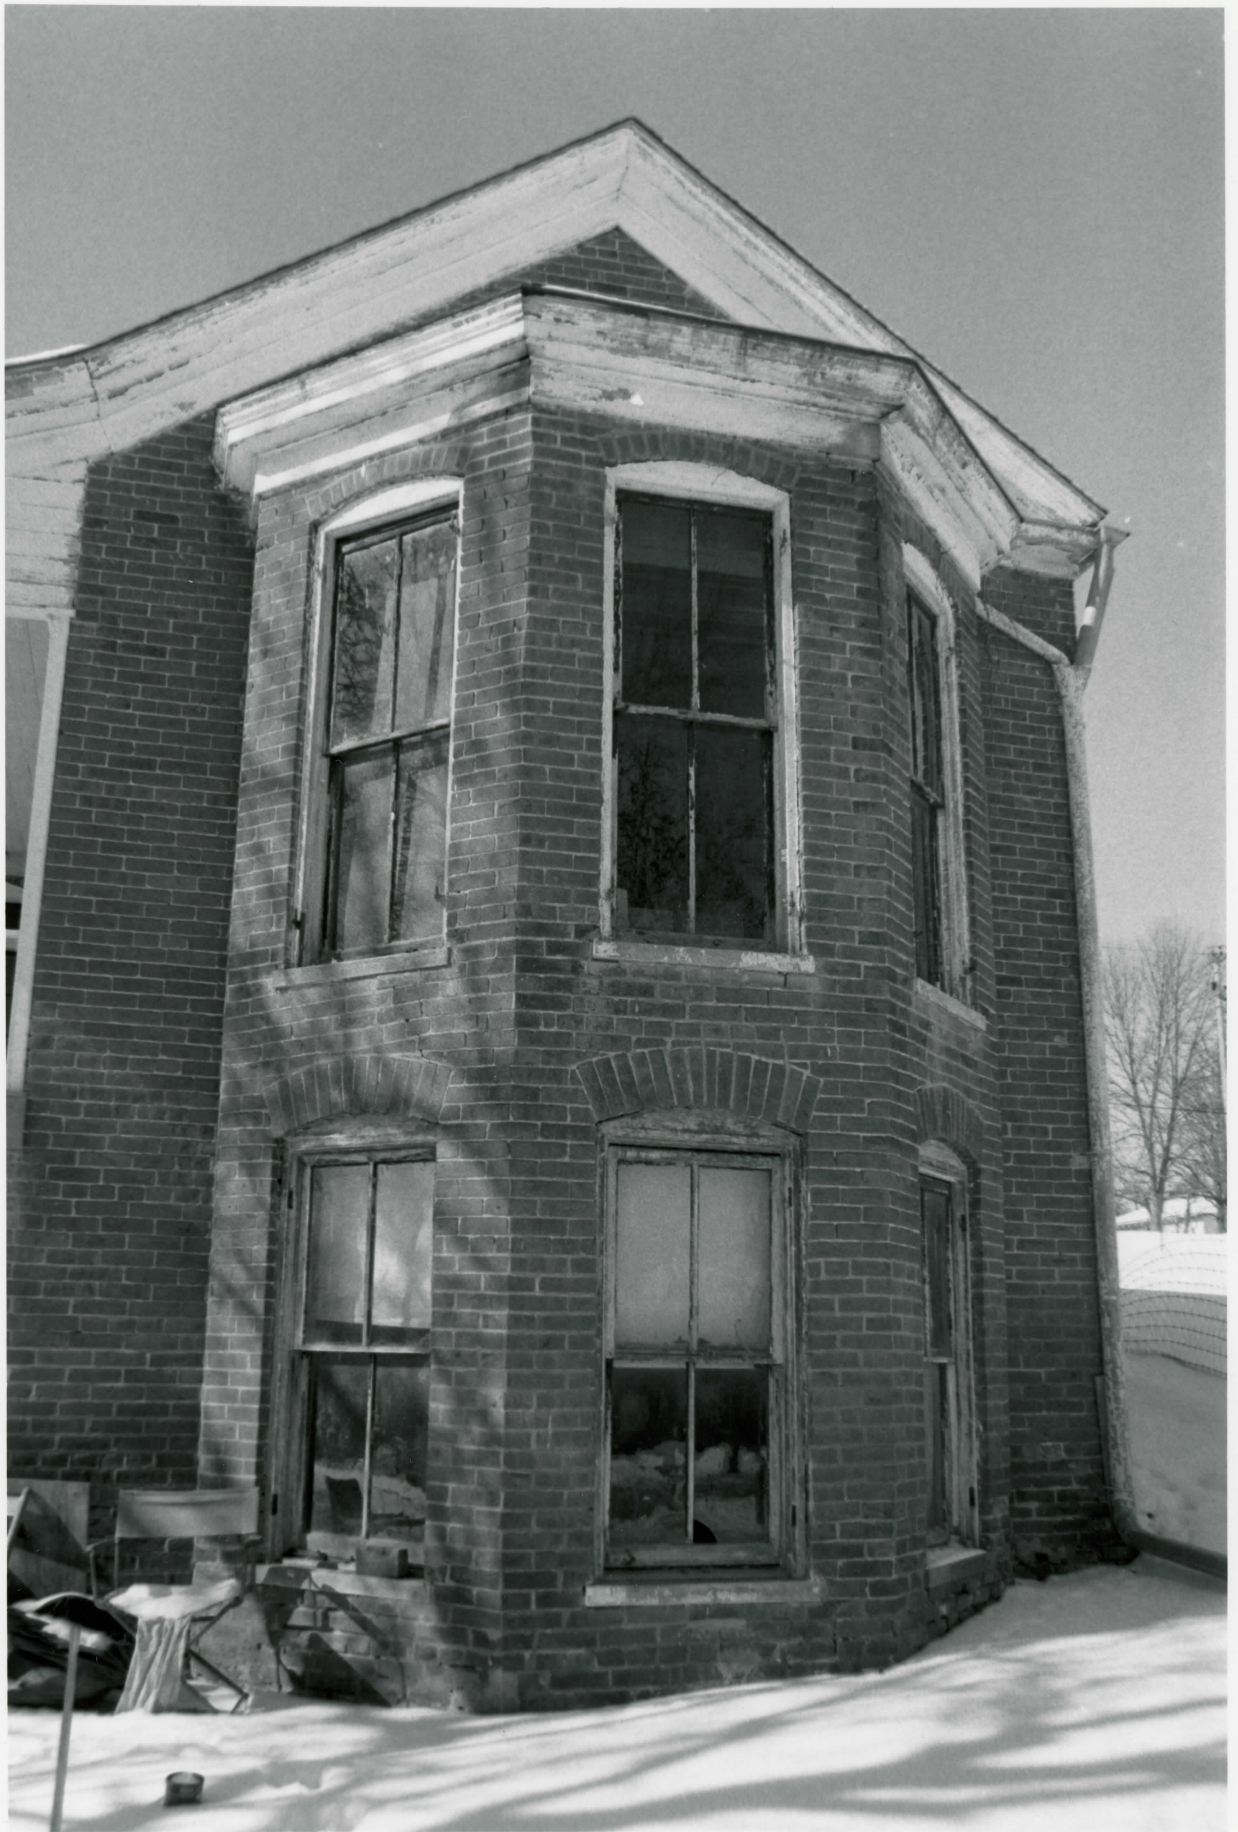
4 of 10

View from Northeast

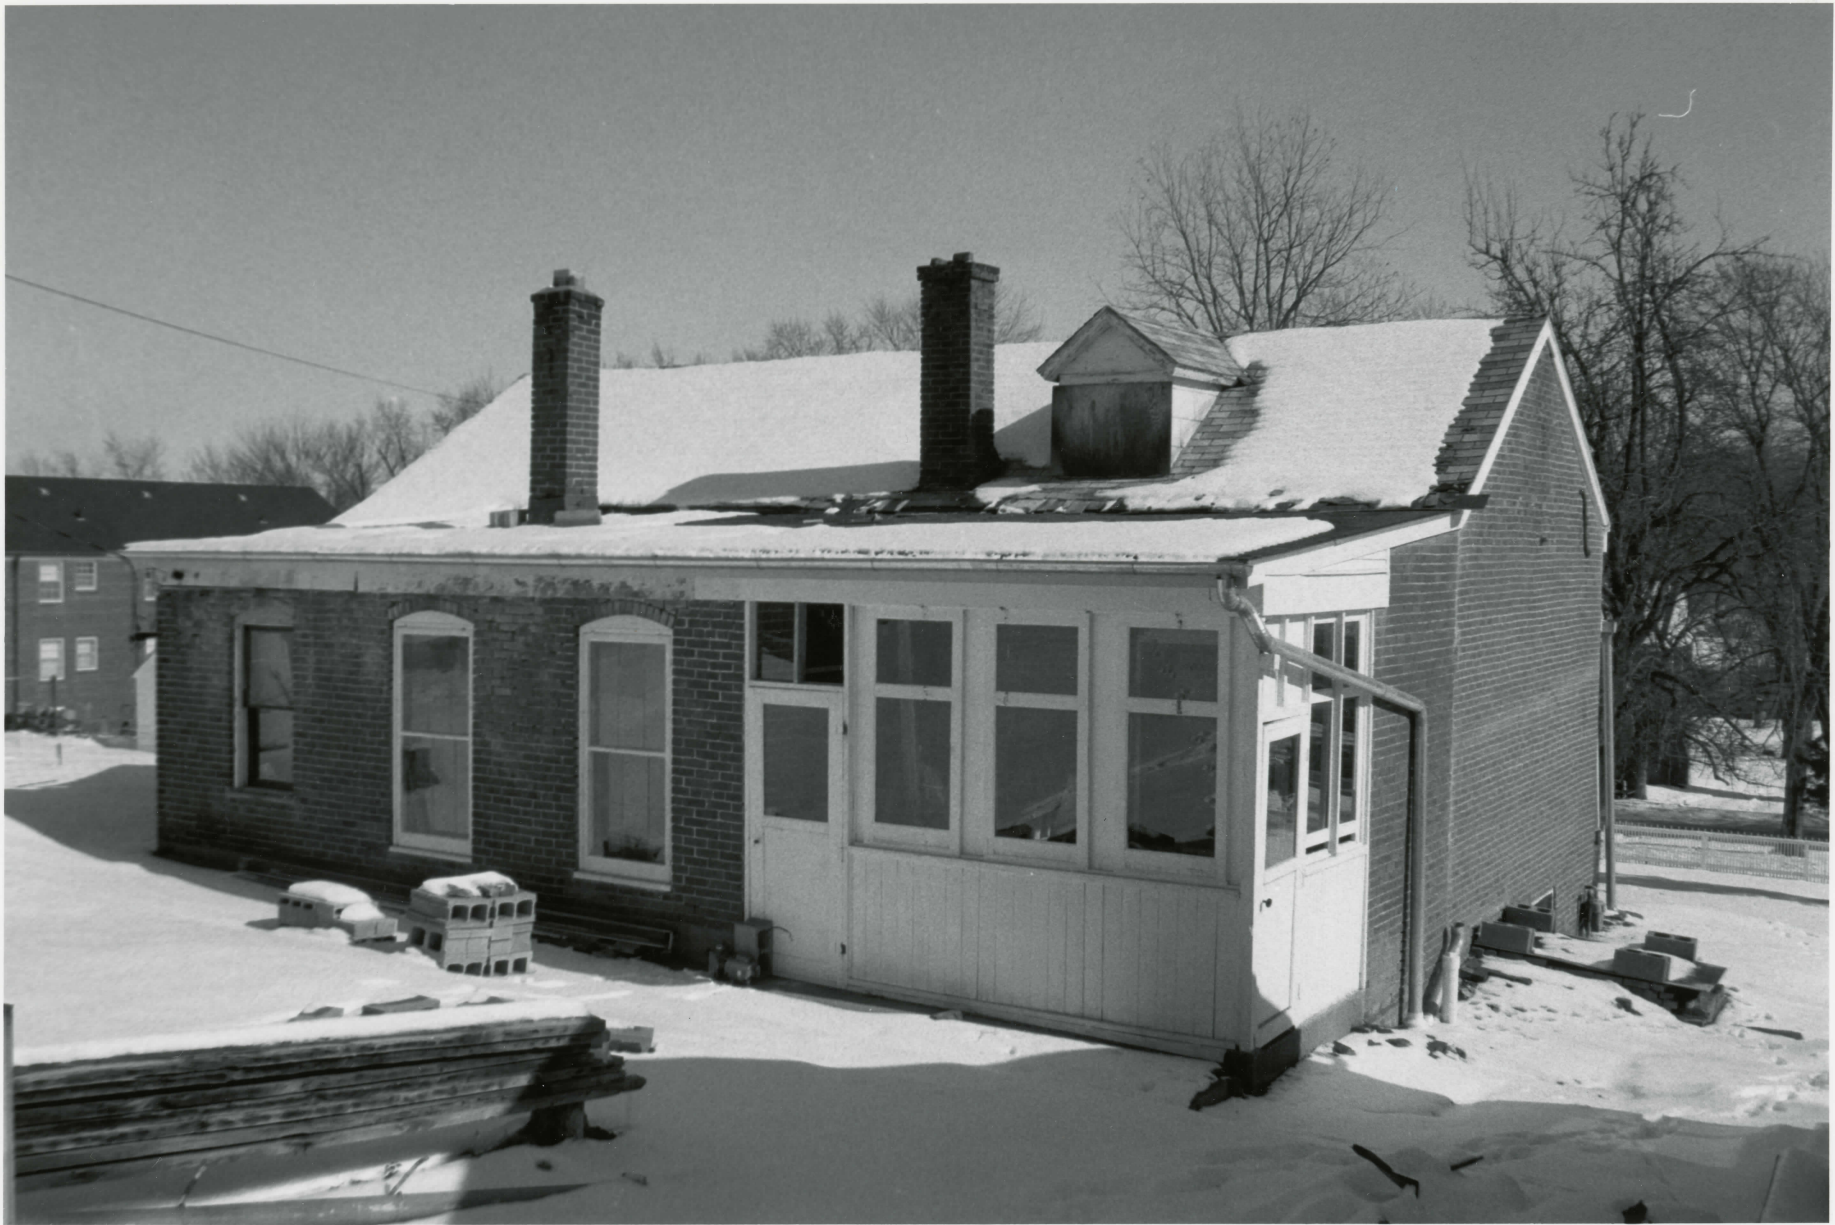
5 of 10

View from Southwest

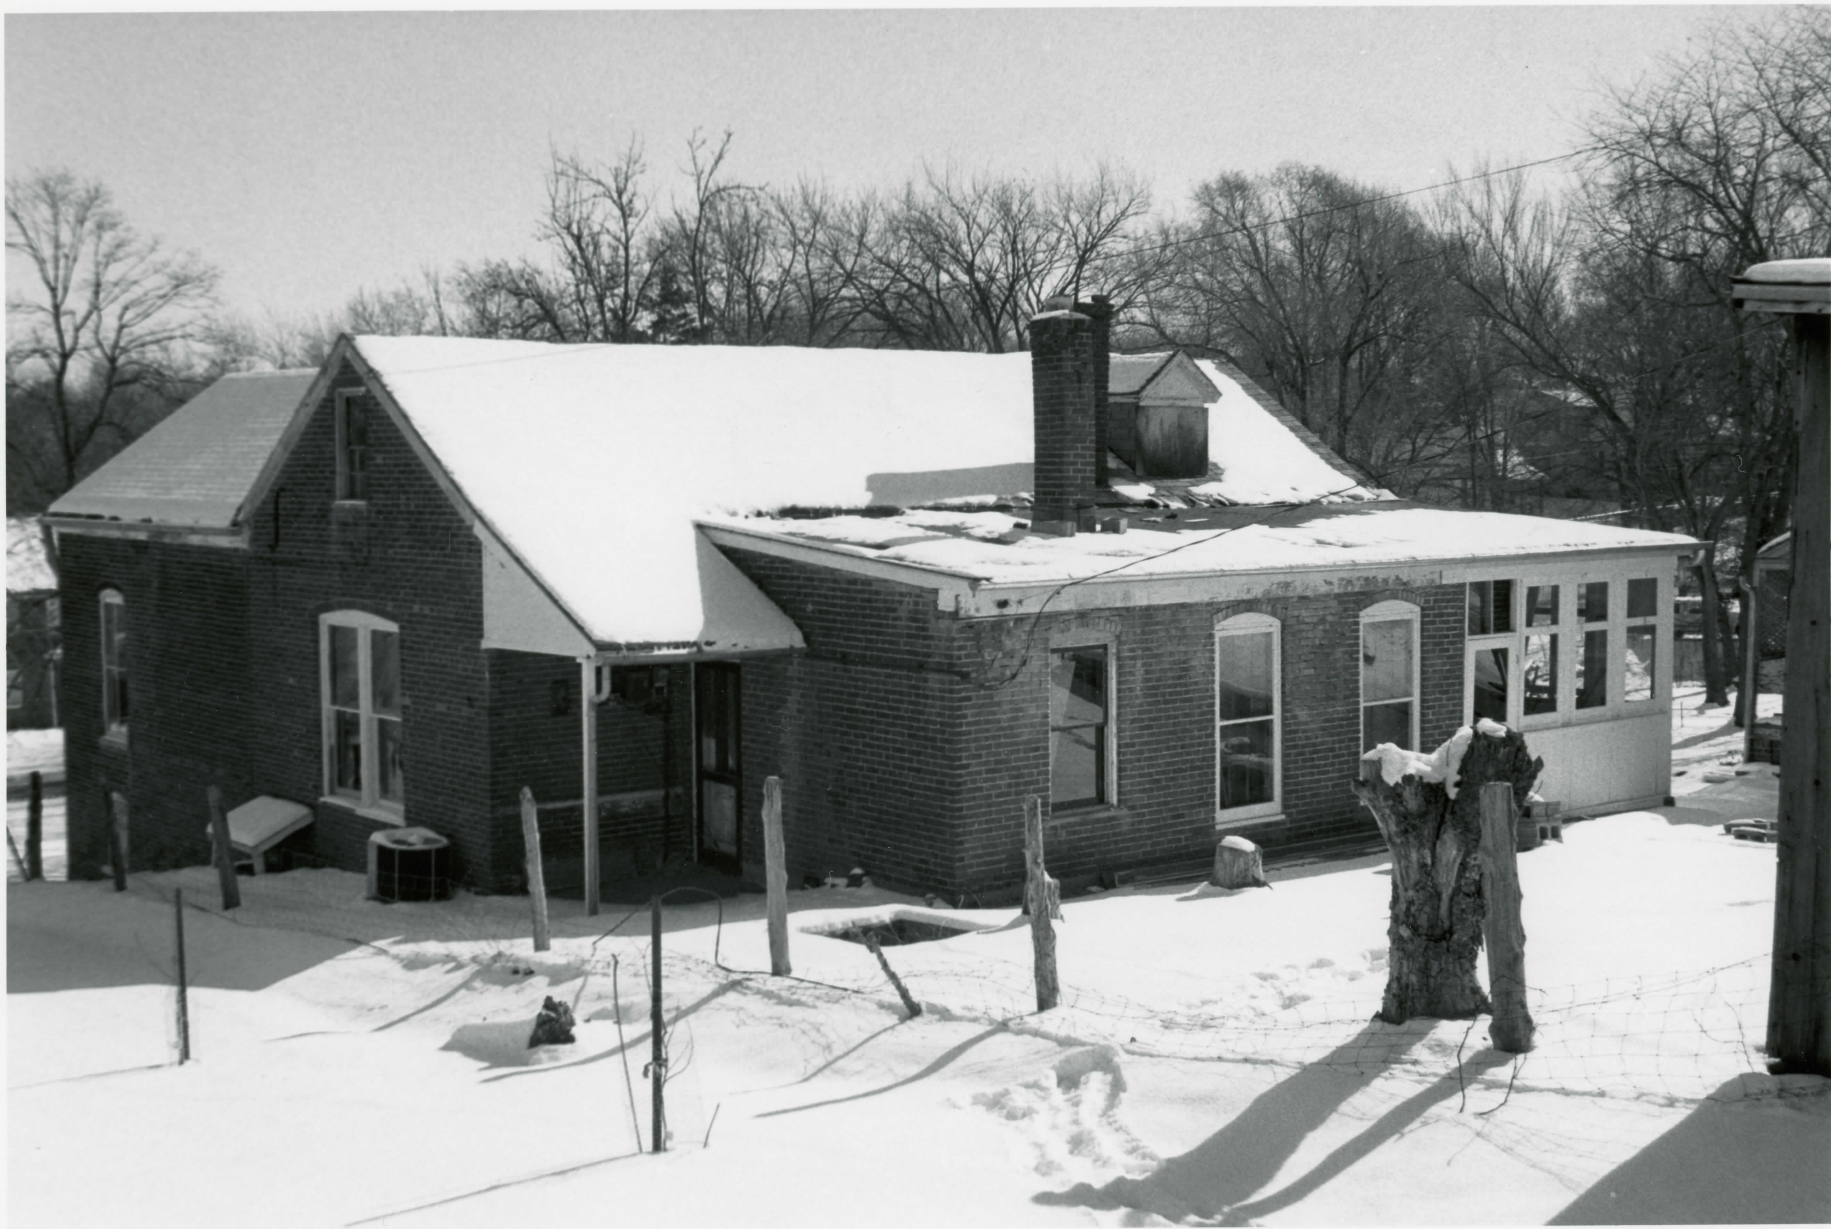
#6 of 10

View from Northwest

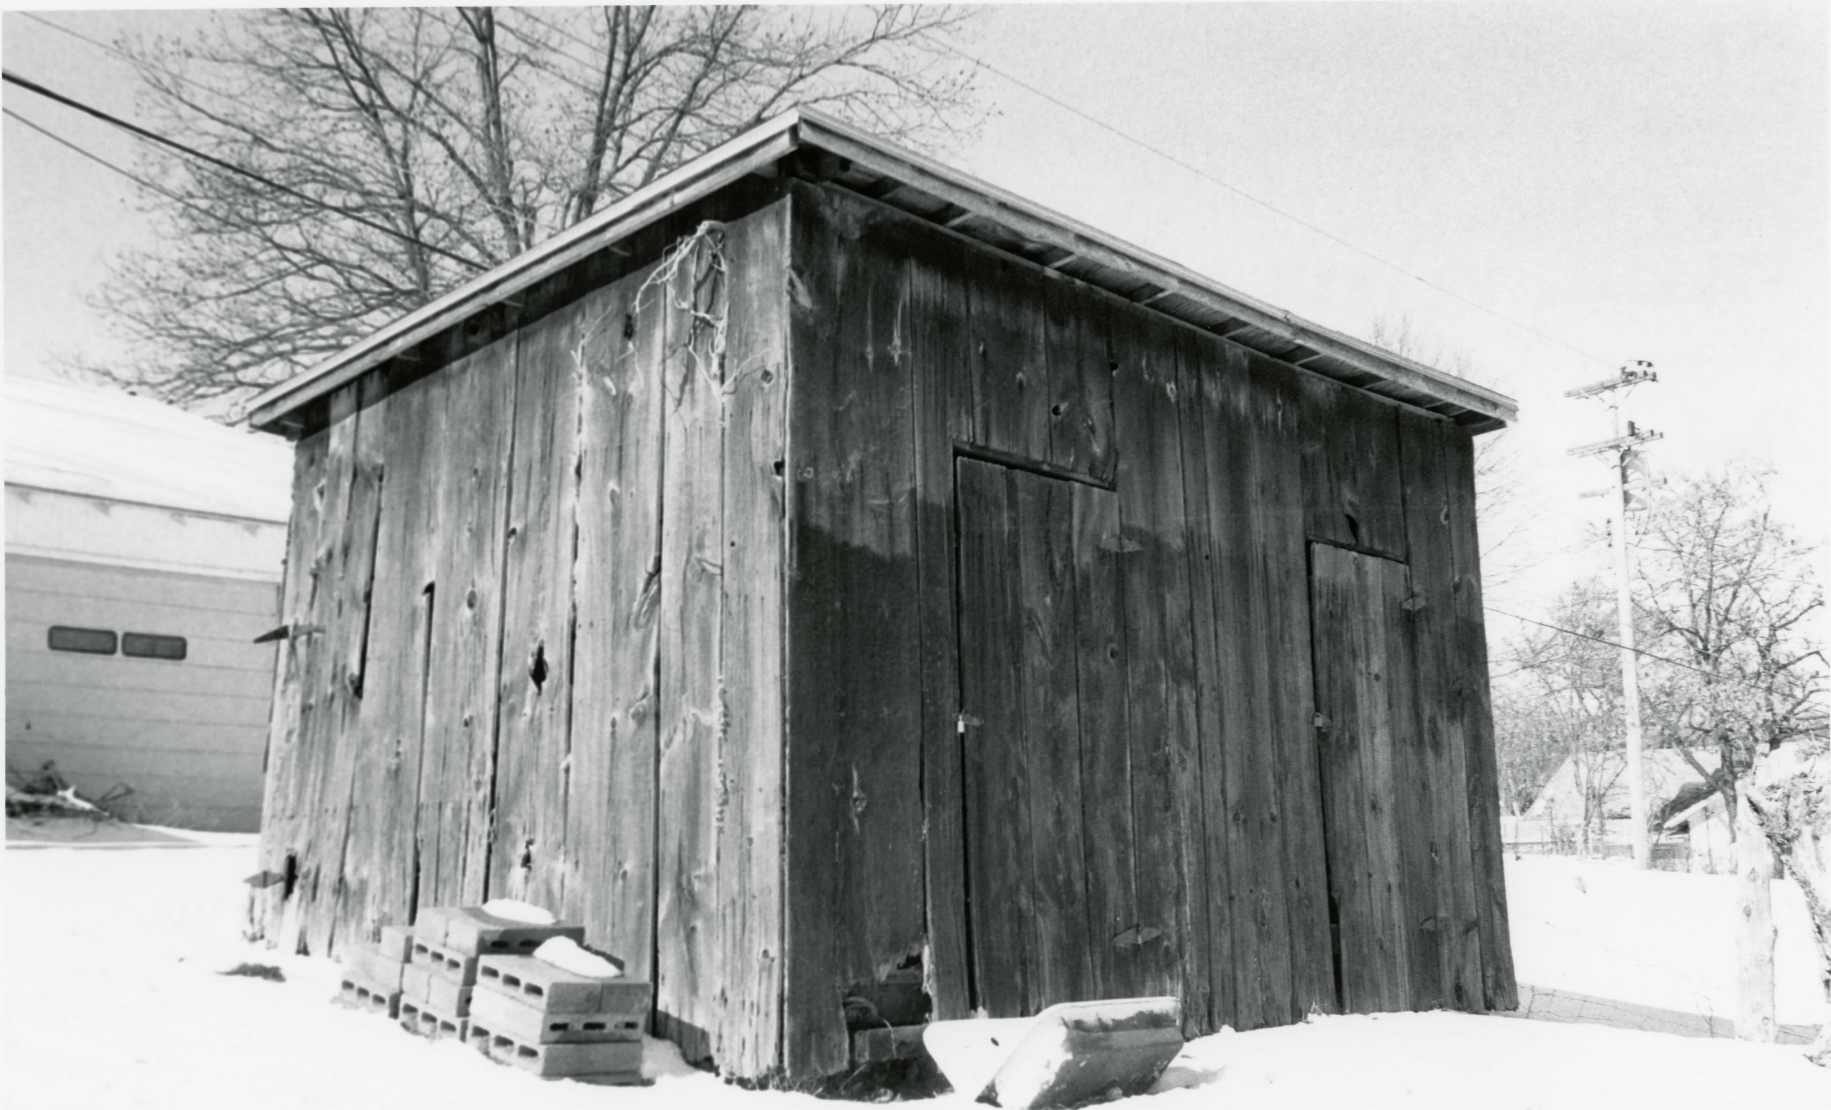
7 of 10

Shed, view from Southeast

A circa 1920 shed sided with vertical boards sits at the edge of the property and against an alley to the west of the house. Two rough wooden doors open on both the northeast and southwest elevations. In 1988, the building was roofed with tin. It rests on brick piers.

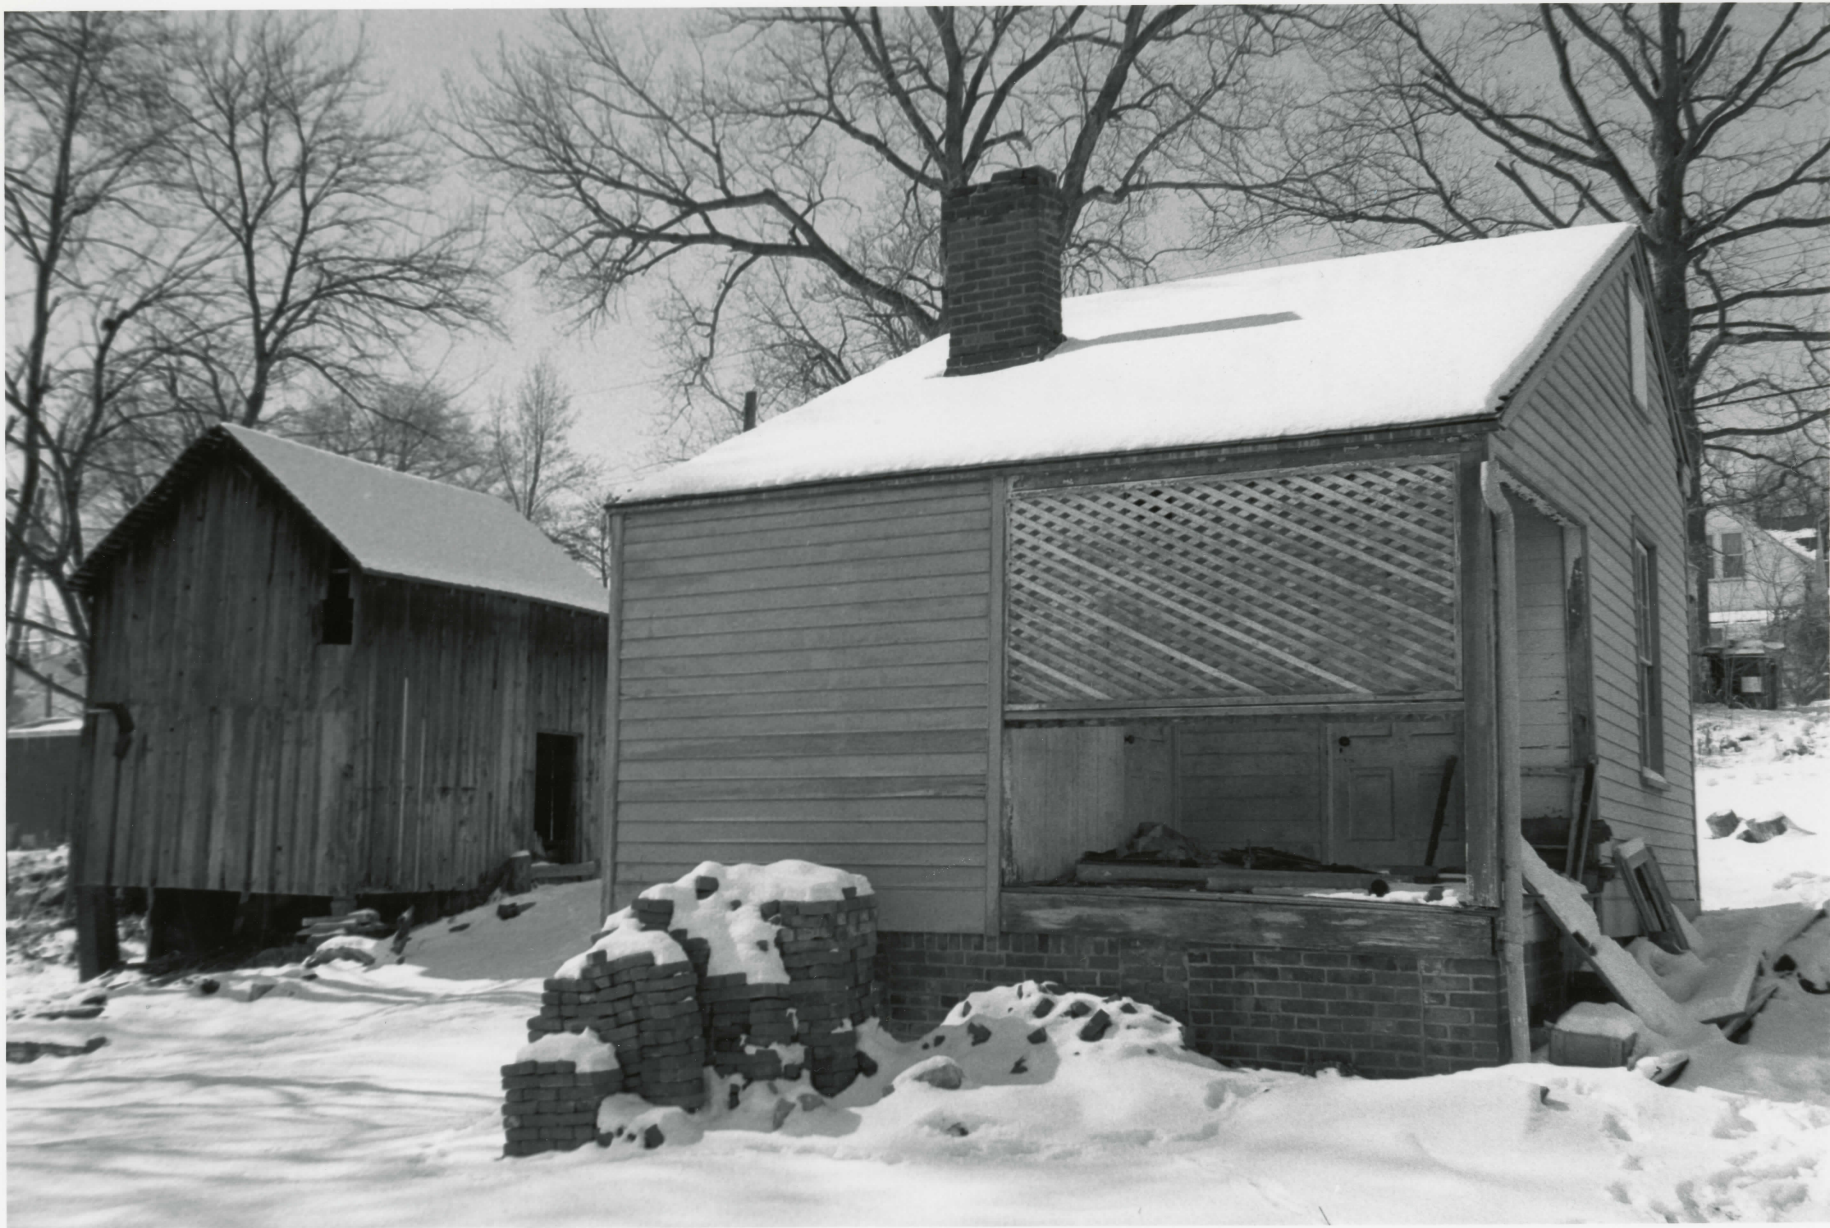
8 of 10

Wash house and barn, view from Northeast

The frame building south of the house may have served as a wash house. It contains two rooms of unequal size. Sheathed with composition shingles, its gable roof extends over a recessed corner porch and room on its northeast elevation and resembles a reversed saltbox roof. A single window bay with no sash is centered in the gable of the northwest elevation, southwest elevation, and gable of the southeast elevation. The three bays open into the larger room. A second empty window bay on the southeast elevation opens into the smaller room. A door opens in the room's northeast elevation onto the recessed porch, which occupies half of this elevation and is partially screened with wooden lattice. The smaller room, which occupies the remainder of the elevation, is entered from the recessed porch by a door in its northeast elevation. A chimney extends from the small room and pierces the roof's eastern slope.

Southeast of the wash house and also resting against the alley, a cow barn perches on brick piers. Its lower floor is divided into a stall on its west side and a crib on its east side. A loft occupies the upper level of the barn. Doors open in the stall on the northwest and southeast elevations. Two asymmetrically placed window cut-outs, covered with hinged doors, provide ventilation for the stall on the southwest elevation, while a single window opening on the southeast elevation opens into the crib. Fragments of wooden underpinning also remain on the southeast elevation. The barn is roofed with composition shingles.

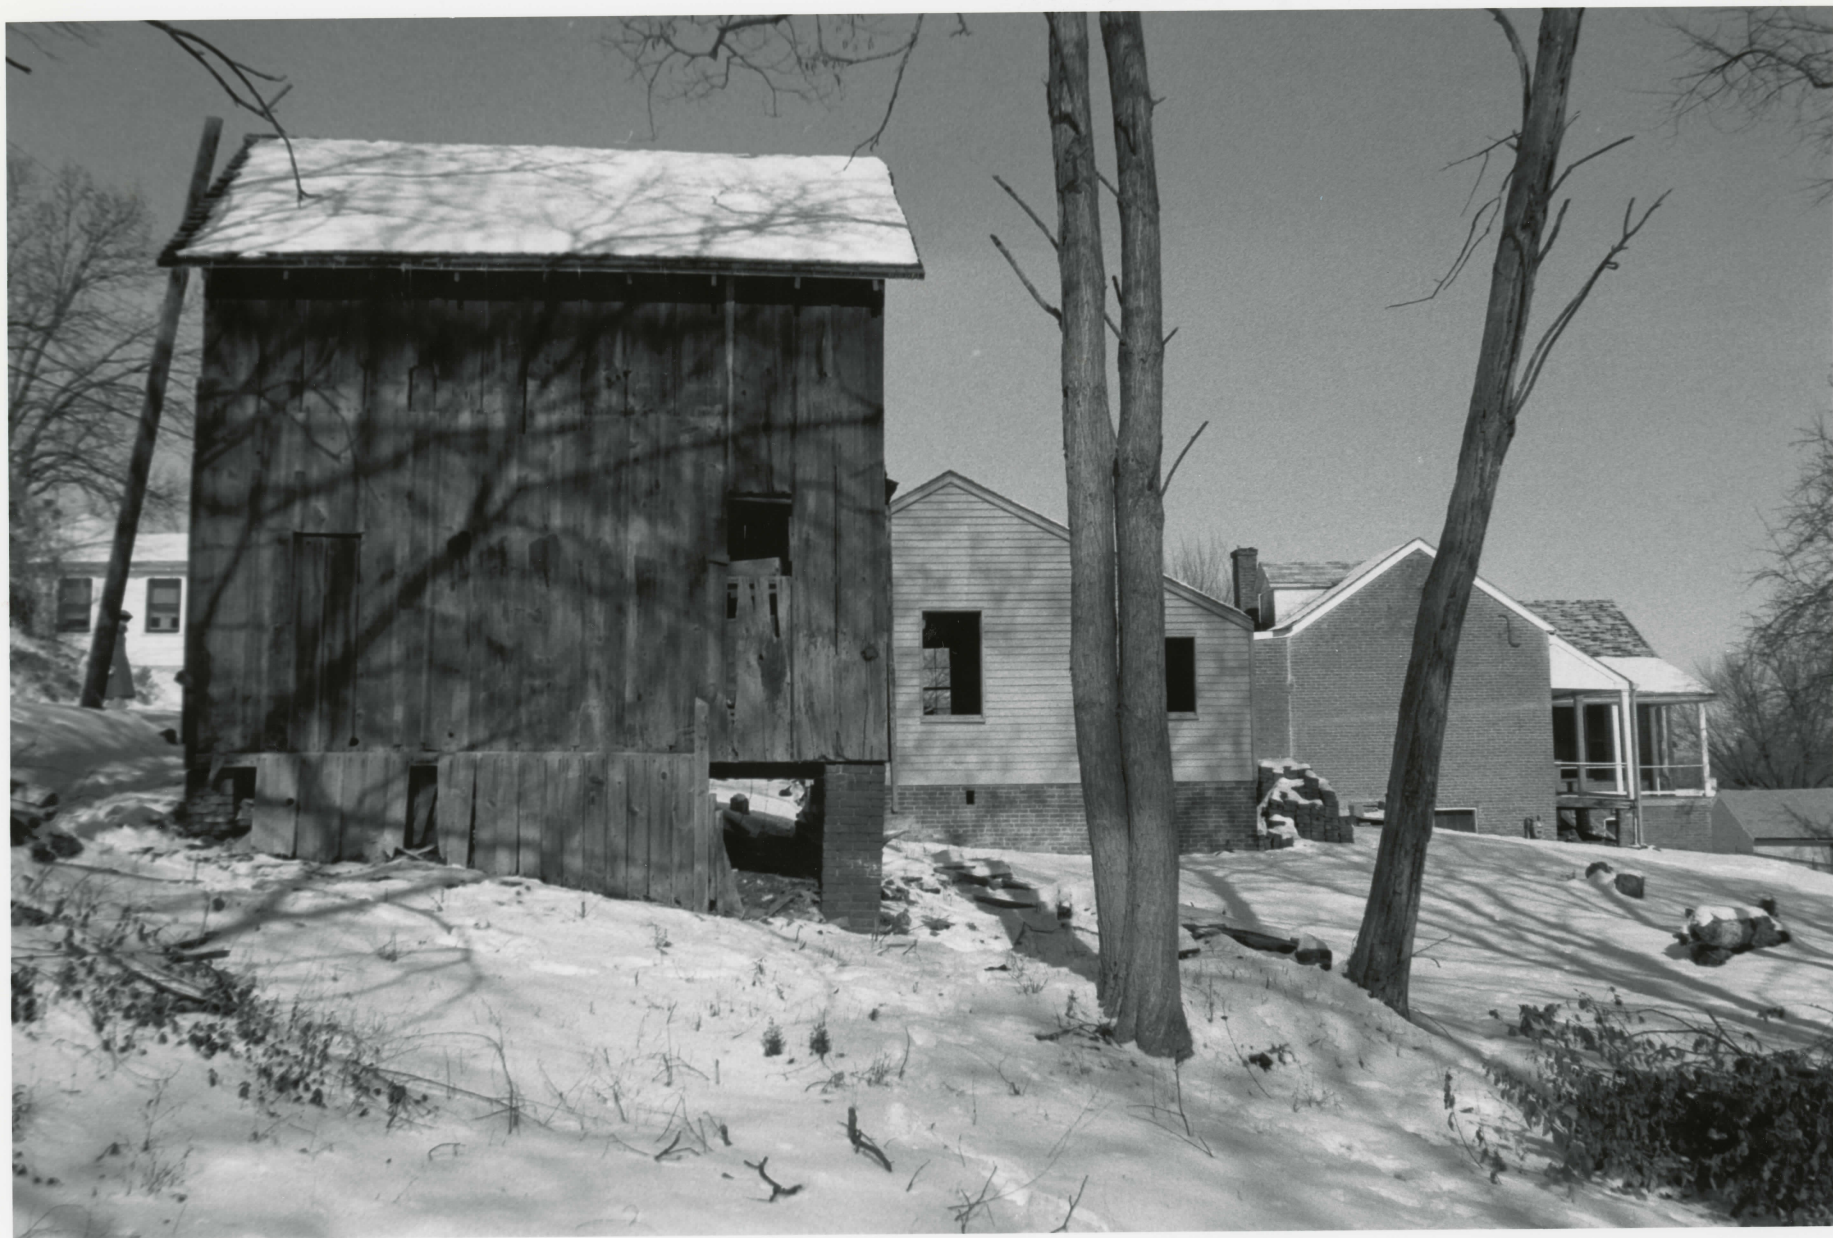
9 of 10

BARN, wash house, and house; view from Southeast
