National Register of Historic Places
Inventory—Nomination Form

historic name Dauwalter, John S., House
other names/site number 0-42

street & number 817 Seventh Street N/A not for publication
city, town Boonville N/A vicinity
state Missouri code MO county Cooper code 053 zip code 65233

JOHN S. DAUWALTER HOUSE

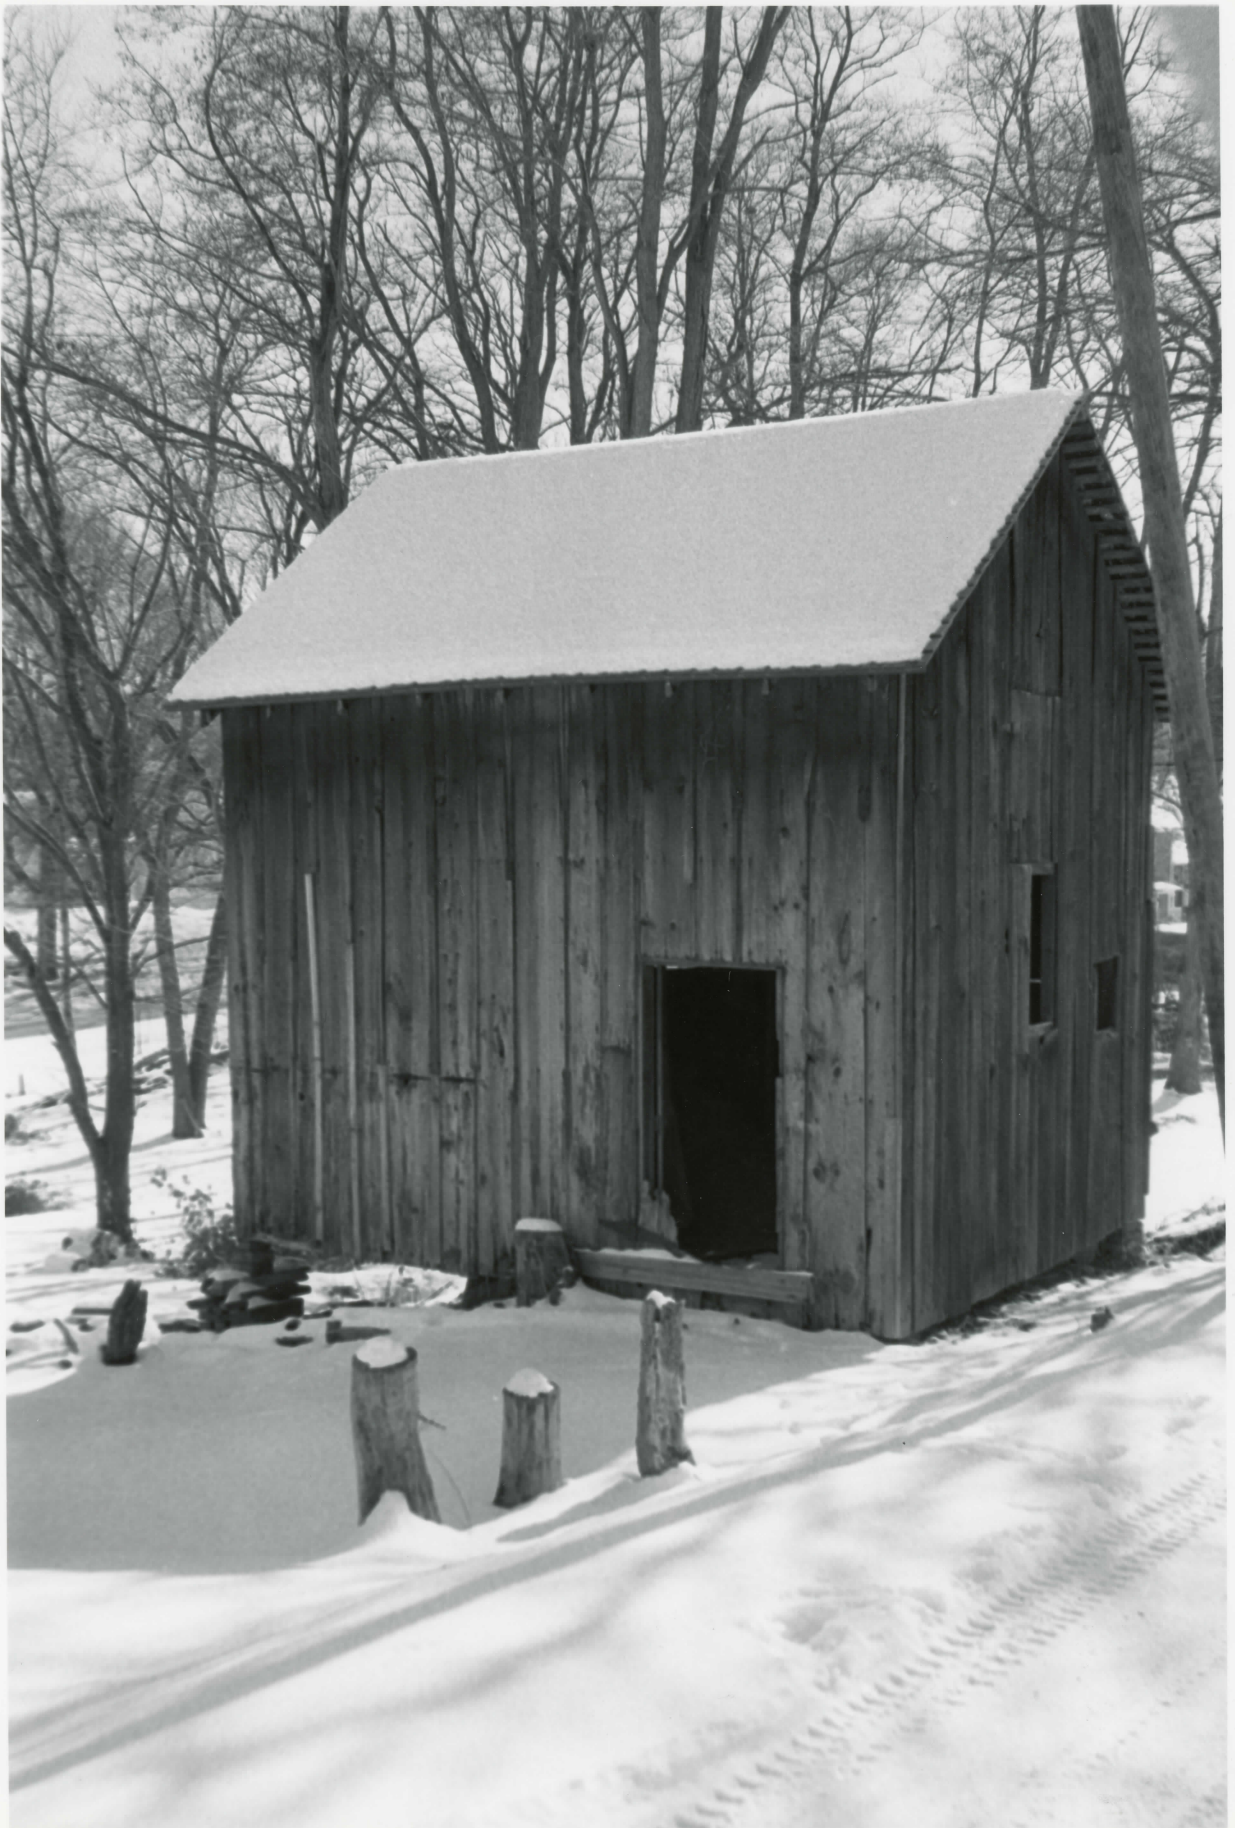
9 of 10

BARN, wash house, and house; view from Southeast
