**National Register of Historic Places
Inventory—Nomination Form**

HISTORIC RESOURCES OF BOONVILLE, MO.

DISTRICT F (Contains 12.86 acres)

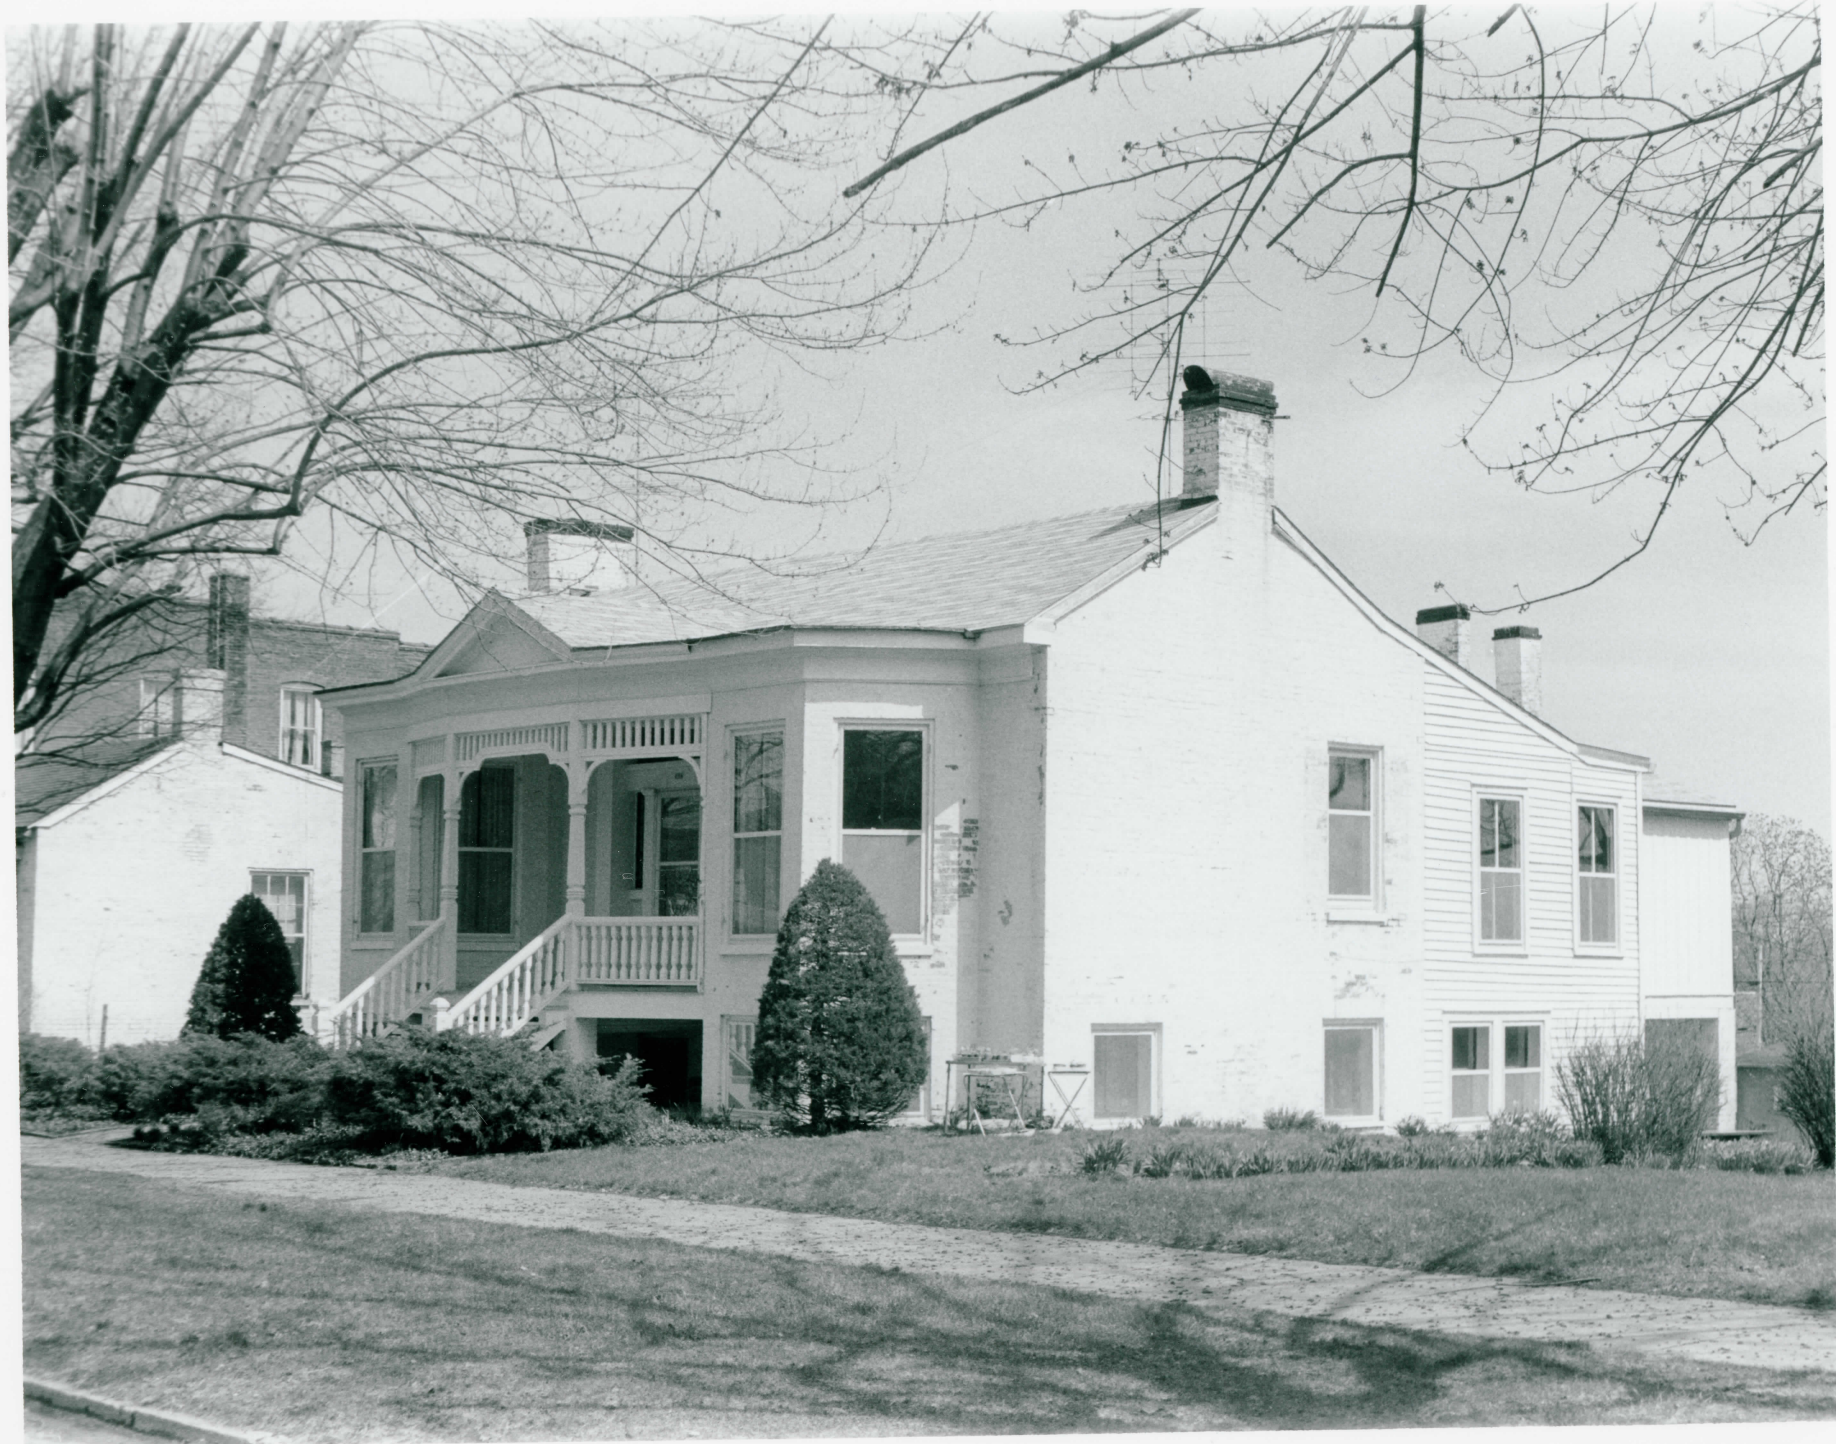
Photo 30 of 37
HISTORIC RESOURCES OF BOONVILLE, MO.

Haun Residence
District F, #26
612 6th St., Boonville, Cooper County,
Mo., 65233

Boonville, Mo.
View from SW

26. Haun Residence, 612 6th, 1846-48. This Greek Revival brick 1 story residence has a large rear ell and 2 bays added to the front. It has a gable roof. There is a small outbuilding.

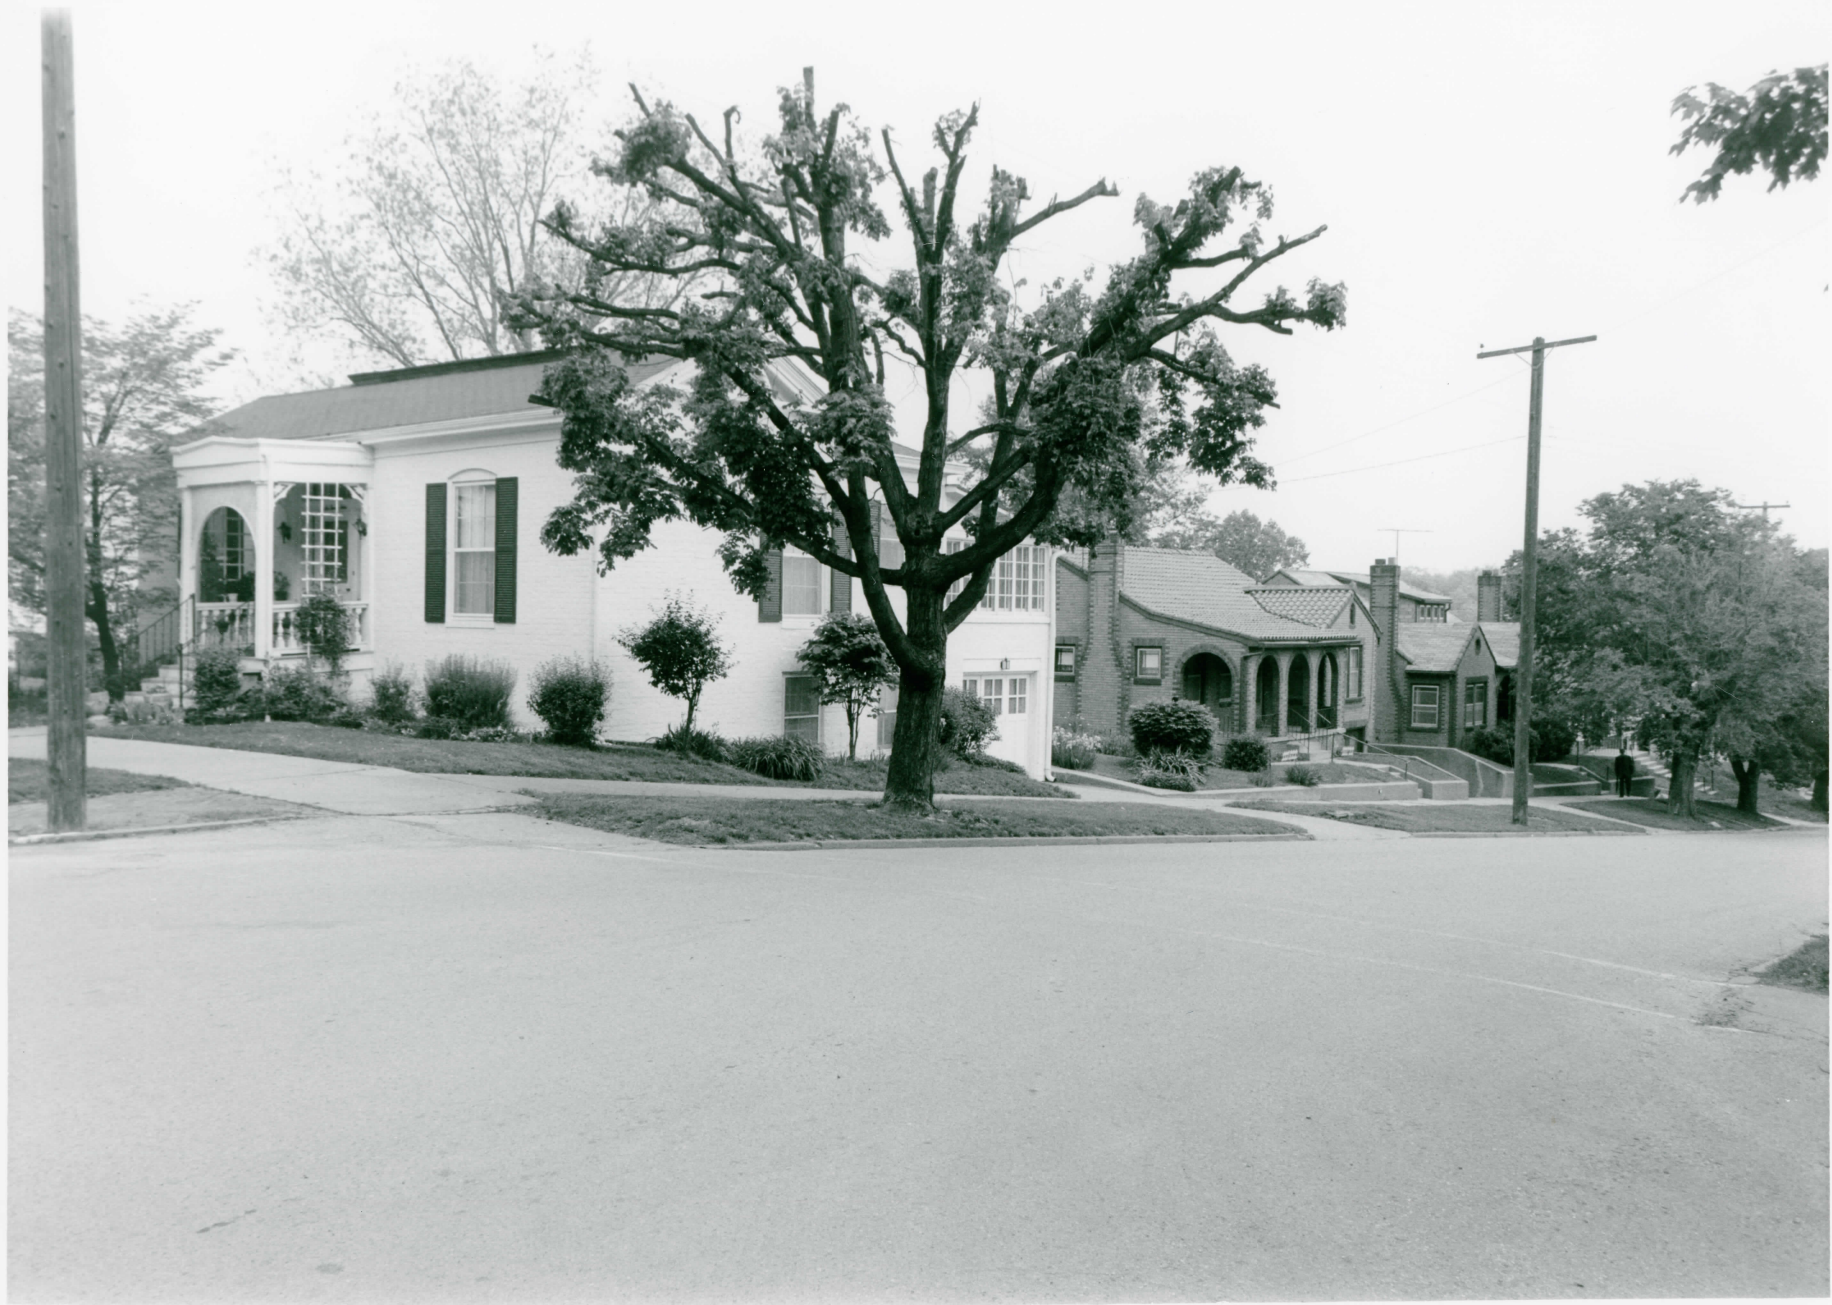
Photo 31 of 37

View from NE Corner of 6th and Locust, left
to right #'s 27, 28 and 29.

27. Miller Residence, 624 6th, 1860. Missouri German in style, the brick structure is 1 story and L shaped with a cross gable roof.
28. Huecker Residence, 607 Locust, 1930's. This buff brick 1 1/2 story cottage is accented by red brick. It has a gable roof.

29. Humfield Residence, 609 Locust, 1930's. Built in the cottage style, this 1 1/2 story brick structure is capped by a gable, red tile roof.
