NATIONAL REGISTER OF HISTORIC PLACES
REGISTRATION FORM

historic name Poplar Bluff Commercial Historic District
other names/site number N/A

street & number Along sections of S. Broadway and Vine Street not for publication N/A
city or town Poplar Bluff vicinity N/A
state Missouri code MO county Butler code 023 zip code 63901

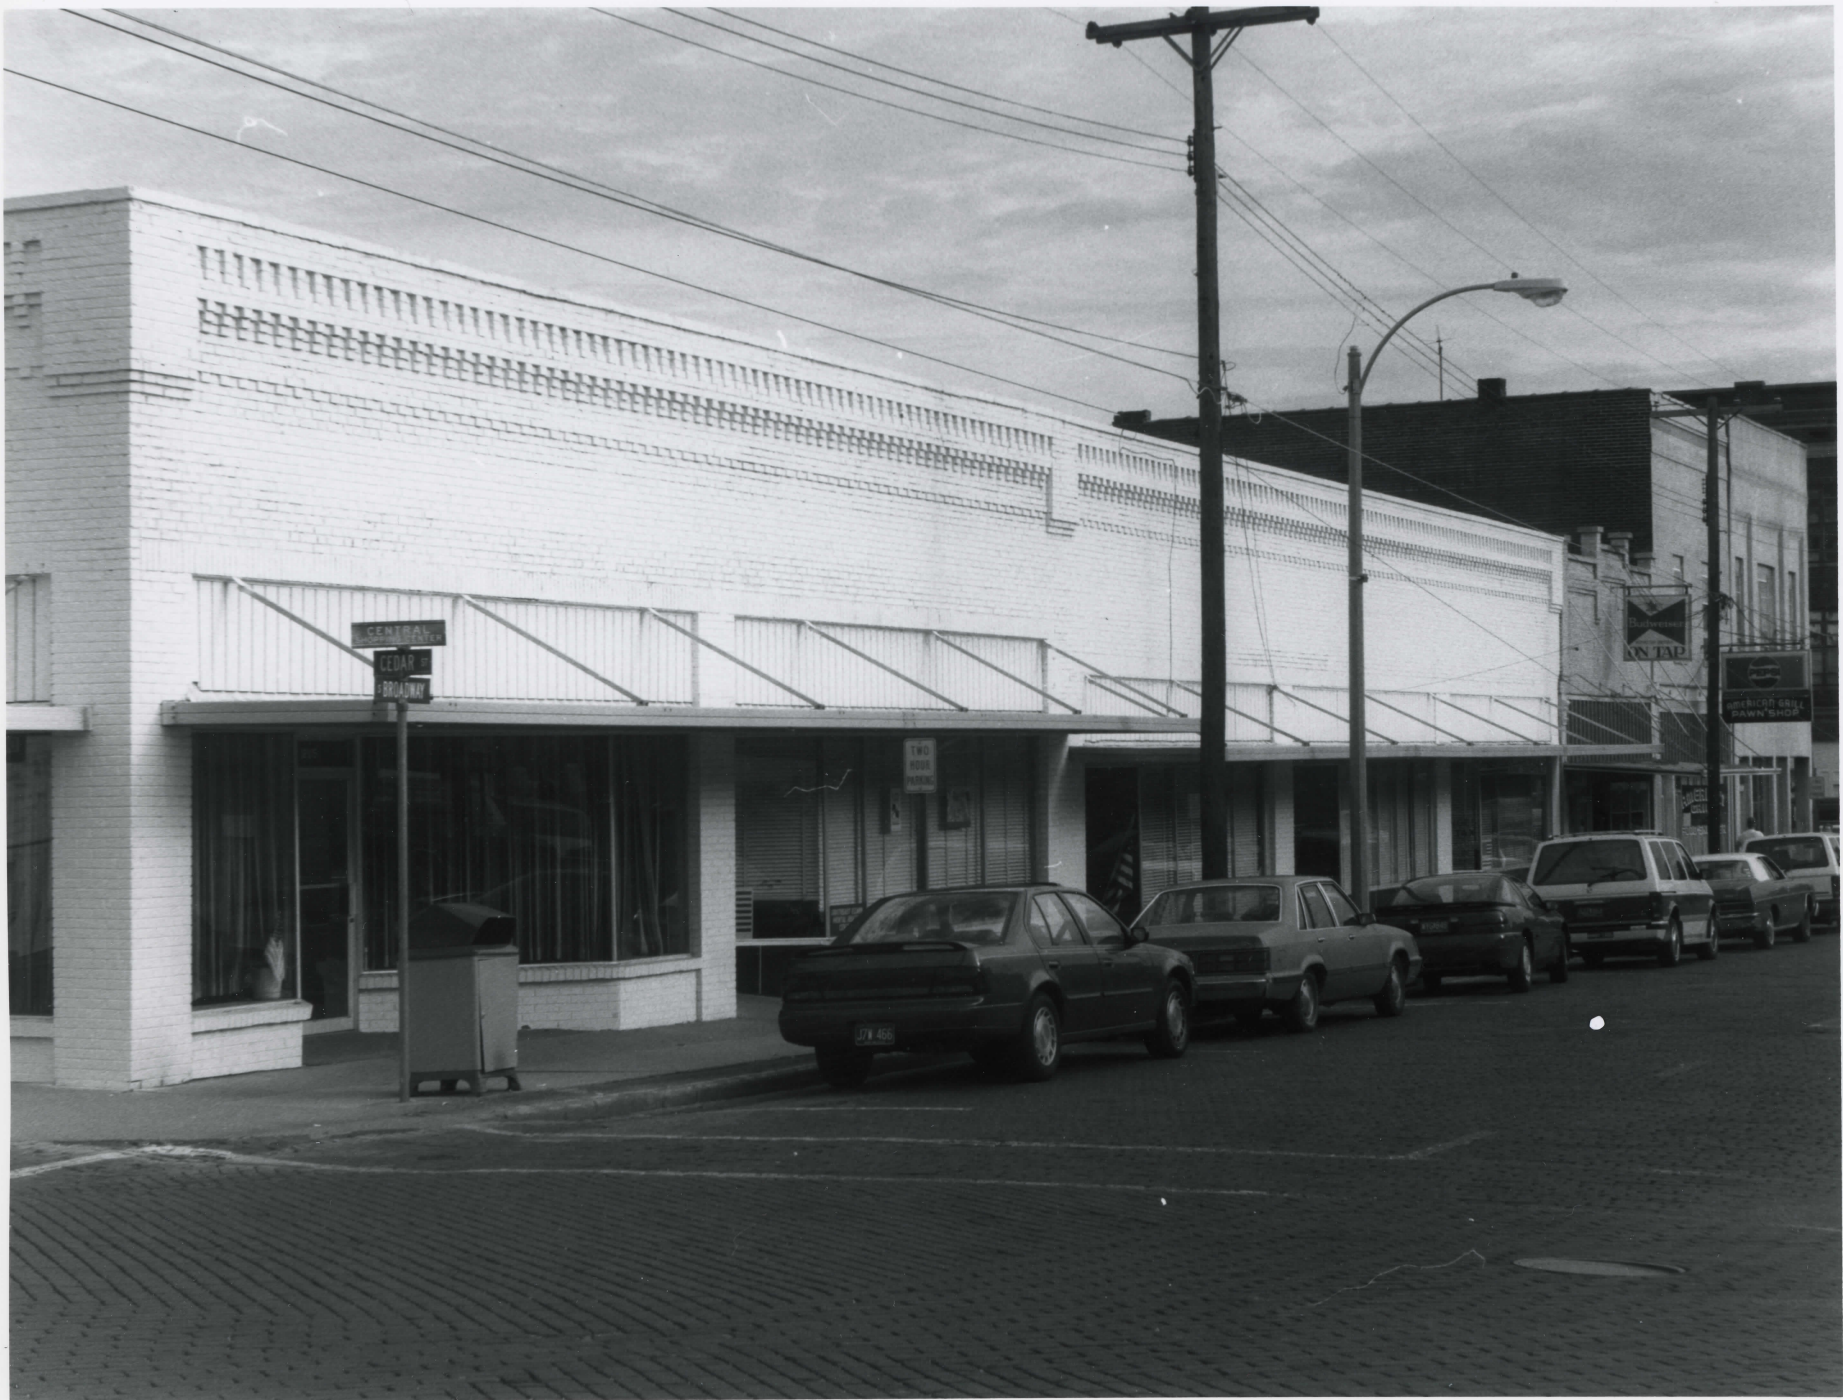
Photo #1 of 12 - Poplar Bluff Commercial Historic District, Poplar Bluff, MO - Butler Co.

Photo No. 1: 200 block of S. Broadway, view towards northwest.

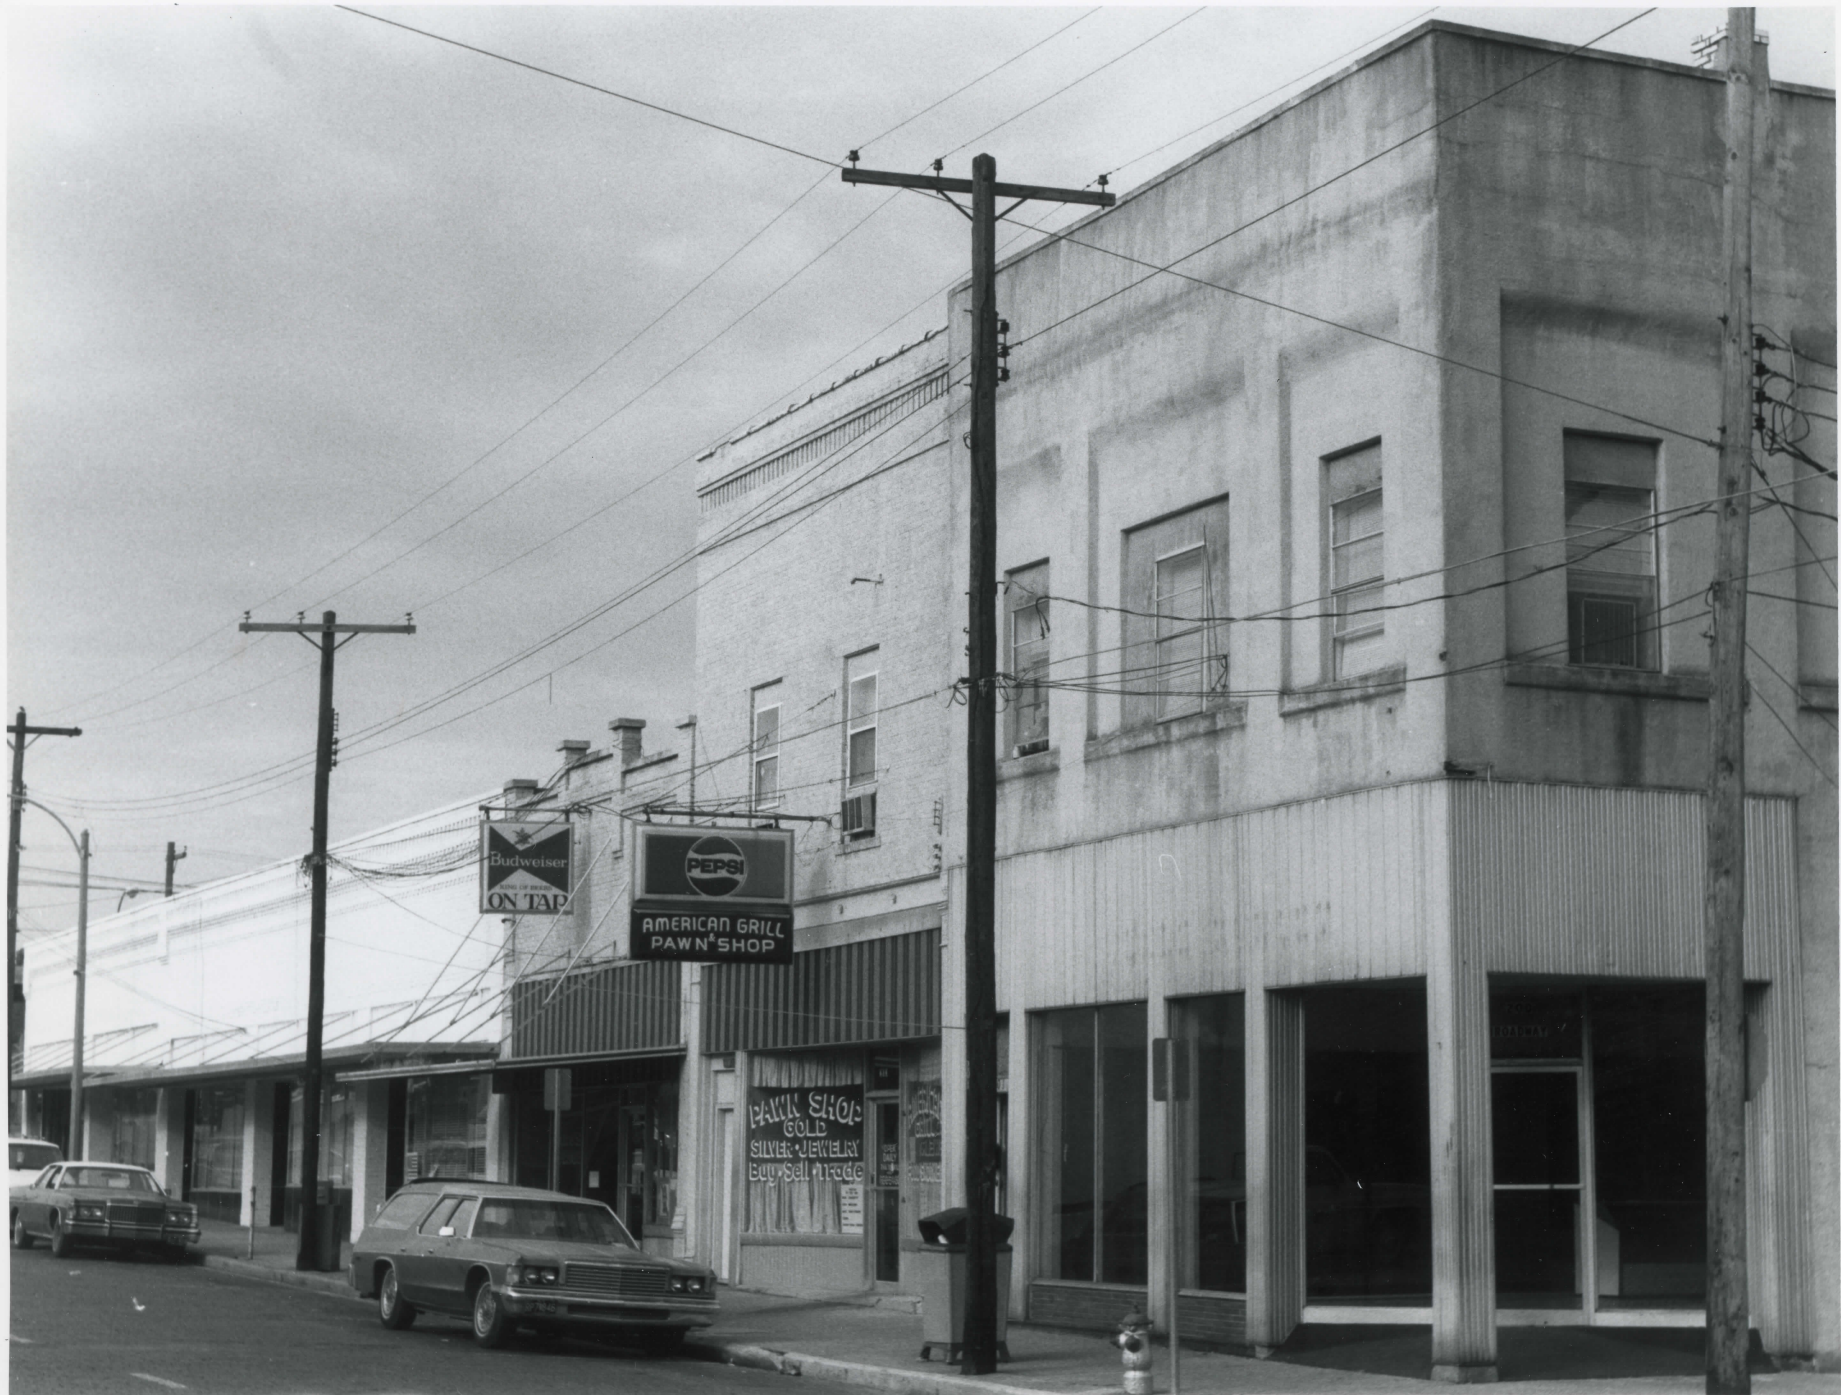
Photo # 2 of 12 - Poplar Bluff Commercial Historic District, Poplar Bluff, MO - Butler Co.

Photo No. 2: 200 block of S. Broadway, view towards southwest.
