National Register of Historic Places
Registration Form

historic name House at 323 Themis Street

House at 323 Themis Street
Cape Girardeau County, MO

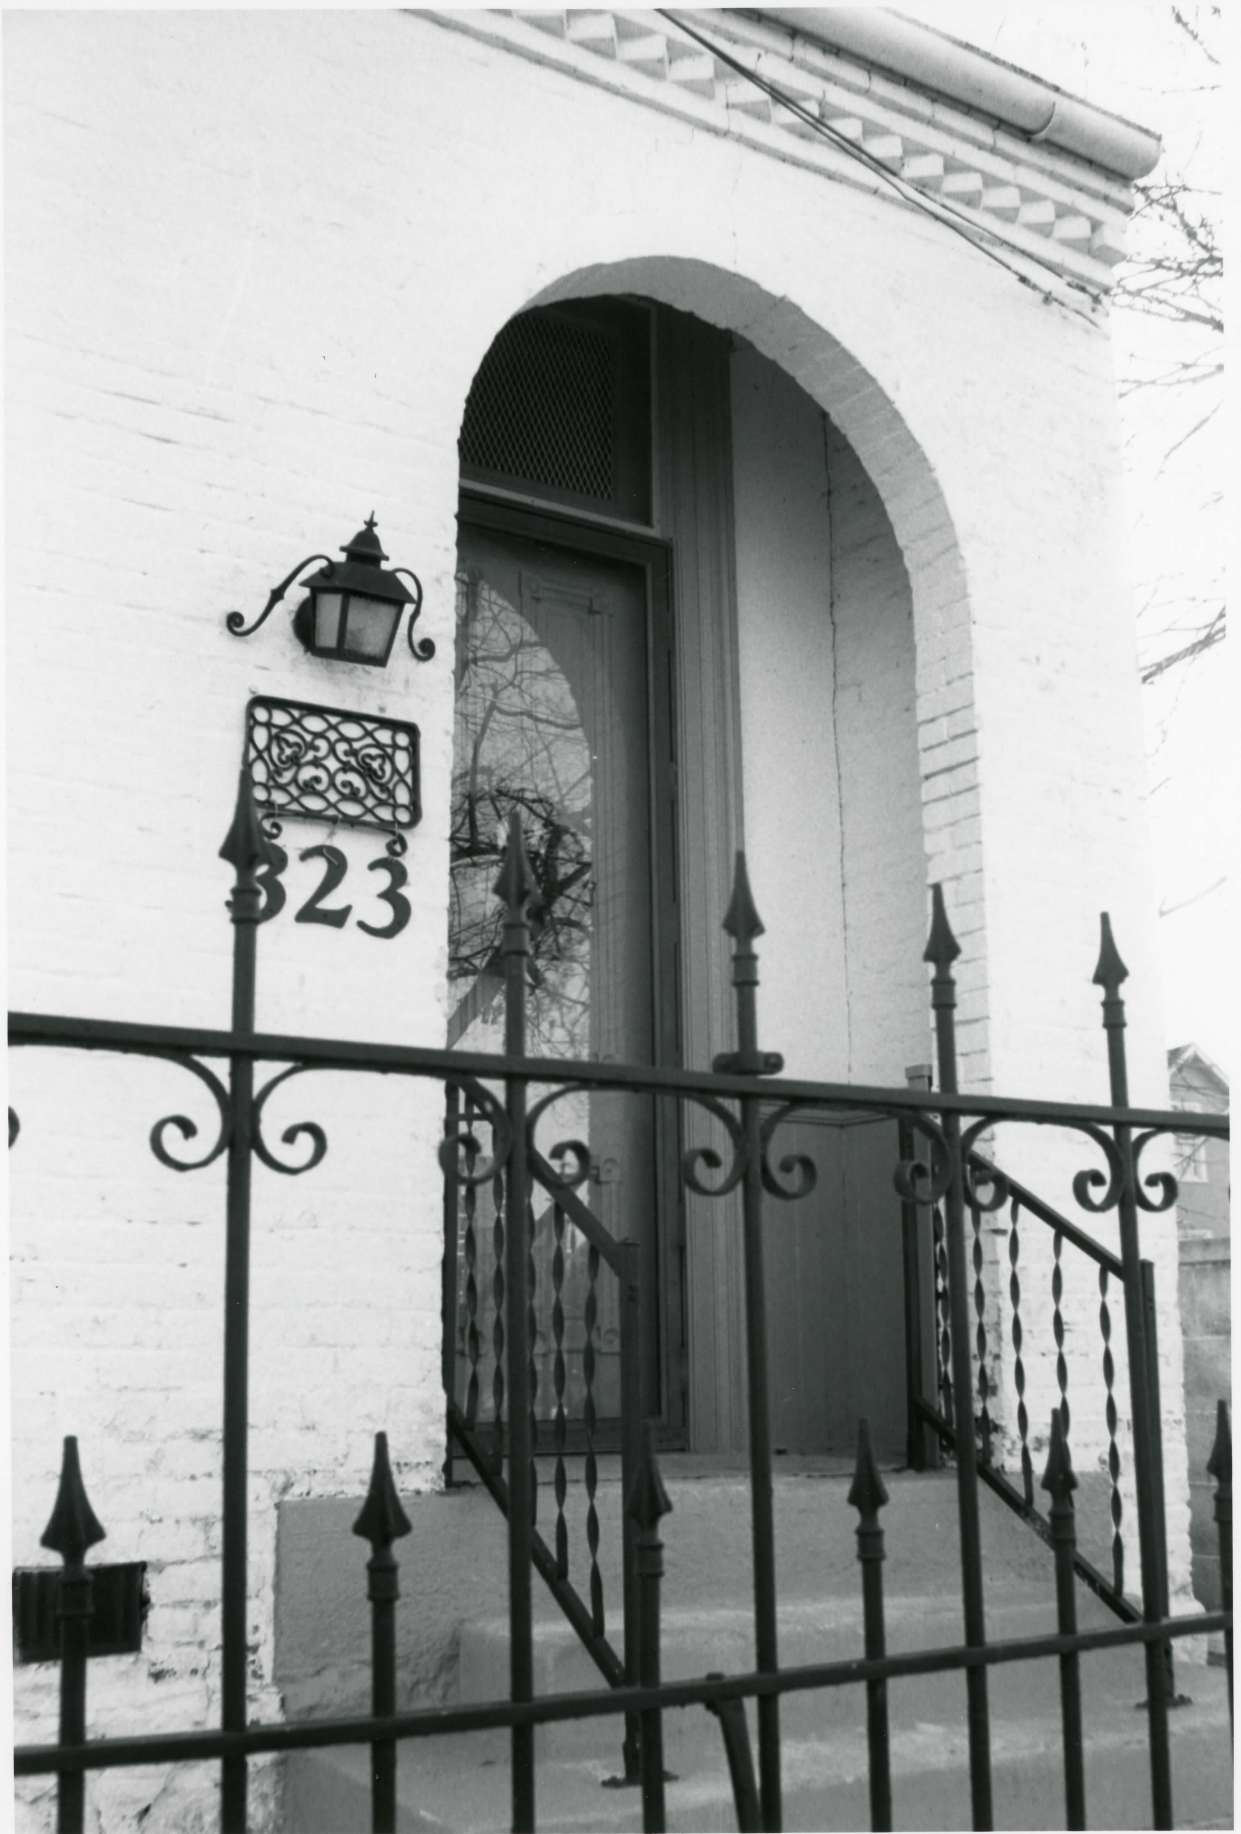
3 of 13

front entry, camera facing south

Narrative: The facade, or north elevation, of the house faces the street and presents a relatively plain appearance. Two arched, double hung, two over two windows and a recessed doorway are set into the wall. The entryway has the original solid wood door, a transom light above it, and wainscoting along the interior. Ornamental brick work below the eaves consists of bricks placed at an angle and bricks projecting beyond the wall surface. The steep second floor roof is interrupted by a gabled dormer which encases the original gable dormer. This alteration was made in the 1964 remodelling.

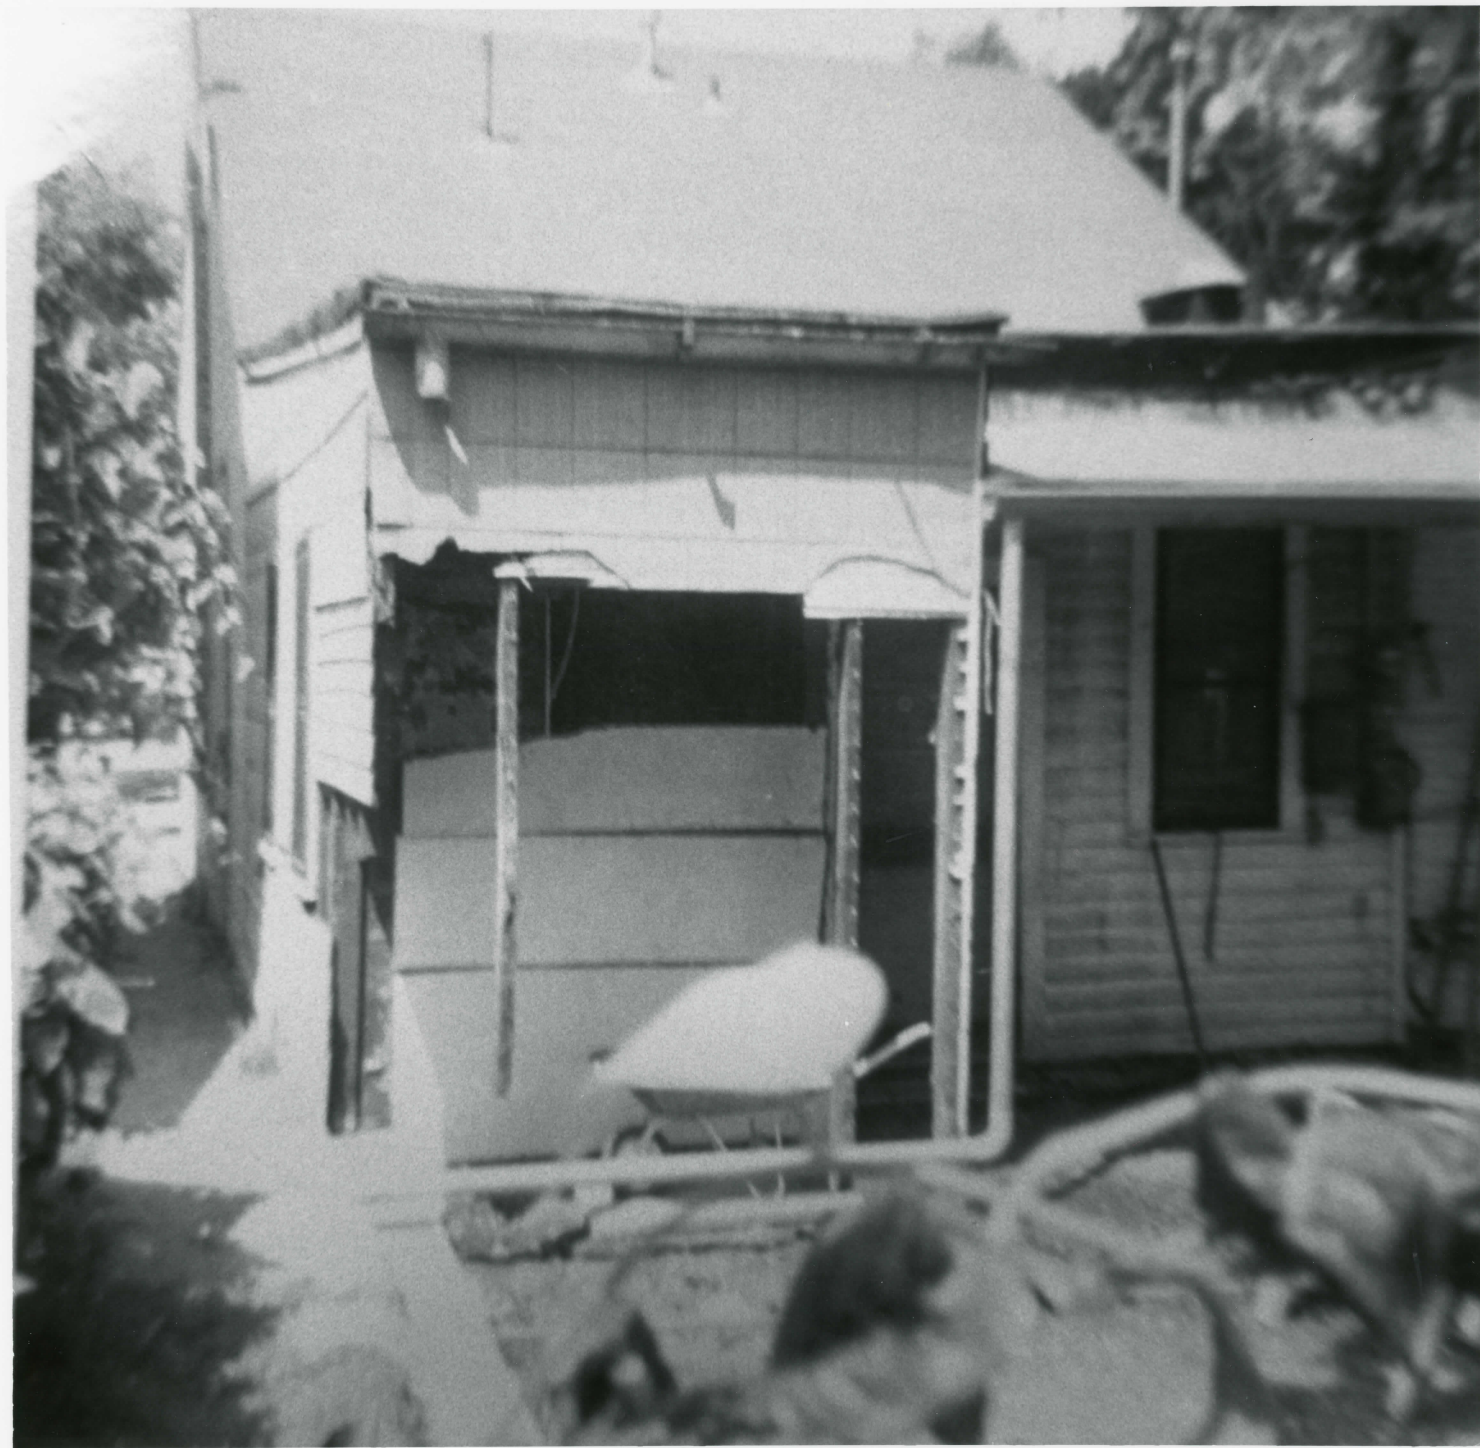
12 of 13

corner facing north - southwest corner before alterations

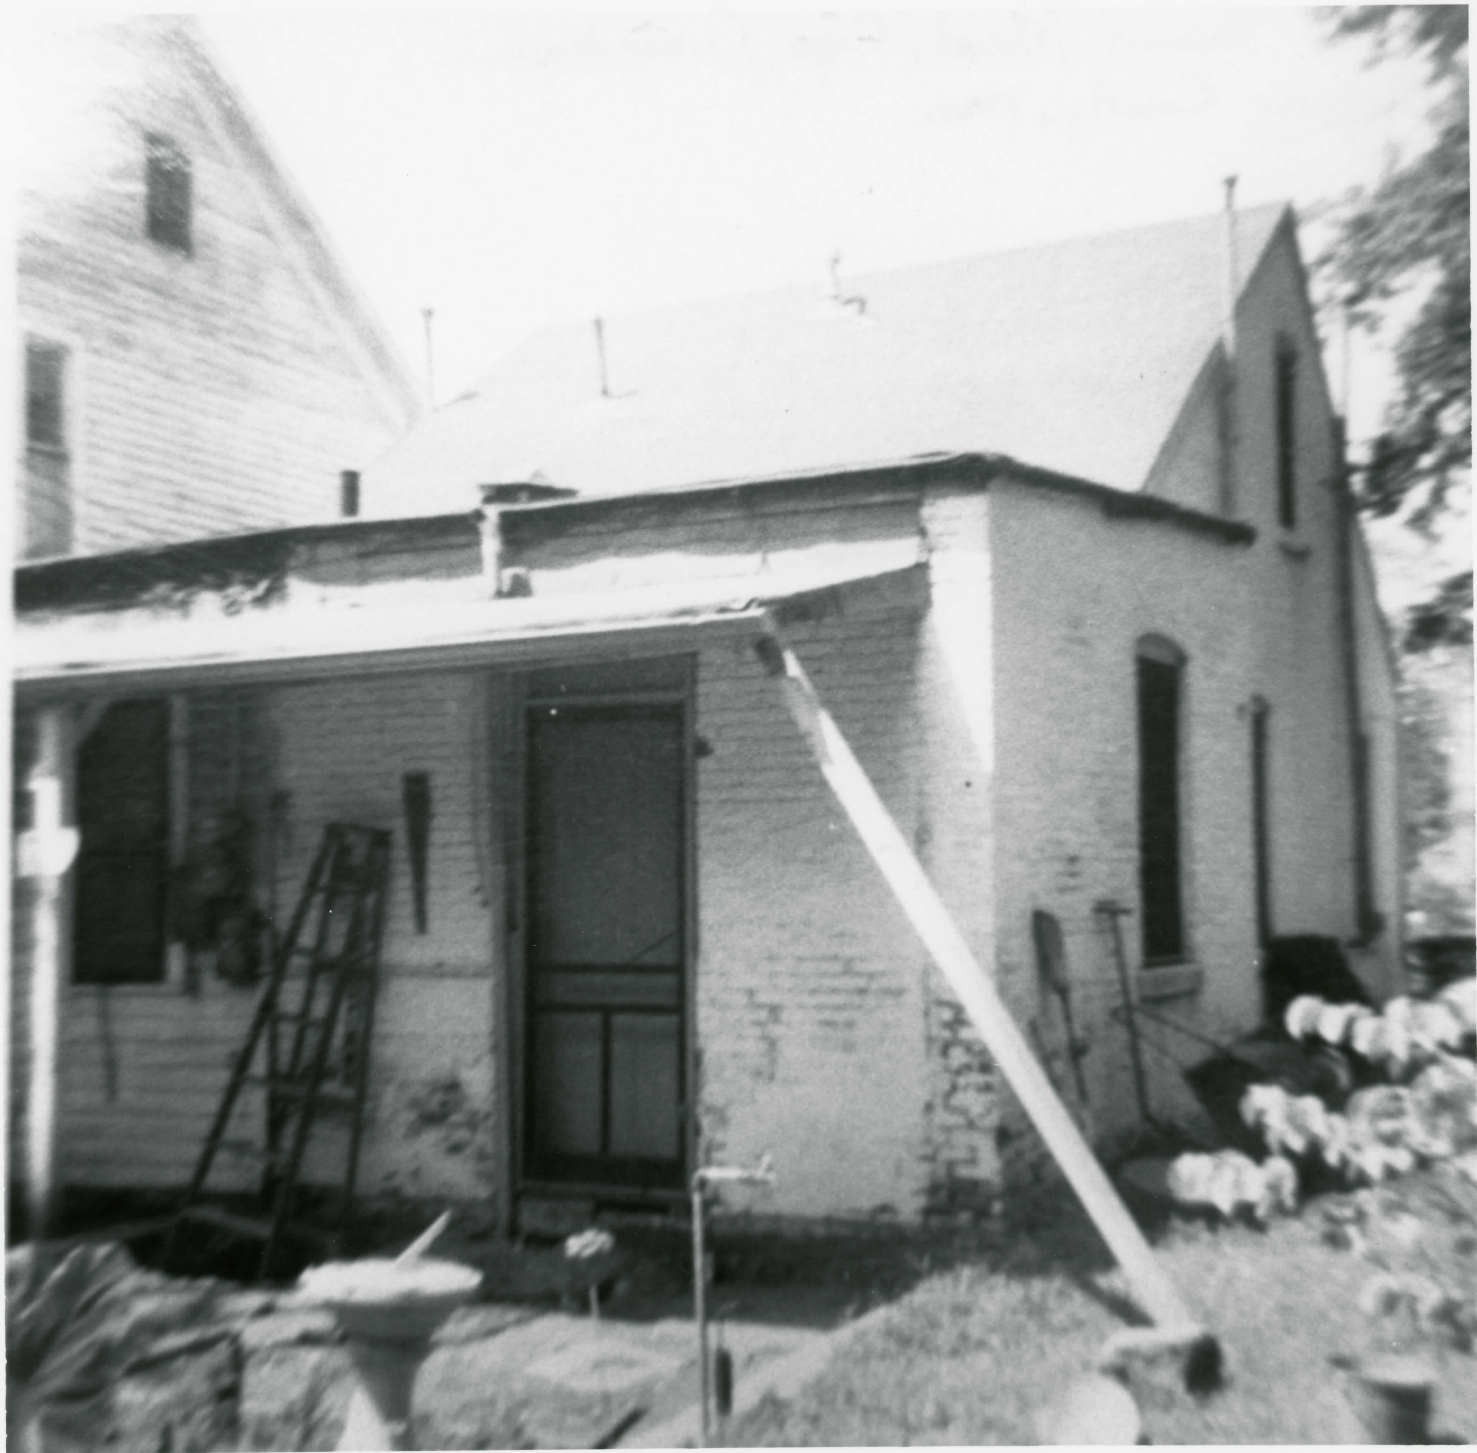
#13 of 13

Camera facing northwest - original kitchen
