NATIONAL REGISTER OF HISTORIC PLACES
REGISTRATION FORM

historic name Rice, Clough H., House

street & number 219 Stoney Mountain Road not for publication N/A

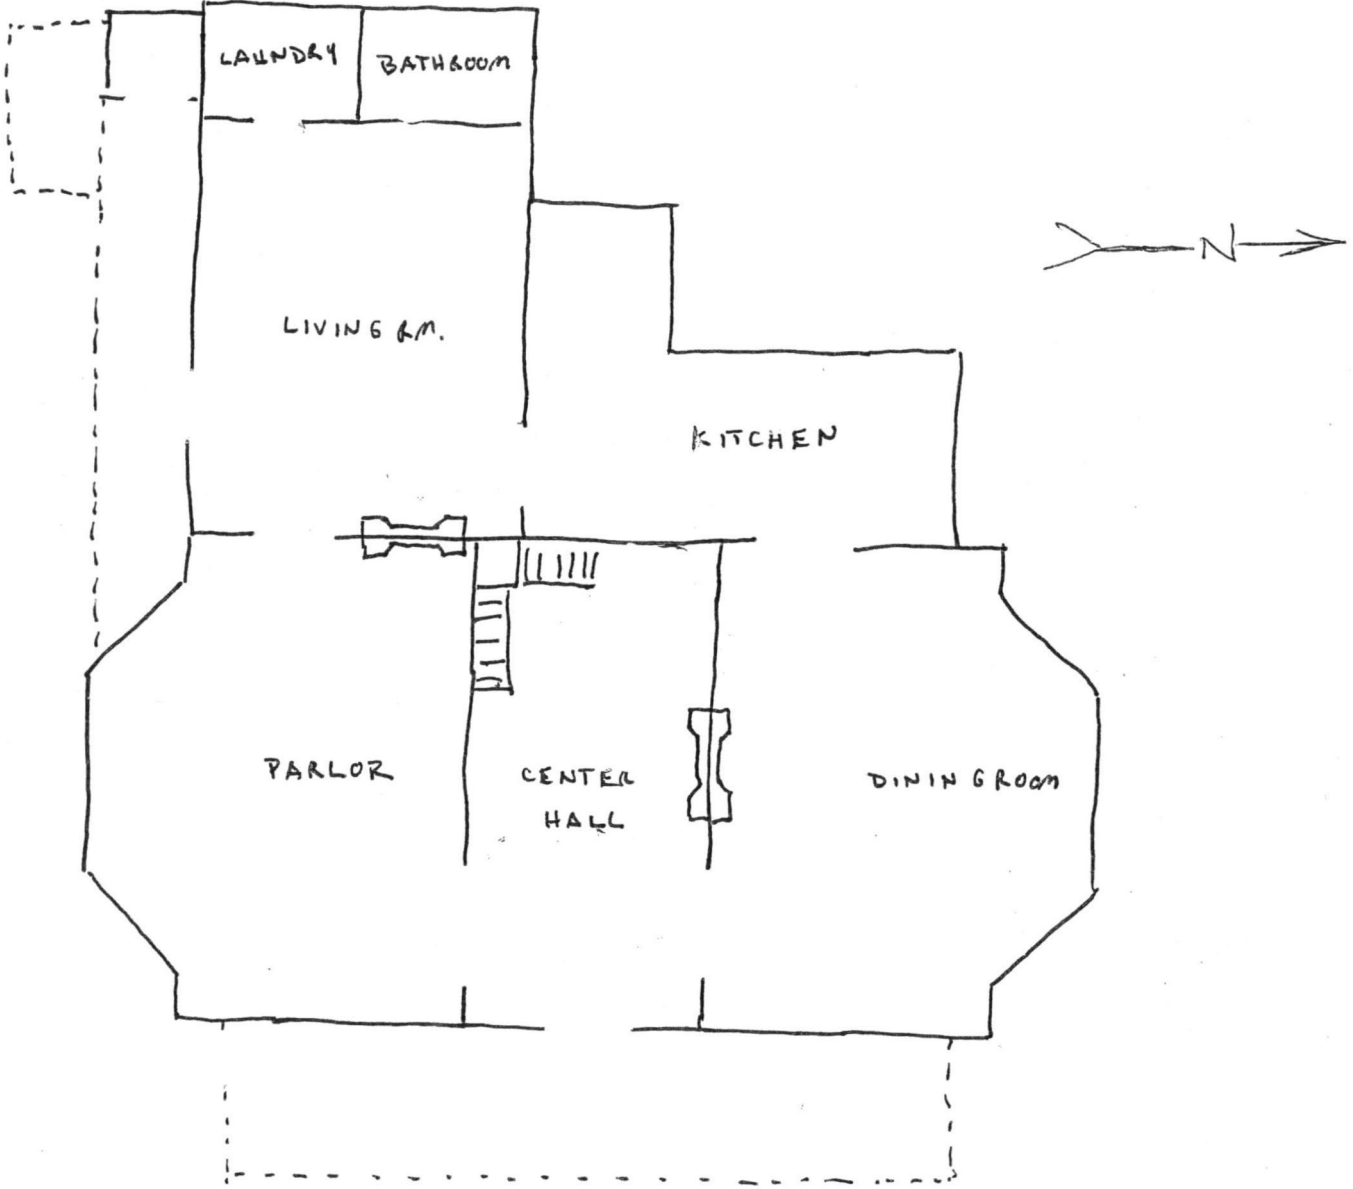
Clough H. Rice House
219 Stoney Mountain Road.
Hendersonville, NC 28791
Henderson County
First Floor Plan and Site Plan

The interior is a typical I-house plan with a wide center hall flanked by a room on each side, in this case a parlor to the south and a dining room to the north. To the west beyond the dining room and center hall is an L-shaped kitchen in the enclosed rear porch. After the porch was enclosed in the 1920s, it was divided into three small rooms, one of which was a bathroom. These changes have been removed within the last five years and the porch, while still enclosed, is now one room that serves as the kitchen. To the west (rear) of the parlor is the living room, with a small laundry room and bathroom beyond in the west end of the ell. A door on the north wall of the parlor leads to a closet under the stair, as does a door on the east wall of the living room located on the north side of the fireplace.

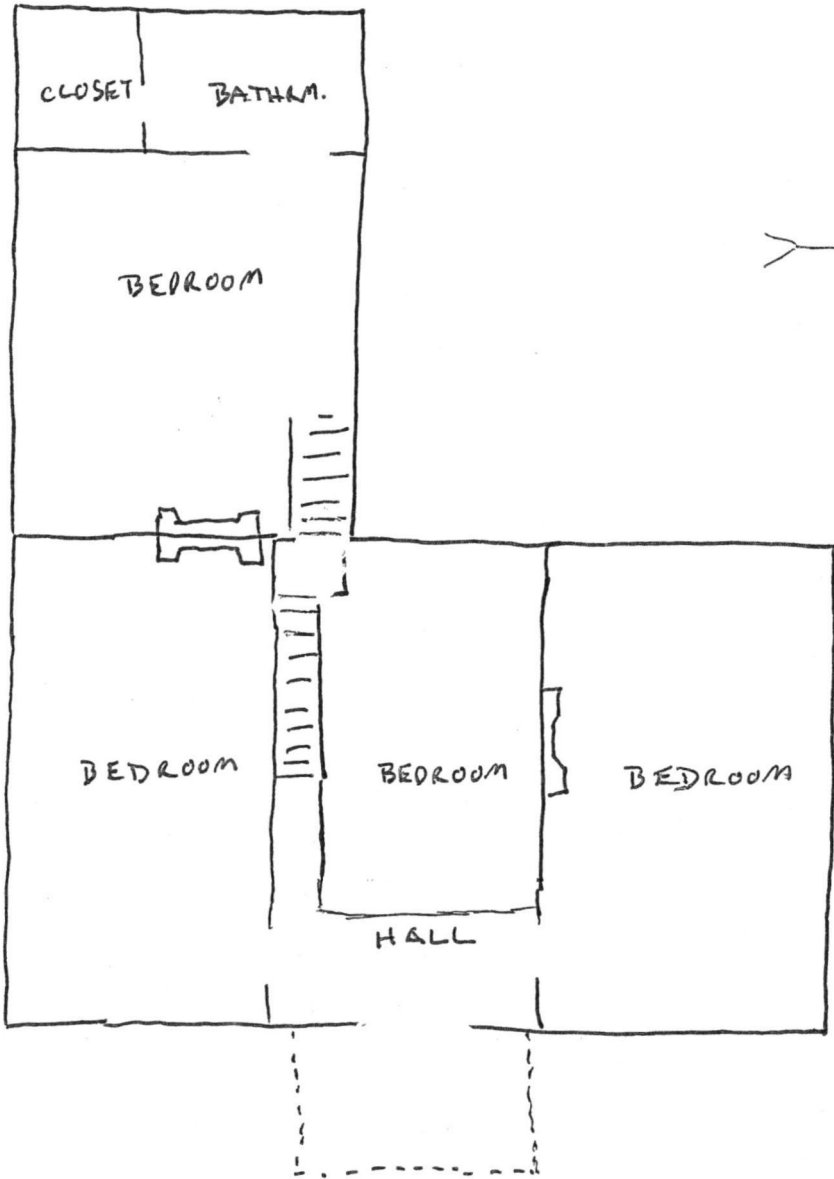
Clough H. Rice House
219 Stoney Mountain Road.
Hendersonville, NC 28791
Henderson County
Second Floor Plan

A quarter-turn stair with closed balustrade rises to the south along the west wall of the center hall to a landing, then turns to the east and rises to the second-floor hall. The second-floor hall runs in a north/south direction with a bedroom at each end and a third bedroom off the west side of the hall. A door leads from the hall to the second-story porch on the façade. On the west side of the intermediate stair landing is a door that leads to a short flight of stairs rising to the west to the

master bedroom and bathroom, located in the second floor of the ell. The chimney that serves the fireplaces in the south bedroom and the master bedroom is enclosed between the west and east walls of these rooms respectively. The balance of the space between these two walls provides a closet for each room, accessed by a closet door on the south side of the fireplace in the master bedroom and the same on the north side of the fireplace in the south bedroom.

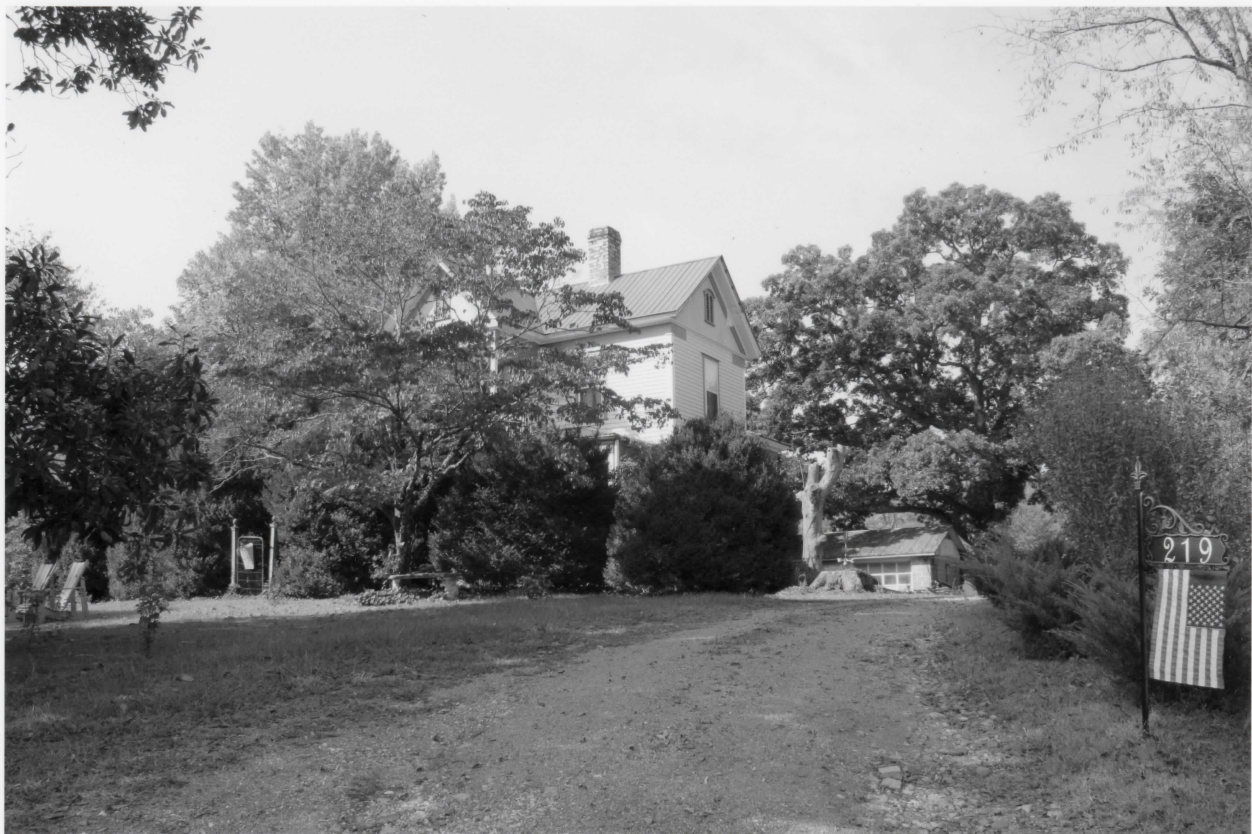
Photograph #1

- # 1 - View from driveway looking west toward house
- # 2 – East and north elevations
- # 3 – North elevation
- # 4 – North and west elevations where the rear porch was enclosed
- # 5 – West elevation of ell
- # 6 – South elevation
- # 7 – South and East elevations
- # 8 – Interior, center hall
- # 9 – Interior, stair
- #10 – Interior, mantle
- #11 - Garage

The property is visually divided by a row of massive boxwoods that were planted in front of the Clough H. Rice House, parallel to the façade. These plantings obscure the first story of the house from view as the house is approached from its private drive. The house and garage are on the west side of the boxwoods and to the east of these bushes is an open, grassy area framed by a massive magnolia tree next to the gravel drive and a ring of hydrangea bushes on the opposite side of the lawn. The gravel drive follows the north property line to just beyond the boxwoods and then turns to the southwest and runs between the boxwoods and the house.
