**NATIONAL REGISTER OF HISTORIC PLACES  
REGISTRATION FORM**

historic name Stonega Historic District  
other names/site number 097-0042

Stonega Historic District  
Wise County, Virginia

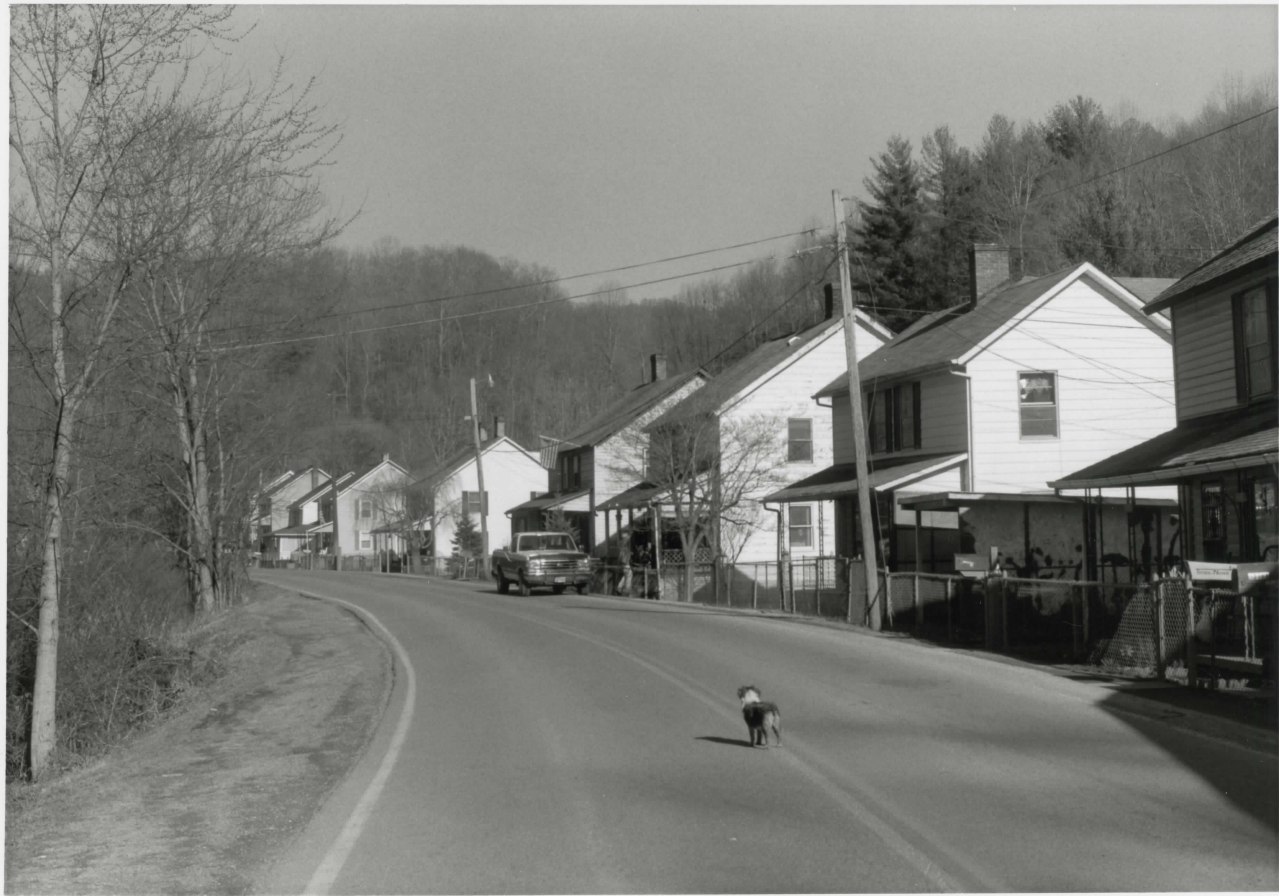
1 of 12

view of Quality Row from West

On the south side of the main road stands a long section of related double dwellings, the homes of the middle management of the colliery and their families. Known, perhaps humorously, as "Quality Row," the section is made up of two house types. The upper end of the row is occupied by nine two-story, double-pile double houses, in which a window and door on each side of a central dividing wall gives access to a separate household. Three similar, single-pile double houses are found at the lower end. Ridge-top chimneys provided heat from grates placed back-to-back in the dwelling units of the larger houses, while a single central chimney served the small ones. The houses, originally sheathed with board-and-batten siding, now are mostly covered with aluminum and vinyl siding. They were provided with wide one-story porches. The houses were originally equipped with one-story sheds across the rear, but some have been expanded over time by two-story gabled ells. Where an ell was added to only unit in a house it resulted in a high wall along the central spine with a single slope of roof to the outer edge, giving an incomplete appearance to the rear elevation. The smaller units each have wide gabled ells across the rear. These houses are located at addresses from 5316 to 5348 Stonega Road (**097-0042-0002 and 097-0042-51 to 097-0042-0061**).

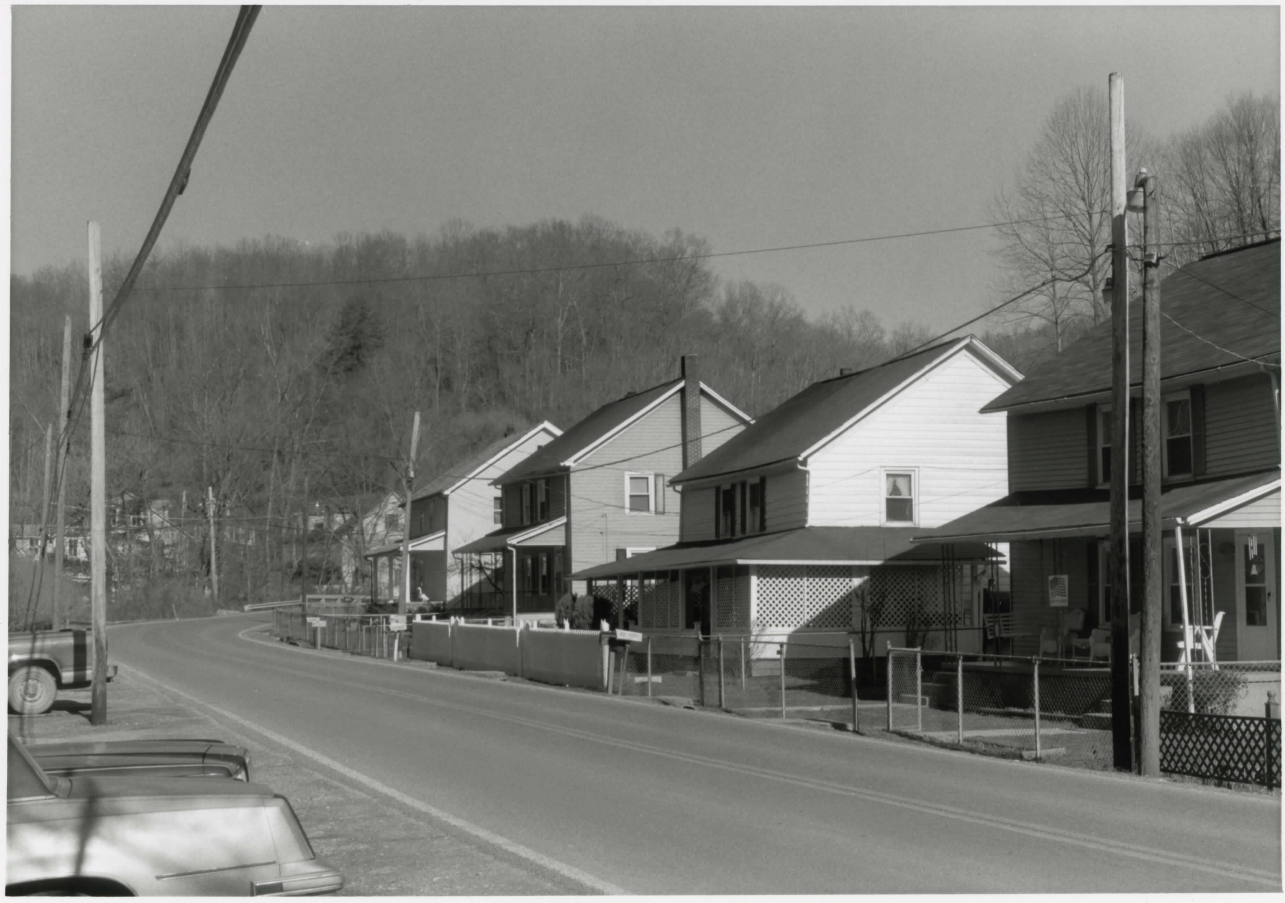
2 of 12

View of eastern end of Quality Row  
from West

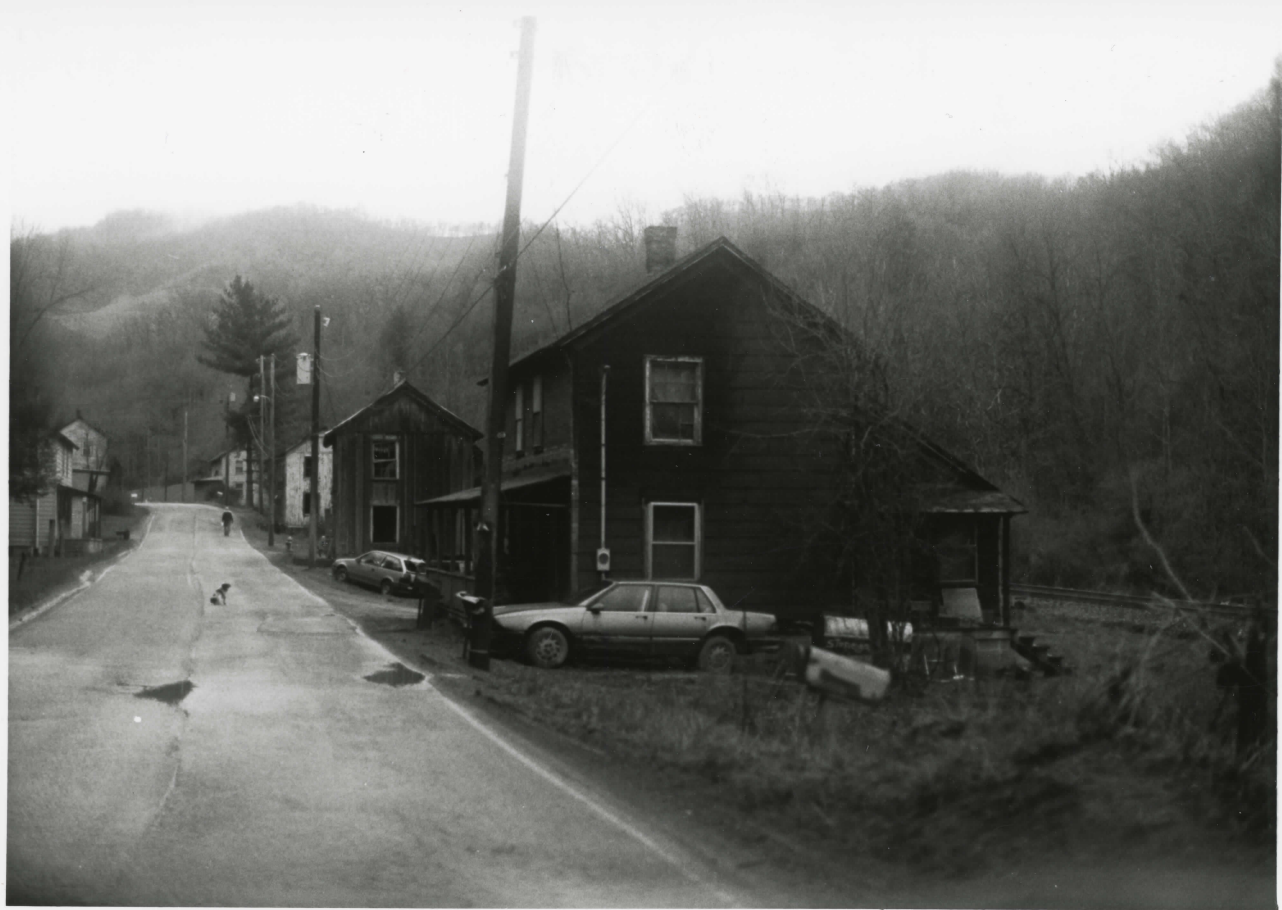
3 of 12

views of East side of Stonega Road in  
Red Room (097-0042-0064 in foreground!)  
from South

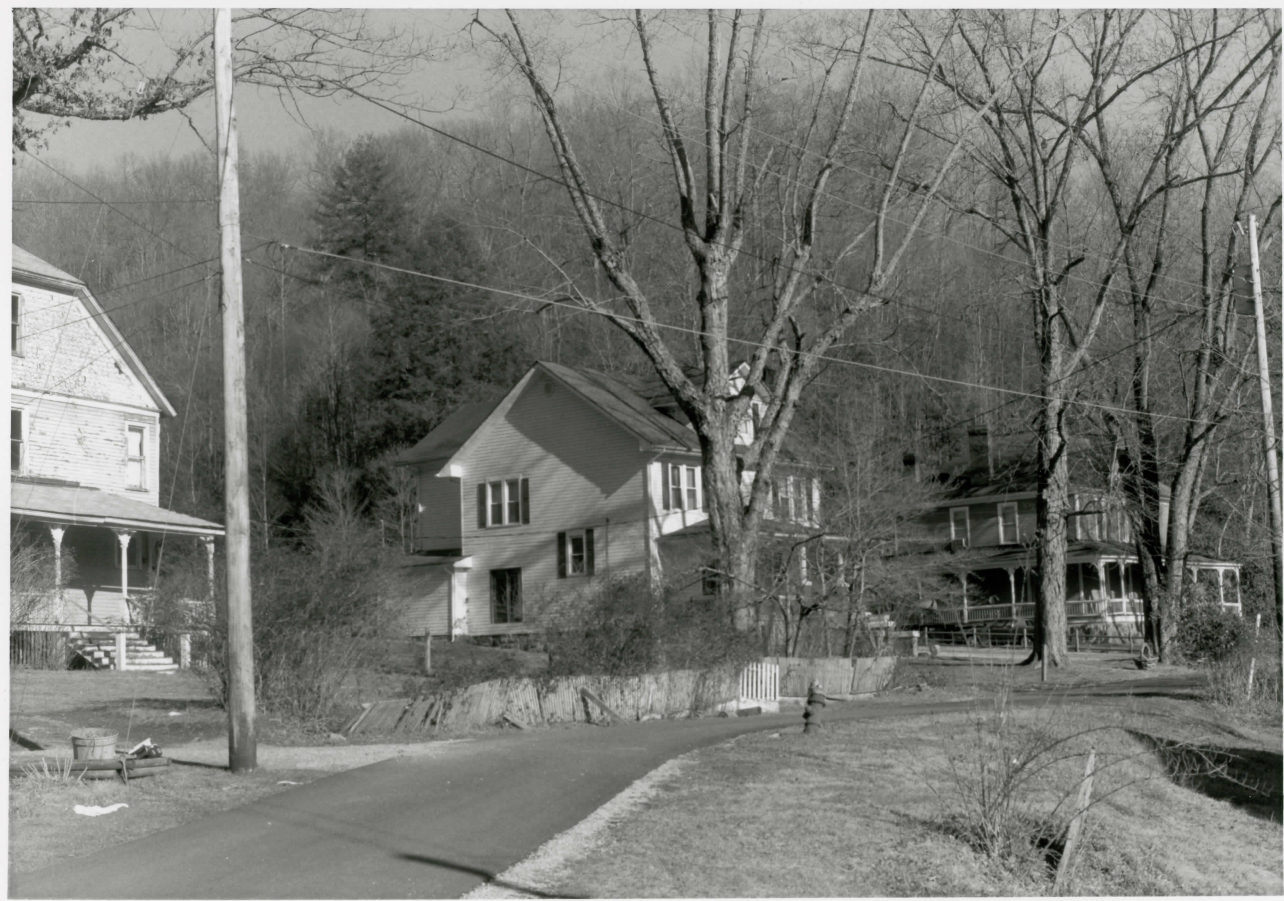
5 of 12

view of Park Place (097-0042-0066 to 0078)  
from West

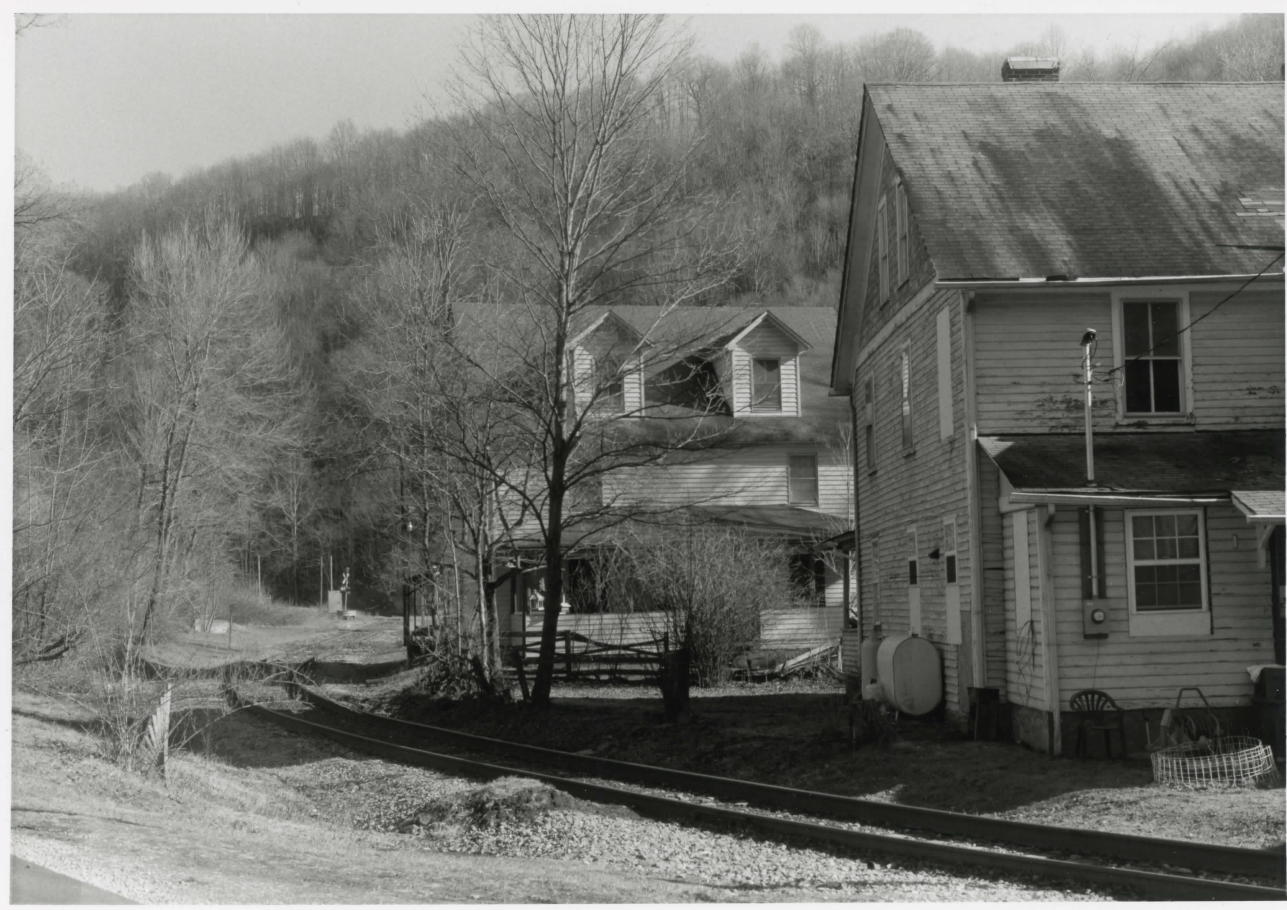
8 of 12

view of 097-0042-0001 and 0062 from N

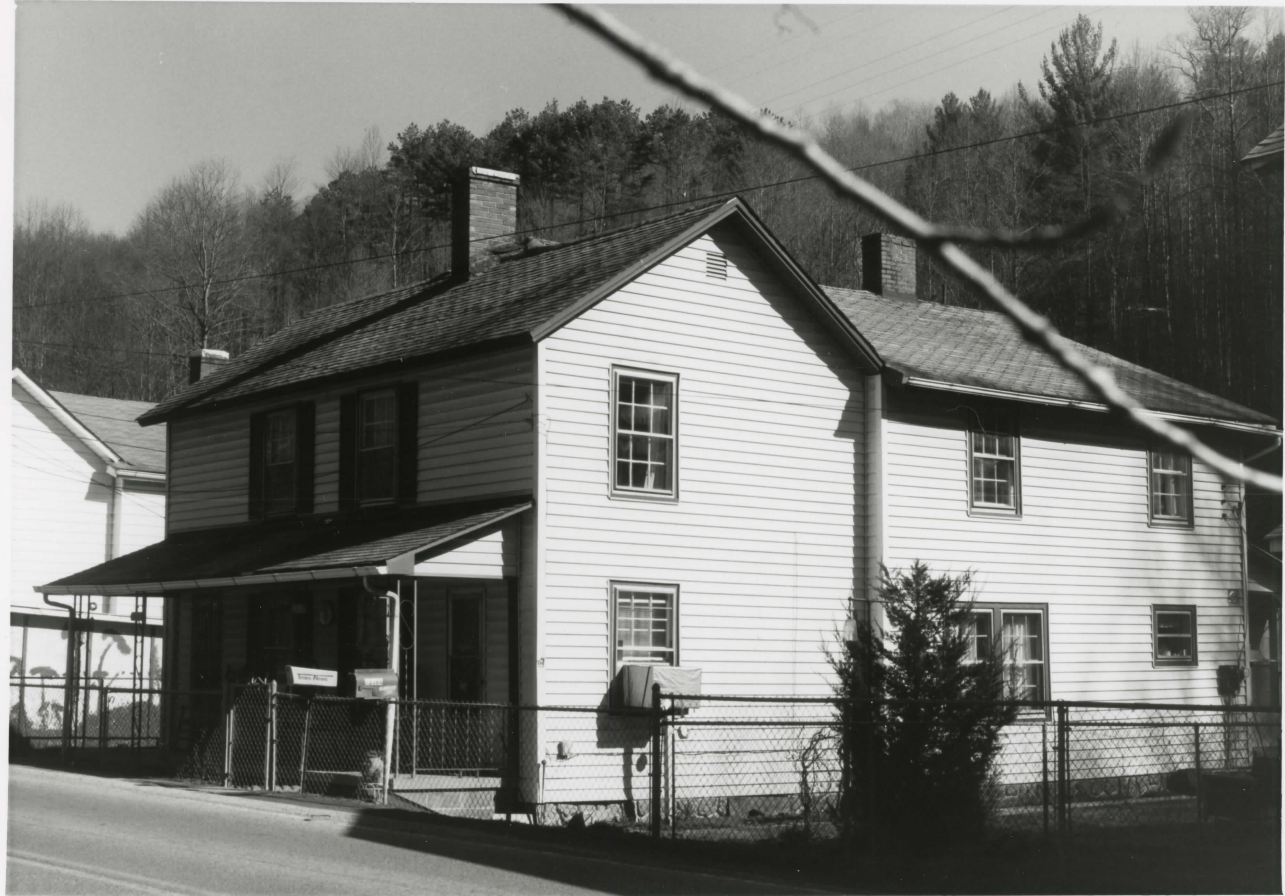
7 of 12

View of 097-0042-0052 from NW

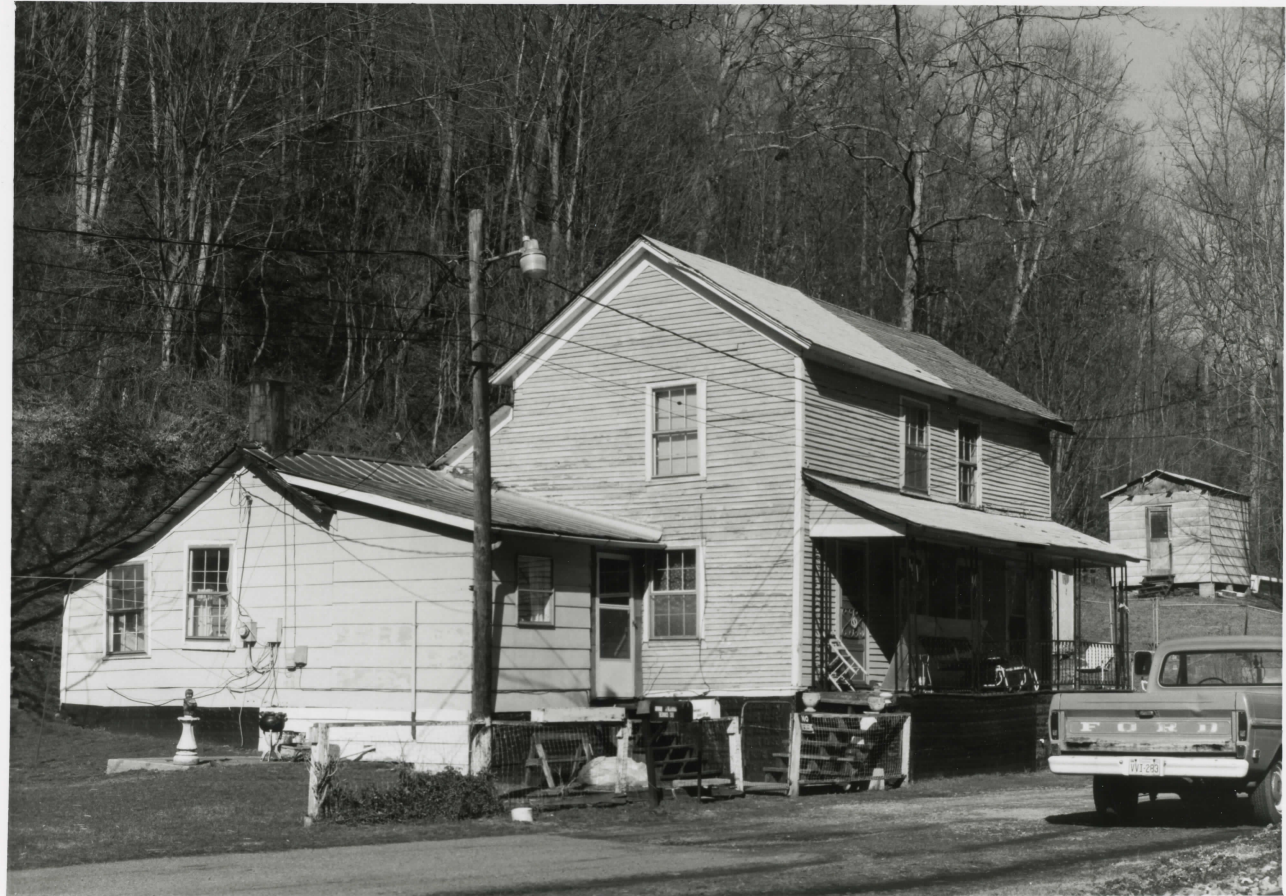
8 of 12

View of 097-0042-0048 from SW

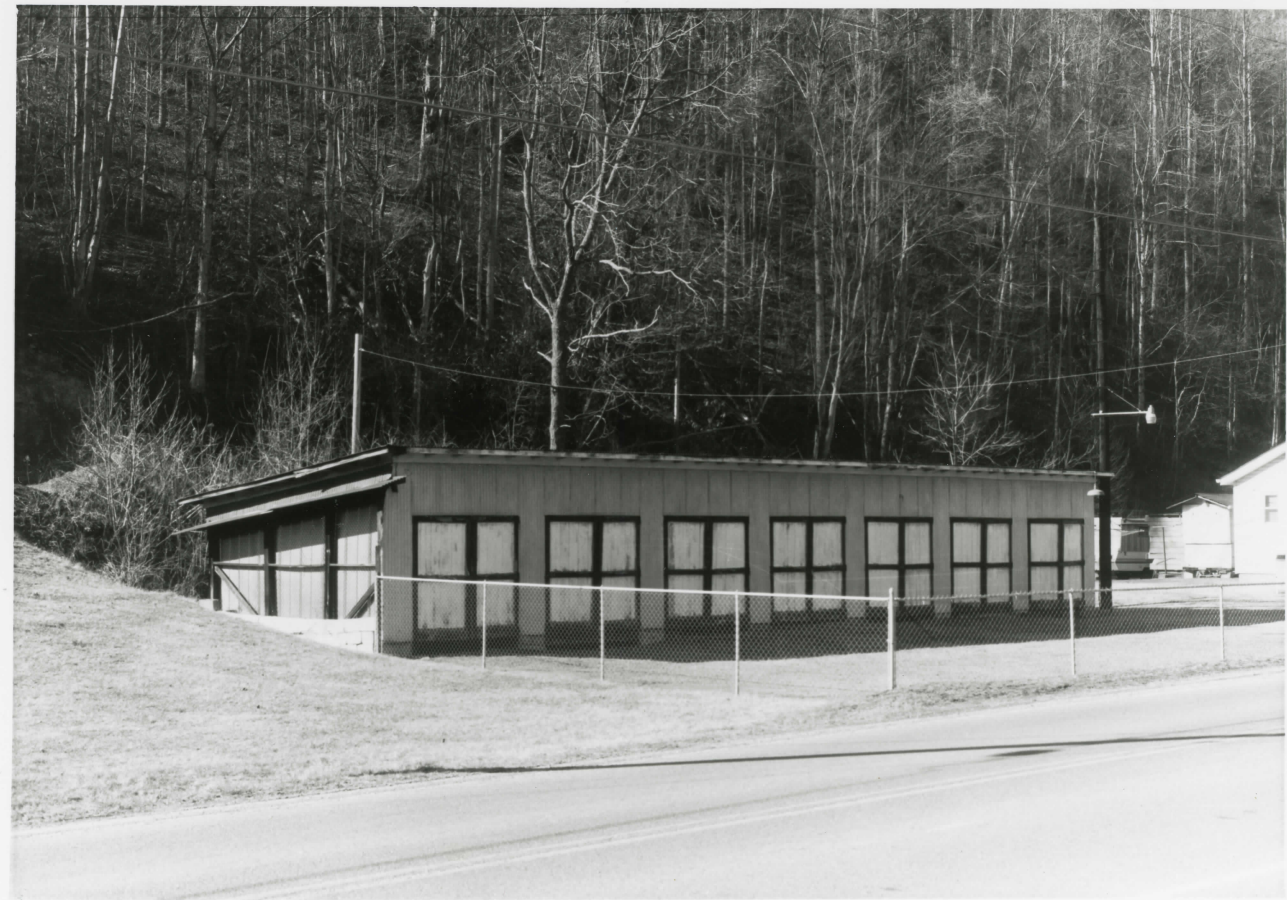
9 of 12

view of 097-0042 - 0039 from South

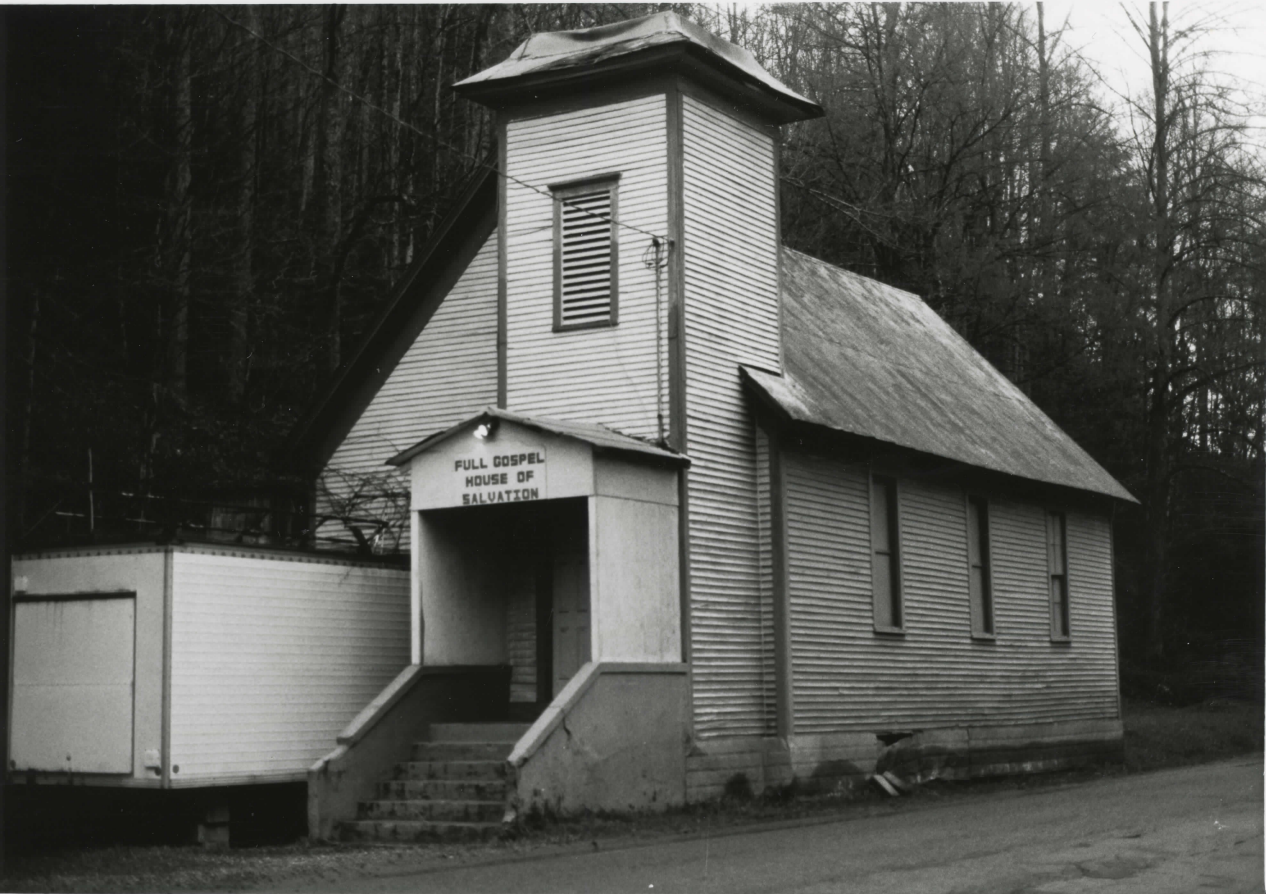
10 of 12

View of Stonega Colored Methodist Church  
(097-0042-0071) from SE

Frame, one-story, three-bay, nave-plan church with narrow matchboard weatherboard siding; four-over-four sash windows (most replaced at mid-century with one-over-one); offset two-stage tower on gable front contains a vestibule on first floor and has a louvered upper opening; pyramidal roof with upper part of spire missing; and modern added porch.

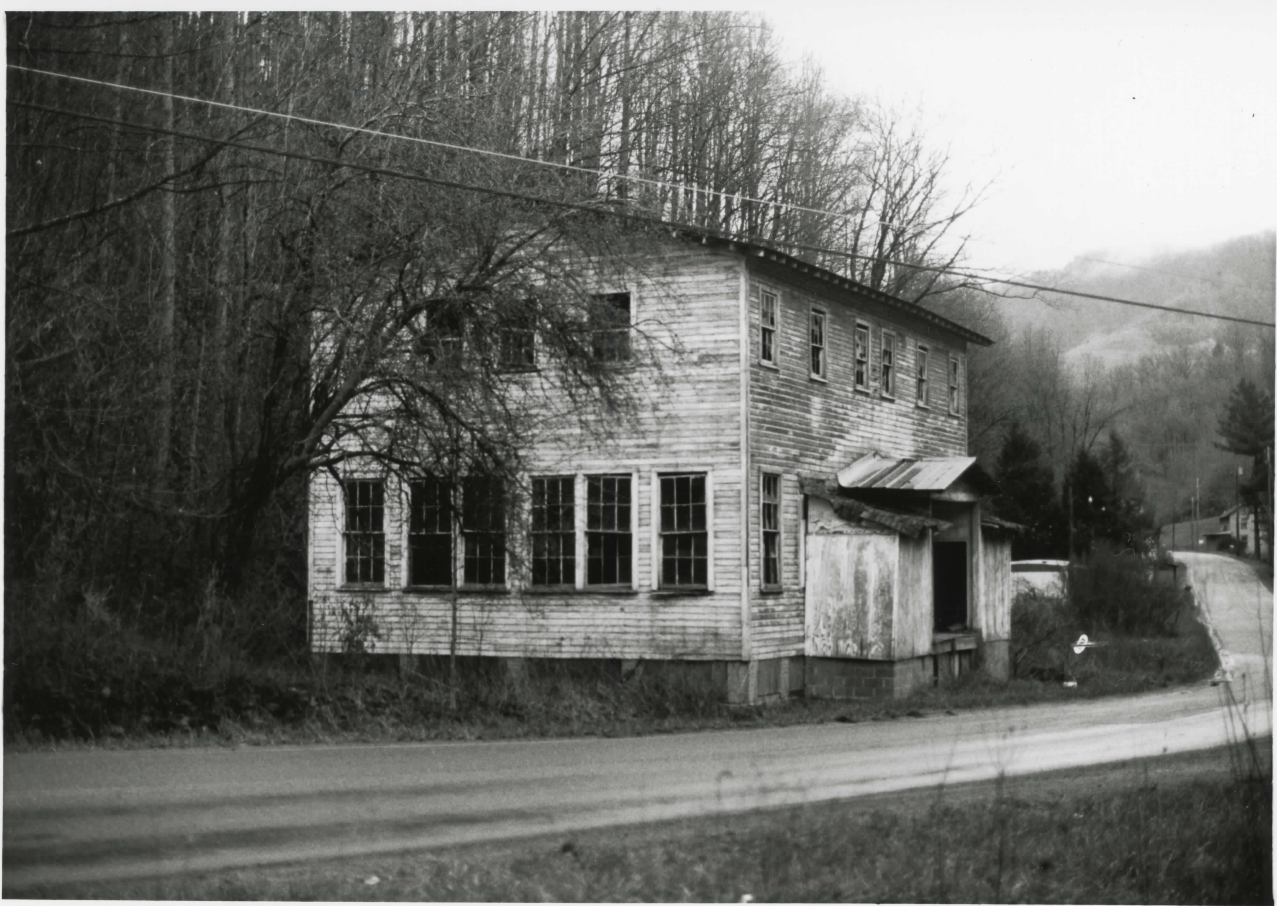
view of Stonega Colored School  
(097-0042-0081) from South

Two-story frame, German weatherboard-sheathed church/school/community center with shallow gabled, asphalt-shingle roof; brick pier foundation; six-over-six sash windows (bank of windows along the south wall lit one schoolroom); and one-story, three-bay gabled porch in center of east front shelters the entry door. The interior contains two rooms on the first floor each with a door off the porch. Small toilet rooms were added on each side of the porch in ca. 1970.

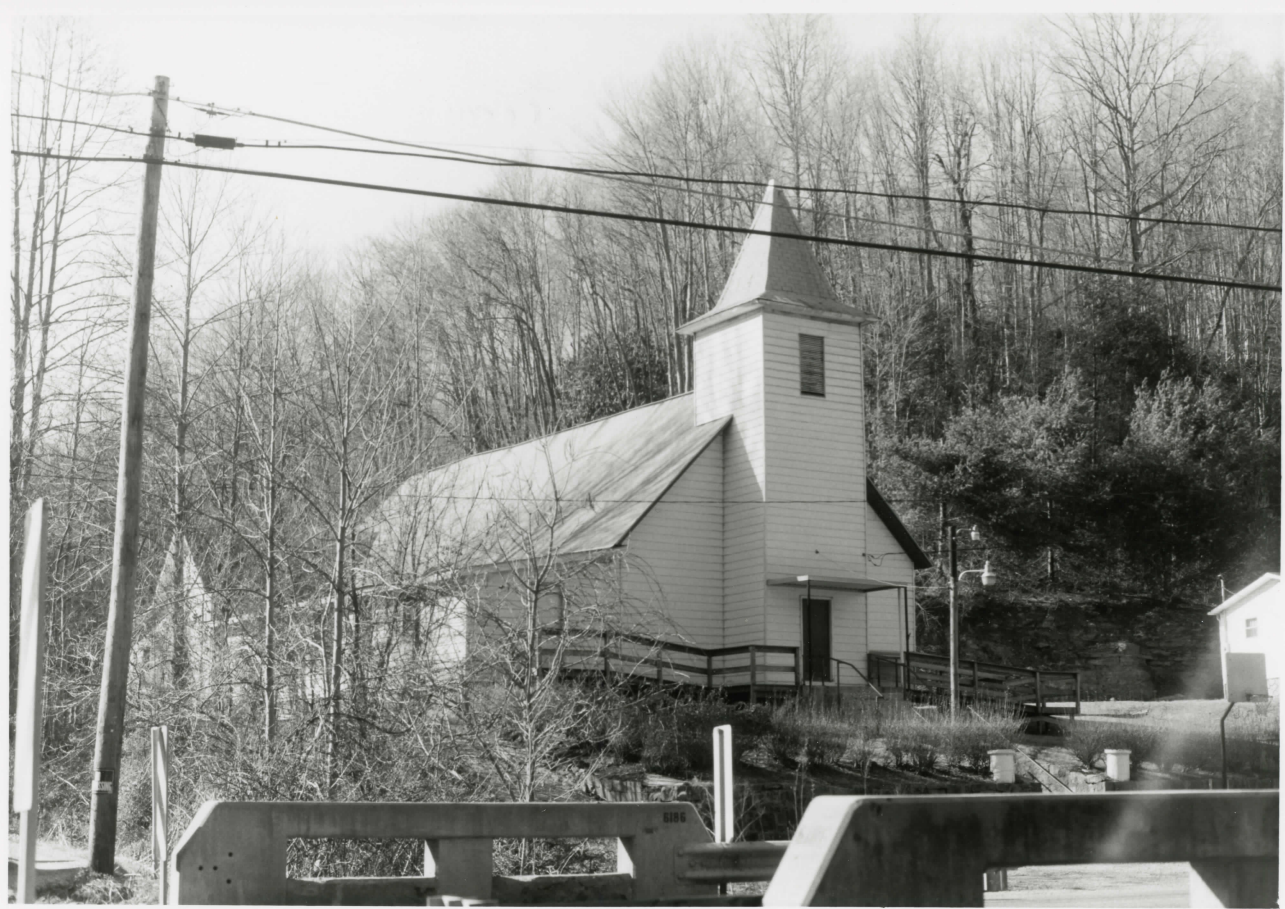
12 of 12

view of Catholic Church (097-0042-0036) from S
