**NATIONAL REGISTER OF HISTORIC PLACES
INVENTORY -- NOMINATION FORM**

Bedford Historic Meeting House (Preferred)

153 West Main Street

Bedford

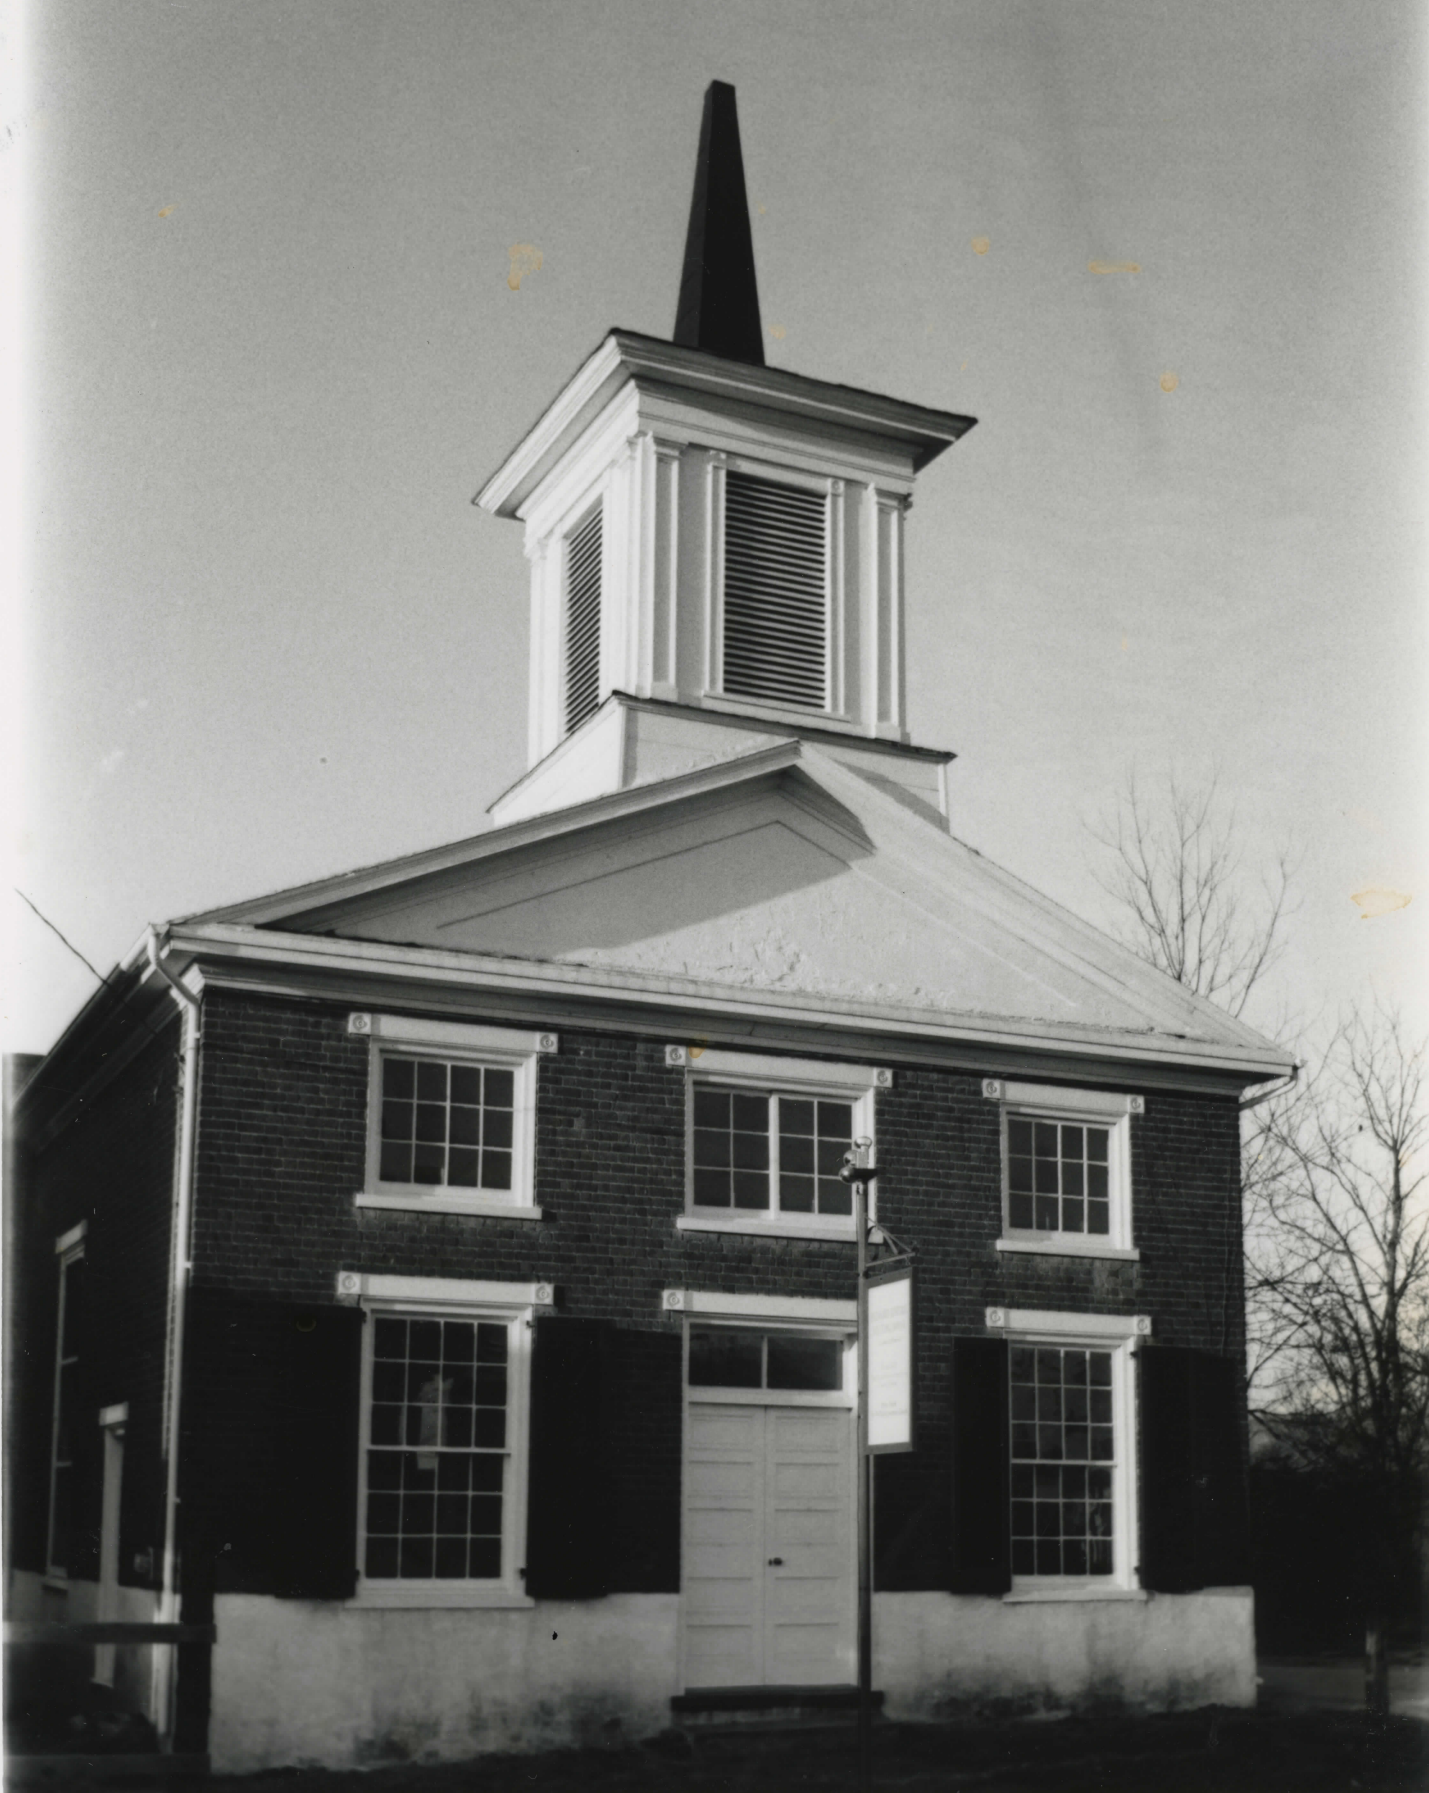
1 of 1

Exterior View from the Northeast

Built as Bedford's first Methodist Church, the Bedford Historic Meeting House is a diminutive, temple-form structure measuring 30 feet wide by 58 feet deep. Flemish bond is employed on all but the rear wall, which is laid in American bond. The base of the building has been stuccoed in recent decades in a crude attempt to counteract a problem of rising damp. In the center of the rear wall is a small appendage which houses a large niche serving as the church's apse. Covering the building is a shallow, pedimented gable roof ornamented with shallow Greek moldings. The roof is supported by a king-post truss system and originally was covered with wood shingles. Sections of these shingles were preserved under the later sheet-metal roof. Directly above the pediment is a square belfry with pilastered corners and a louvred rectangular opening on each face. A stubby, tapered spire, formerly topped by a ball finial, rises from the belfry roof.

The church's facade is divided into three bays with twelve-over-twelve windows hung with louvred blinds flanking the center doorway. The doorway has double doors, each with five horizontal panels. Above the first-floor openings are three twelve-light windows; the end ones are pivoted and the center one has horizontally sliding sash. On each side of the church are two triple-hung windows with six panes per sash. On the south wall is a small door built as a slaves' entrance. All the openings are topped by rectangular lintels with turned corner blocks. A modern chimney is also on the south wall. The rear wall was formerly hidden by a late nineteenth-century, two-story frame annex, but this was destroyed by fire in 1977; the fire also damaged, but did not destroy, the church's roof.
