**NATIONAL REGISTER OF HISTORIC PLACES
INVENTORY -- NOMINATION FORM**

HISTORIC Horn Quarter (Preferred)

Horn Quarter, King William County, Virginia

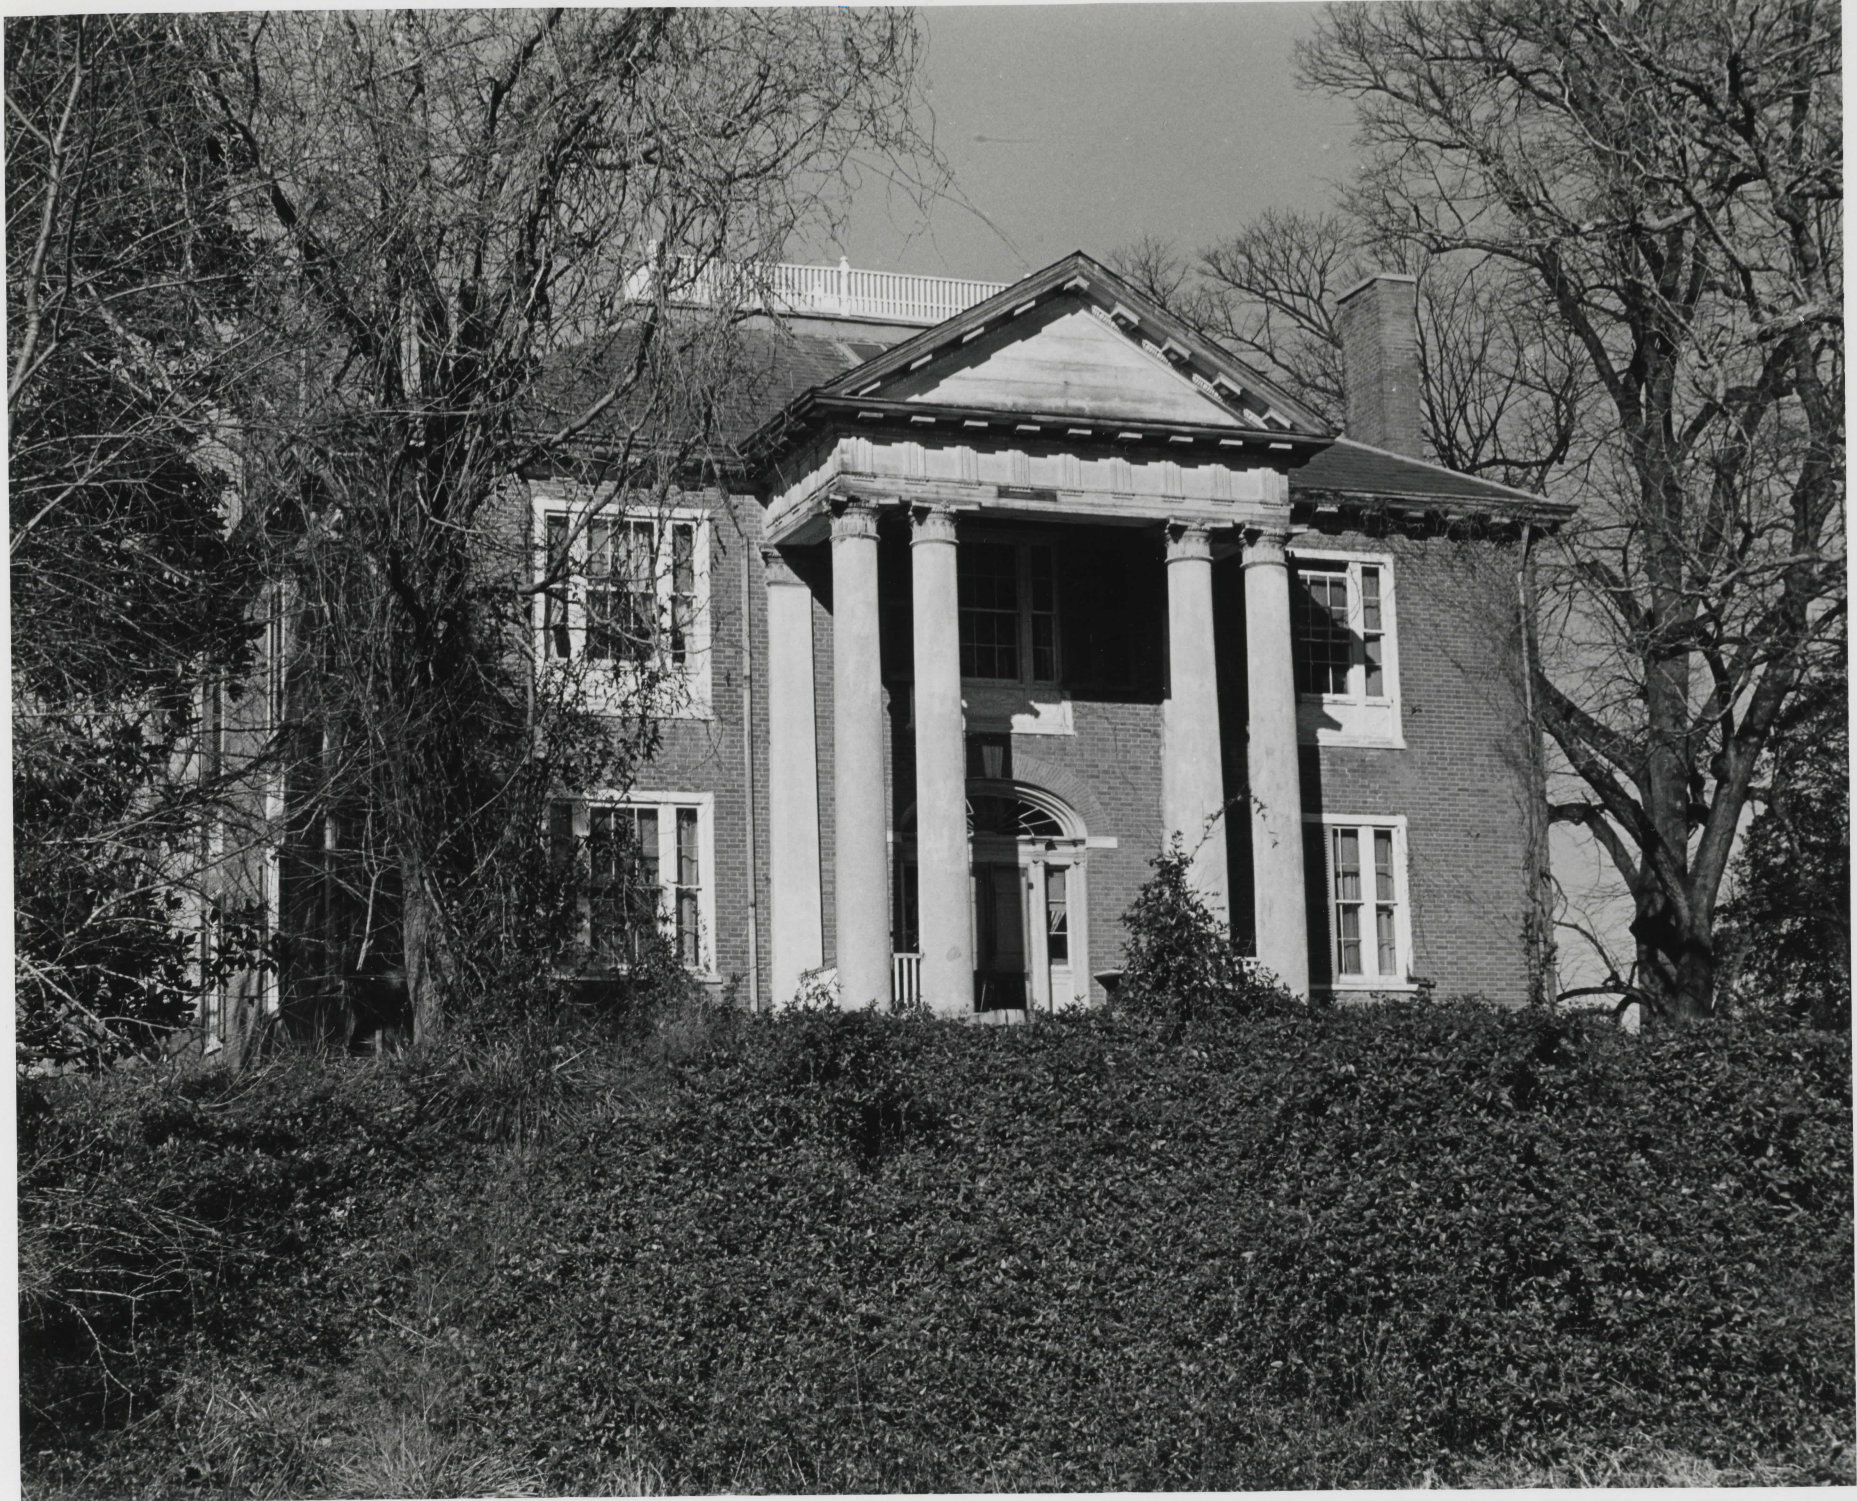
View from south (main elevation)

Horn Quarter, a Federal-style residence, is located on a rise at the end of an axial farm lane off Route 614 in King William County. The rectangular, 57' x 40', two-story brick structure has a double-pile, central-hall plan and is set on a brick foundation. All the walls are executed in notably fine Flemish bond with oiled brick. Gauged brick elliptical arches enhance both the main (south) and rear (north) entrances. A corbeled brick water table is located above the basement story. The original painted mortar joints are still visible under the south portico.

The center bay of the front elevation preserves its original tetrastyle Roman Doric pedimented portico with paired stuccoed columns and pilasters. The capitals are unusual and have egg-and-dart molding and a row of acanthus leaves. The entablature has a triglyph-embellished frieze and an egg-and-dart cornice with mutules. The cornice is repeated along the eaves.

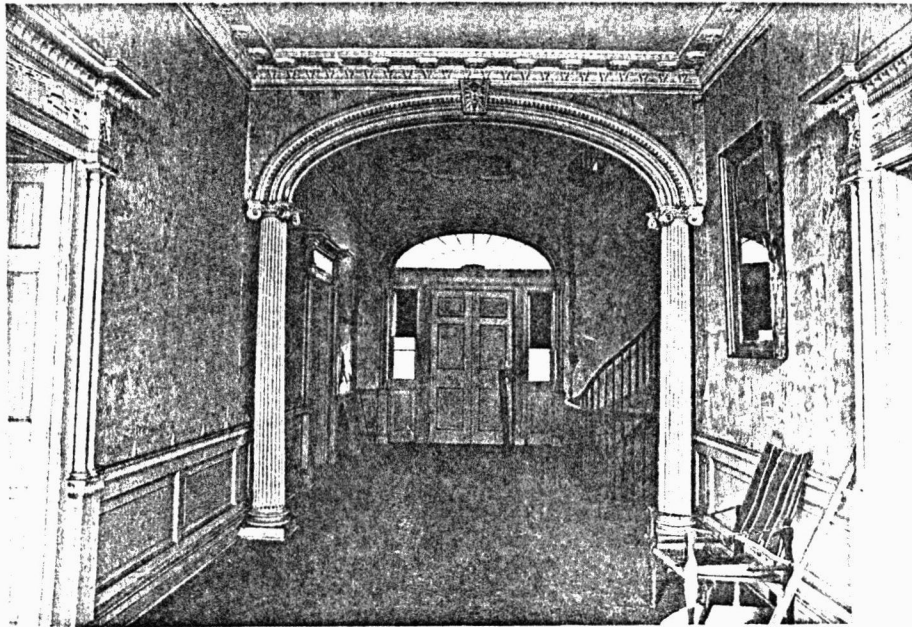
First-floor hall
Second-floor hall

The front and rear portions of the hall ceilings on the first floor are elaborately ornamented with Adamesque-style plastered ceiling medallions. Elaborate plastered cornices and plastered paneled ceilings are found in the principal rooms on the first floor. Simpler plaster moldings grace the second-floor ceilings. The ceiling medallions are based on illustrations in Asher Benjamin and Daniel Raynerd's, The American Builder's Companion, 1806, plates 25, 26 and 27. The doorways in the first- and second-floor halls and in the principal rooms are elaborately treated, the most distinguished having paired colonnettes that support complete entablatures with acanthus ornamentation. The window frames flanking the mantel in the southeast parlor are the most elaborate in the house. The frames have paired colonnettes that support rounded arches that are embellished with cable moldings and stylized keystones. The first-floor mantels are highly Federal in feeling and consist of fluted Ionic columns that support an elongated entablature embellished with carved acanthus and plain tablets. The marble mantel in the southwest parlor is a Victorian replacement. Second-floor mantels show more restraint in carving.

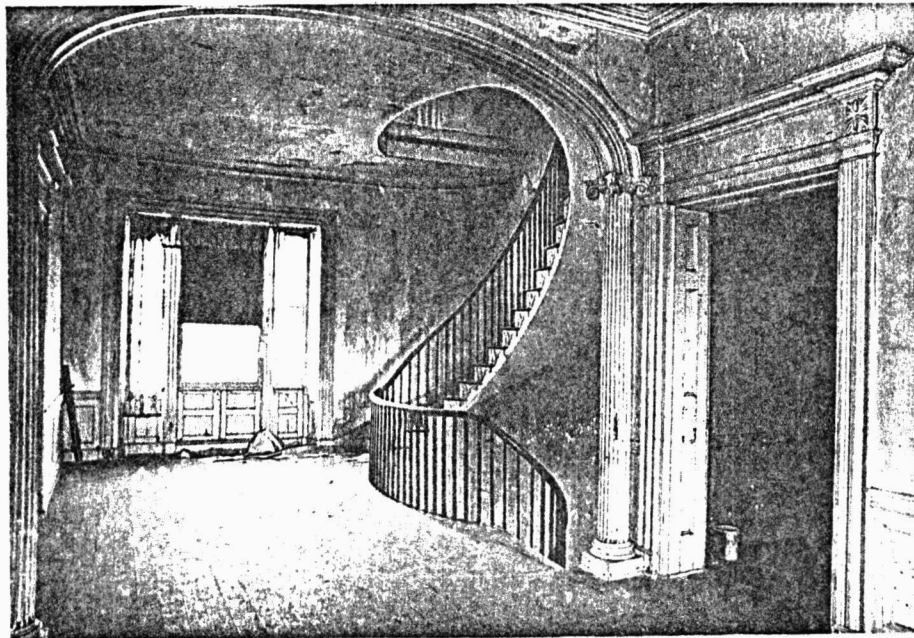
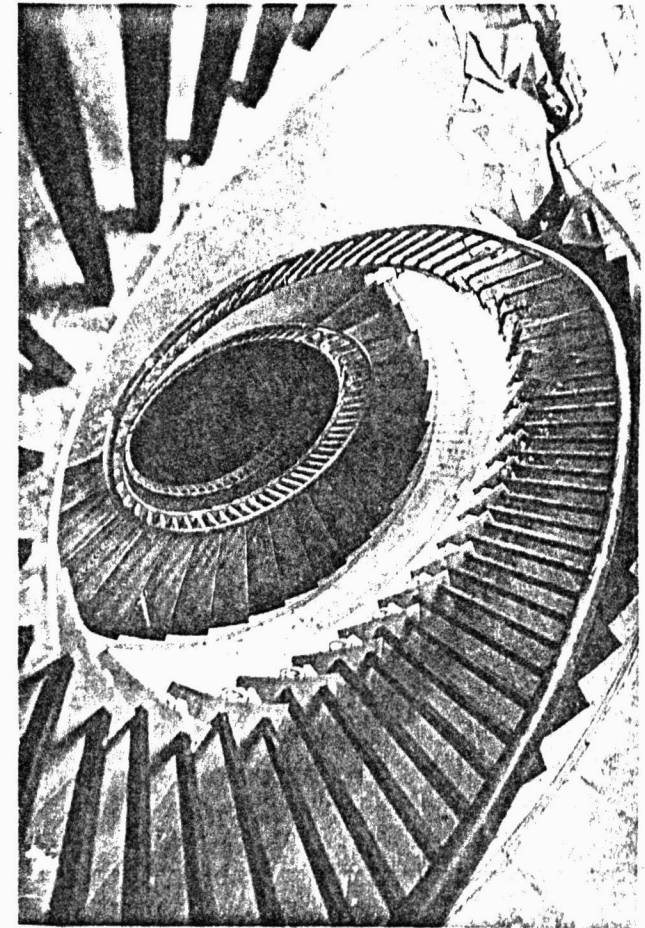
Stair

Horn Quarter contains a distinguished Adamesque interior. The house has a central-hall plan that has in its northeastern corner an open-well stair that runs from the basement to the attic. The basement contains a stone-paved hall that opens on to five rooms. The rooms were used for storage and perhaps informal dining. The stair begins in the basement with a spiral newel and winds to the top with square balusters, a rounded handrail and scroll-sawn brackets. The first-and second-floor center halls are each distinguished by an elliptical arch that has fluted column supports with carved Ionic capitals, a stylized keystone, and handsomely profiled moldings and gouge work. All the woodwork is presently painted white; evidence was found of the use of marbleizing on the columns and graining on the doors.

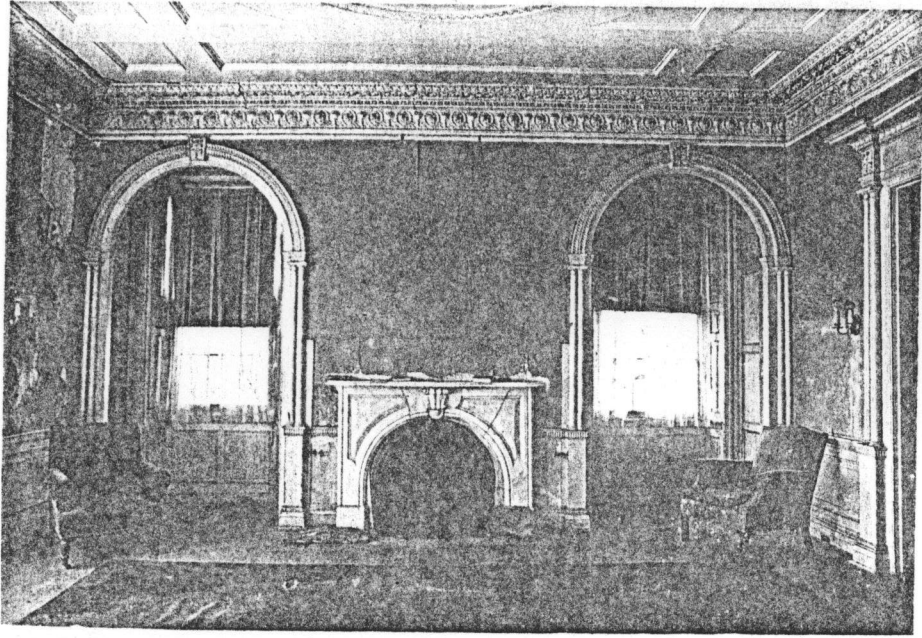
First-floor parlor

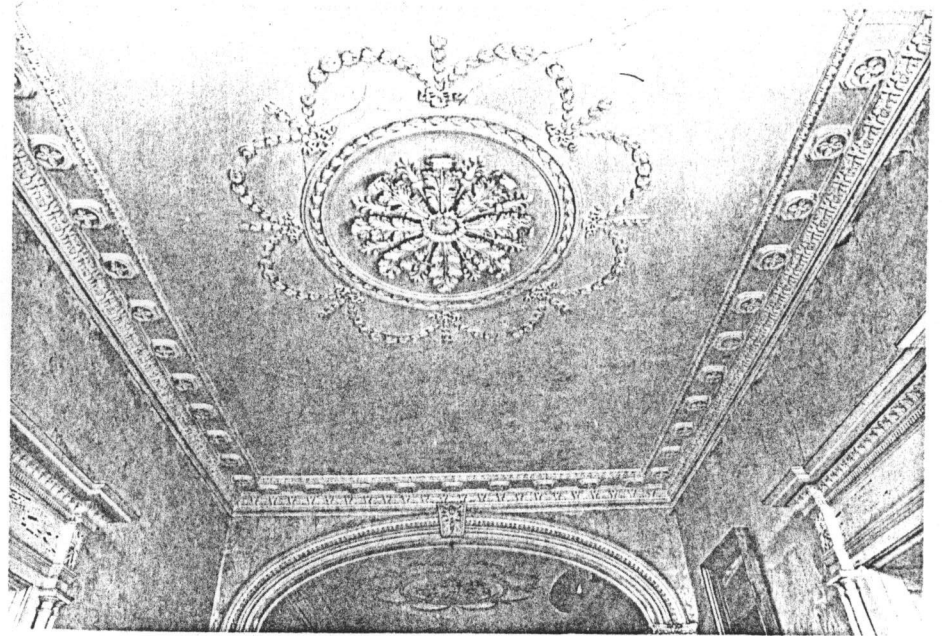
Ceiling first-floor hall

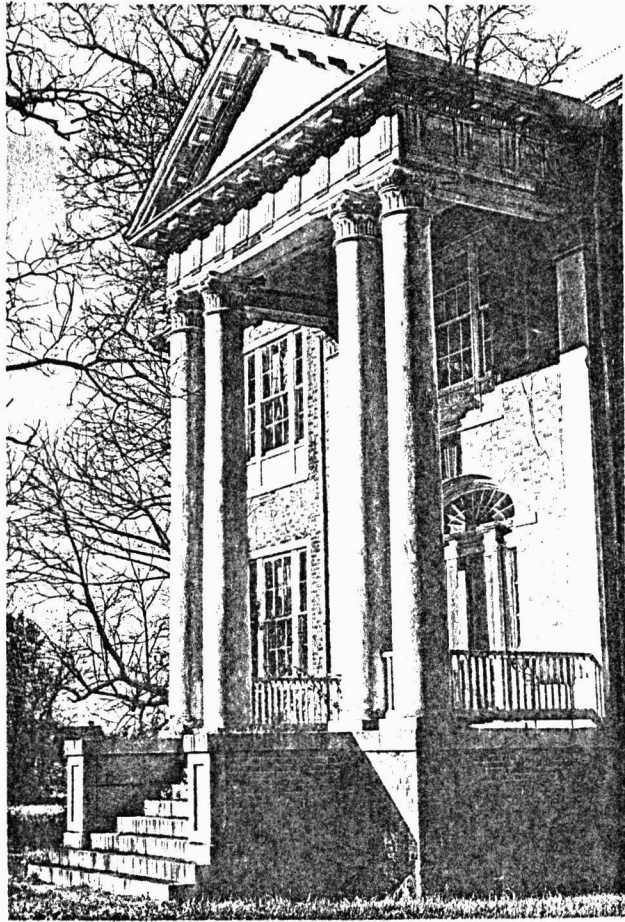
Main portico

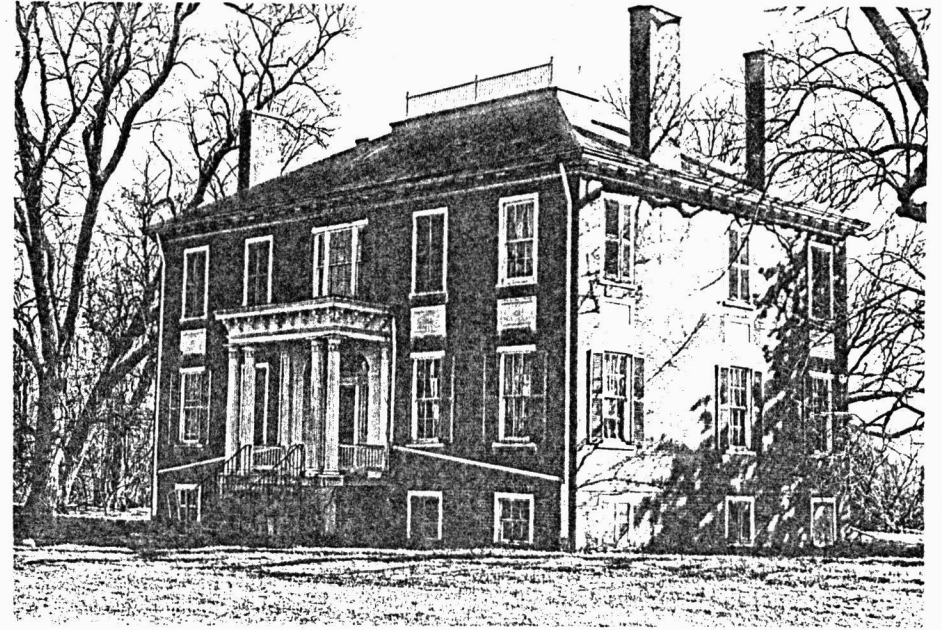
Rear (north) elevation

The small porch on the (north) rear elevation shelters the first-story entrance. The porch partially covers the keystone and stylistically would appear to constitute a later addition. The porch has paired fluted columns, Temple of the Wind capitals, a bracketed frieze and a flat roof. The porch as well as the front portico is set on a brick podium and has granite steps and pedestals. The granite on the front steps appears to be a later addition and may date from the construction of the rear porch.

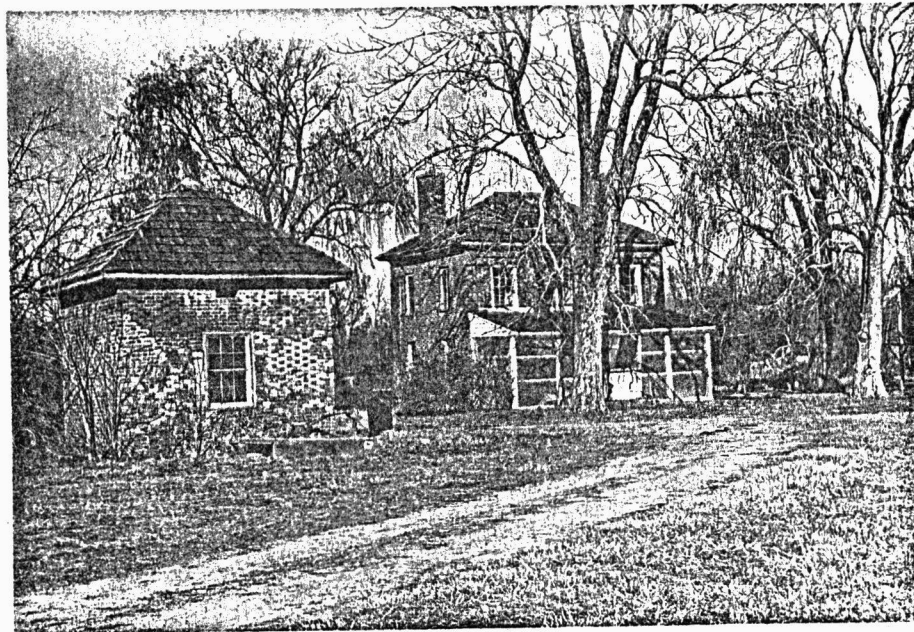
Rear dependency - Overseer's house
Orangery

The estate is fortunate in retaining both its front and rear dependencies. The rear (north) buildings are one story in height and are executed in Flemish bond. The structures have 6/6 hung-sash windows, paneled doors and pyramidal roofs covered with shingles. On axis with the main house and also flanked by the dependencies, the overseer's house is a two-story structure executed in Flemish bond. It is covered by a hip roof and has two interior end chimneys and 6/6 hung sash. The first-story screened porch is covered by a shed roof. A recent fire has destroyed the original interior.

The front dependencies flank the formal garden. The east and west buildings respectively consist of an orangery and a schoolhouse or office. Both structures are executed in a combination of Flemish bond and random course American bond. The edifices

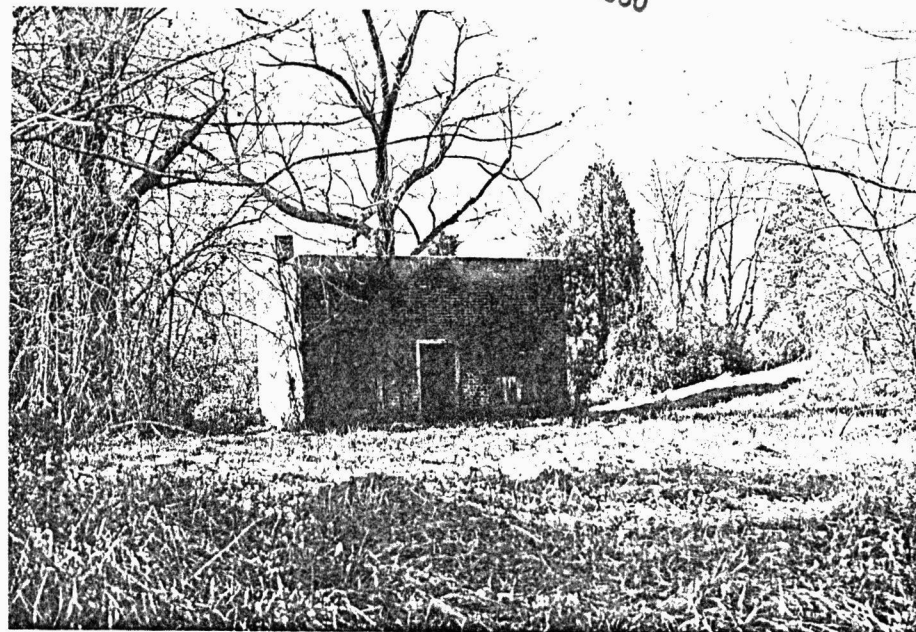
Office/Schoolhouse

have a central entrance flanked by 6/6 hung-sash windows with shutters and are covered by shed roofs with parapets. The dairy is a one-story brick structure also located southwest of the main house. The building has weatherboarded gables and a steep shingle-covered roof.
