# National Register of Historic Places Inventory—Nomination Form

historic Tankersley Tavern (DHL File # 81-201)

TANKERSLEY TAVERN, Rockbridge Co., Virginia  
Continuation sheet # 1 Item number 7

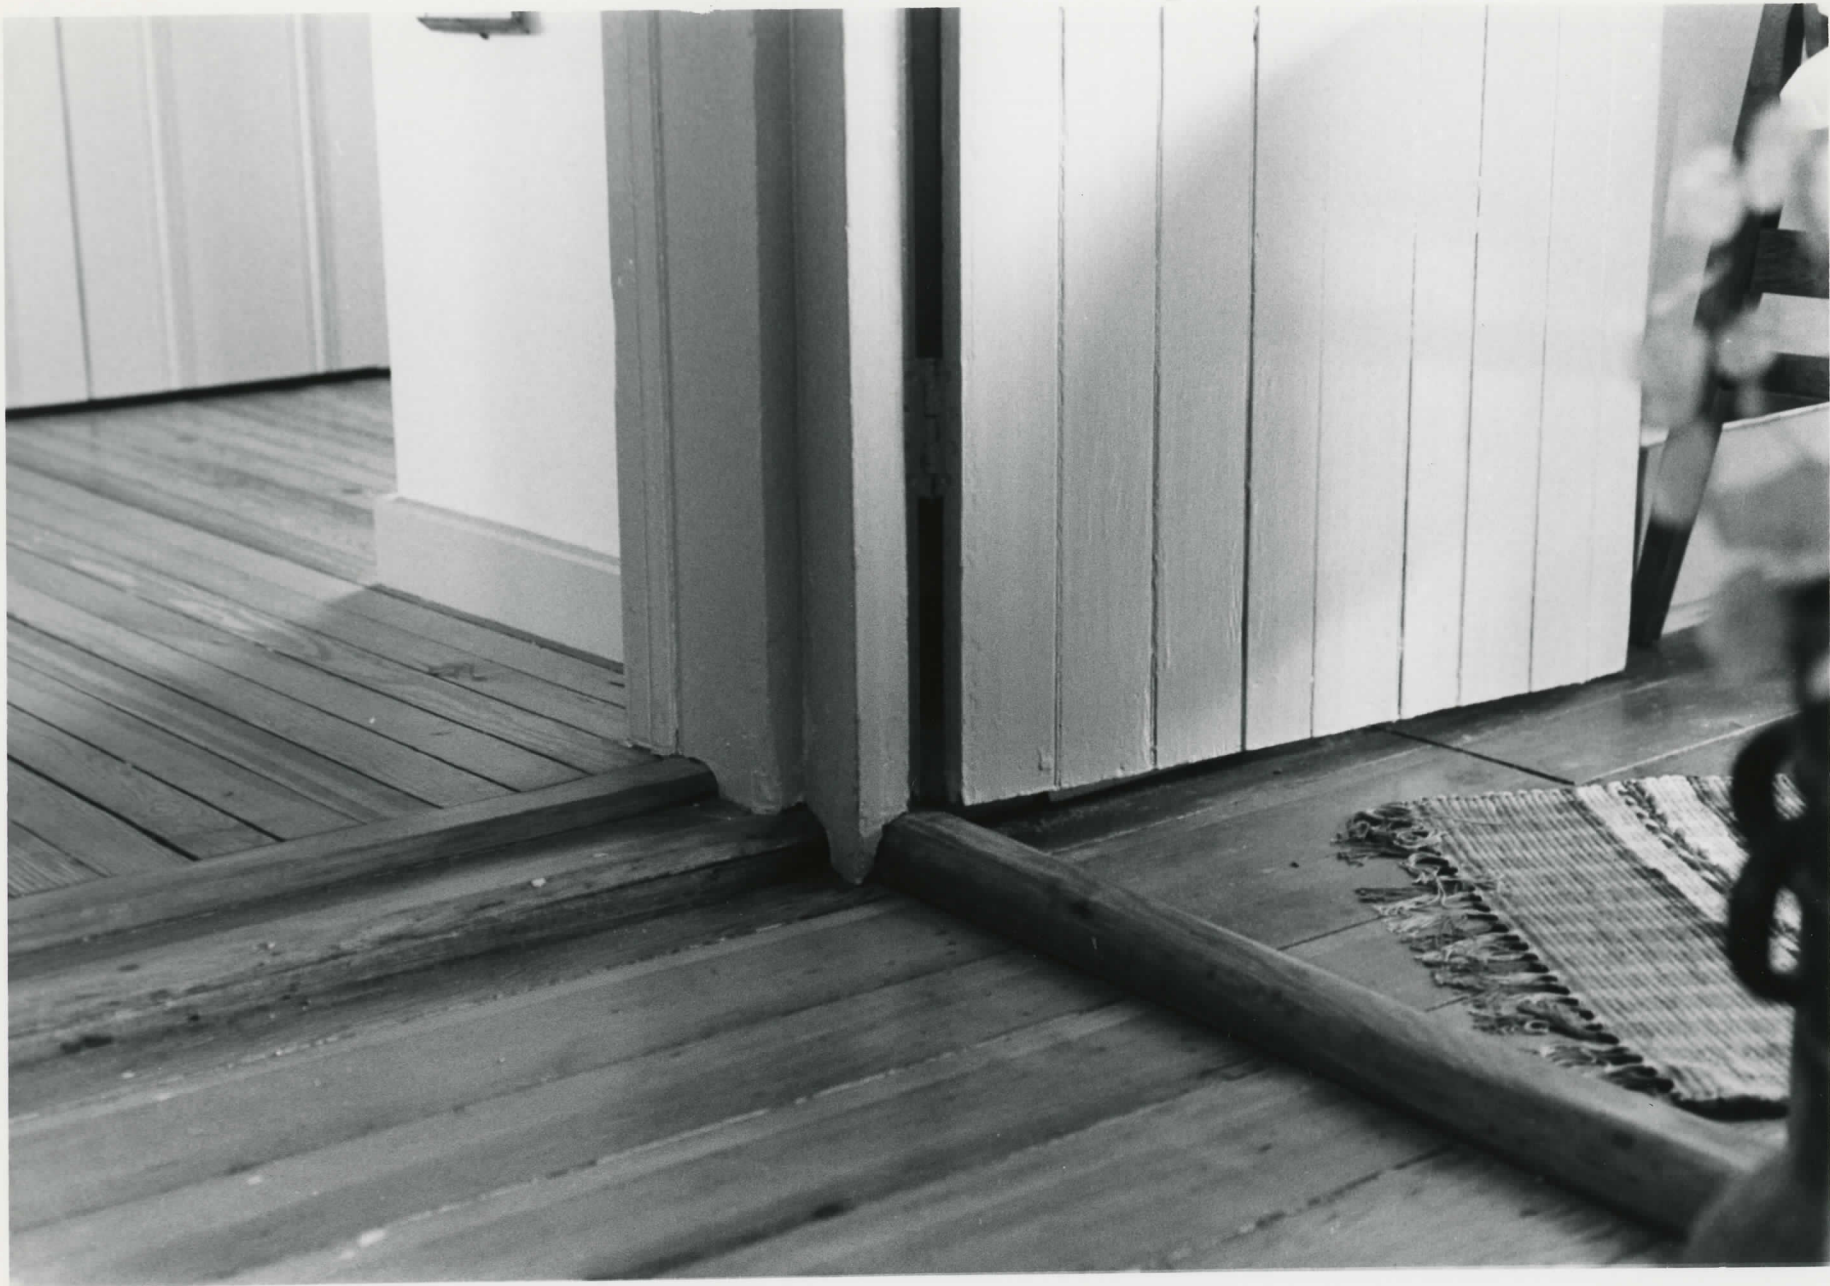
Photos

TANKERSLEY TAVERN  
Rt. 7, Box 5, Lexington, VA  
Credit: Ann Bausum  
Date: 1987  
View of Threshold, ca. 1835  
section, looking E.  
Neg. No.: 8737
